Check the QN01 safety switch located by the slip ring

Check F18 overload relay

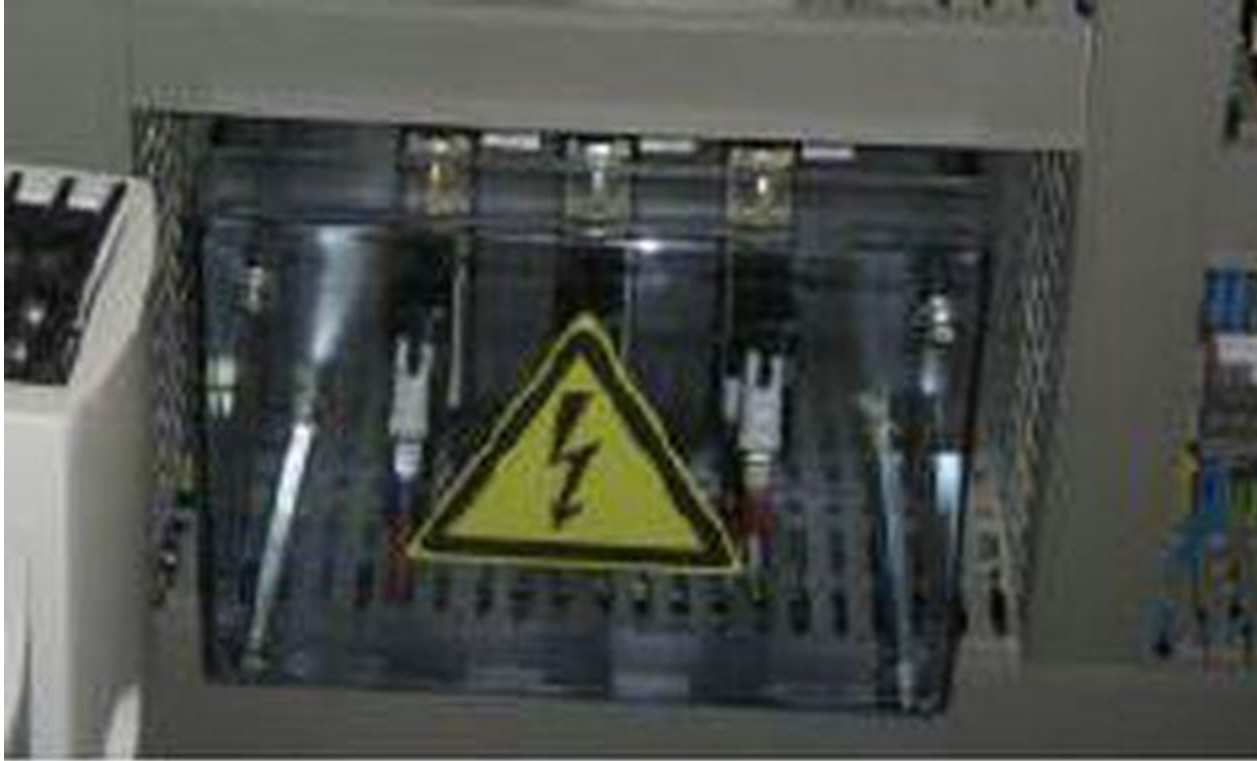
Check the Fuses in Position F17 in the AT2 cabinet

- **Explanation**
Use a multimeter to check the 125 Amp fuses in position F17. Replace any that you find bad.

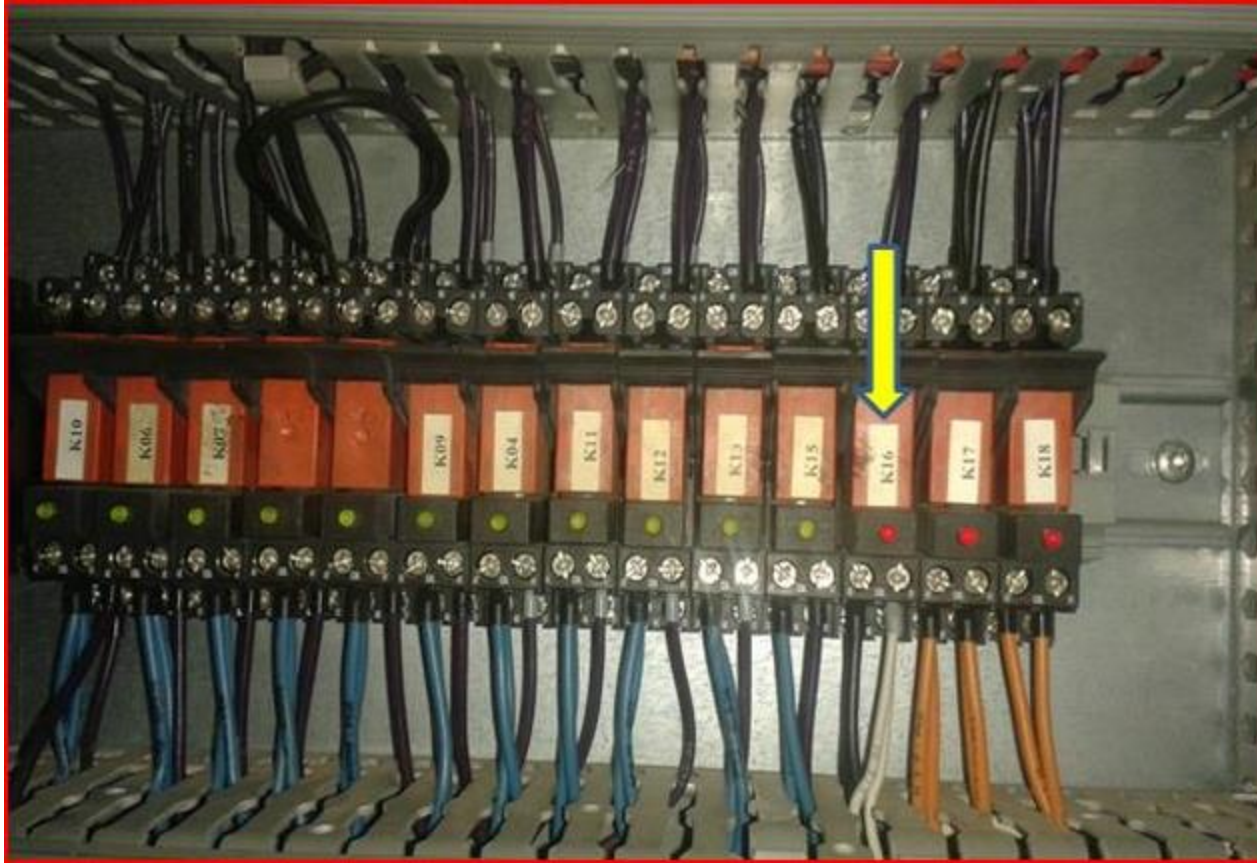
Check for loose connection at the relay K16 terminal (point11, 12, 14).

If the relay is defective replace with new.

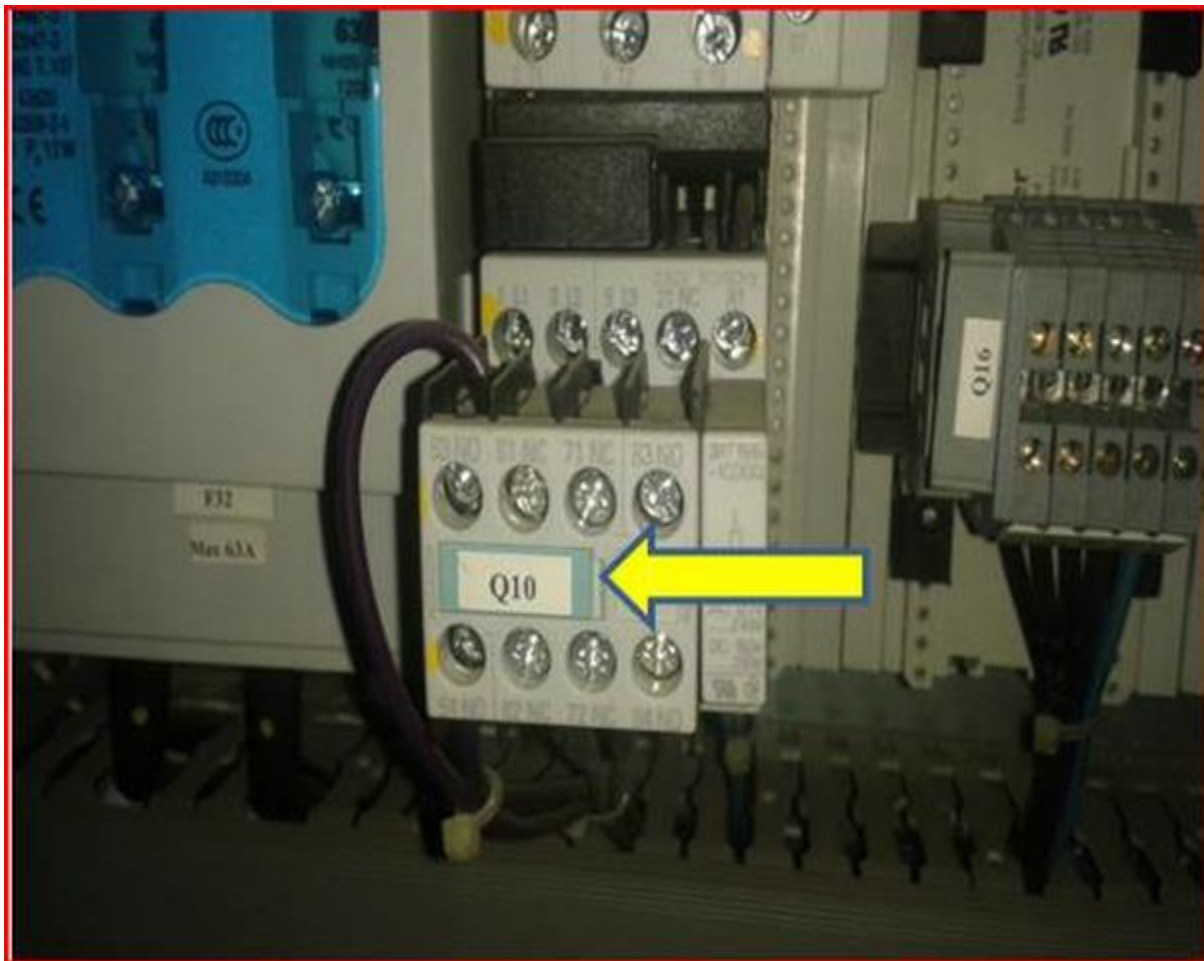
Check for any loose connection at the Pitch feeder pump aux contact Q10 terminal
(point 53 and 54)

If the Q10 Aux contact is defective replace with new.

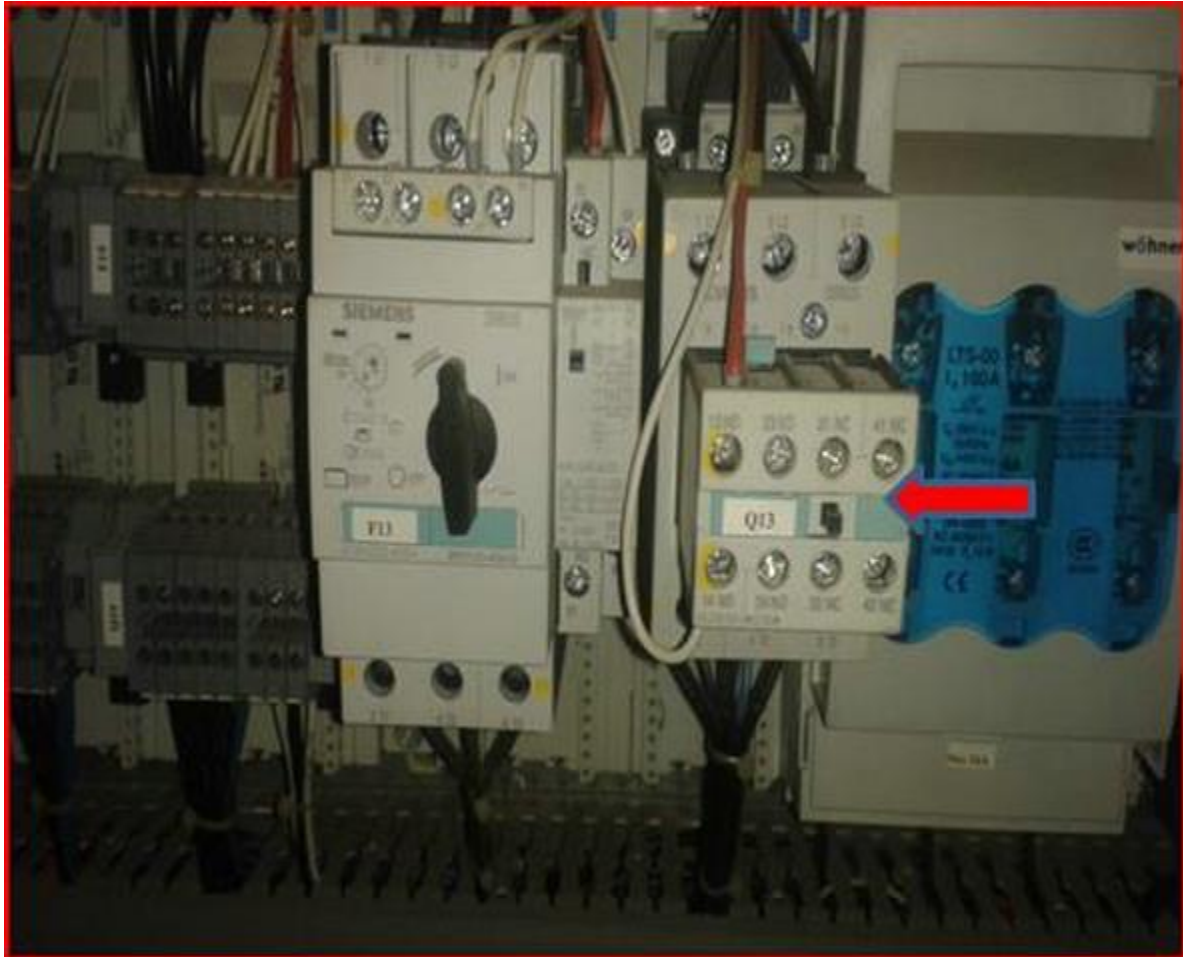
Check for any loose connection at the contactor Q13 terminal (A1 and A2) and Aux contact terminal (point13 and 14).

If the contactor is defective, replace with new.

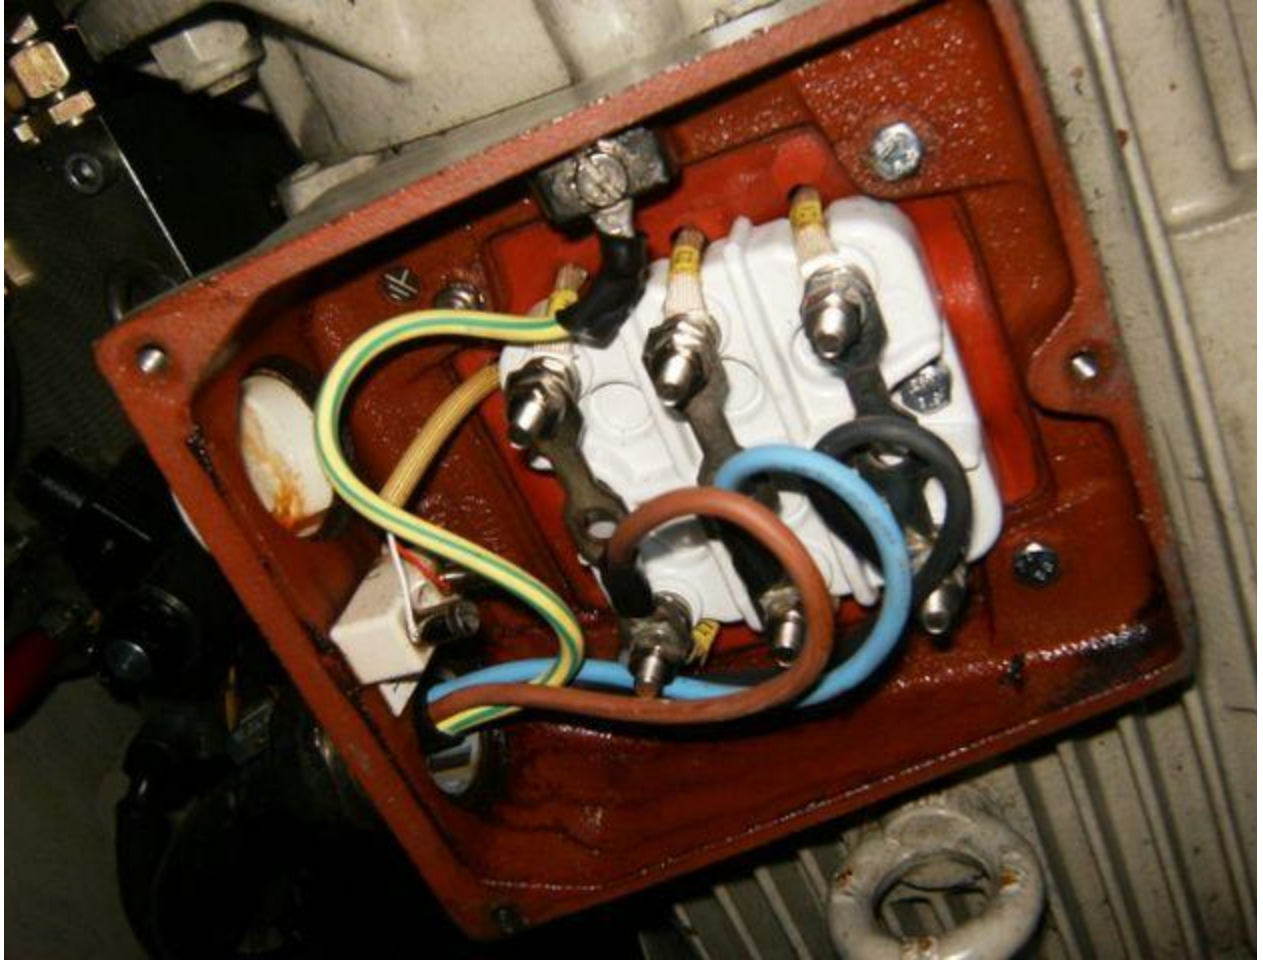
Also check all connections in the circuit for tightness. The motor leads may loosen over time.

Replacement of Pitch Pump Motor Doc#: [0001-3425](#)
