Replace the F03/F09 MCB

Replace yaw motor/magnetic coil

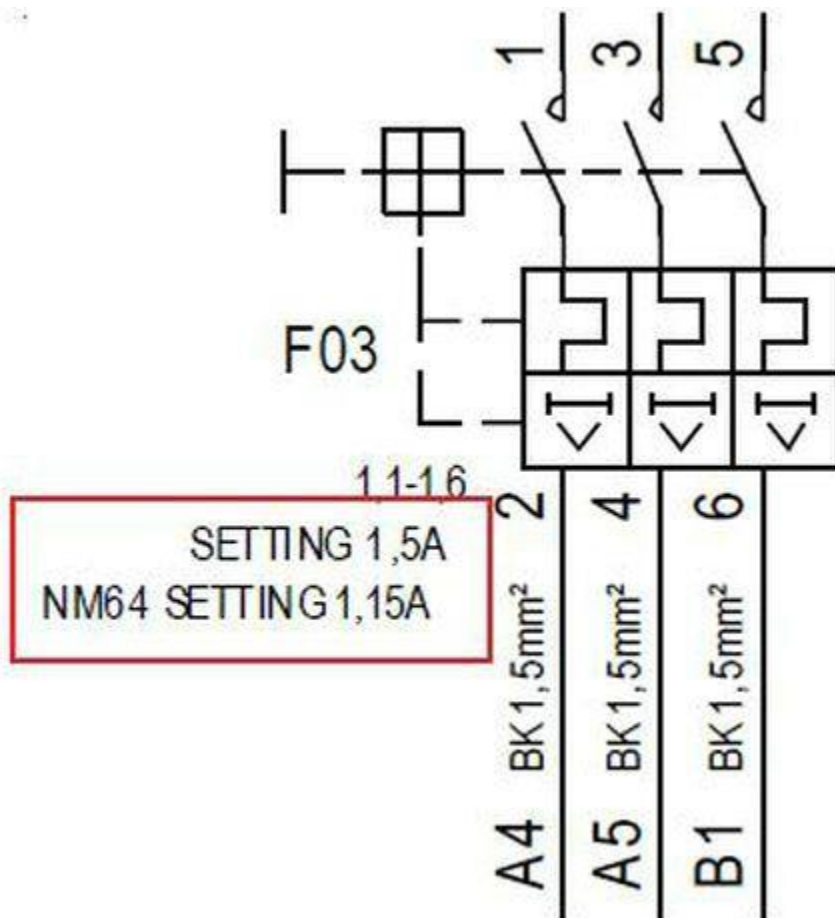
- **Explanation**
50 Hz

- Check the INPUT/ OUTPUT voltage(F03= 50Hz-F09= 60Hz)
- Check the MCB function.
- Check the MCB continuity.
- Check the required current setting in the MCB
- Check for loose connection in the terminals and cable condition.
- Check the Auxiliary relay function input to TOI.

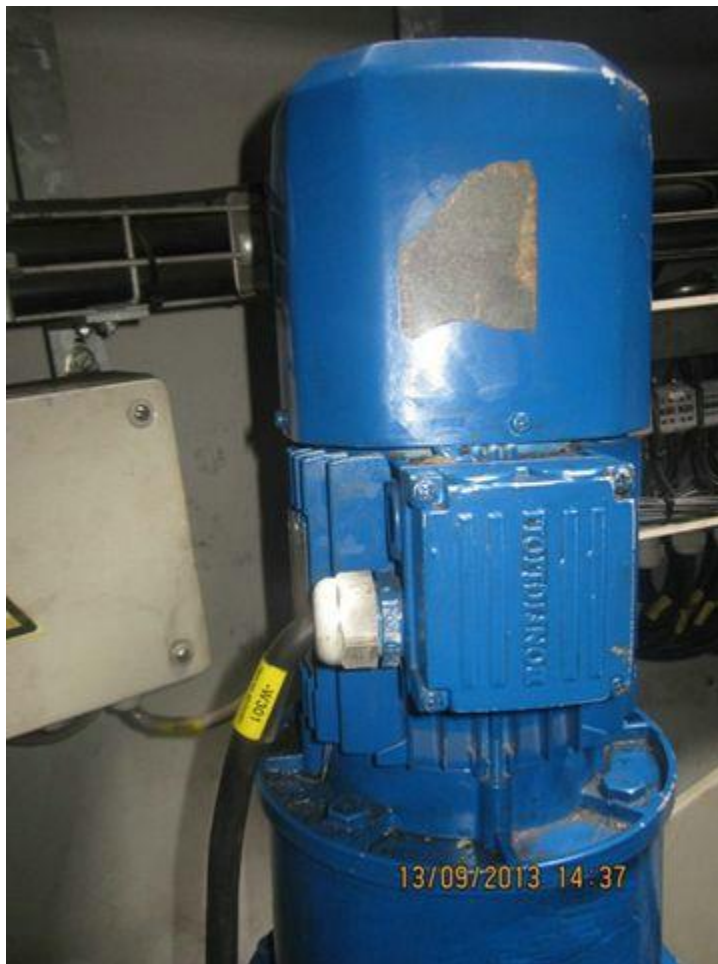
Yaw motor

- Check for any loose connection in the terminal box:
- Remove the STAR/ DELTA connections and check the Winding /coil resistance value

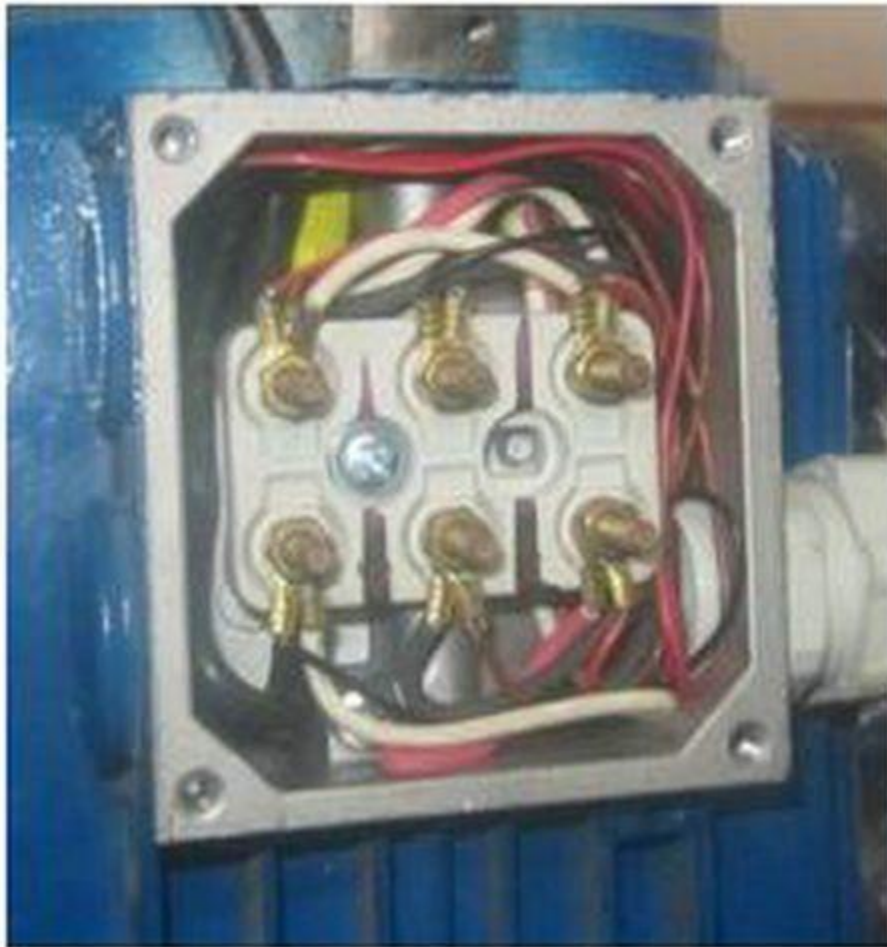
Yaw motor connection:

Remove the Yaw brake magnetic coil connection

And Measure the resistance value of the motor windings and magnetic coil.

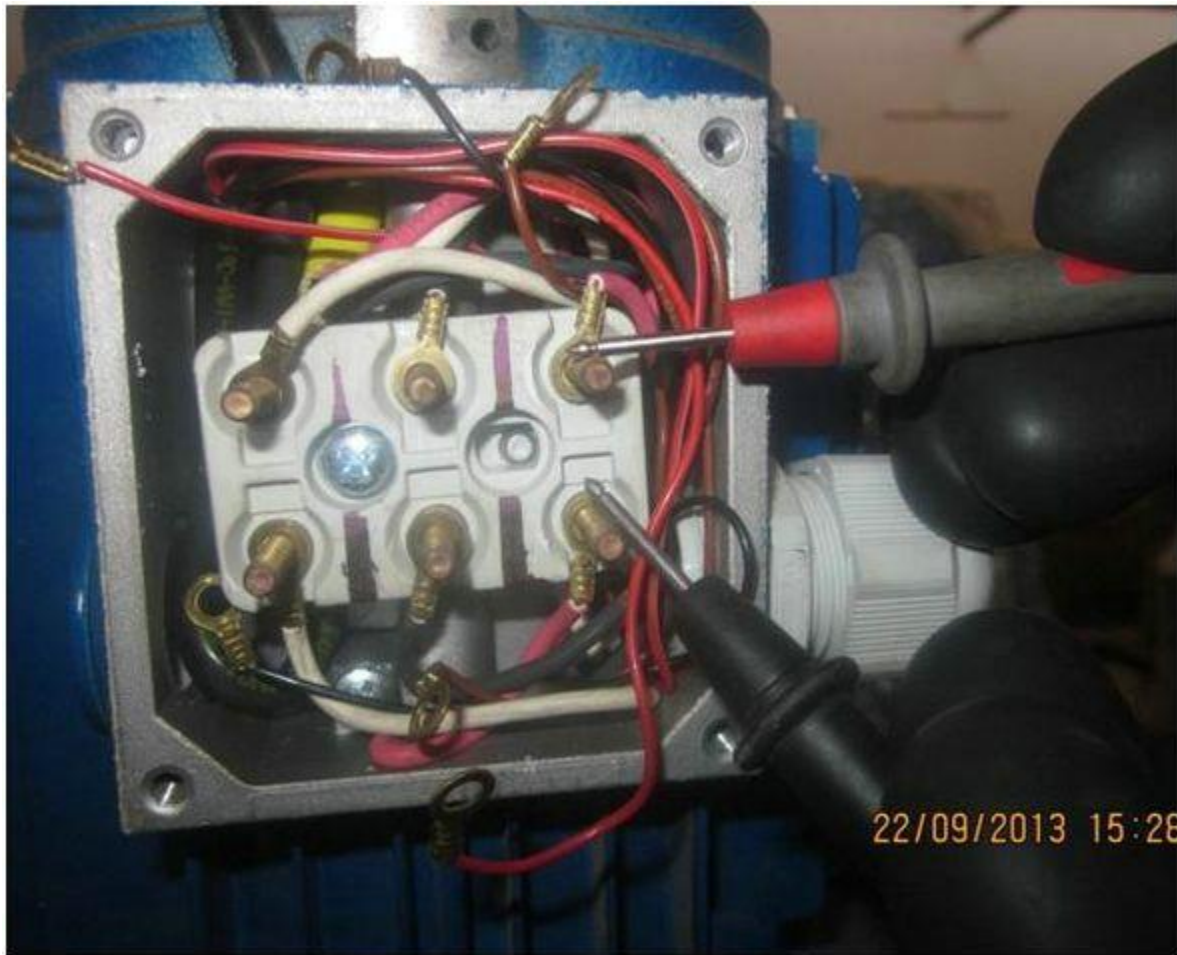
Measure phase to phase and phase to earth on all windings.

The resistance value should be $>1\text{M}\Omega$.

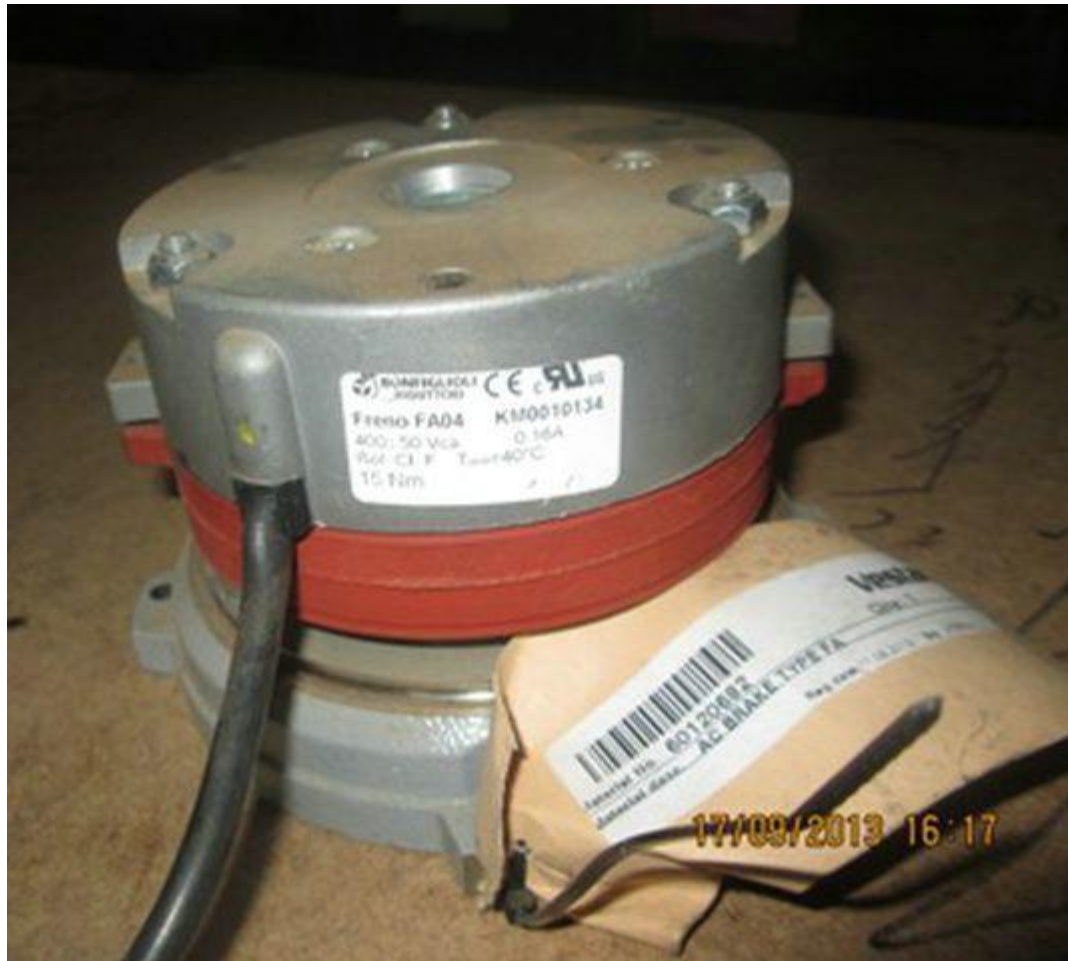
Yaw motor magnetic coil

Check & adjust the yaw magnetic brake –Refer the Service Work Instruction for Yaw System” [1000686](#)

If magnetic coil failure, we can replace coil only

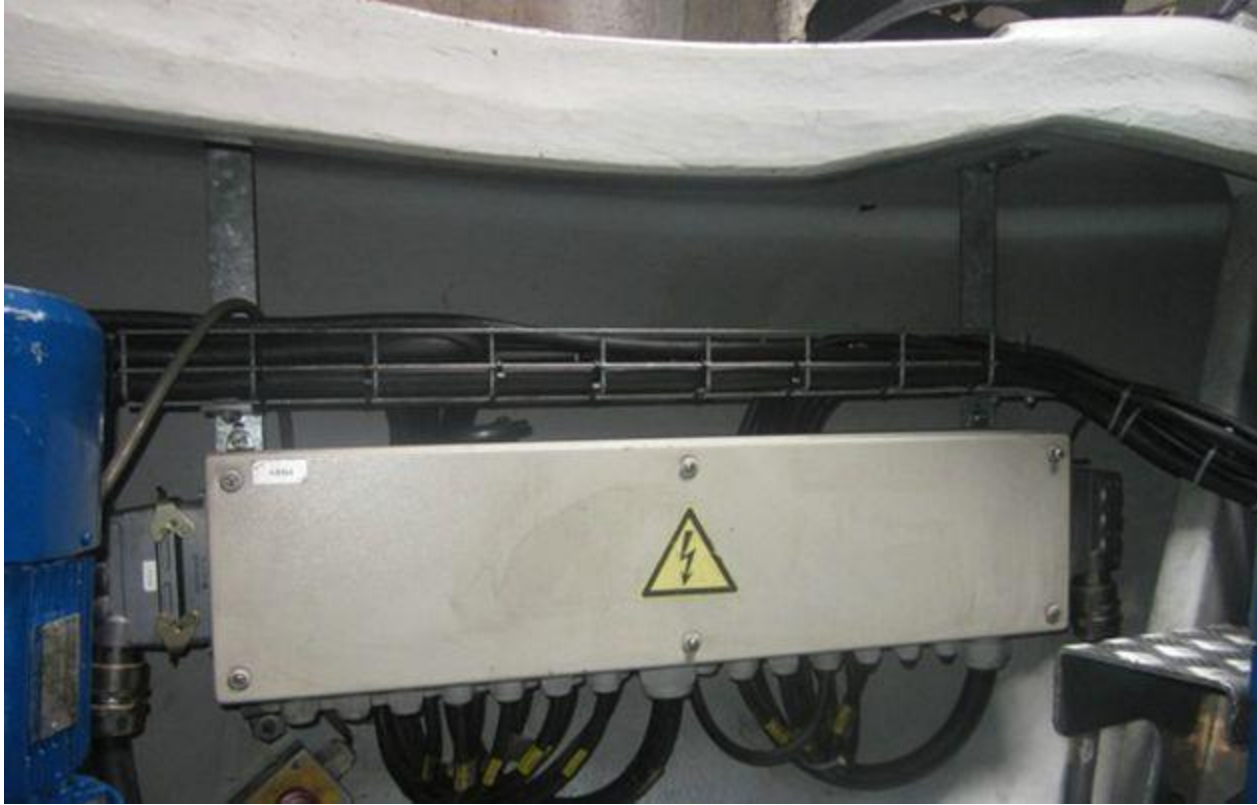
- **Explanation**
Cable coming from +AN4 to yaw motor2 terminal box

- Check the incoming cable from Control panel (+AT2) to motor box (+AN4)
- Check the cable connection from motor box(+AN4) to Yaw motor 2 terminal box (W301)

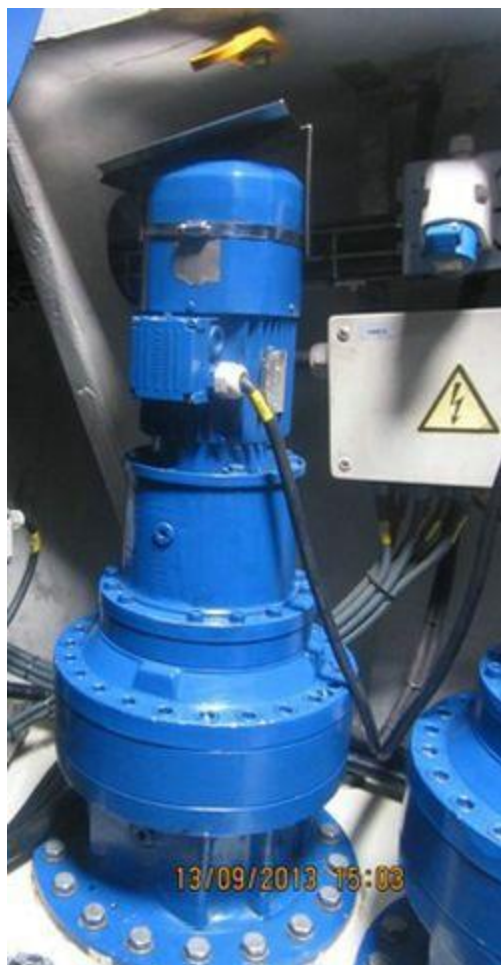
Picture view yaw gear:

- Keep the yaw motor safely
- Check the oil level in gears. If necessary, top up yaw gears with correct type of oil.
- Operate the yaw gear and observe the any kind of abnormal sound.
- Ensure yaw gear rotate or not.
- If not rotate the yaw gear unit or create abnormal noise, change the yaw gear unit as per WKI.
