**Check and replace the TAC-II, if it is found defective**

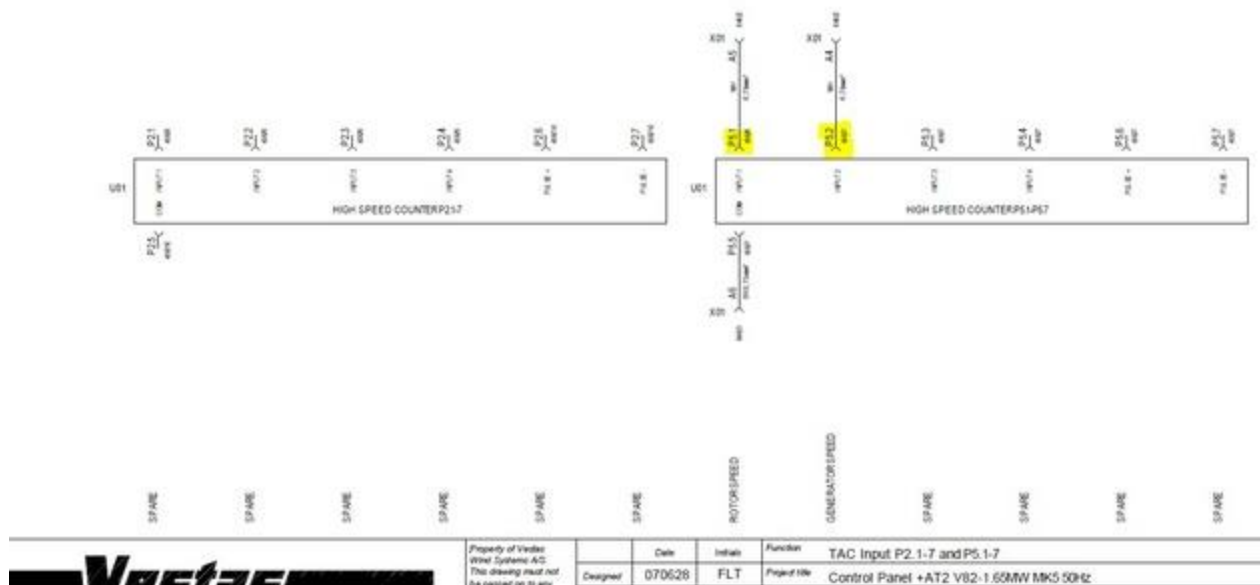
- **Explanation**  
**IN THE AT2 CABINET:**

Relevant spare parts	
Description	Item No.
CABLE Y-JZ 8G0.75mm2 IEC	<a href="#">60008948</a>
CRP TERM 0.75 8MM INS SINGLE	<a href="#">60006336</a>
