Check and replace the defective needle valve

PARKER SYSTEM:

REXROTH SYSTEM:

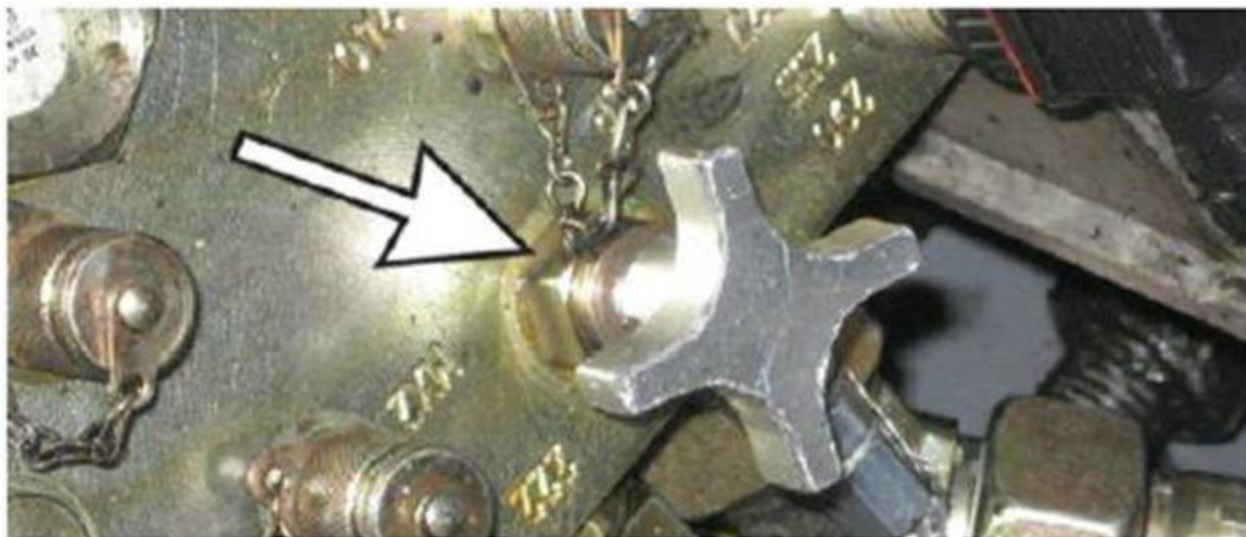
Description	Item No.
NEEDLE VALVE, NVH-2201	60104032
KNOB FOR NEEDLE VALVE	60112623

Swap the needle valve to quickly determine if it is leaking.

If defective, replace with new.

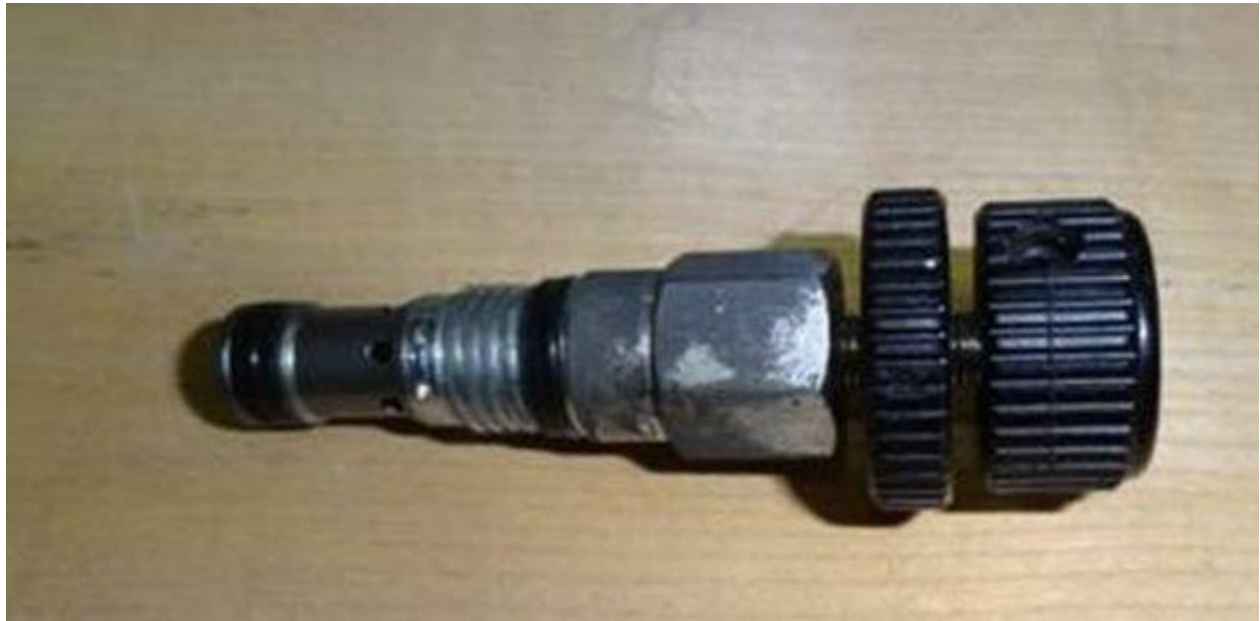
Needle valve part number for REXROTH System –TYPE-1: (POS: 447, 222)

THROTTLE VALVE: NFBC-KCN A3031	60096478
HANDLE FOR NFBC-KCN A30316JG01	60109005

Ensure the Rexroth hydraulic system needle valve type before replacing.

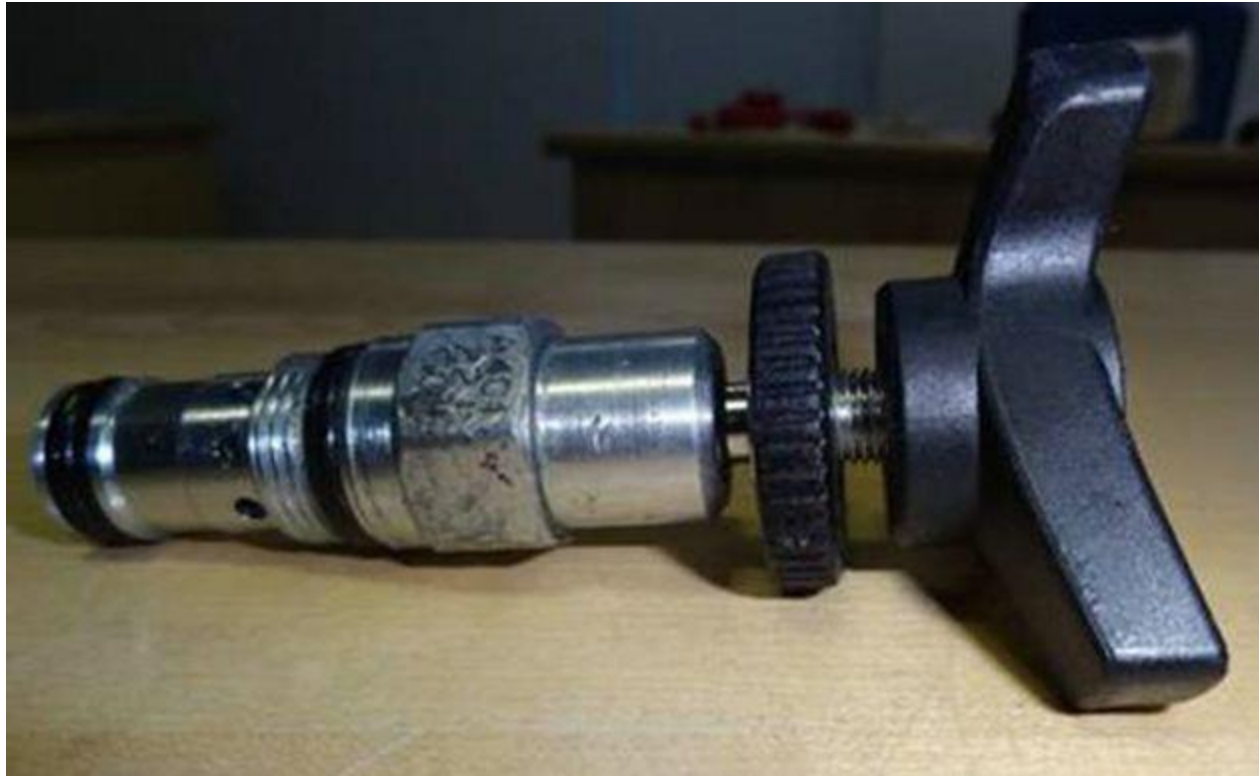
Needle valve part number for REXROTH System –TYPE-2:

Relevant spare parts	
Description	Item No.
THROTTLE VALVE NFCC-LCN A40122	105103
HANDLE FOR THROTTLE VALVE NFCC	60112482

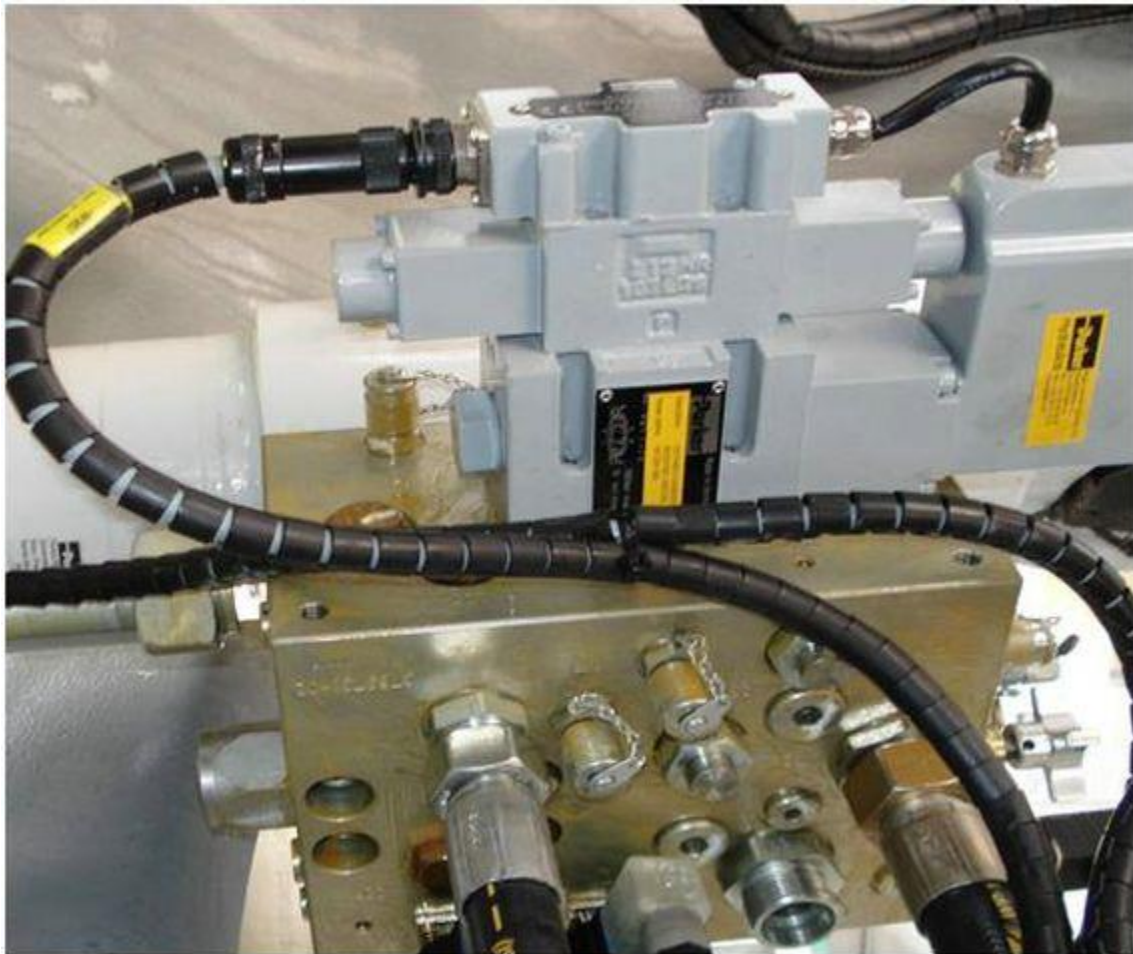
Check the following position valves:

Swap the valves one by one in to other manifolds and check valve operation.

If the fault shifted to other blades the valve is likely defective. If not check other valves.

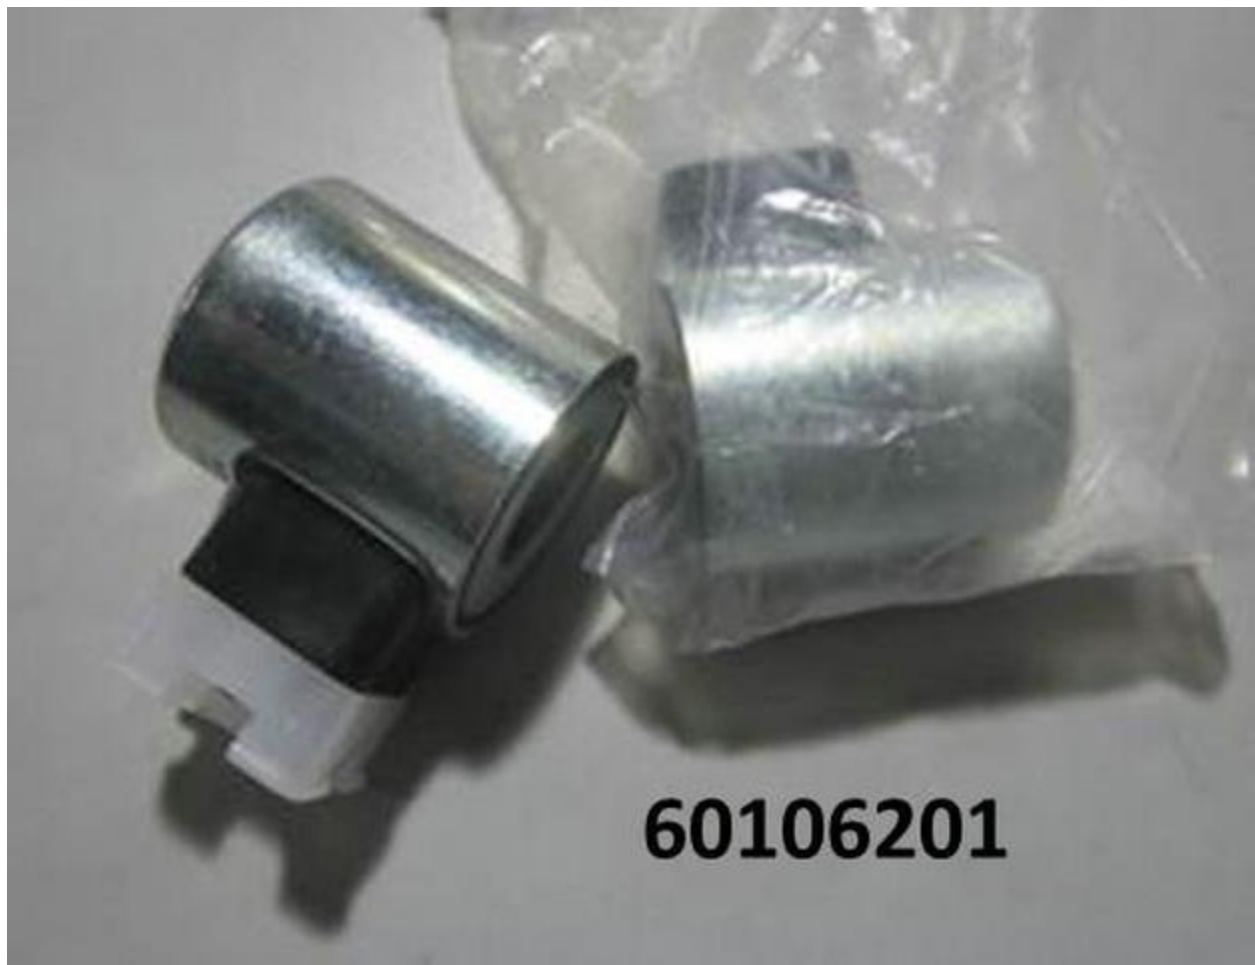
The part No.60096475 is phased out and henceforth replaced by 109795 & 60106201.

(Rexroth) Valve/Solenoid- 440

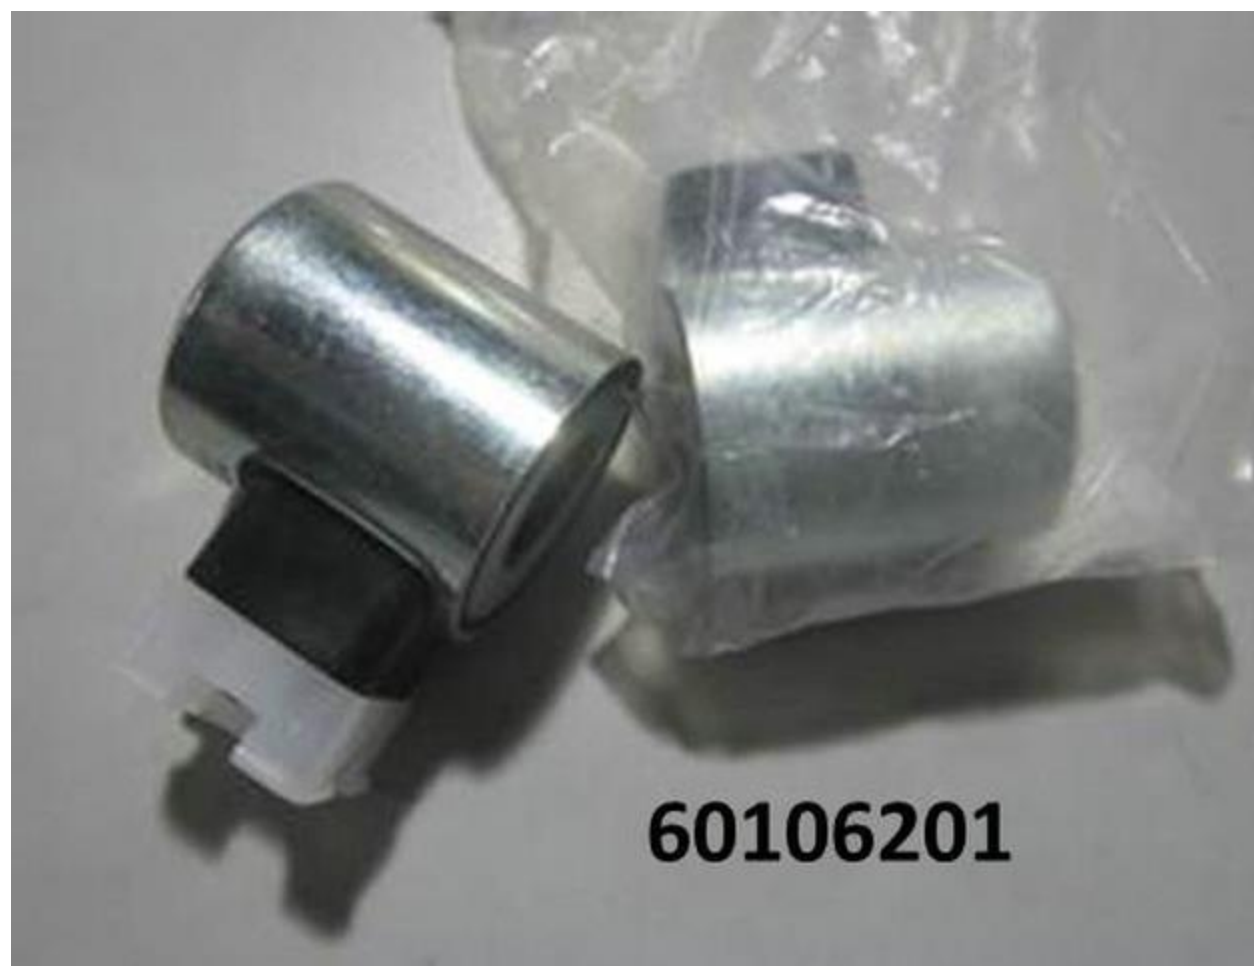
60106201

The part No.60096475 is phased out and henceforth replaced by 109795 & 60106201.

(Rexroth) Valve/Solenoid- 210 & 215

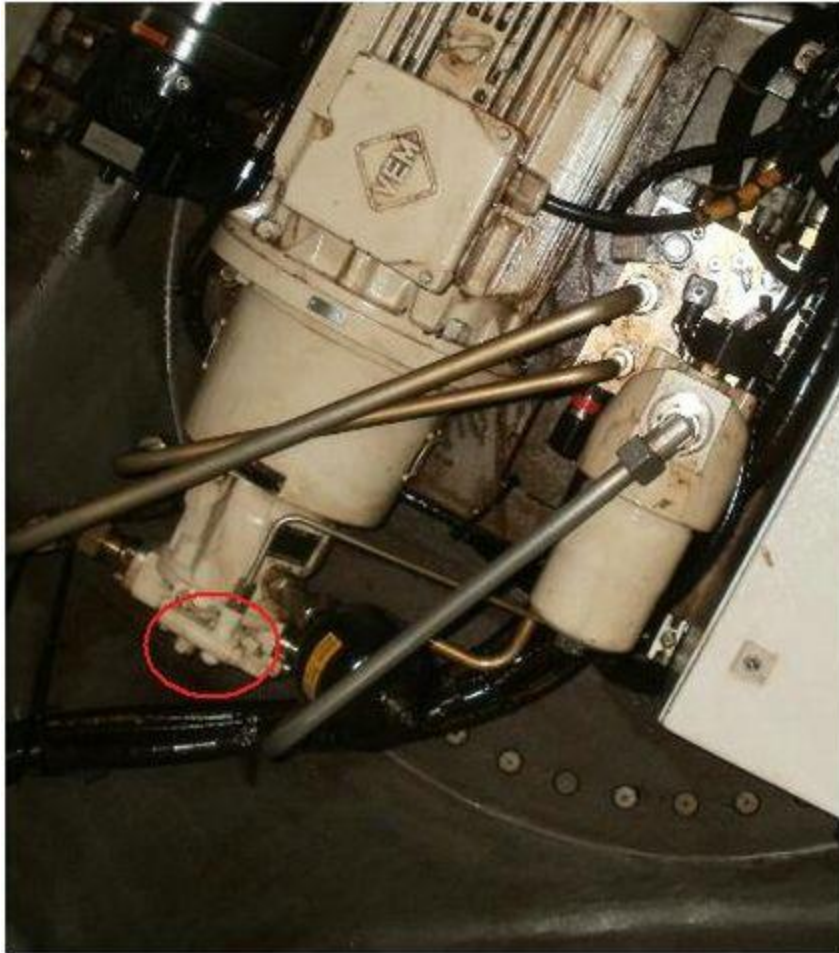
REXROTH SYSTEM:

Check the compensator valve (relief valve) setting in the hydraulic pitch pump.

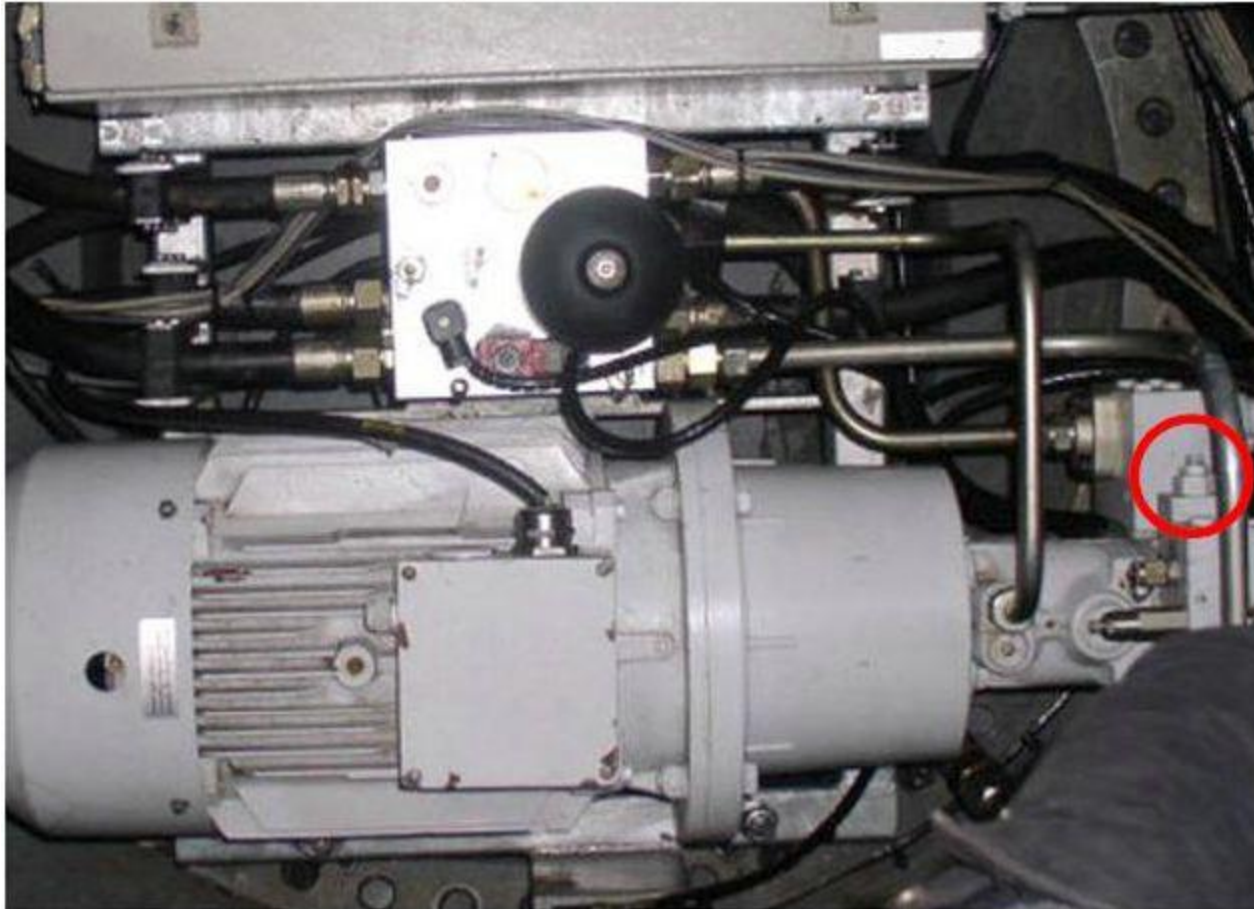
Parker hydraulic systems have two different types of compensator valves.

Ensure the valve type before replacing with a new valve.

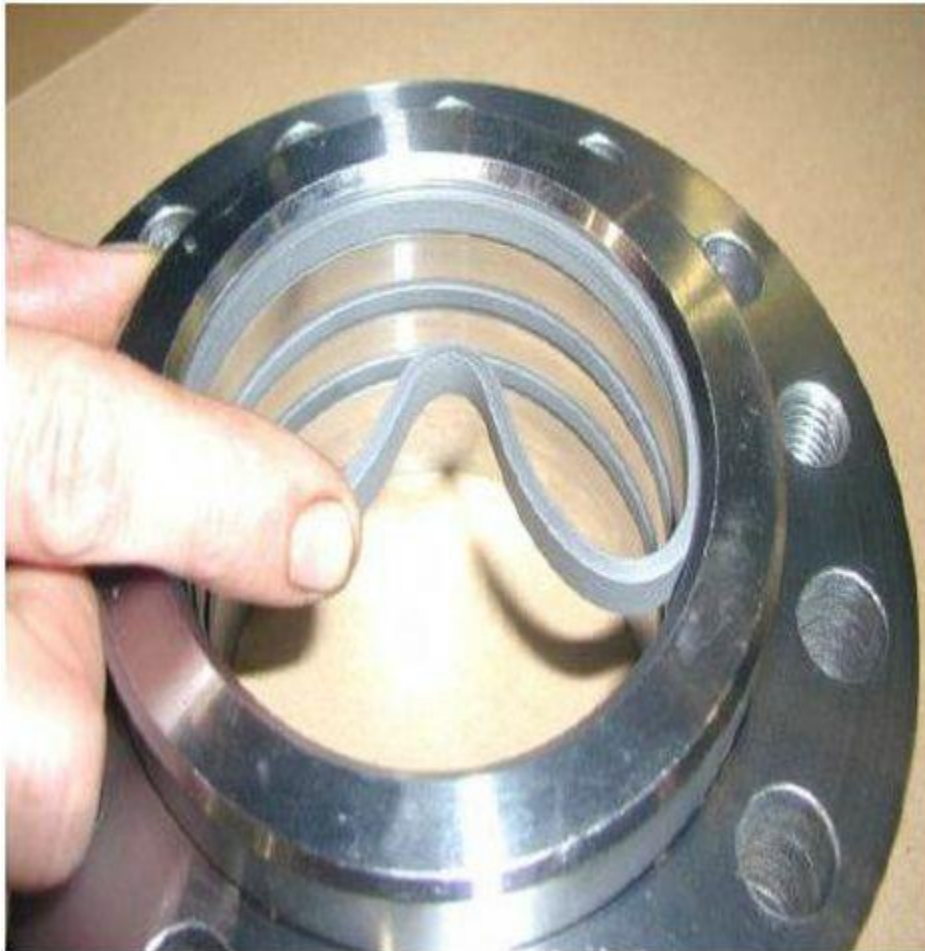
Note: An individual Parker cylinder can be replaced with a Rexroth cylinder in any combination (example: 1 Parker and 2 Rexroth or 2 Parker and 1 Rexroth). Refer to Technical Info Sheet “TIS_V82_Replacing Parker Cyl w/Rexroth” DMS # 0059-7339 for instructions on making this conversion.

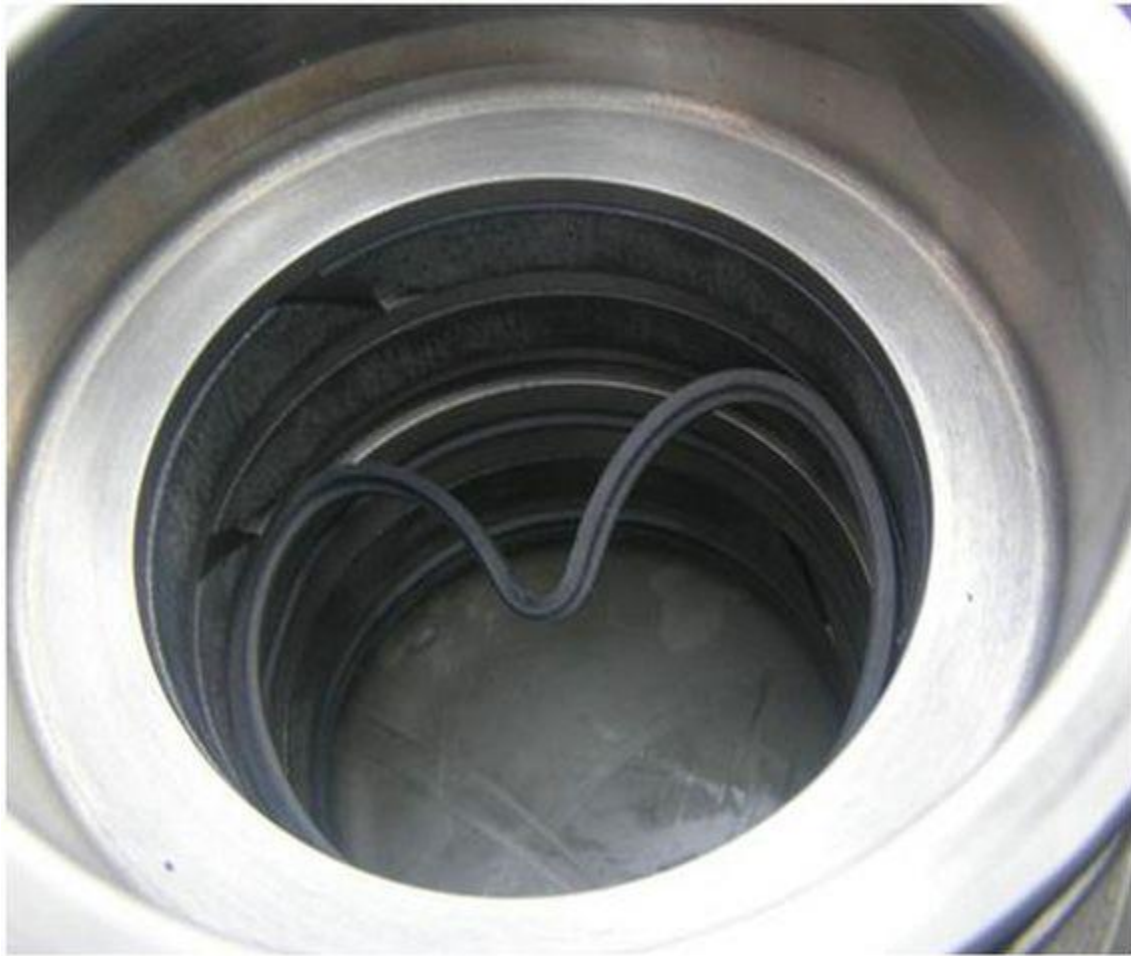
REXROTH System:

Relevant spare parts (Rexroth Actuators)	
Description	Item No.
HYDR CYL 140/90x884 STD+AR	60114028

HYDR CYL 140/90x884 STD+AR	60114091
----------------------------	--------------------------
