Check pump and accumulator pressure

Check and adjust the Motor- Pump coupling

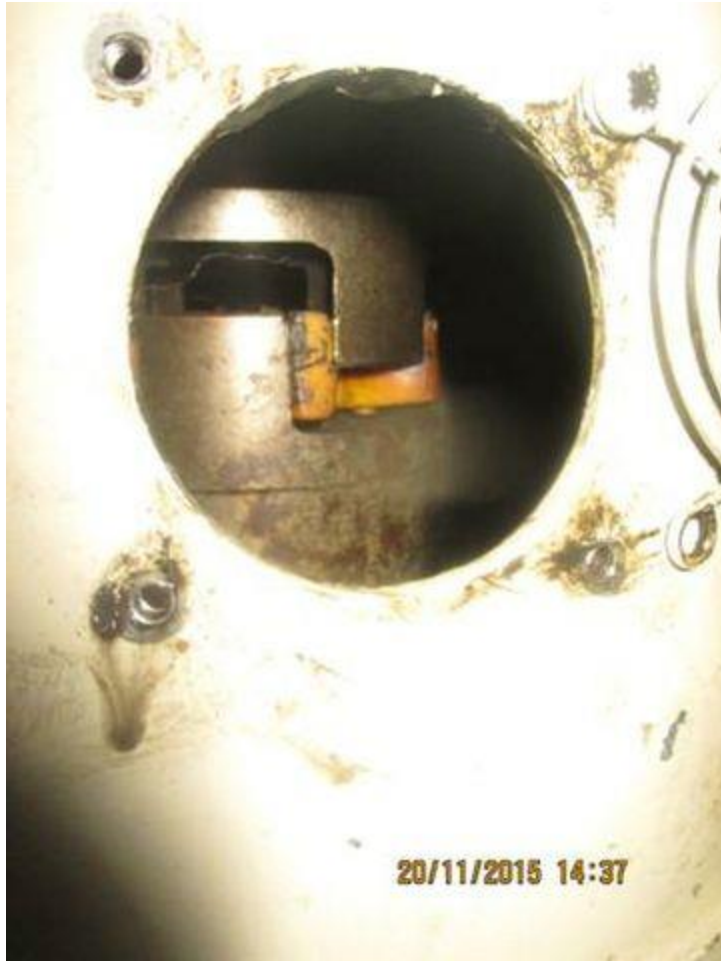
Coupling dislocated view:

- **Explanation**
Check the Pitch Main pump-Motor (M01) coupling for any dislocation from its original position as shown below;

If coupling found damaged, replace the same with new one.

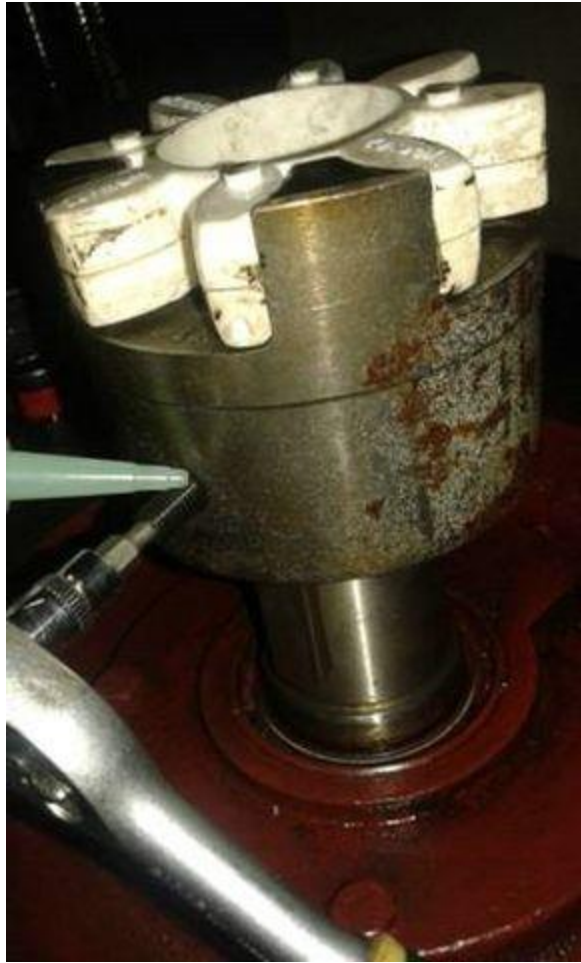
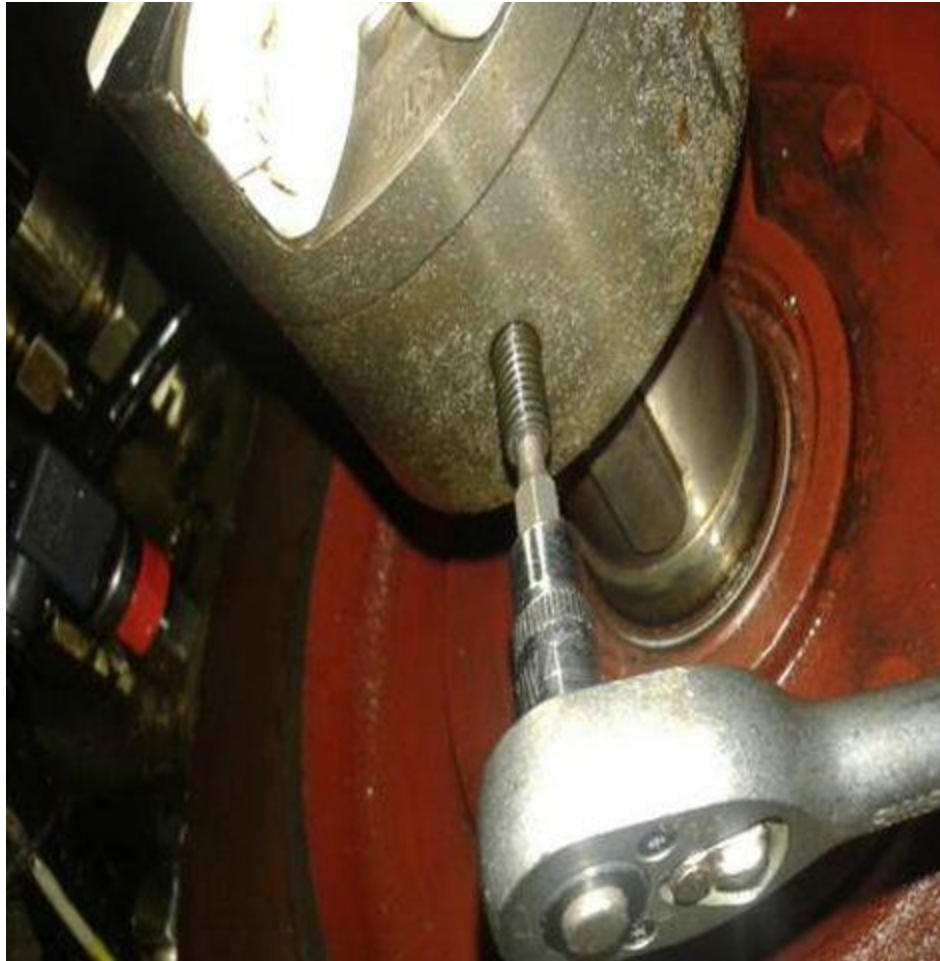
Apply Loctite 243 while assemble the grub screw as shown below;
