Perform the blade position calibration

Controller - NM82/72 - 1650kW - Power Supply - Poor performance

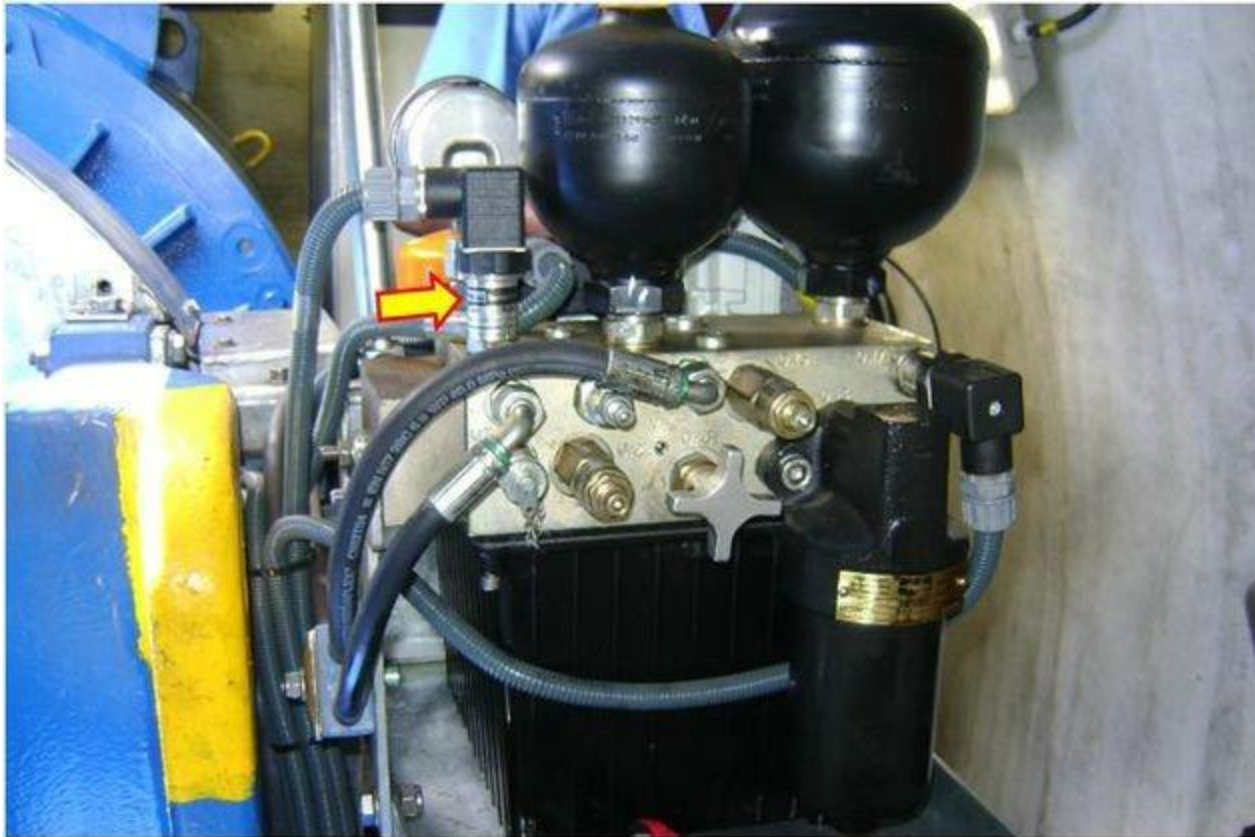
Check the pressure value through the TAC -II controller,

Status→ Pressure→ Pressure shaft brake.

If the displayed pressure shows as a negative value, the pressure transmitter is may be defective and has to be replaced

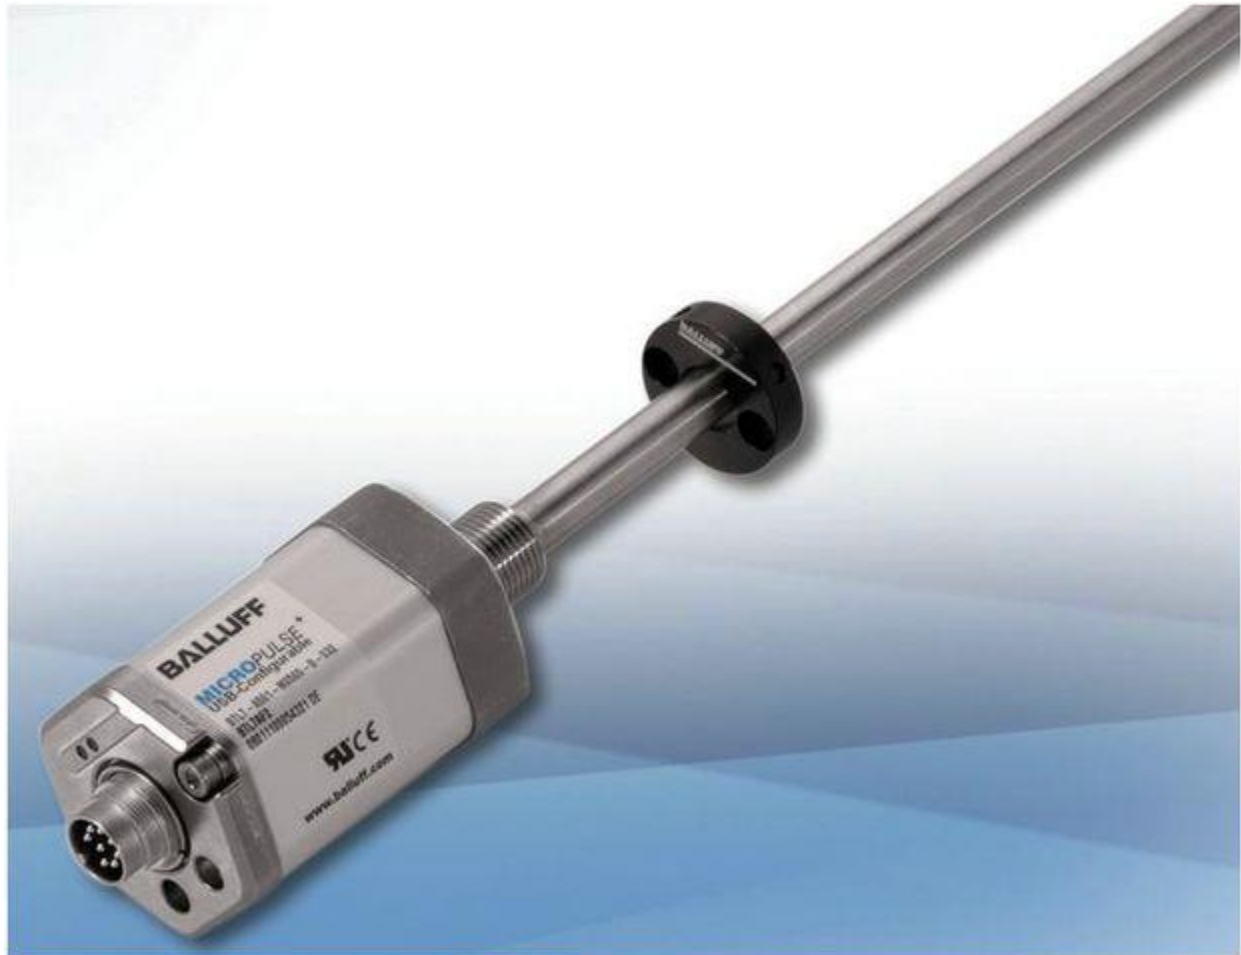
Description	Item no.
TRANSDUCER BTL5-E10-M0950-A-S	60098816

Service Module Item Number:

Relevant Spare parts	
Description	Item no.
SERVICEMODUL, BTL5 - E10	60102394

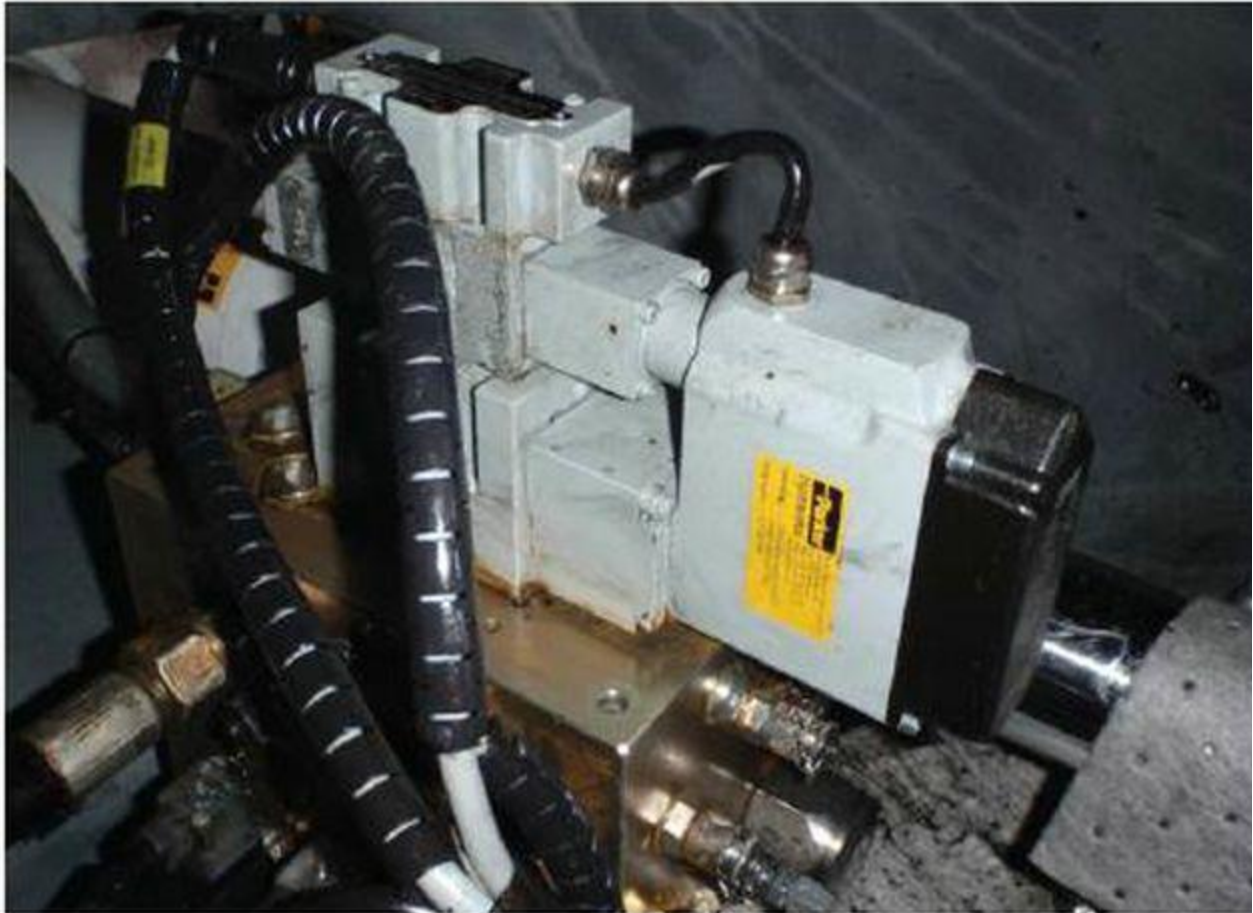
First swap the signal wire to the proportional valve on the hub computer.

If the fault follows to the new blade then the fault is either in the proportional valve or one of the cables.

If the alarm follows the valve to the other blade, the proportional valve is defective.

If it does not, the proportional valve is likely not the cause.

If it is red and there is pressure verified on test port MP, then the valve may also be defective.

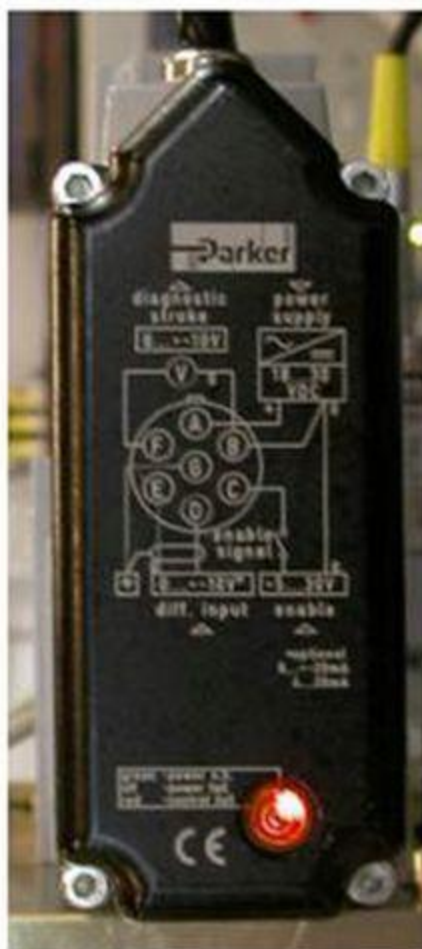
For Parker proportional valves check to see the color of the LED on the valve circuit board.

The LED should be green with the pitch system pressurized.

Display Color	Indicates
Green	Normal operation
Off	Supply voltage outside permissible range of 18 to 30 VDC
Red	Spool position error / Low pilot pressure
