## Perform the blade calibration as per the WKI

## Replace the defective power net

## Replace the defective Pitch position sensor and defective cables

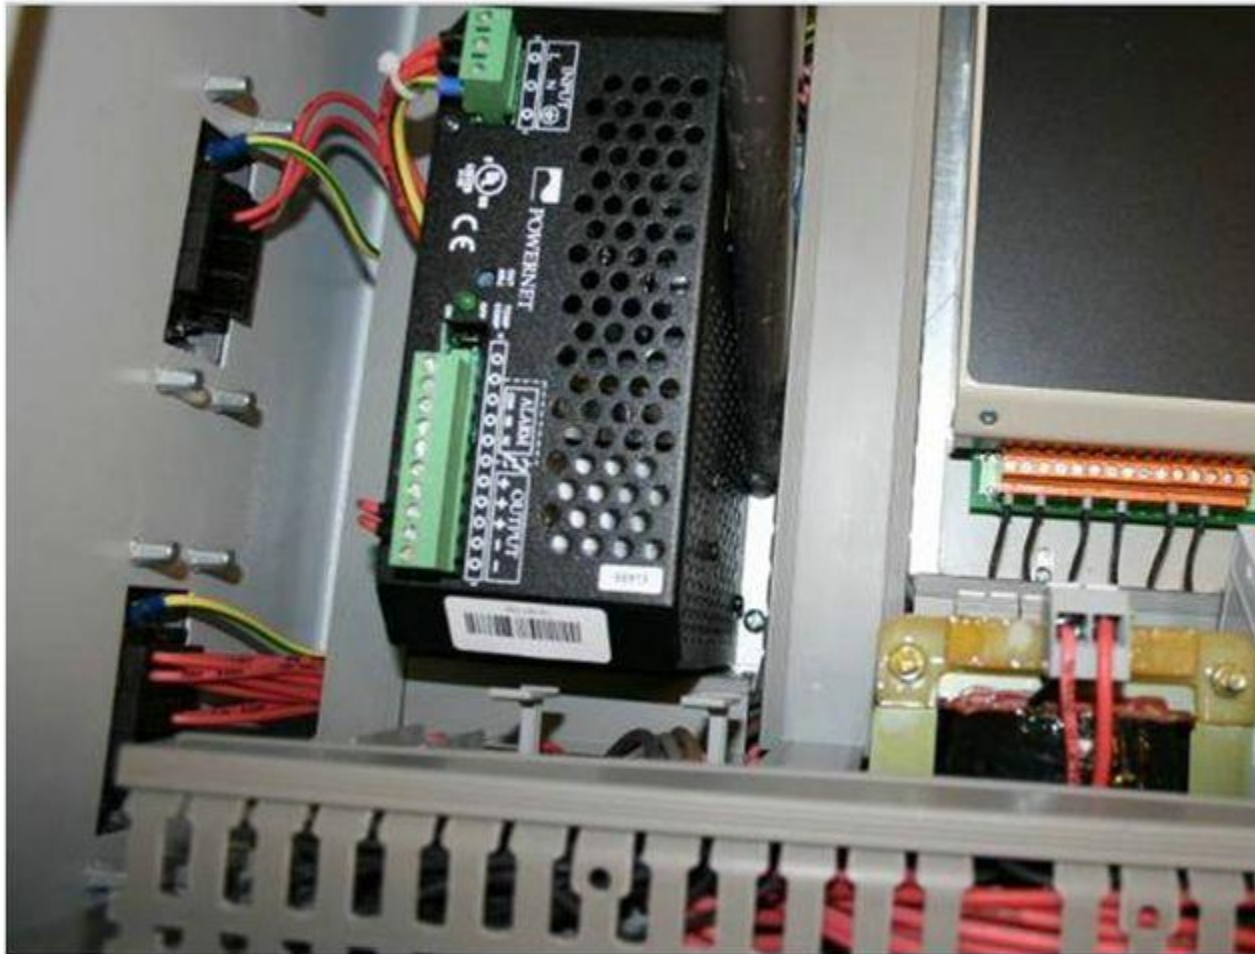
Check for any loose connections at the power net (Pos: G401).

Check input and output voltage 230/115VAC /24VDC

If defective replace the power net.

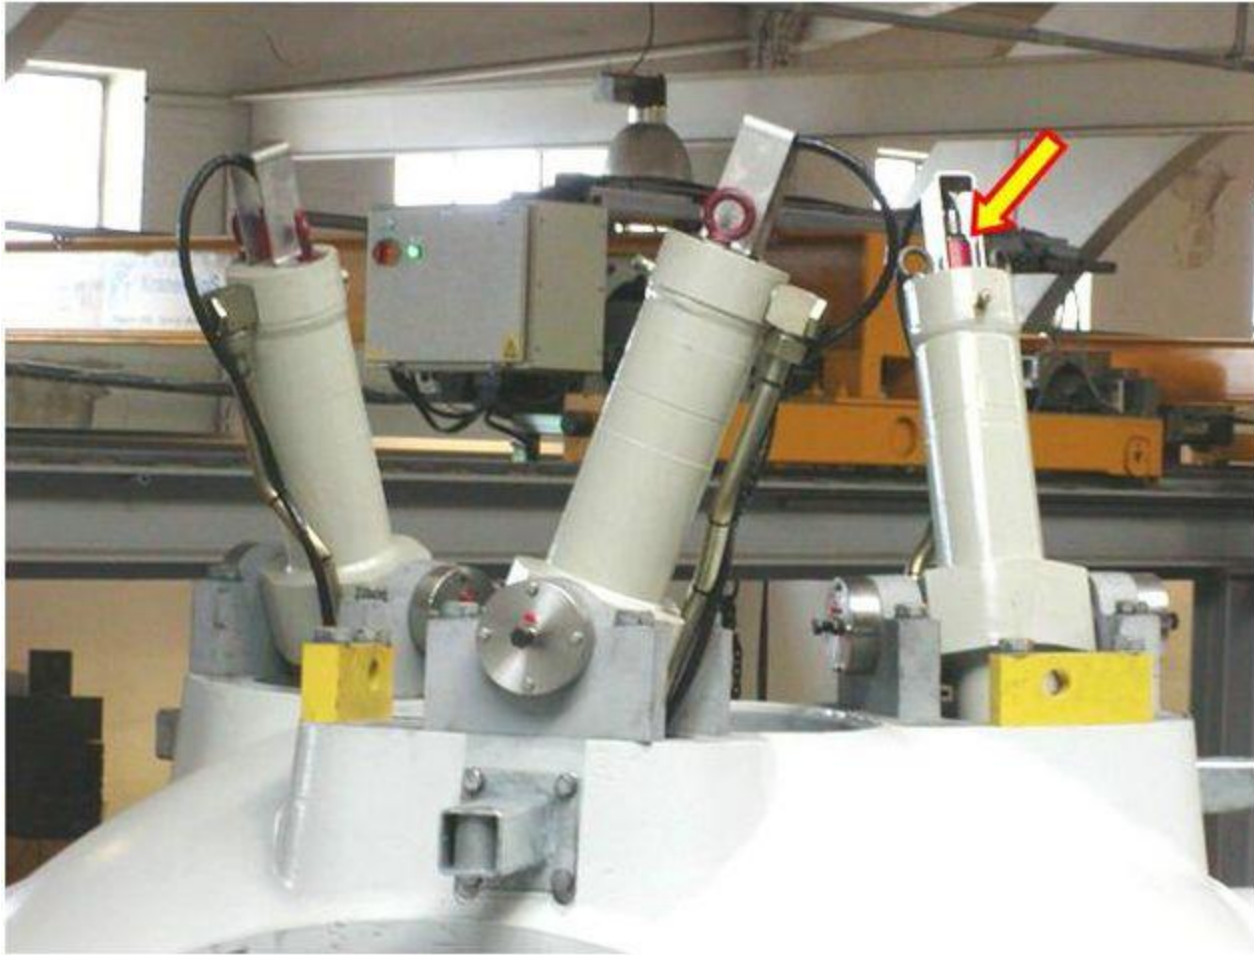
Check for any loose connections in the hub computer terminal X19.

Check for any loose connections on the Blade position sensor.

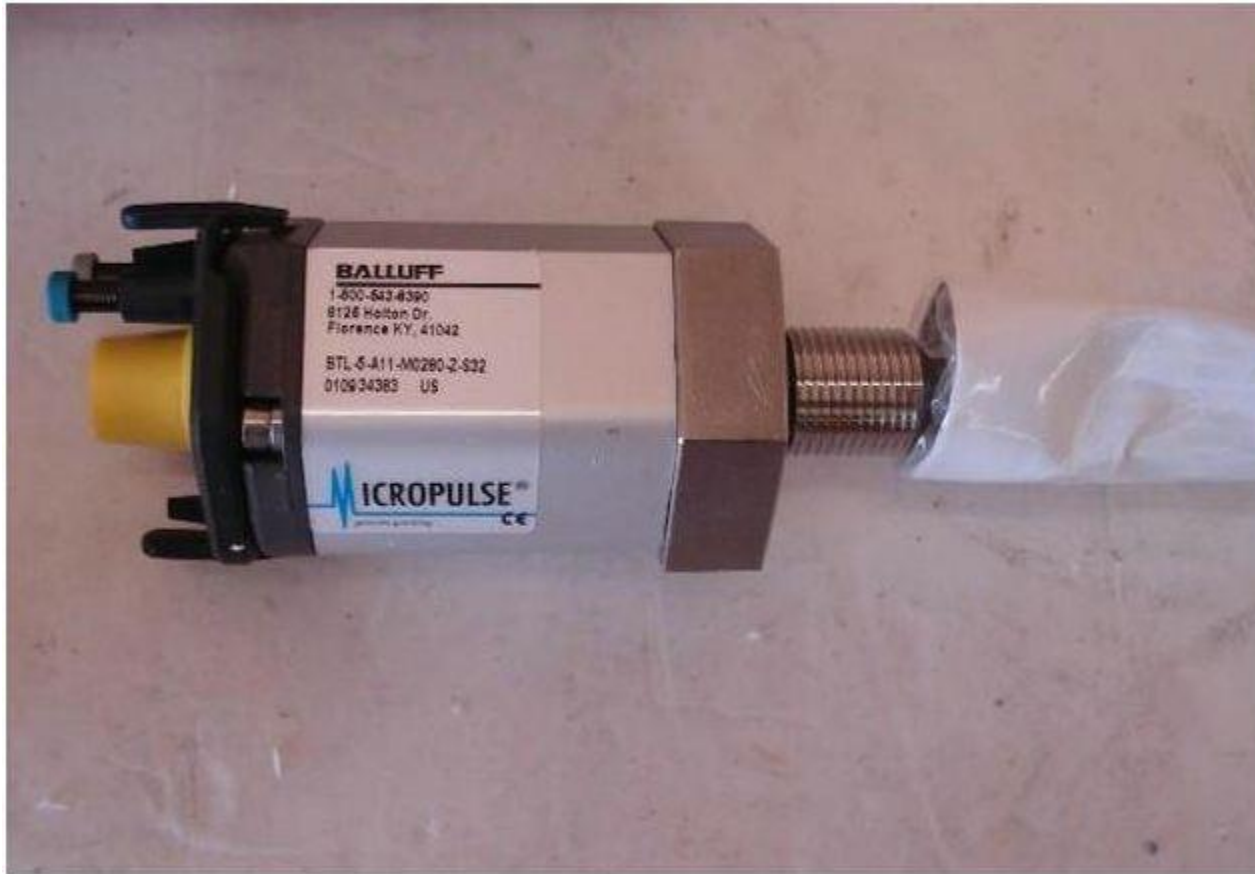
#### Pitch position sensor Item number:

Description	Item No.
TRANSDUCER BTL5-E10-M0950-A-S	<a href="#">60098816</a>

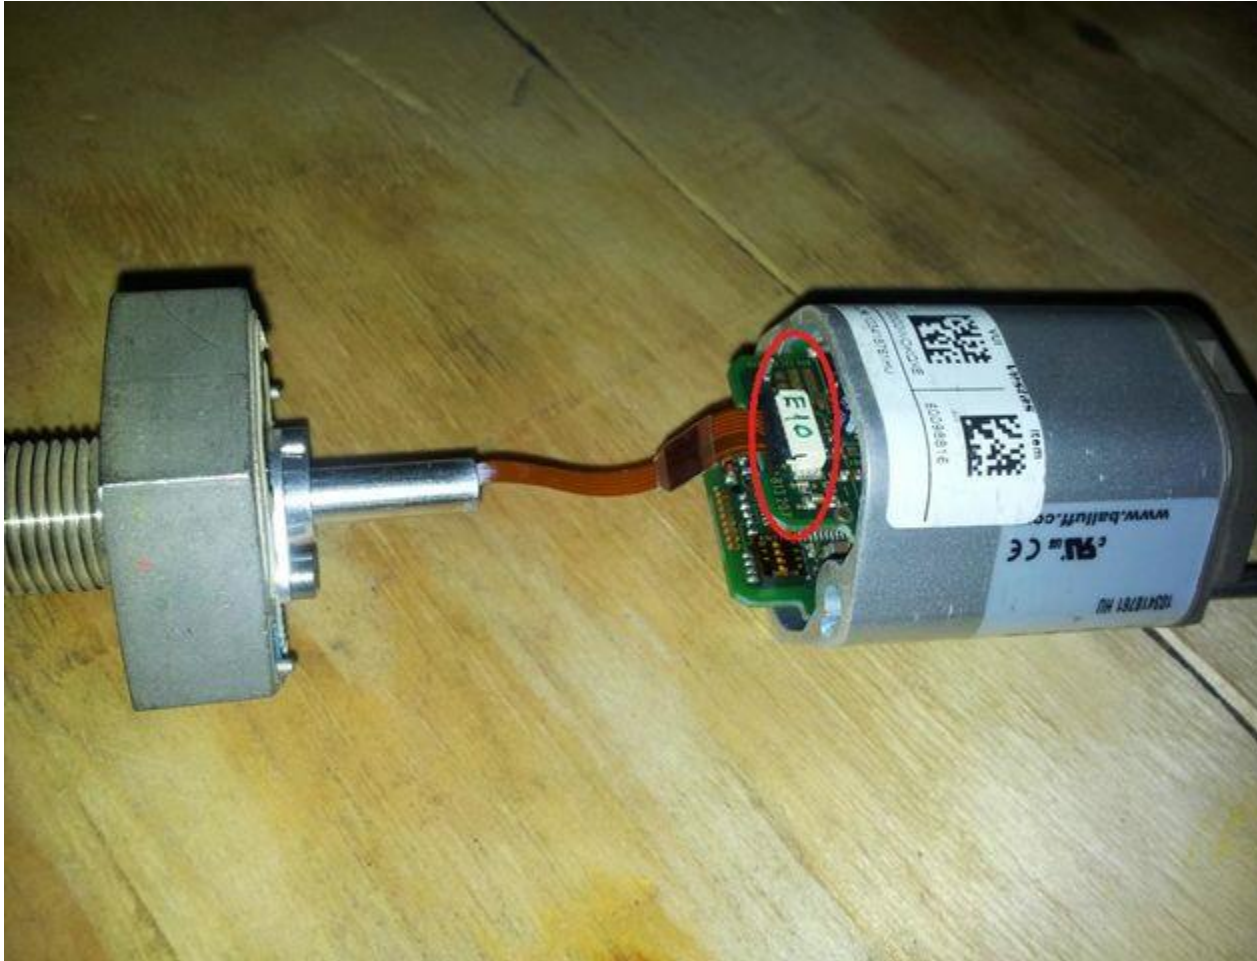
Check the cable for any or short due to the cable rubbing near the hub casting or friction between the cable and the hydraulic hose.

Replace any defective cables.

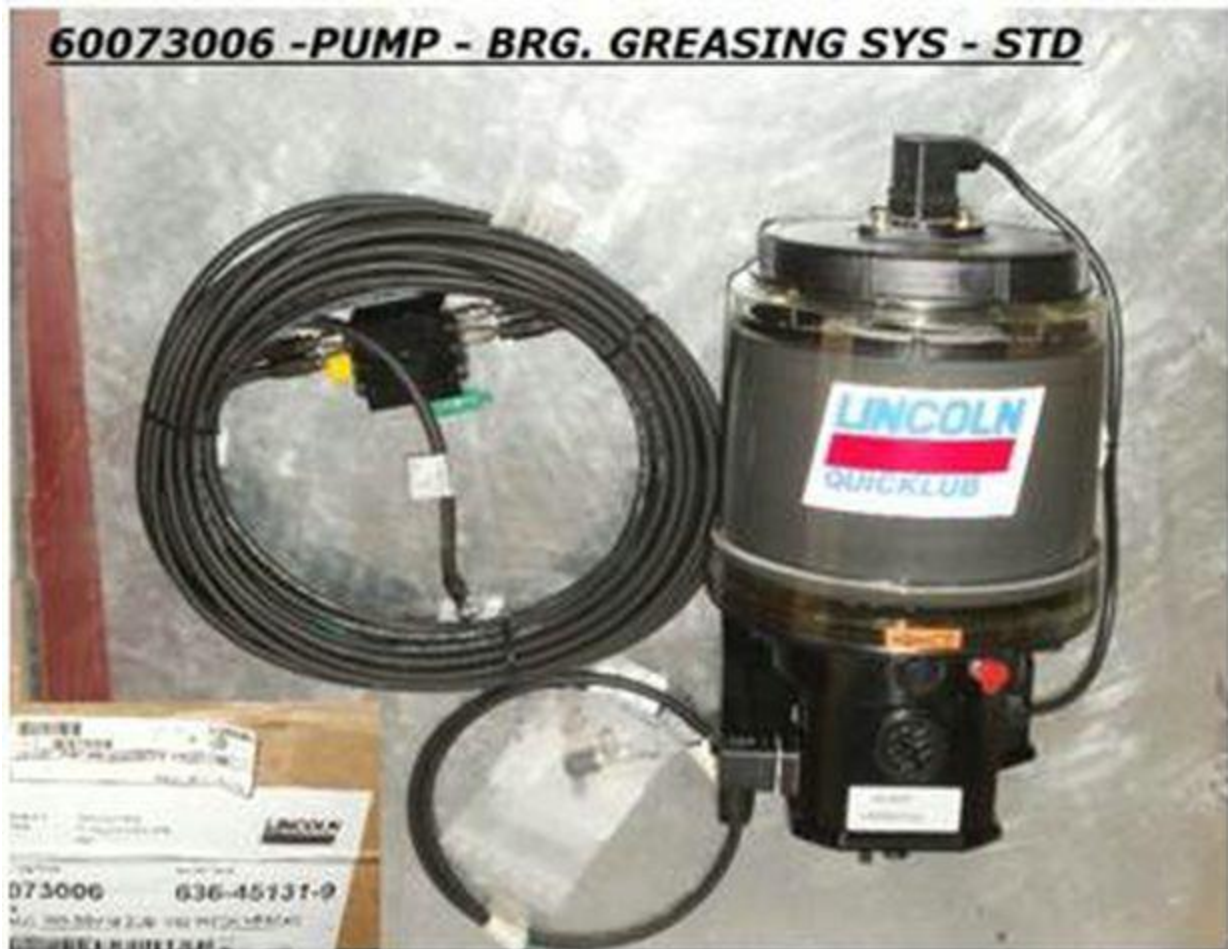
Relevant spare parts	
Description	Item No.
PUMP - BRG. GREASING SYS - STD	<a href="#">60073006</a>

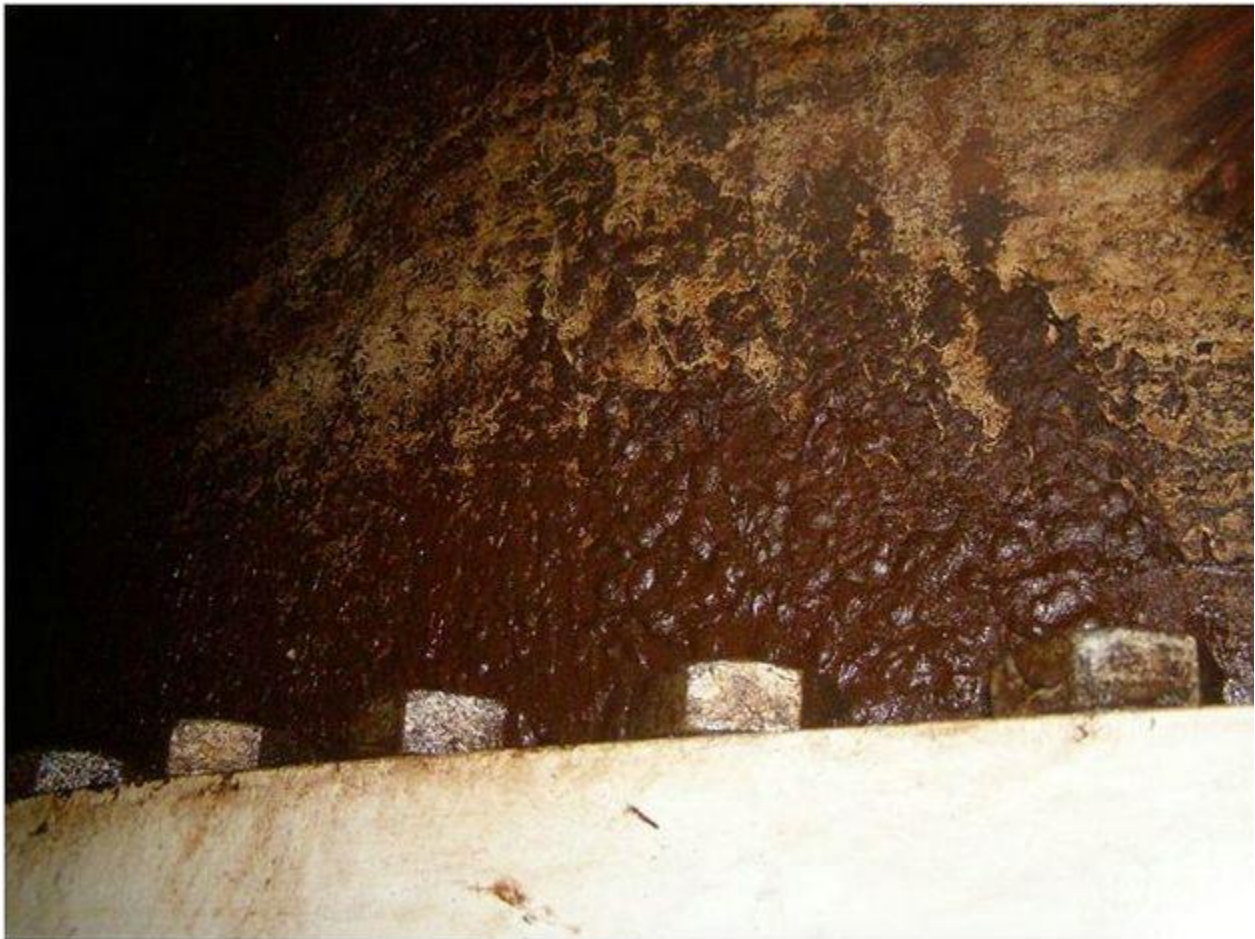
Check blade bearings for any grease leak.

Check the hydraulic system for any leaks, isolate and repair any leaks that are found.

Check for grease or oil stains on the blades and spinner.

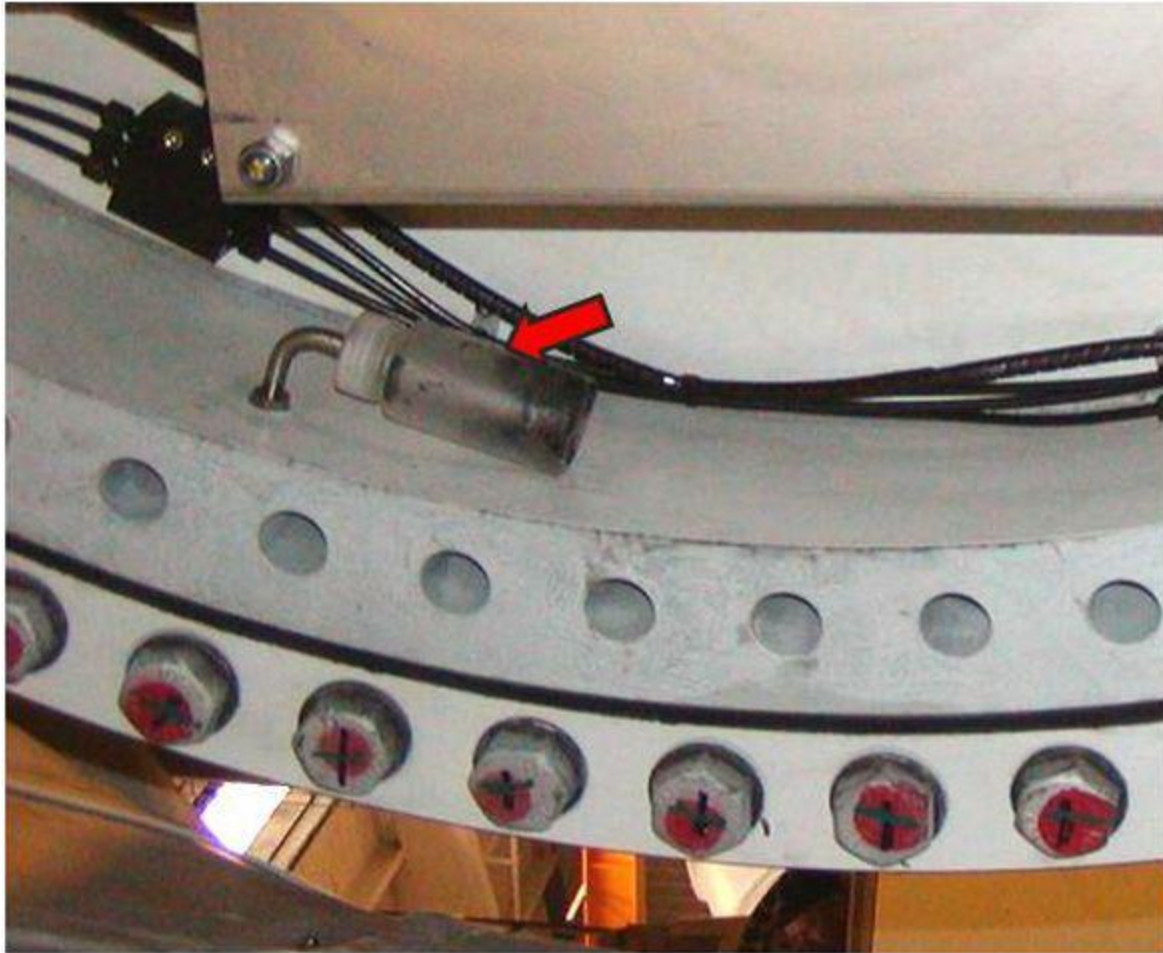
Check the grease collector bottles in all blade roots. If there is a large volume of oil in the hub or evidence that oil has penetrated into the bearing, perform a manual greasing operation on all of the blades.

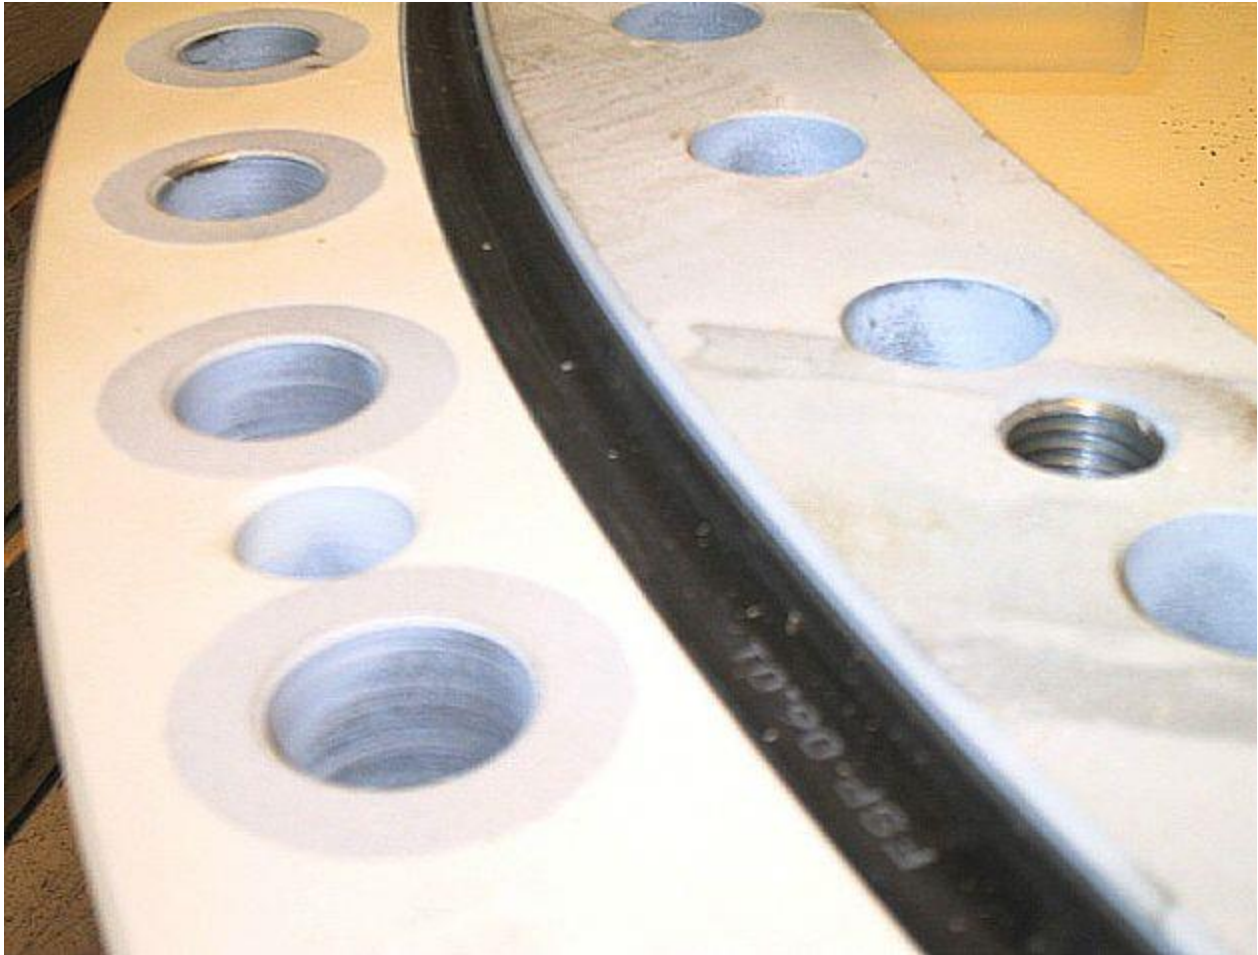
Check the inner and outer blade bearing seals.

If there is any damage or heavy grease leak replace the seals.

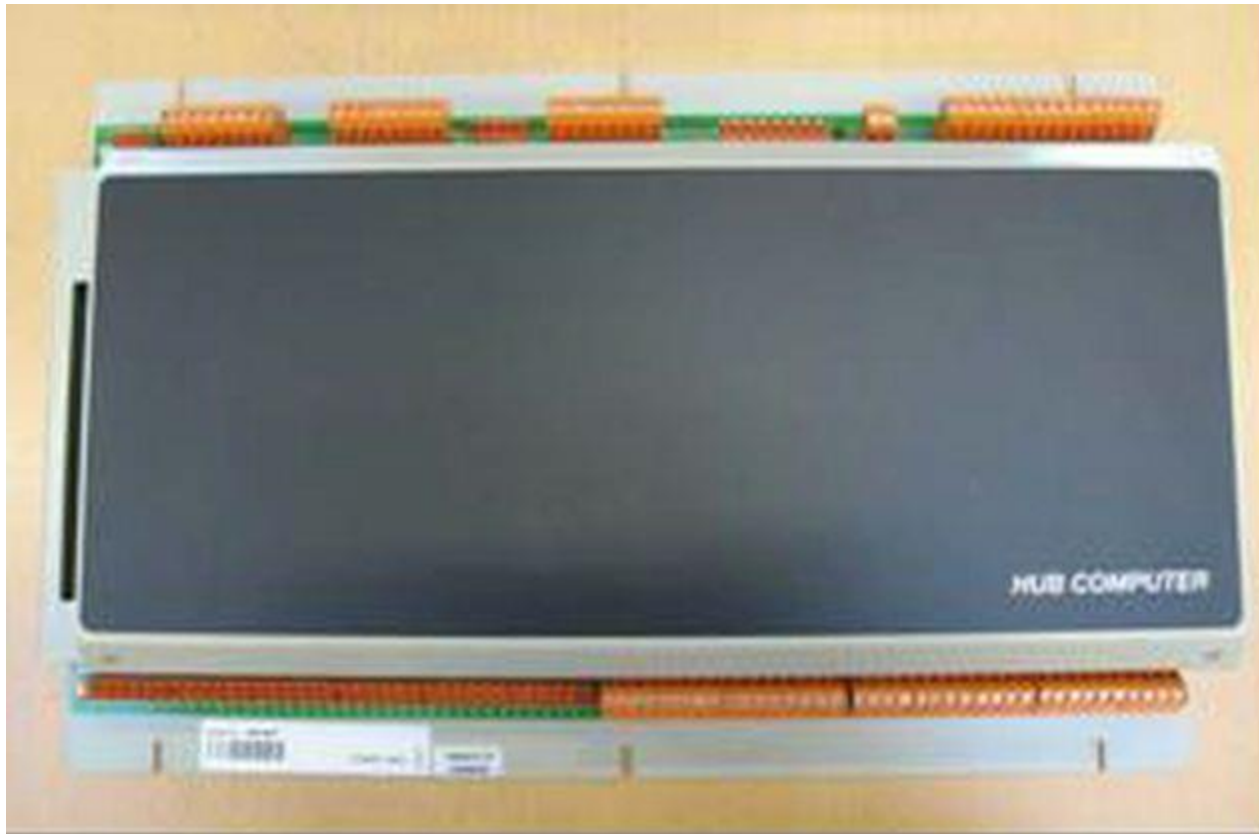
Check for Surge protector upgrade in Power net as per Document:

Relevant documentation	
Description	DMS No.
Test Proj_Adnl Elec Prot_V82	<a href="#">0013-3681</a>
Add_Elec_Protec_V82	<a href="#">0033-3872</a>

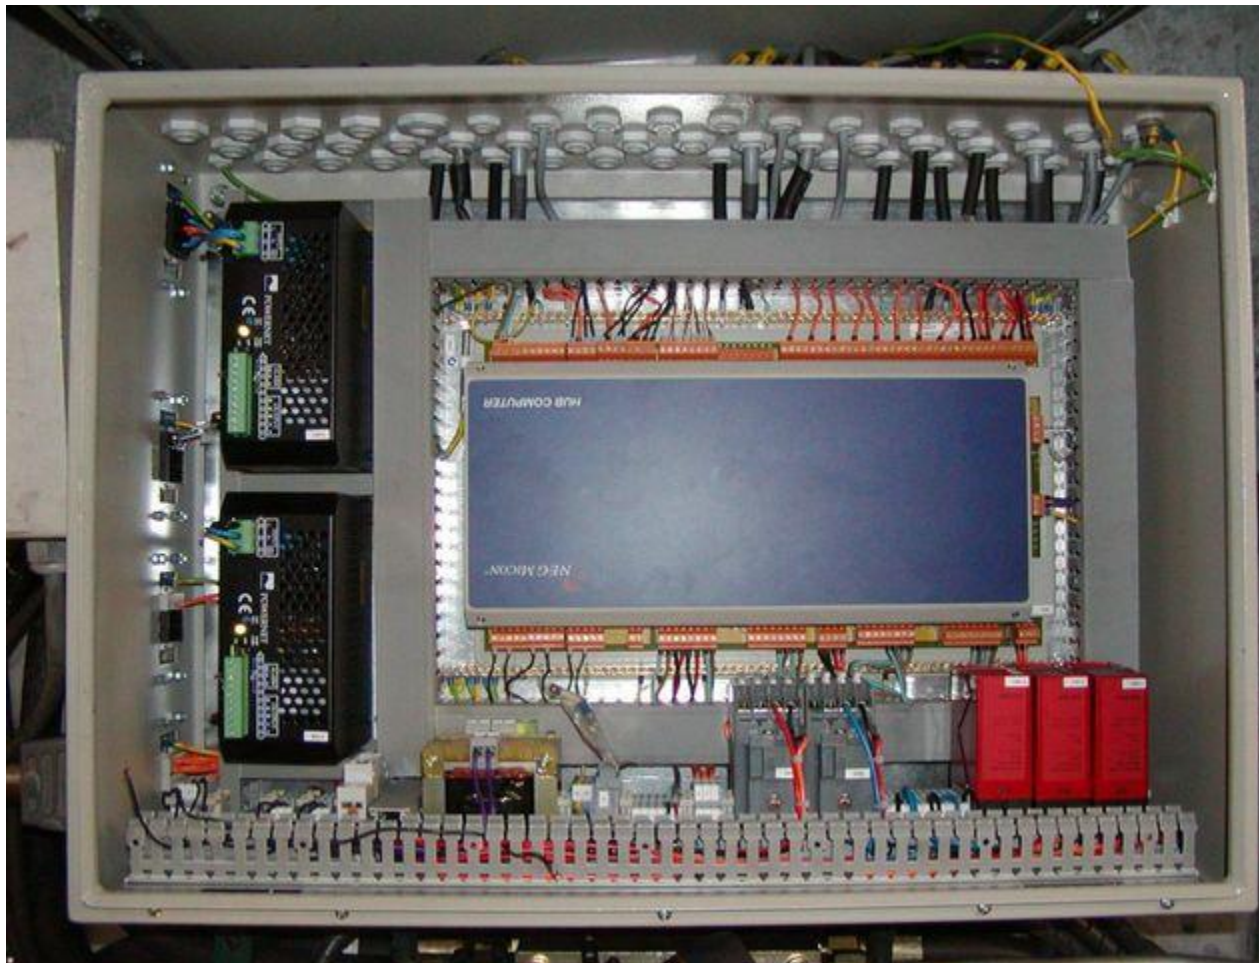
First swap the signal wire to the proportional valve on the hub computer.

If the fault follows to the new blade then the fault is either in the proportional valve or one of the cables.

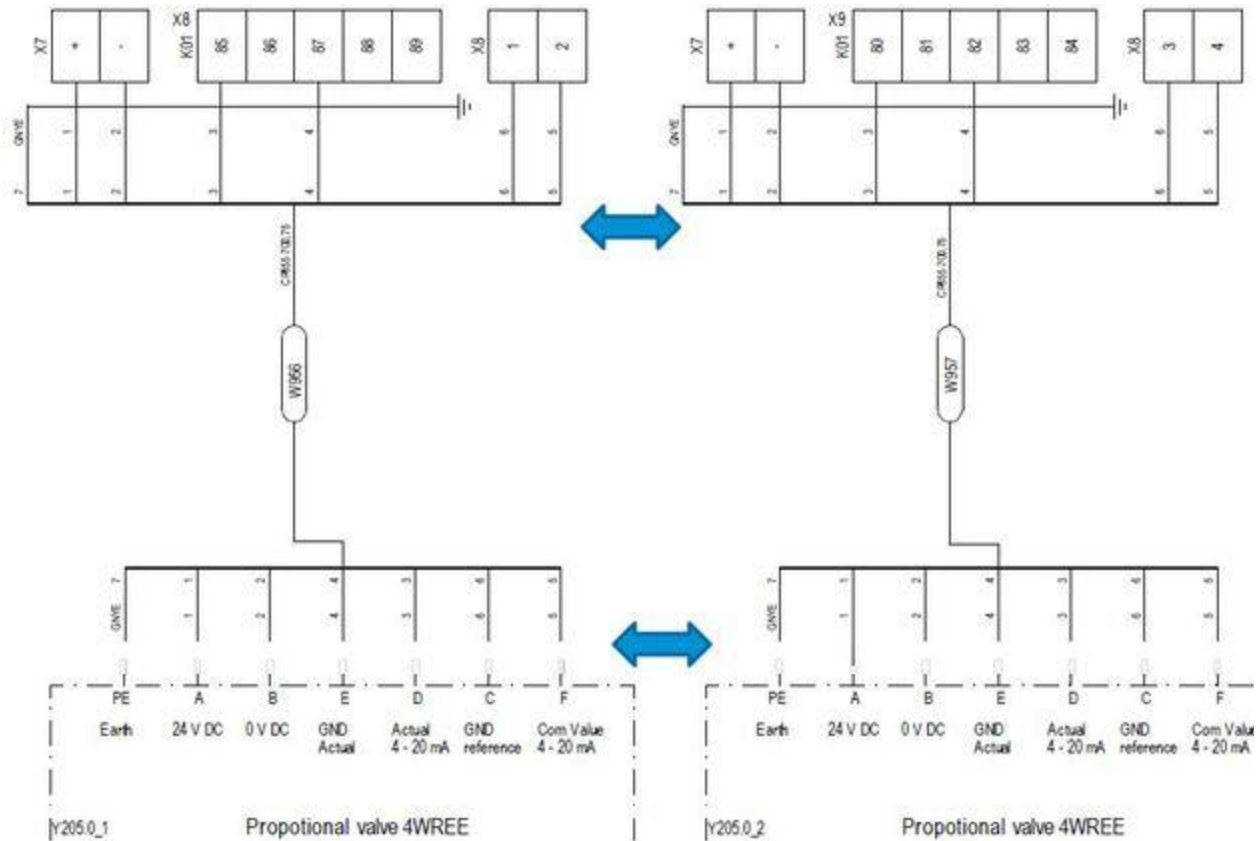
In the example below, we are swapping the plugs between blades A and B.

Place the cables back to their original position and then swap proportional valve from affected blade to another working blade.

If the alarm follows the valve to the other blade, the proportional valve is defective.

If it does not, the proportional valve is likely not the cause.

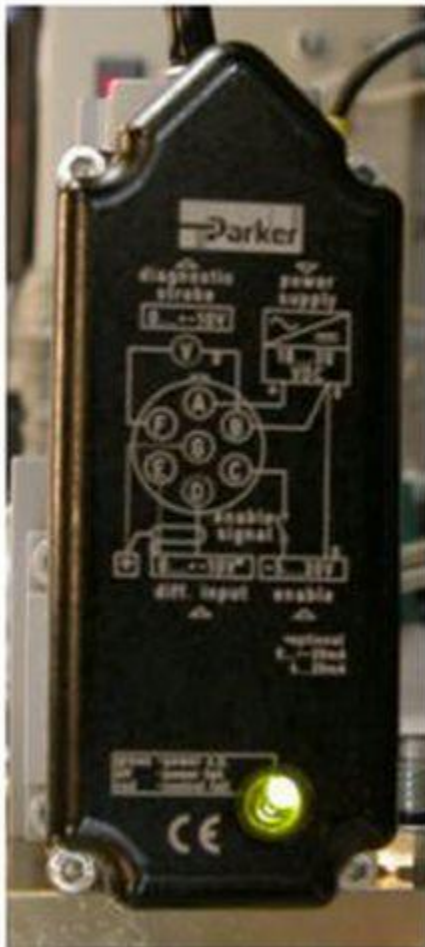
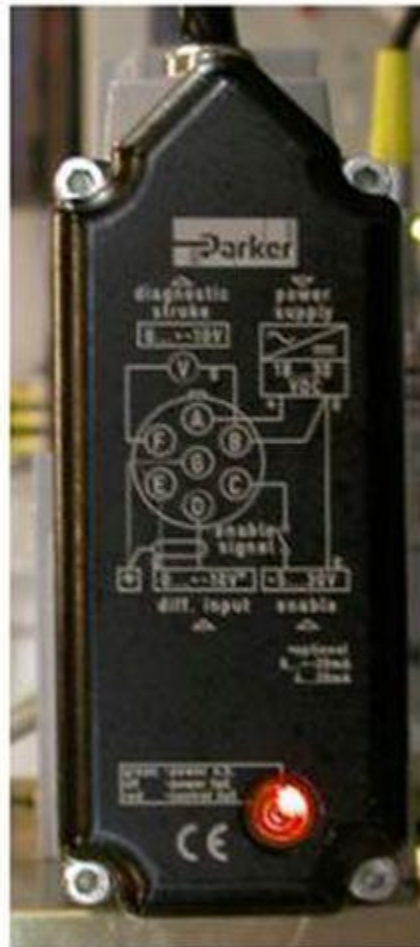
For Parker proportional valves check to see the color of the LED on the valve circuit board.

The LED should be green with the pitch system pressurized.

If it is red and there is pressure verified on test port MP, then the valve may also be defective.

Display Color	Indicates
Green	Normal operation
Off	Supply voltage outside permissible range of 18 to 30 VDC
Red	Spool position error / Low pilot pressure

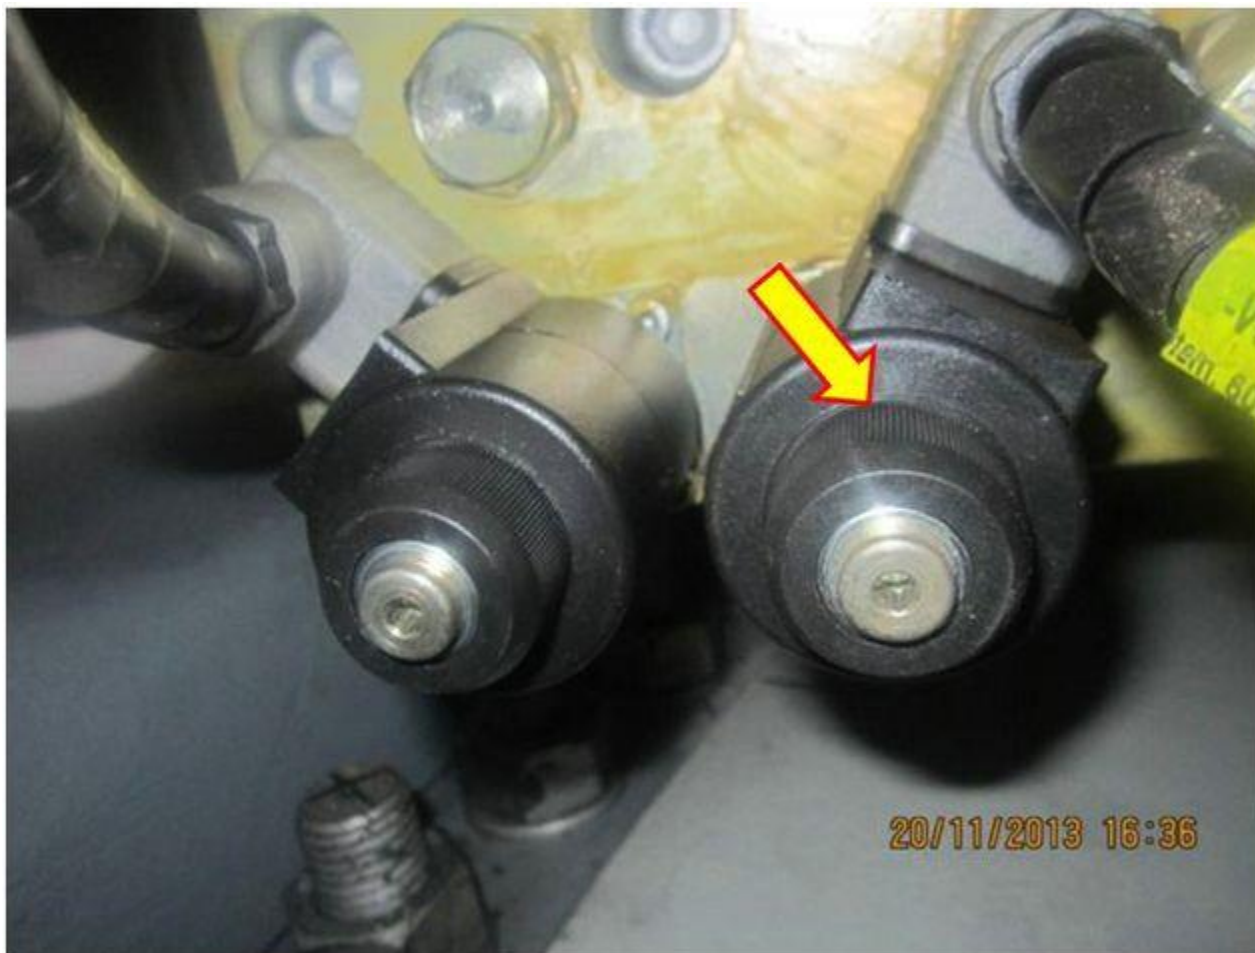
Swap POS. 215 Solenoid valve with one from another blade.

If the valve operates normally, replace the original faulty valve.

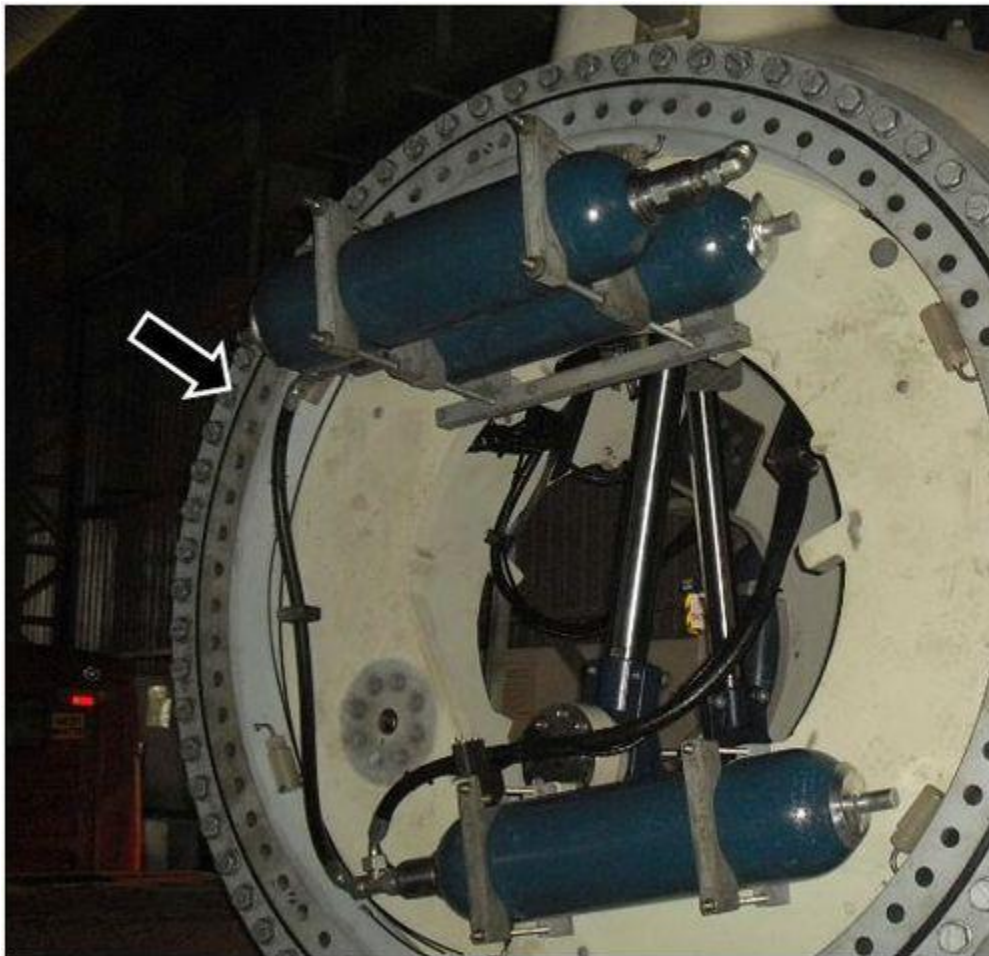
Check the Blade bearing operation 'Pitching to run' and 'Pitching to stop'.

Check for any blade vibration or any abnormal noise during operation.
