Replace the defective pressure transmitter

Replace the feeder pump filter clogged switch

Test / Replace the defective feeder pump motor

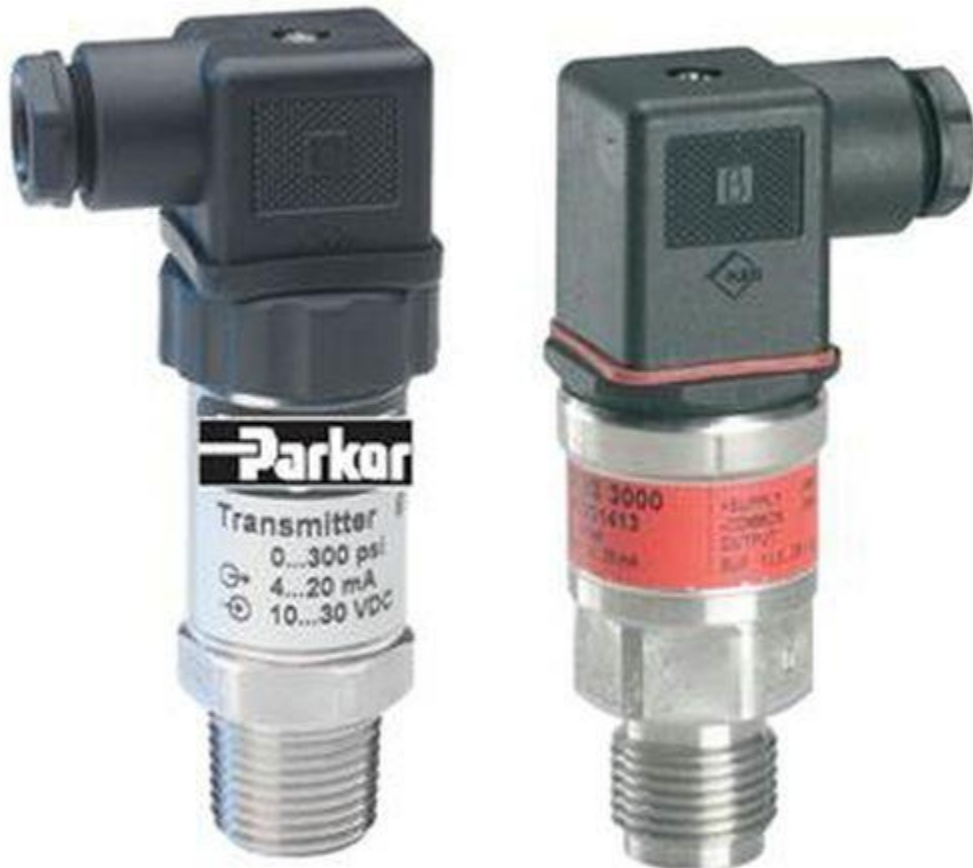
Visually inspect the pressure transducer on the pump manifold for damage or loose connections.

With the feeder pump running, use a manometer to measure the inlet pressure at MF. If the value read from the manometer matches the TAC readout, the pressure transducer is good. If the value deviates from the TAC readout more than 1 or 2 bar, the transducer is likely faulty and needs to be replaced.

Replace the pressure transmitter if it is found to be defective.

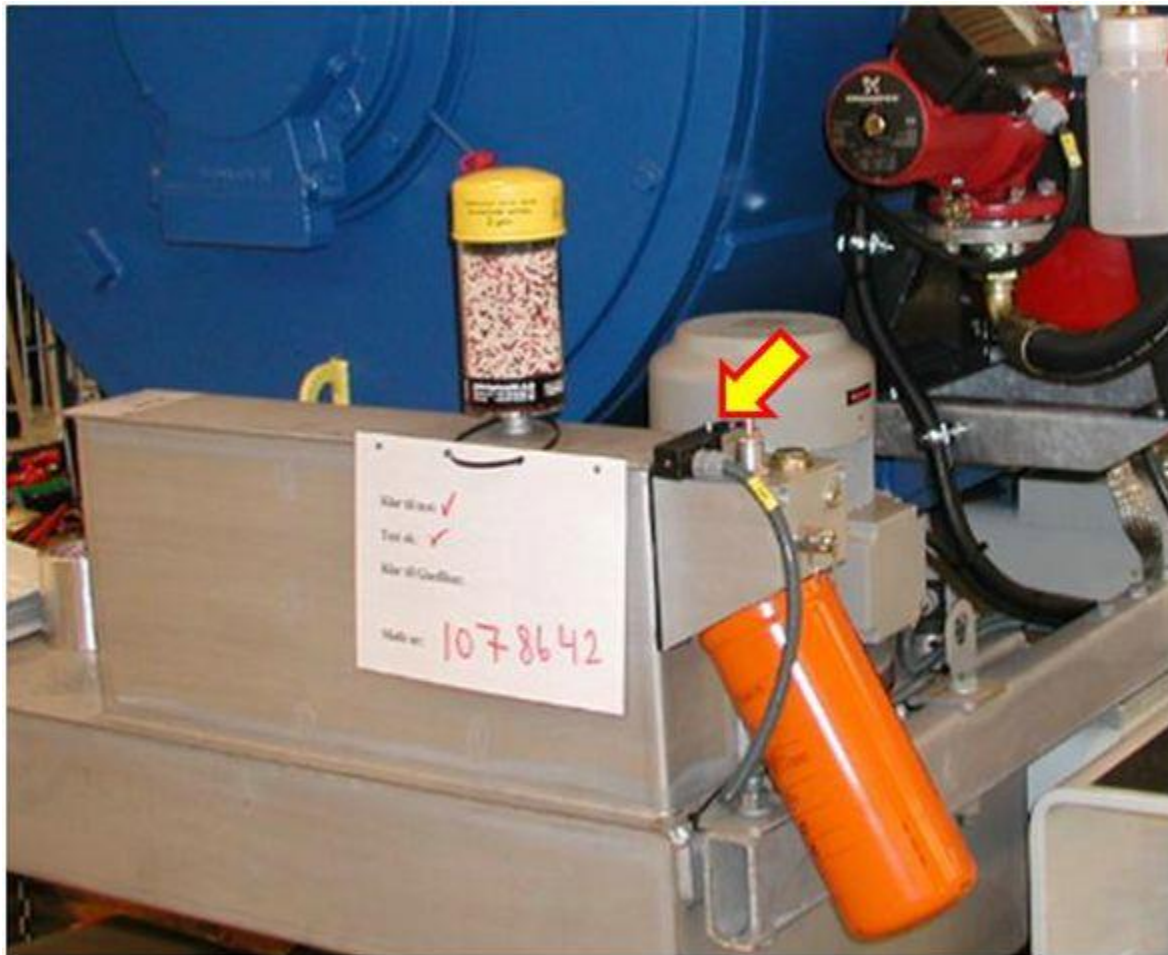
MkIII+

Check the feeder pump filter clogged switch signal in the TOI.

Check the circuit for any loose connections.

Replace the filter clogged switch If failed.

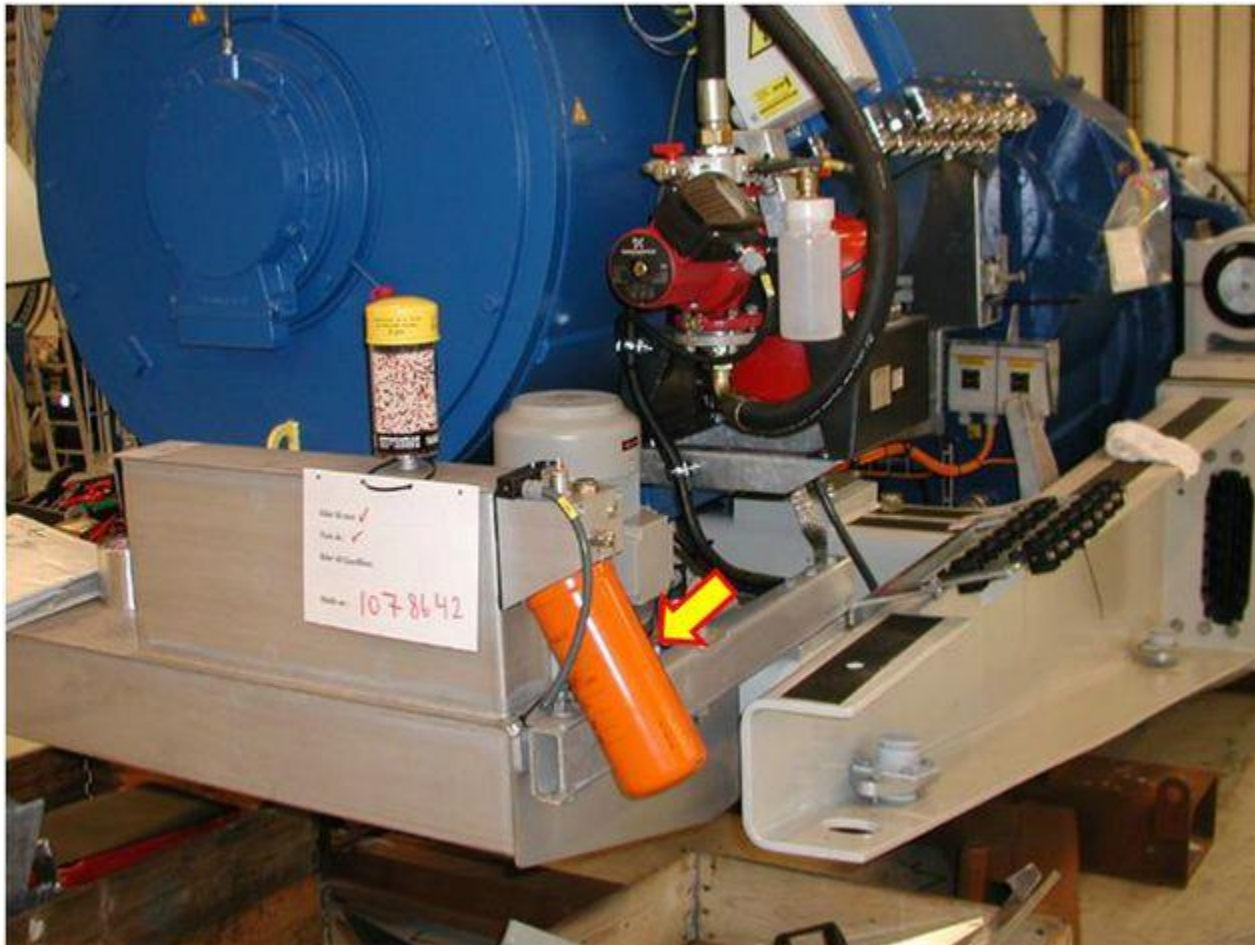
Check feeder pump filter for oil leaks.

Replace the filter if it is clogged.

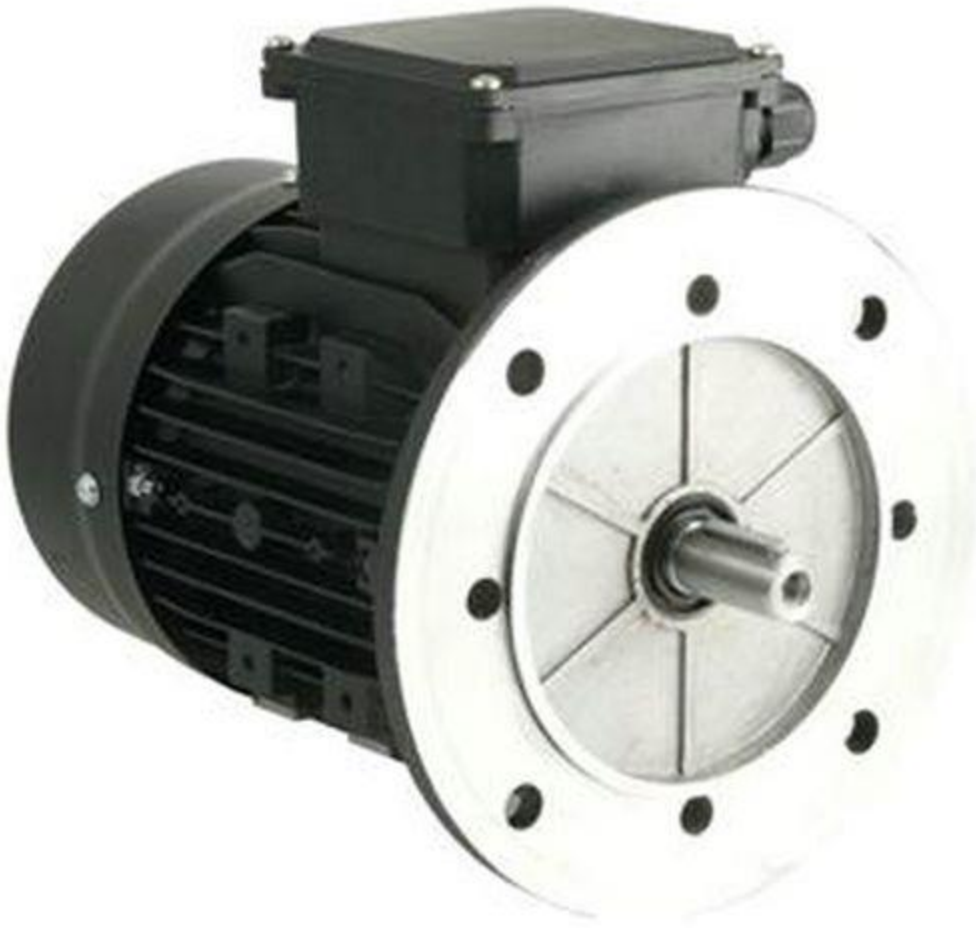
Check for any loose connections in the motor terminal box

Operate the motor and listen for faulty bearings or abnormal noise of any kind.

Remove the STAR/ DELTA connections and measure the resistance value of the windings.

Measure phase to phase and phase to earth on all windings.

If the Motor is found to be defective replace the Motor

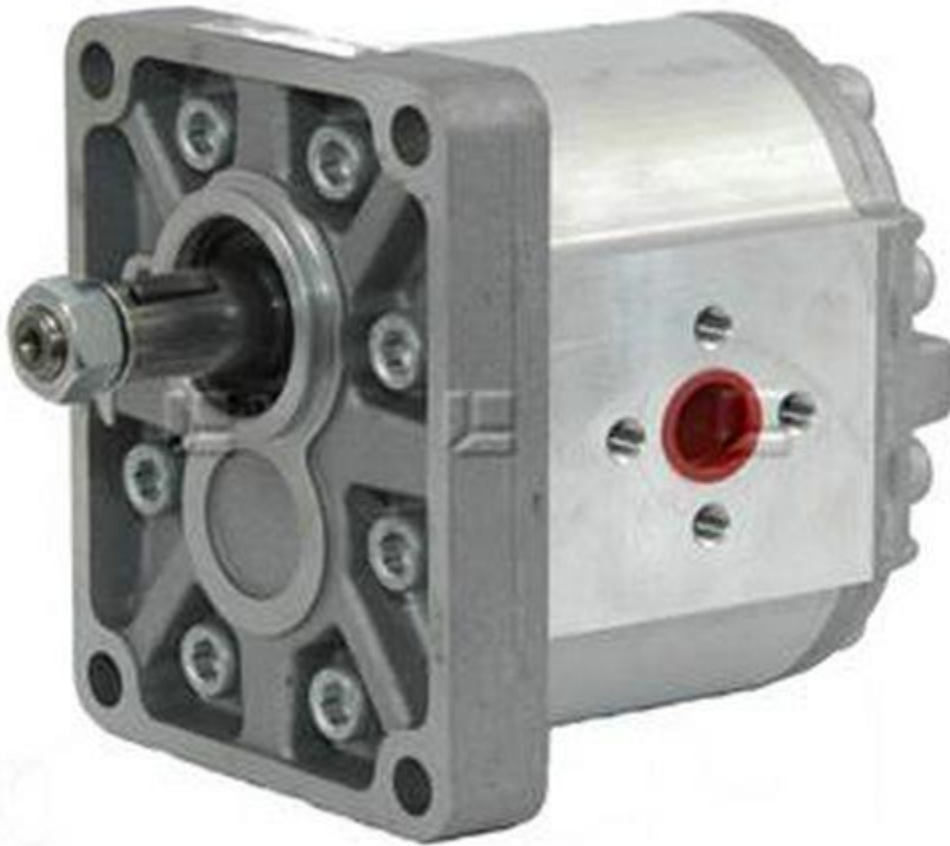
Operate the pump and observe for faulty bearings or abnormal noise of any kind.

If pressure is not developing the likely cause is a defect hydraulic pump or the hydraulic pump may be obstructed internally.

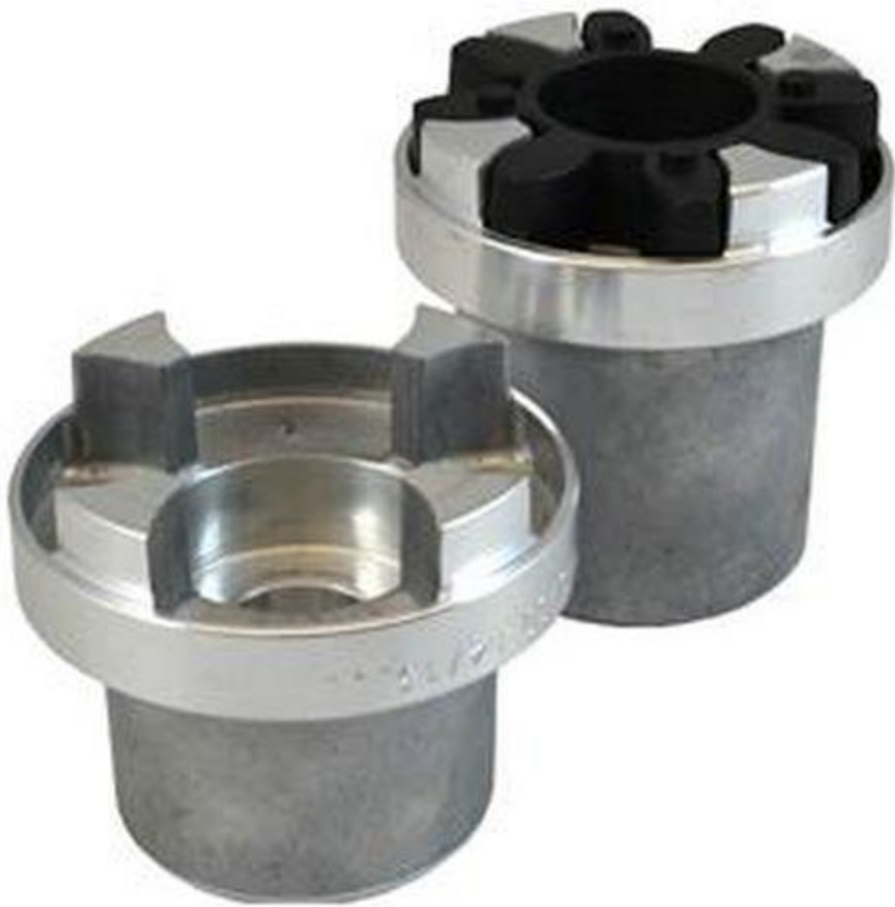
Visually inspect the lovejoy coupling for any damage or debris.

Replace the coupling if it is defective or damaged beyond use.

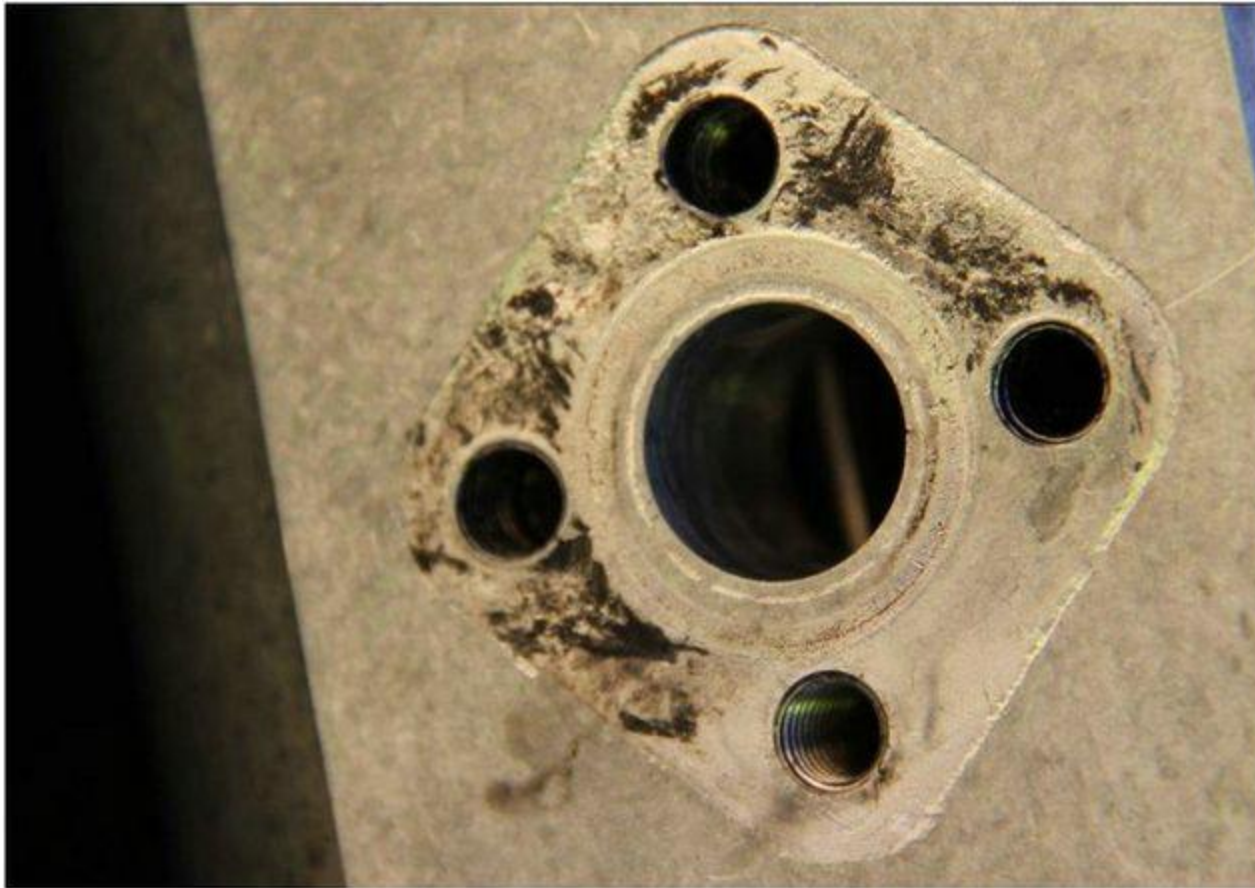
Pump with hose connection:

Ensure the bolts tightness / connection between the pump and hose.

Ensure the O ring is in good condition.
