Test/Replace PT100

Clean grease from bearing

Inspect generator shaft/Generator Bearing

Change the faulty TOI-2 Tower, Water pump motor and Contactor **Does this solve the problem?**

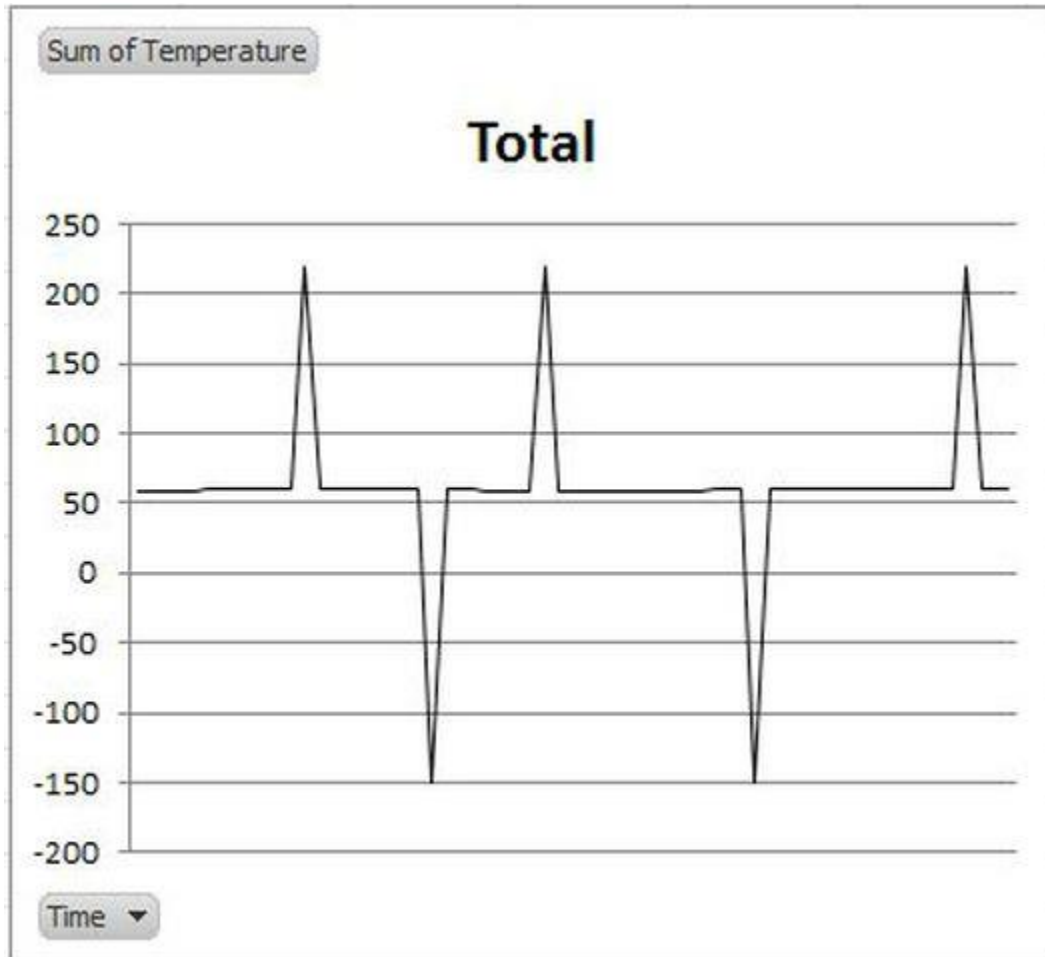
In the Collected Data Viewer, check the temperature measurement going back several days if needed. Collect the minimum and maximum temperatures.

In the data, look for momentary spikes in temperature (<30 Seconds- durations longer than 30 seconds will cause alarm 877- Pt100 fault gen. bear. Rear).

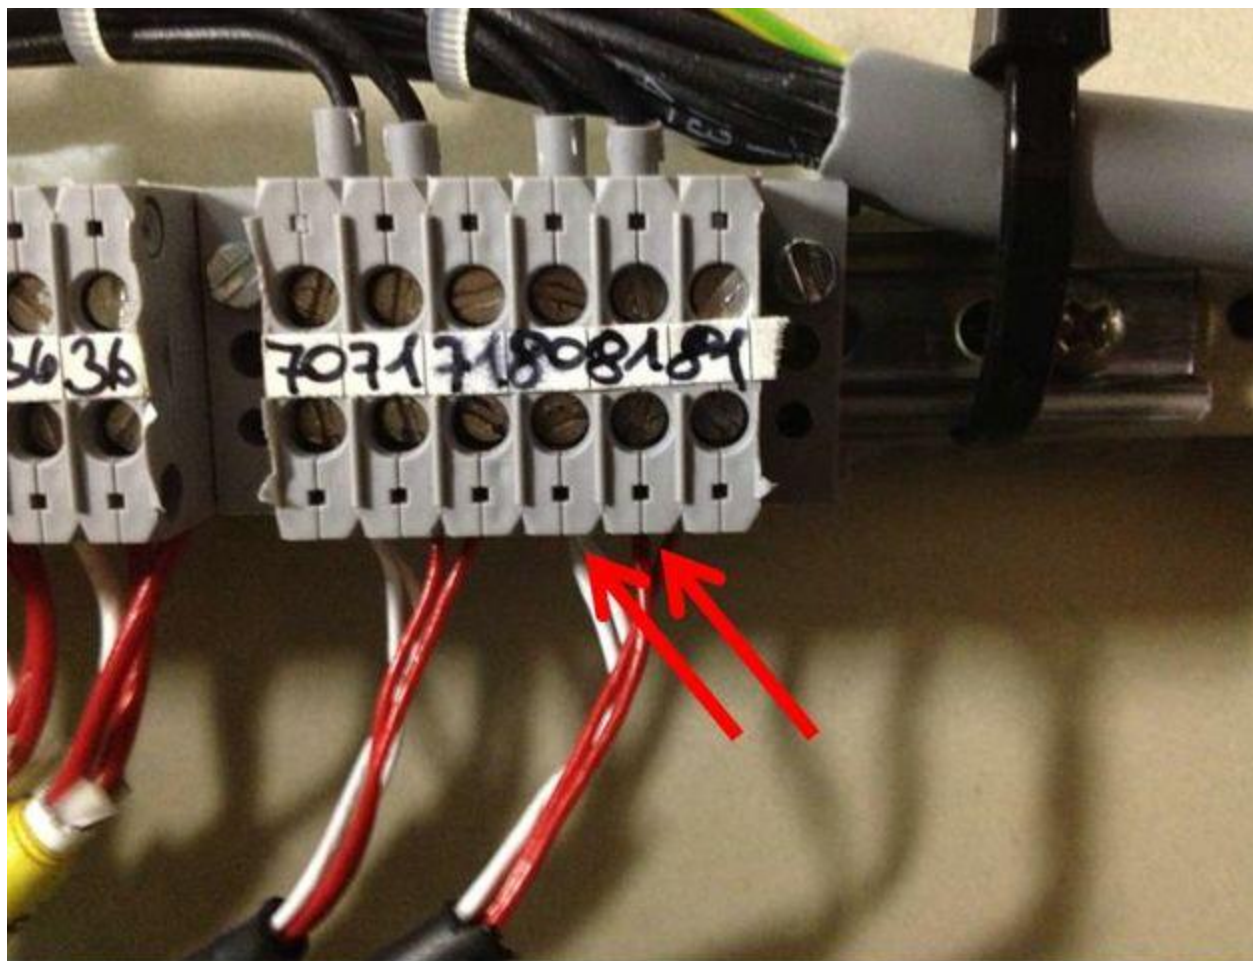
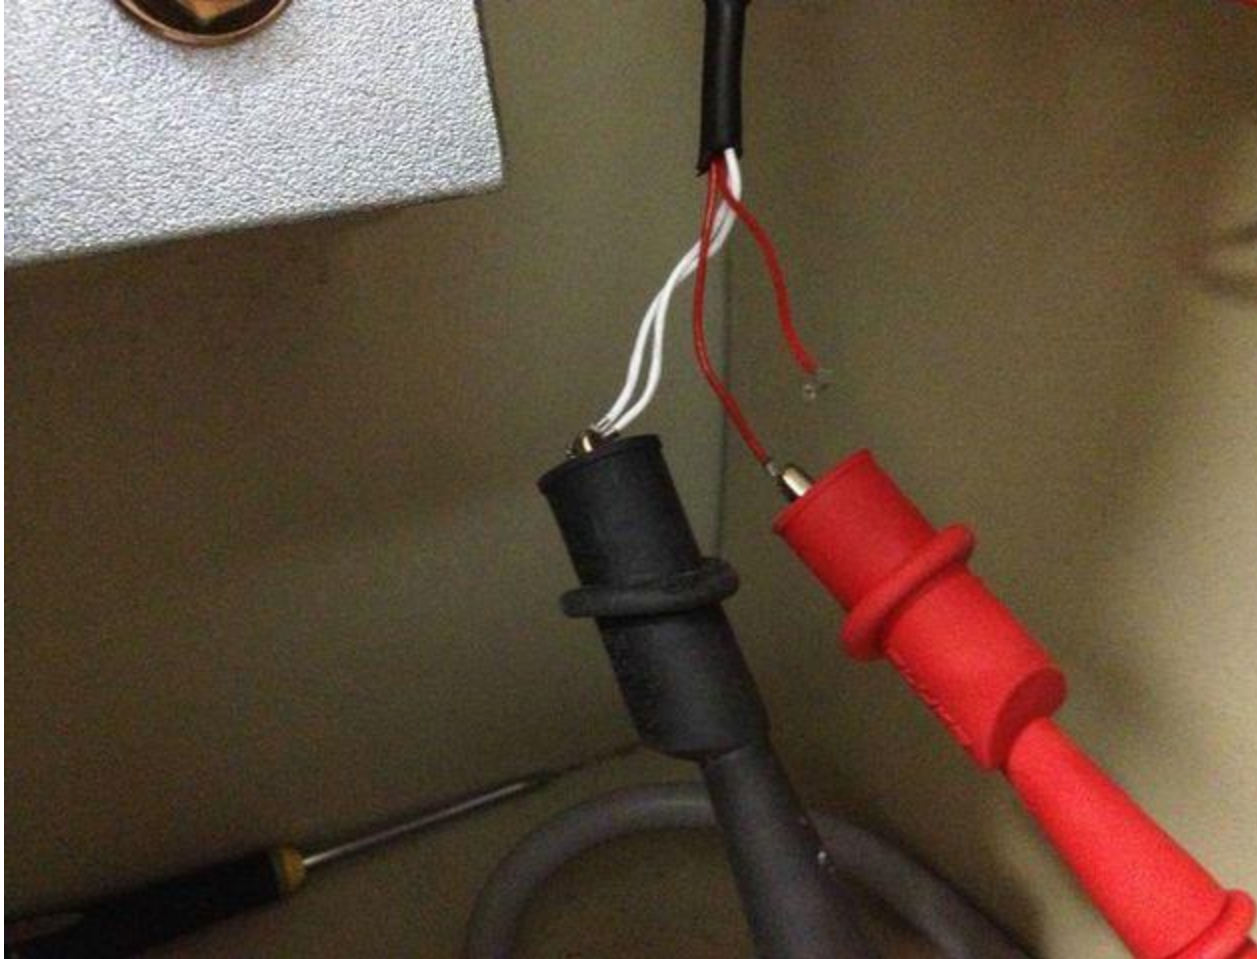
Sensors can be tested in the generator junction box. Generator bearing rear sensor wires are at terminals 80 (white), 81 (red) & 81 (#2 red).

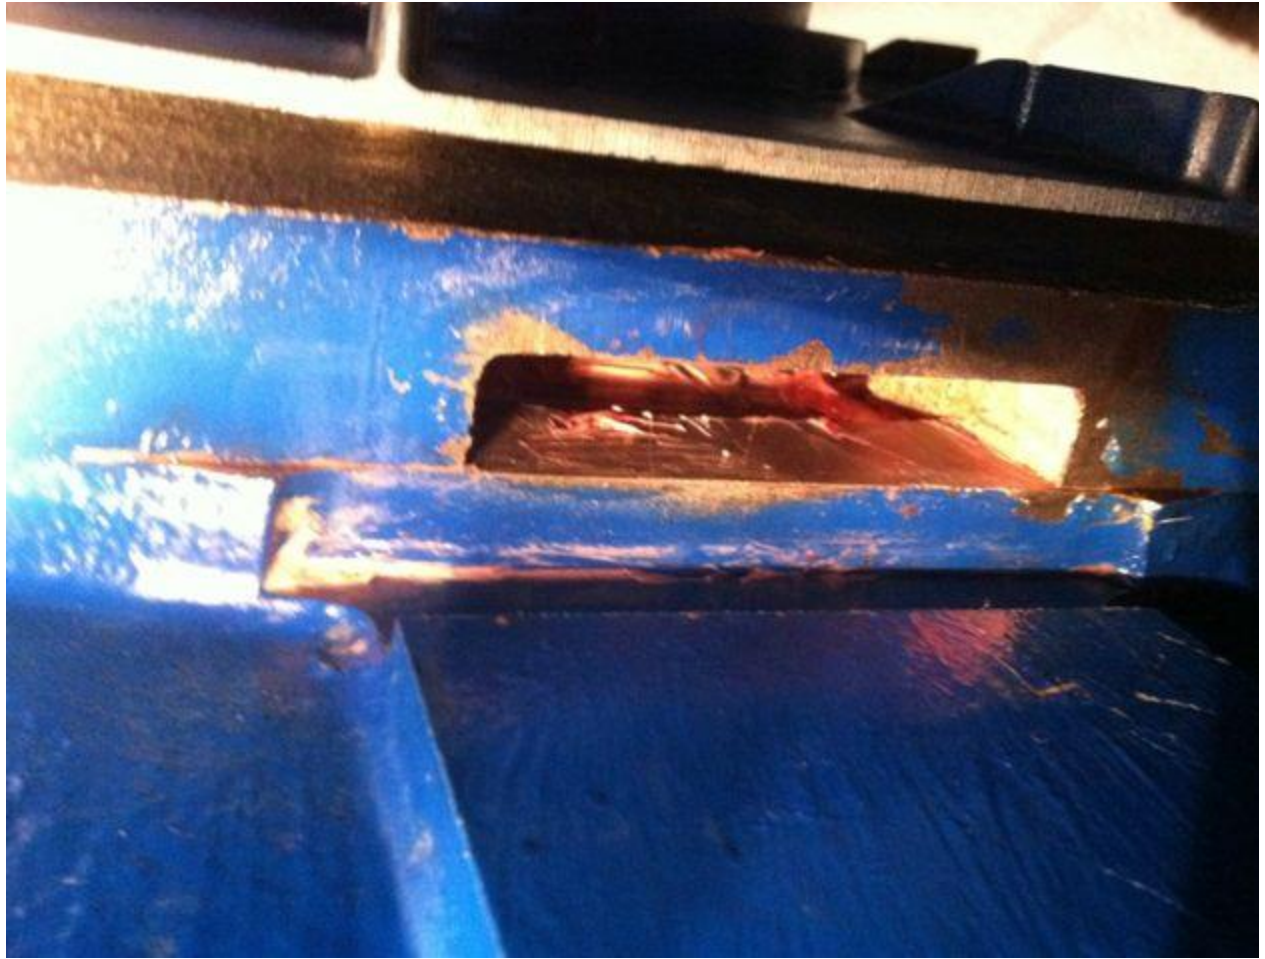
- **Explanation**
Using the generator bearing cleanout tool (Elin A-E and Winergy models) remove the grease catch container from the end of the generator.

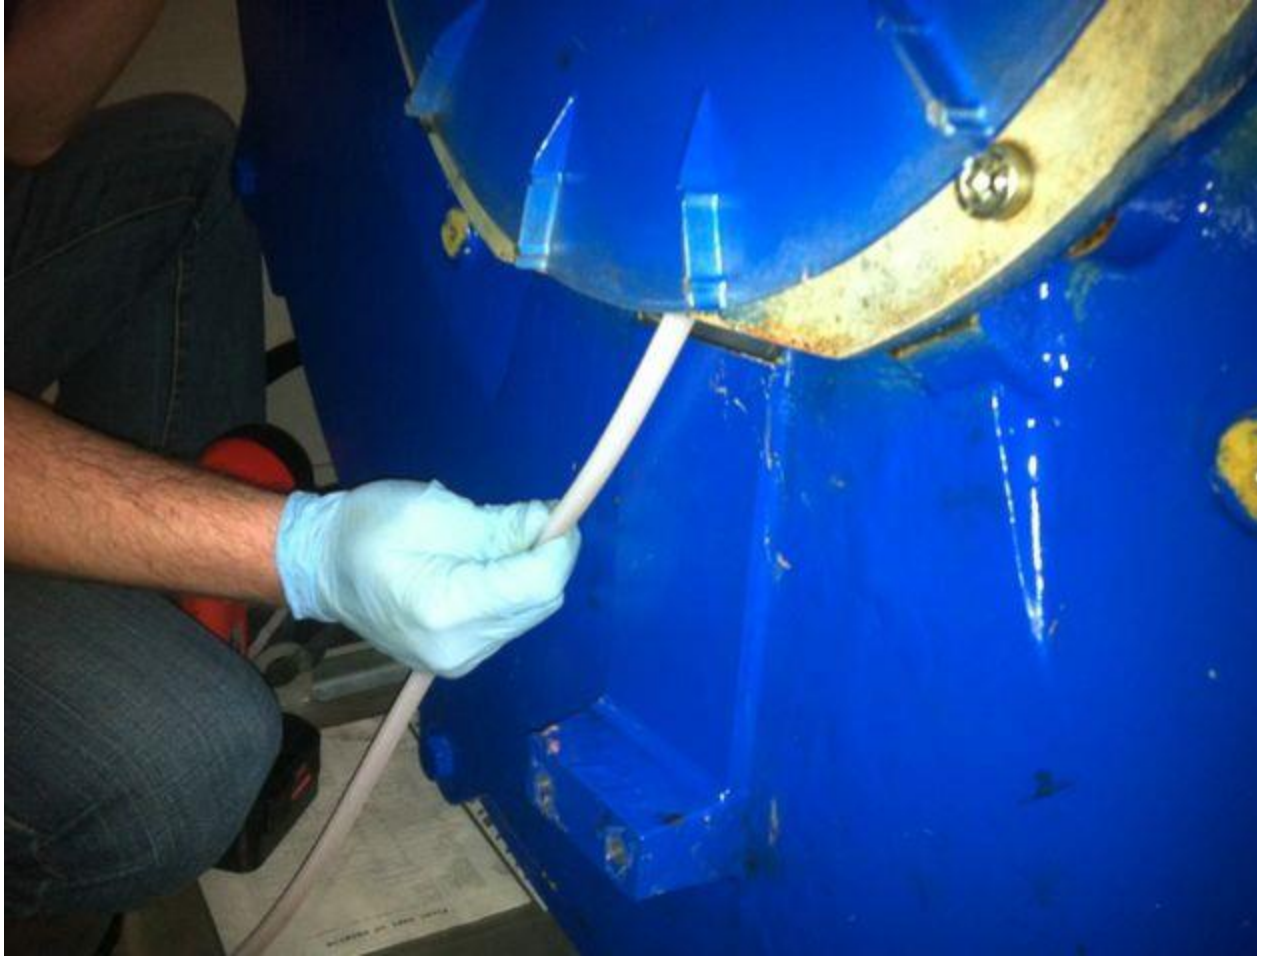
Run the end of the bearing clean out tool up through the grease drain opening.

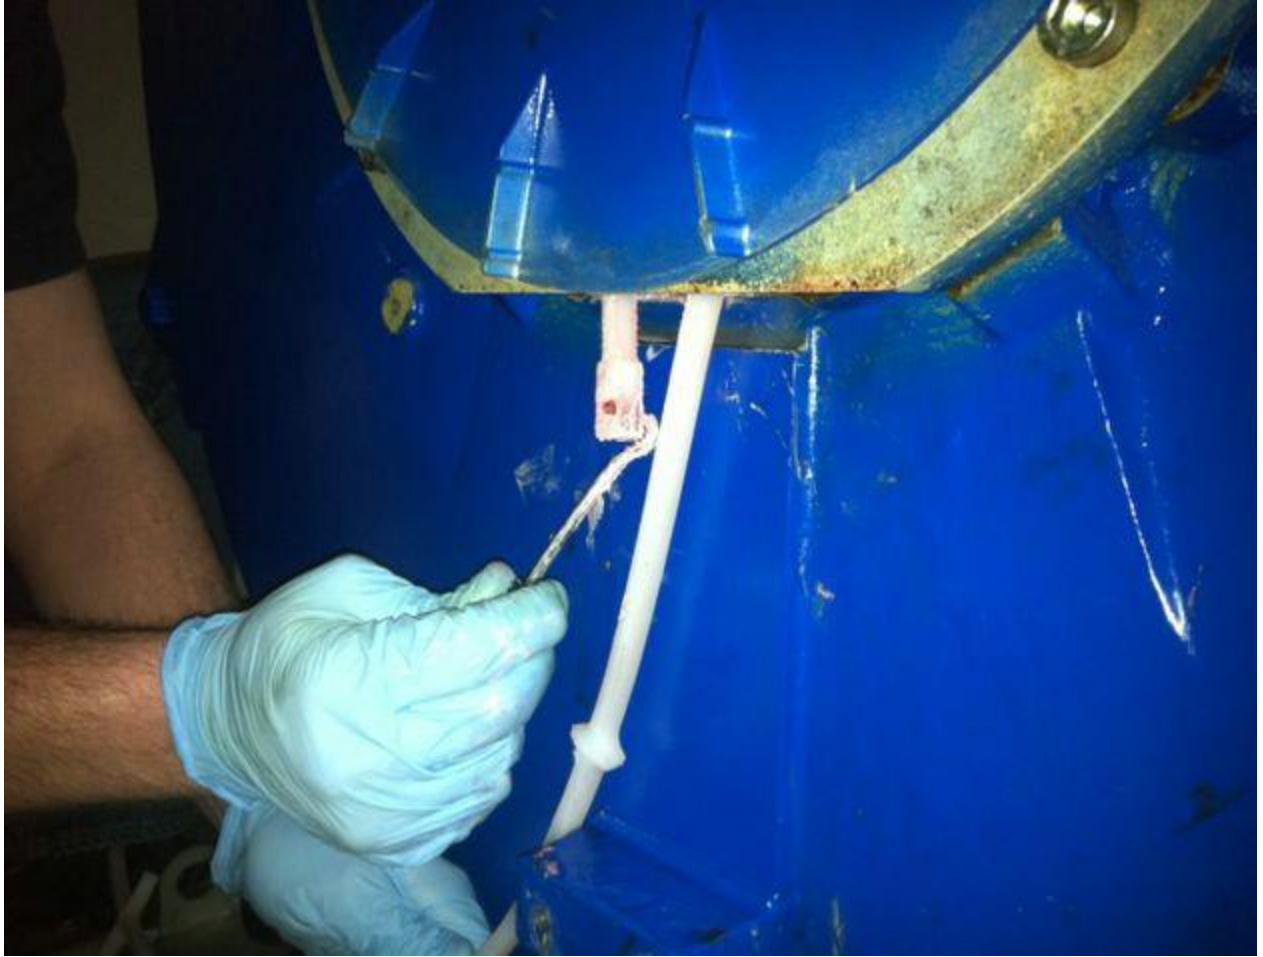
Use an O-Ring tool to catch the end of the cleanout tool.

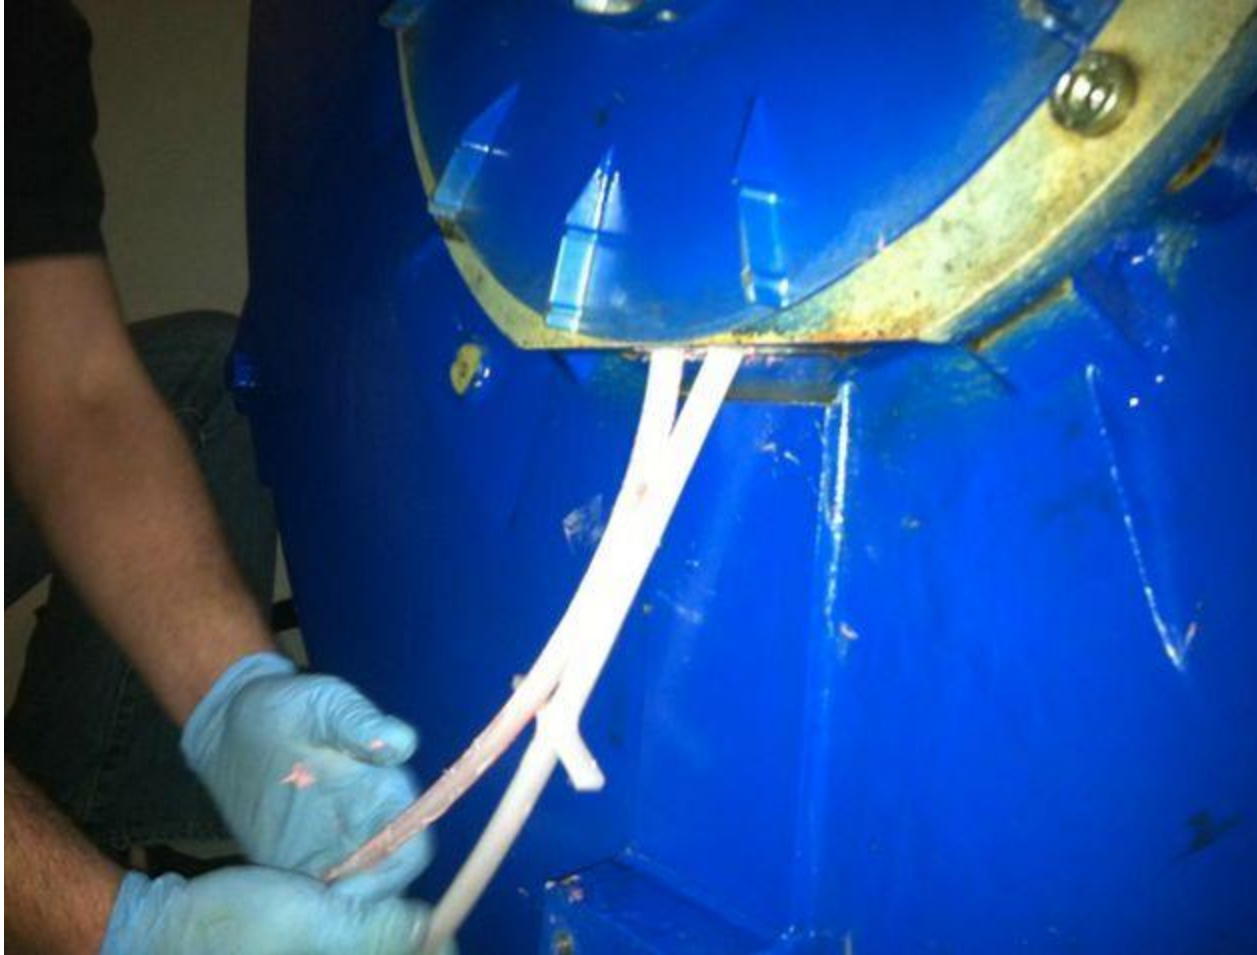
Pull the tool completely around the shaft several times until little or no residual grease comes out with the tool.

Performing this task will not remove grease from the bearing, but will remove grease from the void that has already been used in the bearings. Given that no grease will be removed from the bearings, there is no need to replenish the grease.

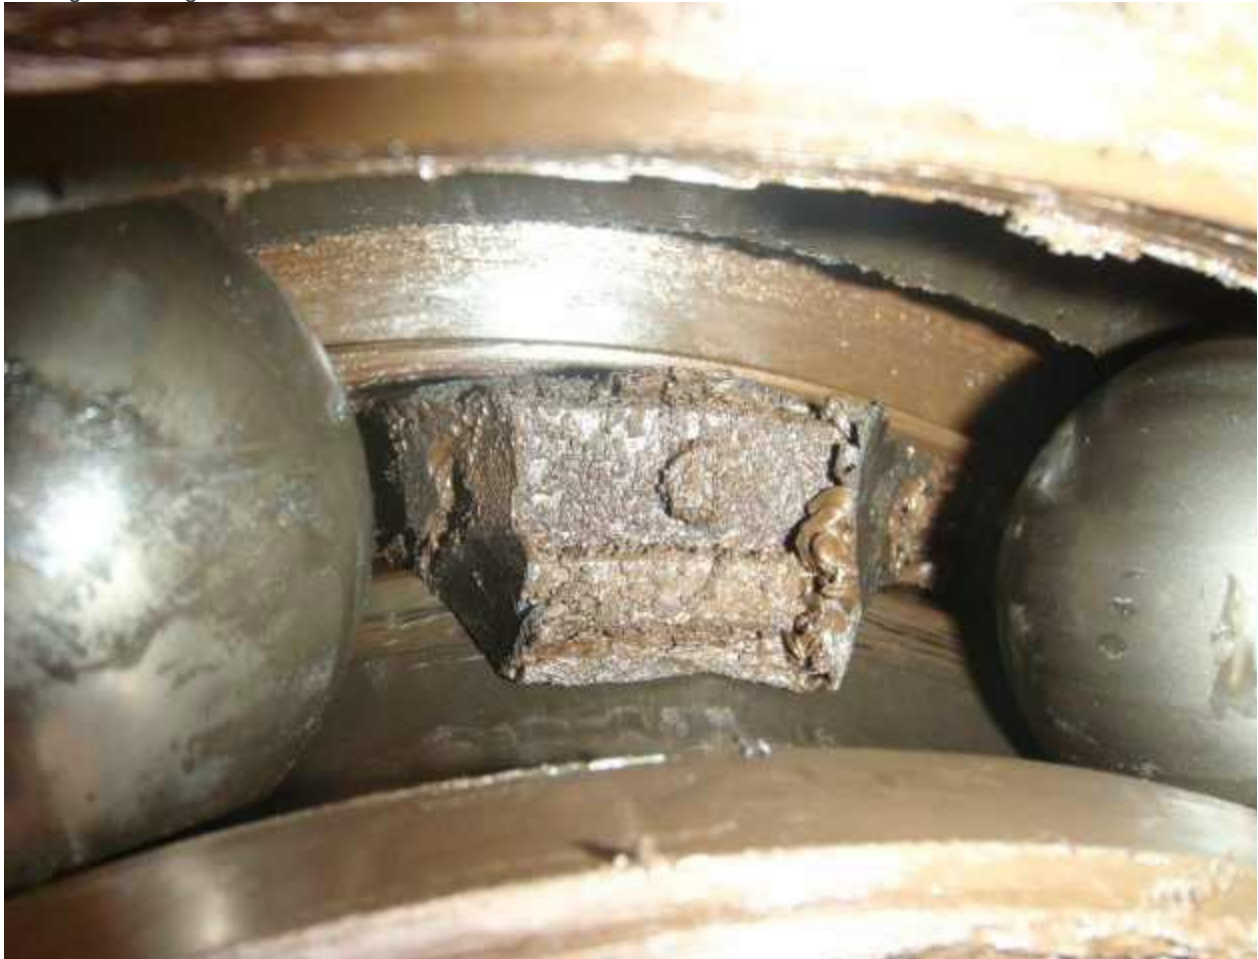
Damaged Bearing:

If abnormal noise can be heard from the bearings, remove the bearing covers and inspect 1. The bearing and 2. The inner bearing race on the shaft for signs of rotation.

If the bearing is found to be damaged, it must be replaced. Select the correct bearing based on the generator type from document 0003-0086: - Generator Bearing Spare part list V82 (NM82, NM72) Generator.

Replace the bearing in accordance with document:0000-9630 - Elin Generator Bearing Replacement - NM64C, 1500, NM72/NM72c/NM82, 2000, V82-1.65MW

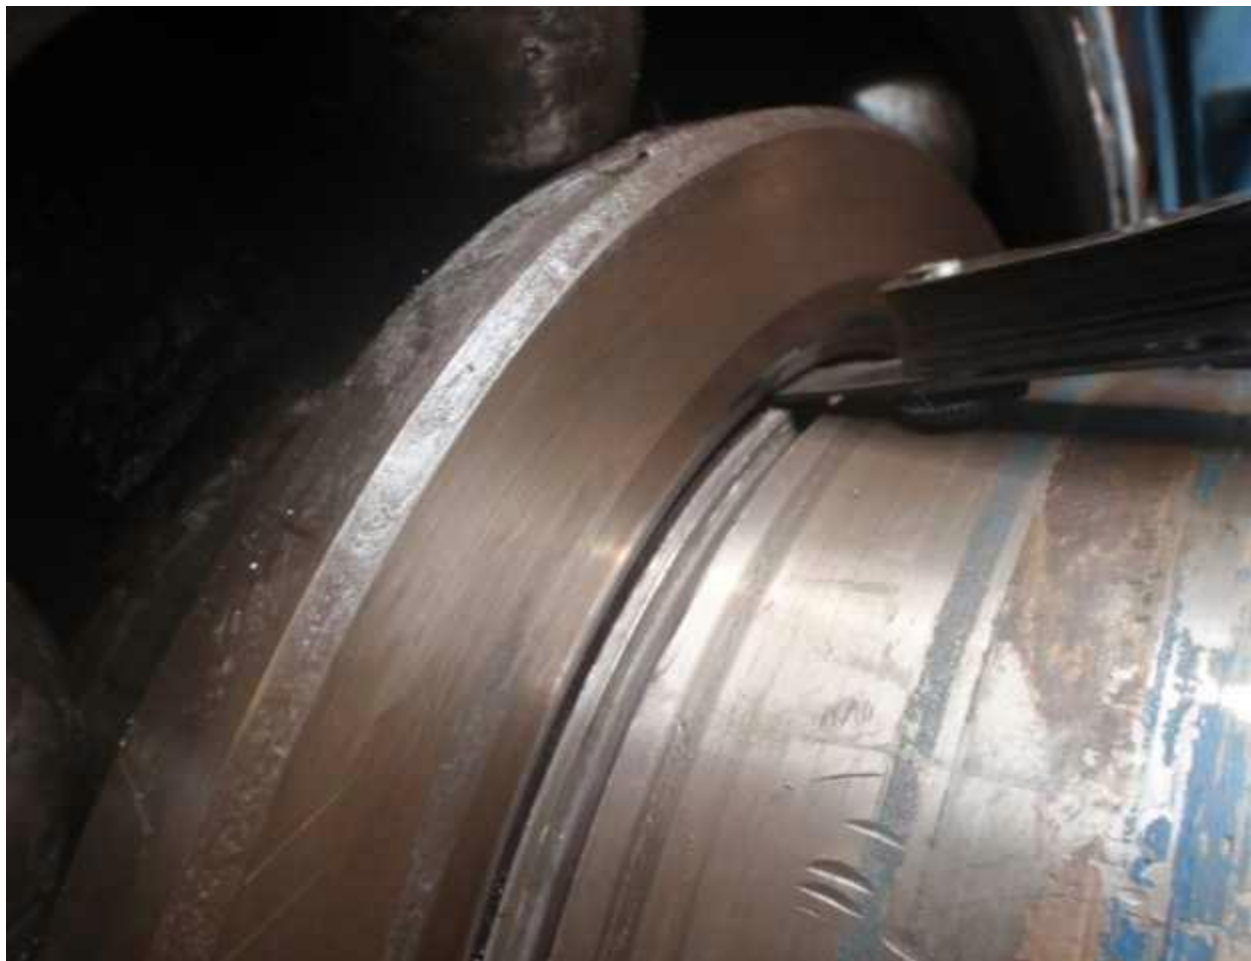
When the cover is removed and the bearing is exposed, a feeler gauge can be placed between the shaft and inner race to determine if spinning has caused wear on the shaft.

Using a feeler gauge to check for a gap between the rotor shaft and inner bearing race.

There should be zero clearance between the shaft and the bearing inner race. If there is any measurable gap between the inner race and the shaft, the bearing is spinning and the generator must be repaired (In accordance with the latest CIM 2020 solution) or replaced. If the bearing is found to be spinning on the shaft, complete a CIR for CIM 2020 and consult Engineering on how to proceed.

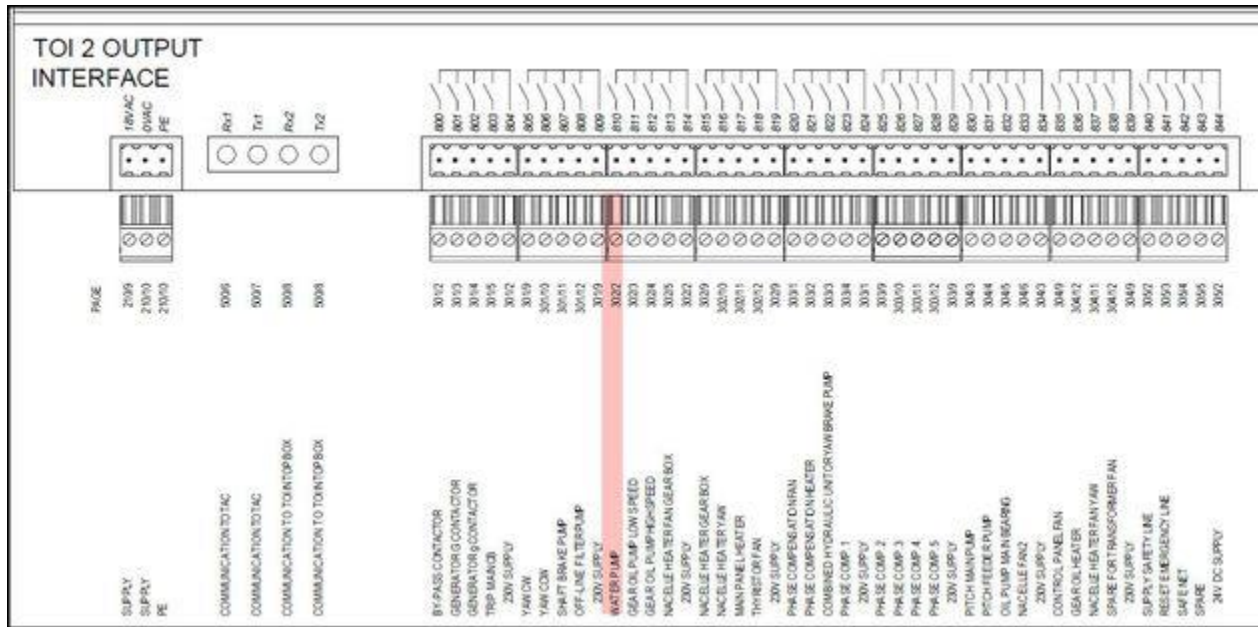
50Hz

AT2 Cabinet Check the TOI-2 Tower out put 810 Water pump, if there is no out put while testing change the TOI-2

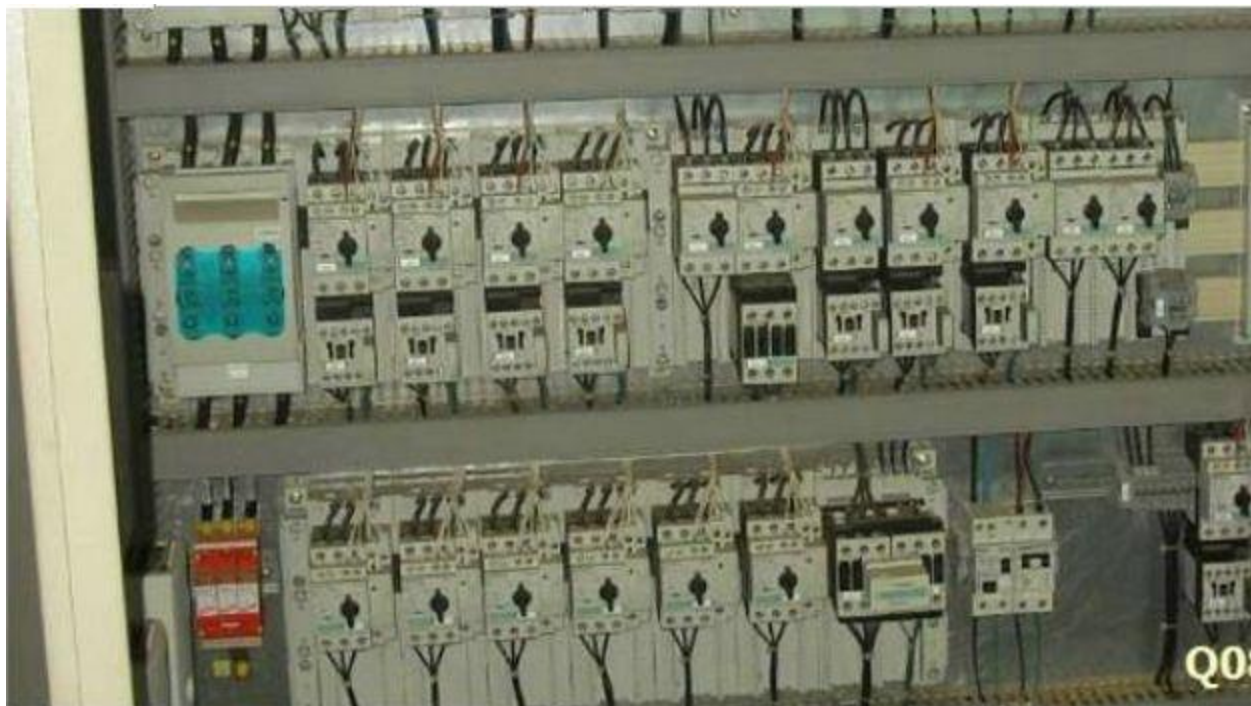
At Nacelle Check input voltage to the motor (M06) and supply voltage present but motor not run, stop the test function disconnect the supply voltage and check the winding continuity, if the motor winding opened, the breaker will not trip since single phase circuit not closed. No fault current flow. Change the motor.
