Execute the safety line test

SERVICE MENU → MANUAL TEST → TEST SAFETY LINE

EMERGENCY CIRCUIT DIAGRAM:

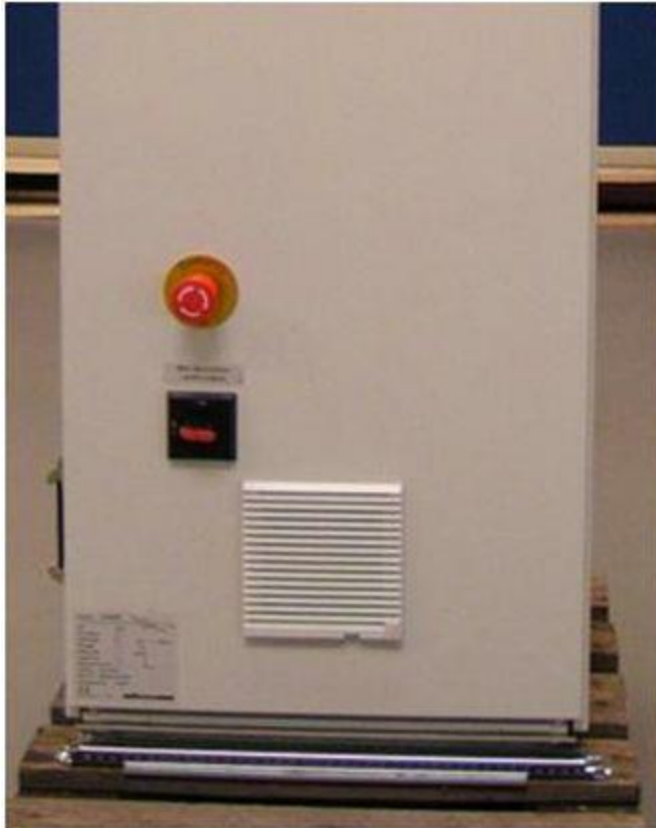
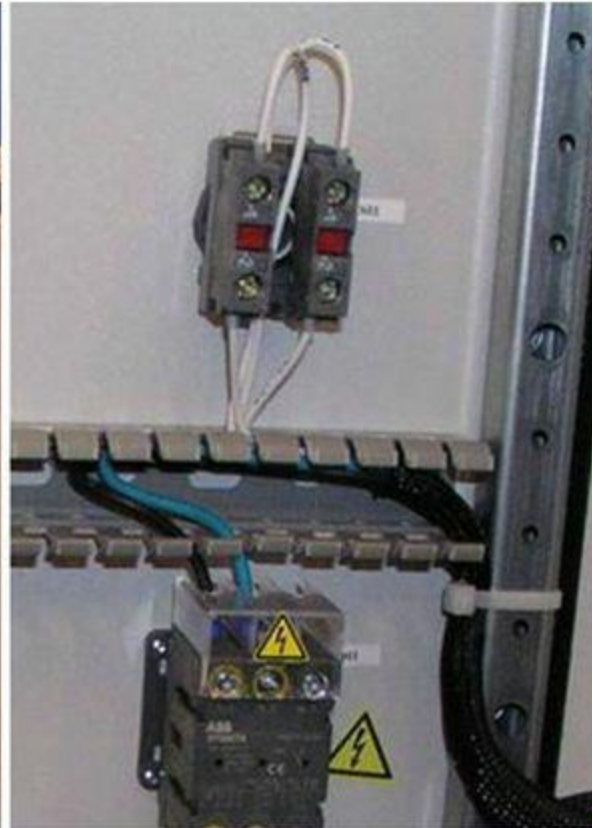
EMERGENCY SWITCH – IN THE NACELLE +AN1:

Check for any loose connections in in the emergency switch.

Check that voltage is present through the switch and switch operation.

If the switch is found to be defective, replace with new.

Relevant spare parts	
Description	Item No.
MUSHROOM BUTTON ISAF616510R1001 RED	60005824
CONTACT ELEMENT SK616 001-B 1NC	60005846
HOLDER for 3 ELEMENTS SK616 01	60005848

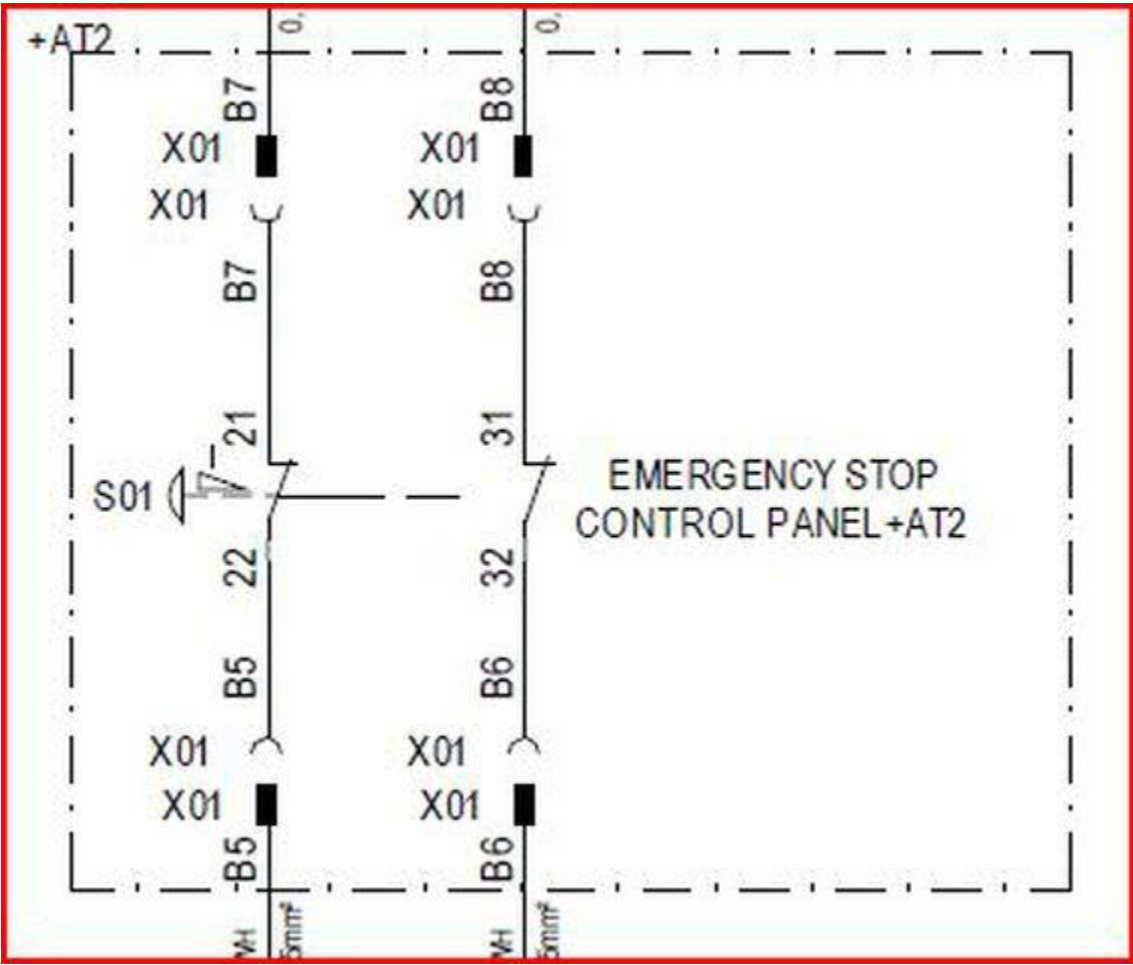
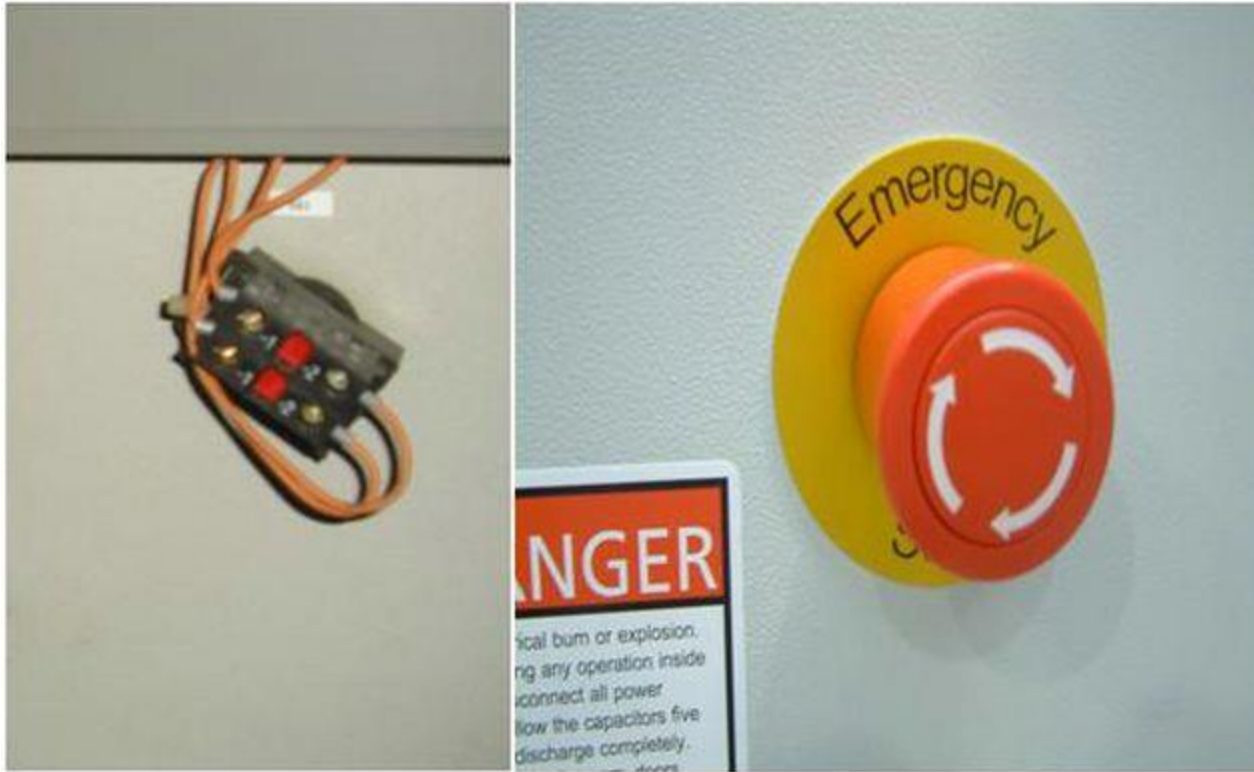
- **Explanation**
EMERGENCY SWITCH – IN THE TOWER +AT2:

Check for loose connections at the emergency switch.

Check that voltage is present and switch operation.

If the switch is found to be defective, replace with new.

Part number for emergency switch:

60005824 - MUSHROOM BUTTON ISAF6165

60005846 - CONTACT ELEMENT SK616 001

60005848 - HOLDER for 3 ELEMENTS SK616

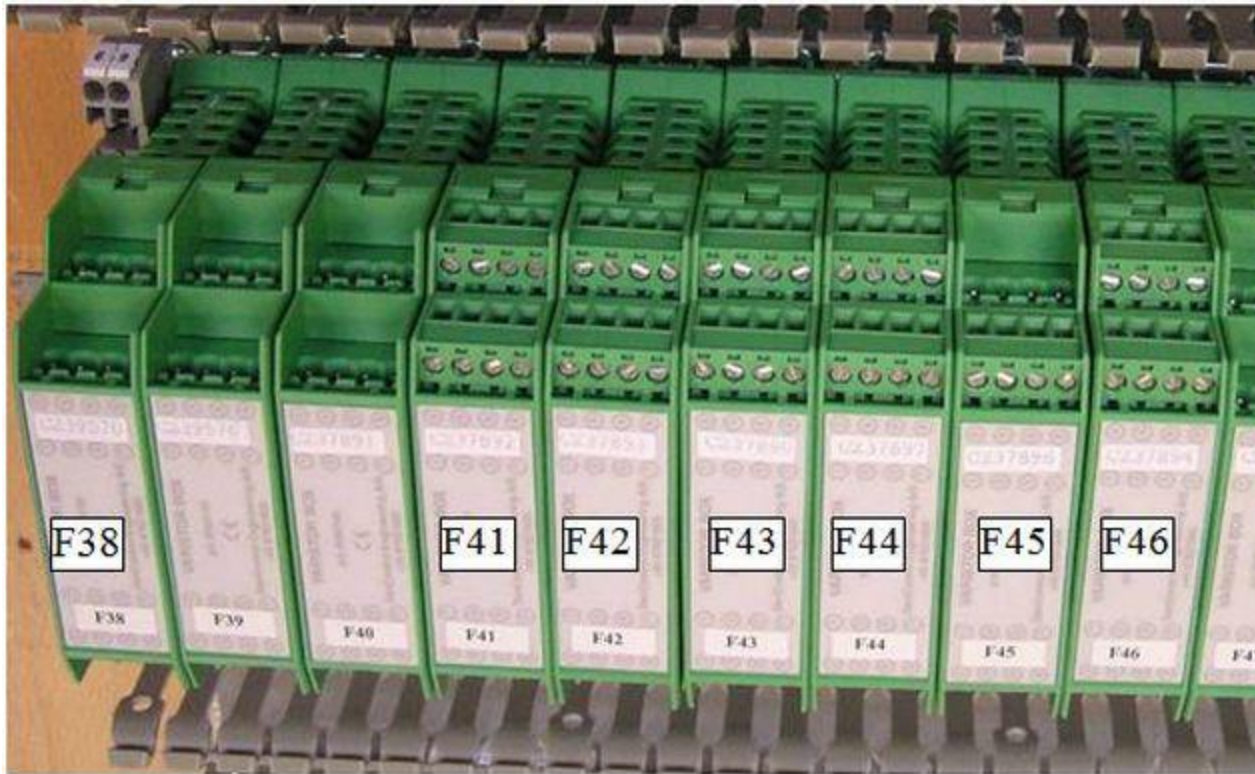
- **Explanation**
VARISTOR F45, F38, F33- IN THE AN1 PANEL:

The emergency line in the nacelle is connected through varistor boxes F33, F38, F45.

Defective varistors can also cause this alarm.

Varistors can be tested individually by placing a multimeter (set to measure Ω) lead on the common (earth) side of the varistors and the other on the individual varistor terminals. The resistance value over the varistor should be ∞ or in the high M Ω range. If the resistance is lower, the varistor has been damaged by an over voltage in the circuit and must be replaced.

Relevant spare parts	
Description	Item No.
VARISTOR BOX X8	51706201

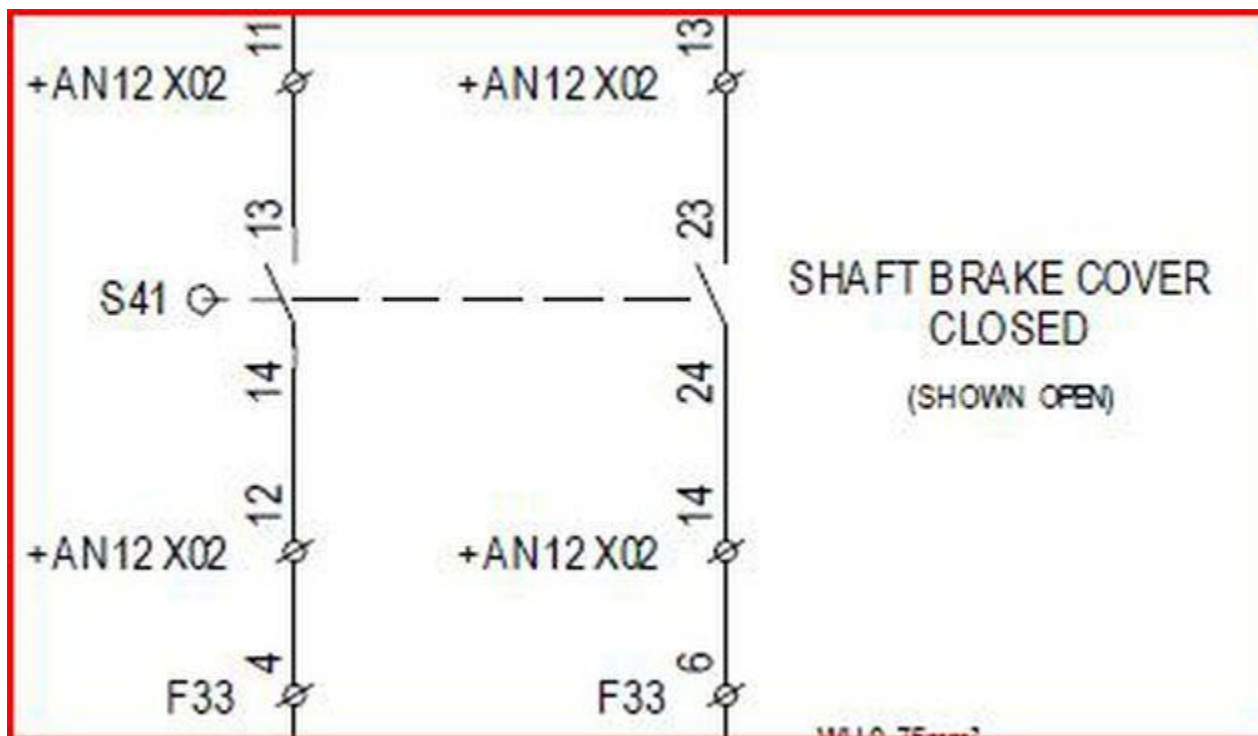
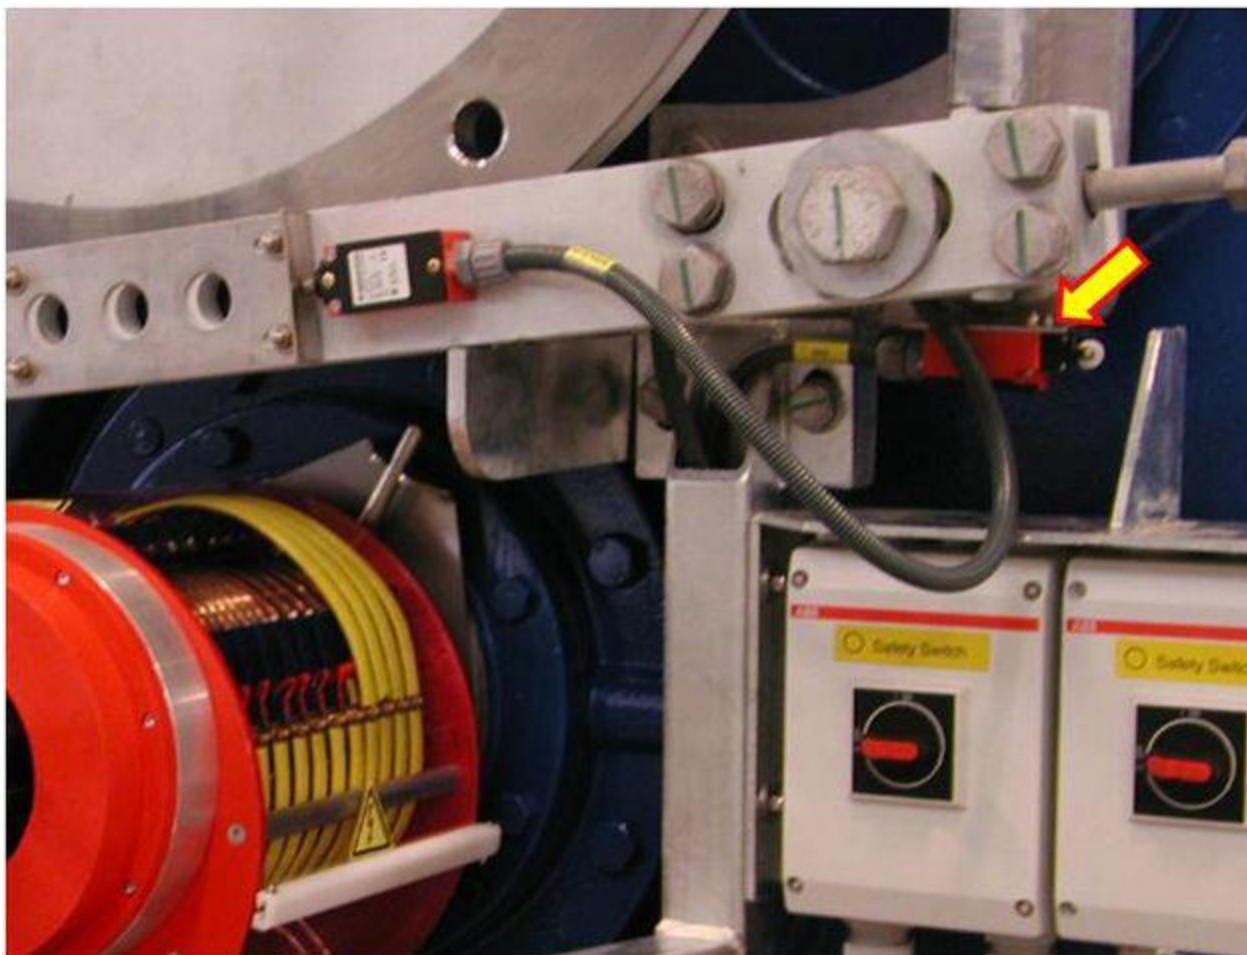
- **Explanation**
SHAFT BRAKE COVER – IN THE NACELLE:

Check for loosening of the shaft brake cover and ensure the cover is properly closed.

Check for any loose connections at the shaft brake switch and switch operation is ok.

Check for the presence of voltage through the switch with a multimeter.

If the switch is found to be defective, replace with new

Relevant spare parts	
Description	Item No.
ENDSTOP S 6086803014 I88-E2W (NO+NO)	60009254

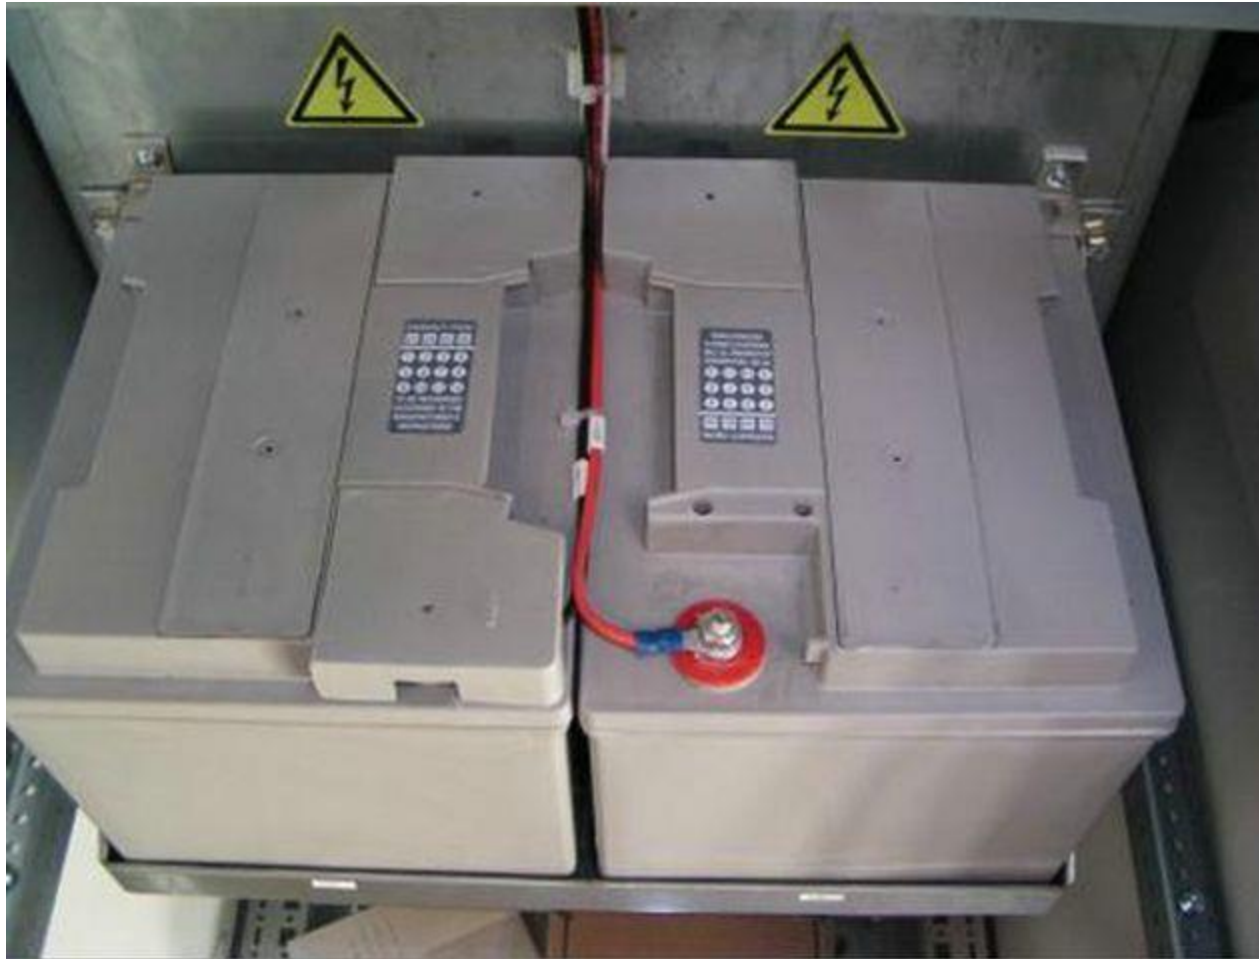
- **Explanation**
IN THE NACELLE:

Check the battery line backup 24V DC supply presence, if not present – refer to “[686](#) - **Battery charger fault**” alarm guides to restore the backup supply.

If a battery is found defective, replace it.

Relevant spare parts	
Description	Item No.
BAT H4 12V 32Ah	60000711

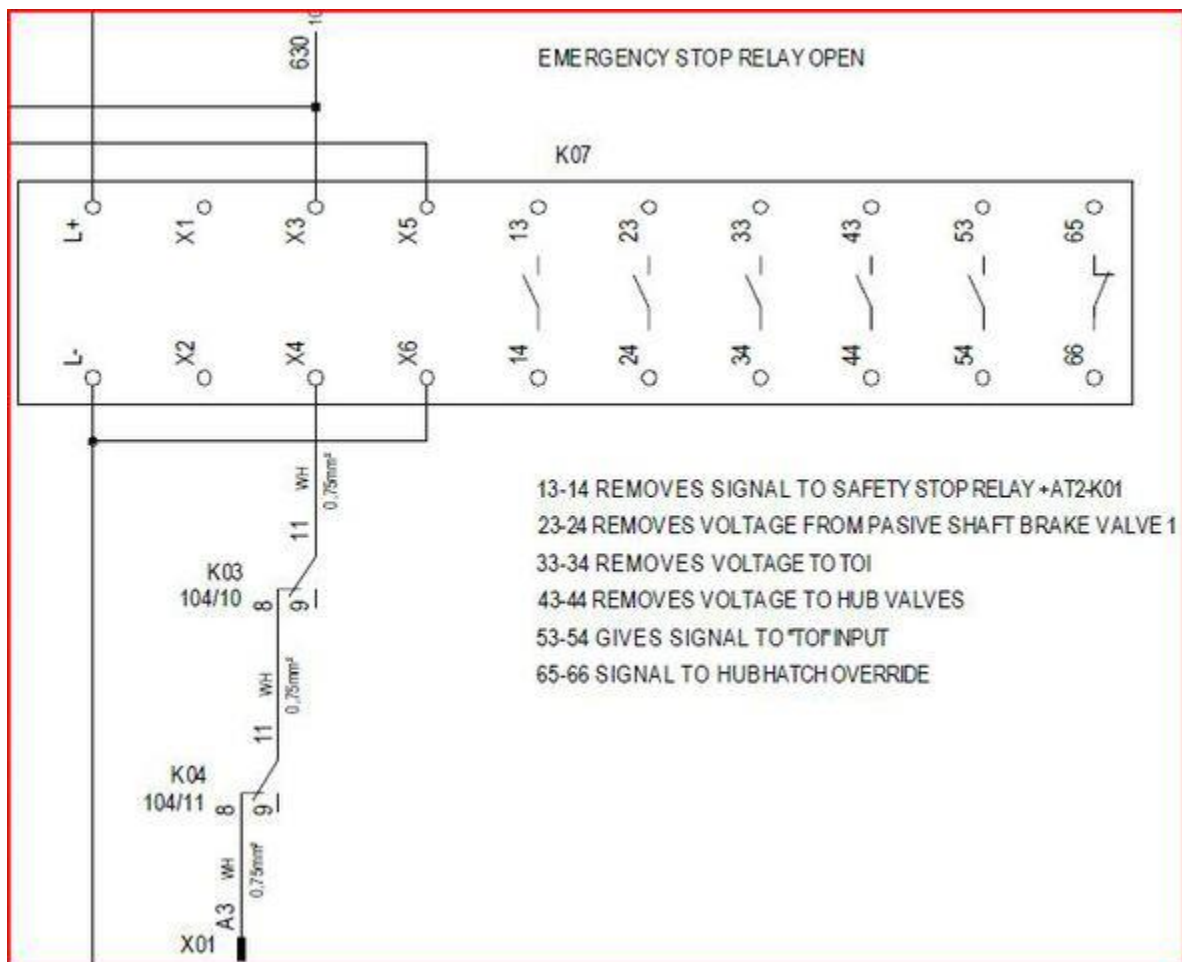
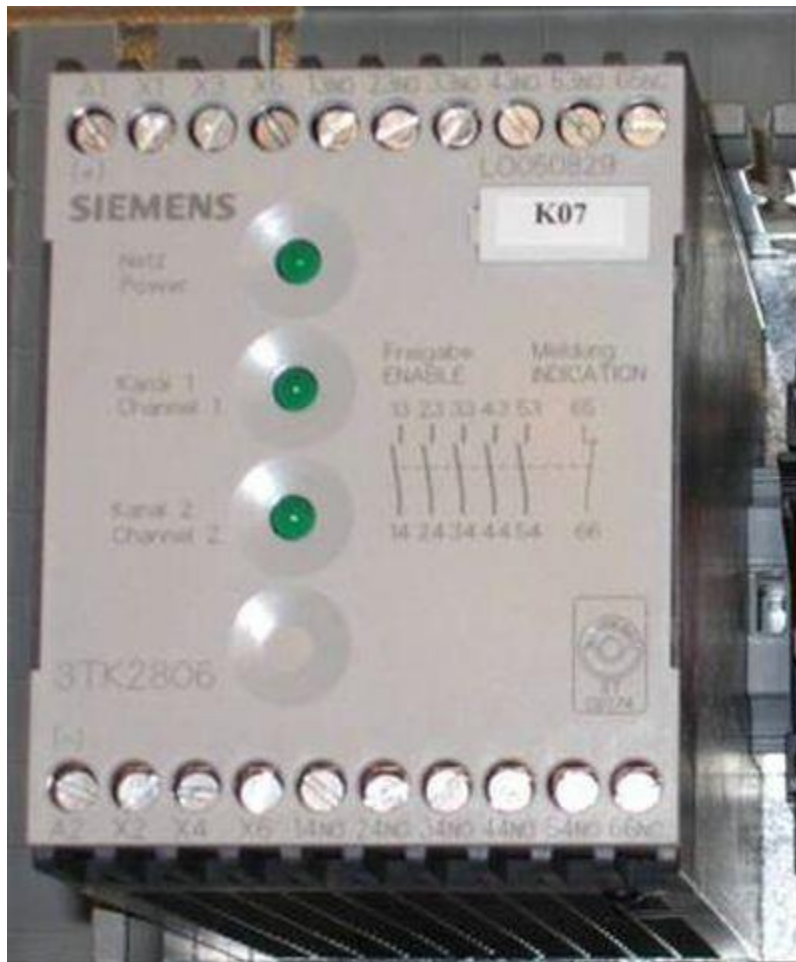
- **Explanation**
EMERGENCY RELAY (K07) – IN THE +AN1 PANEL:

Check that the K07 relay input supply indicates 1st Green LED,

Check that the 24VDC voltage of +X3, +X5 terminals indicates 2nd and 3rd Green LED's.

After checking of 24V DC L+, X3, X5 terminals, then 24VDC pulse given to X4 terminal means the relay should be closed.

If not closed, it is likely that the relay will be defective.

Relevant spare parts	
Description	Item No.
RELAY SAFETY 3TK2806-OB4 24VDC 5NO+1NC	60004996

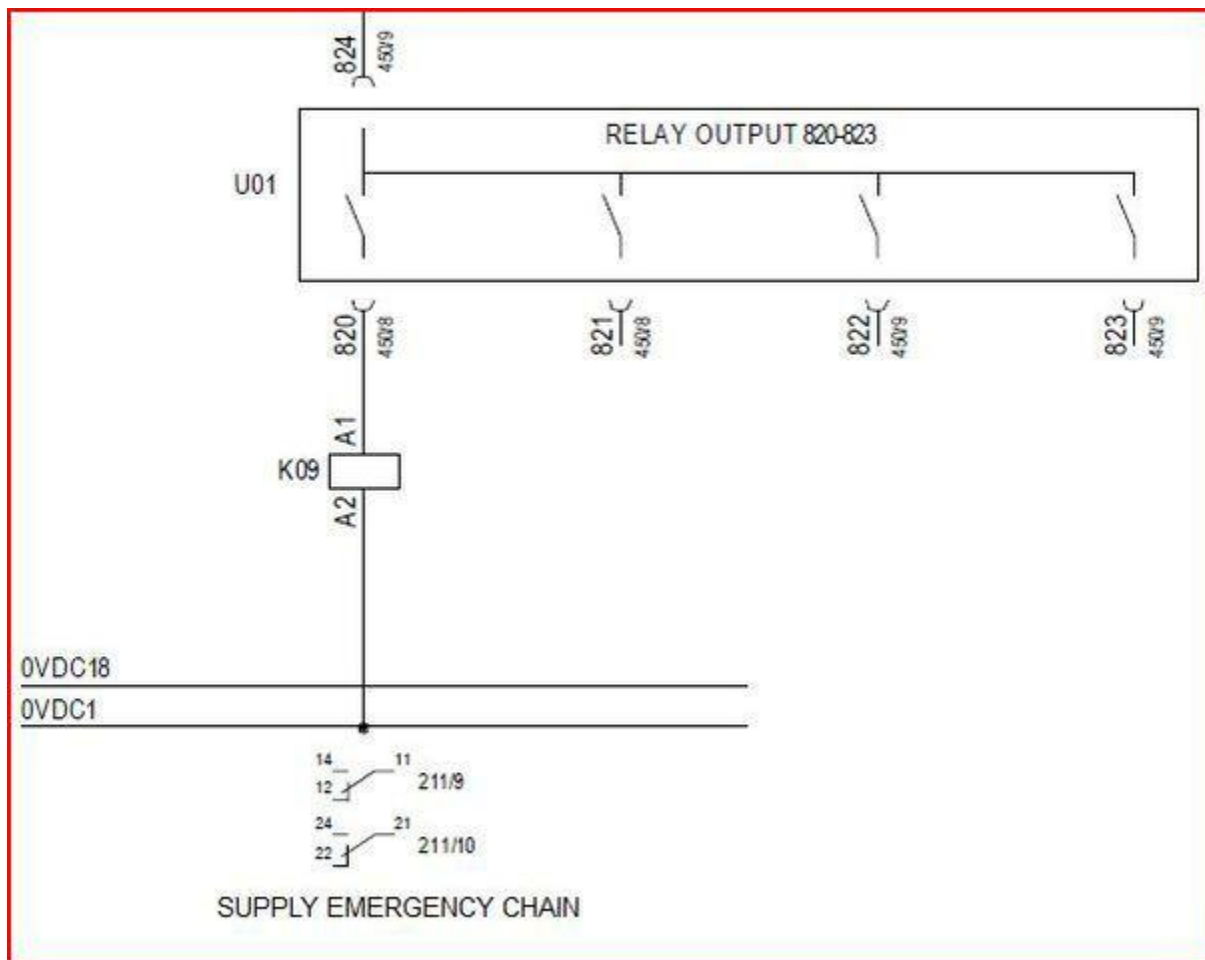
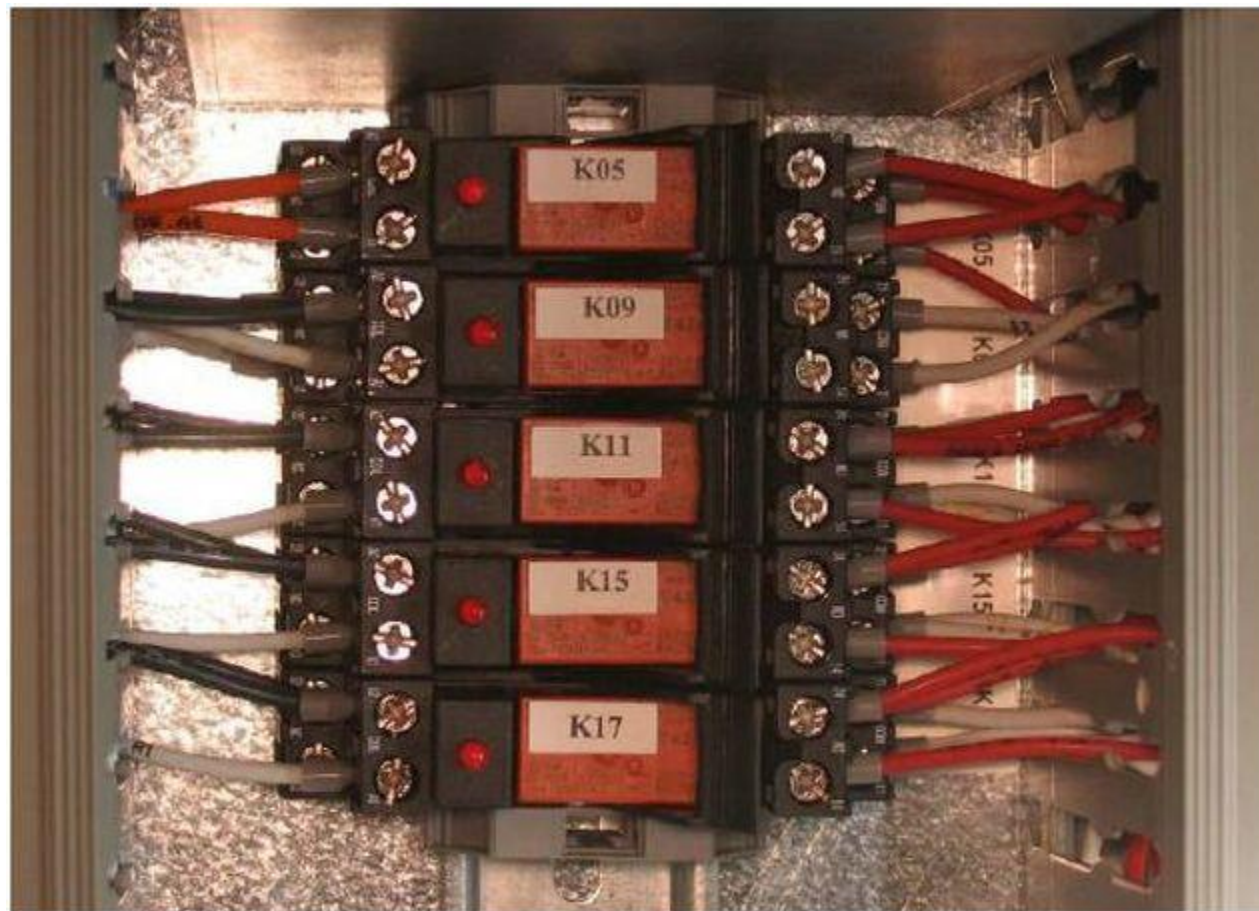
SUPPLY EMERGENCY RELAY – IN THE +AN1 PANEL:

Check for loose or damaged connections in the relay, tighten any loose connections.

If the relay is found to be defective, replace with new.

Relevant spare parts	
Description	Item No.
RELAY RT424024 8A 24V 2P	60004513

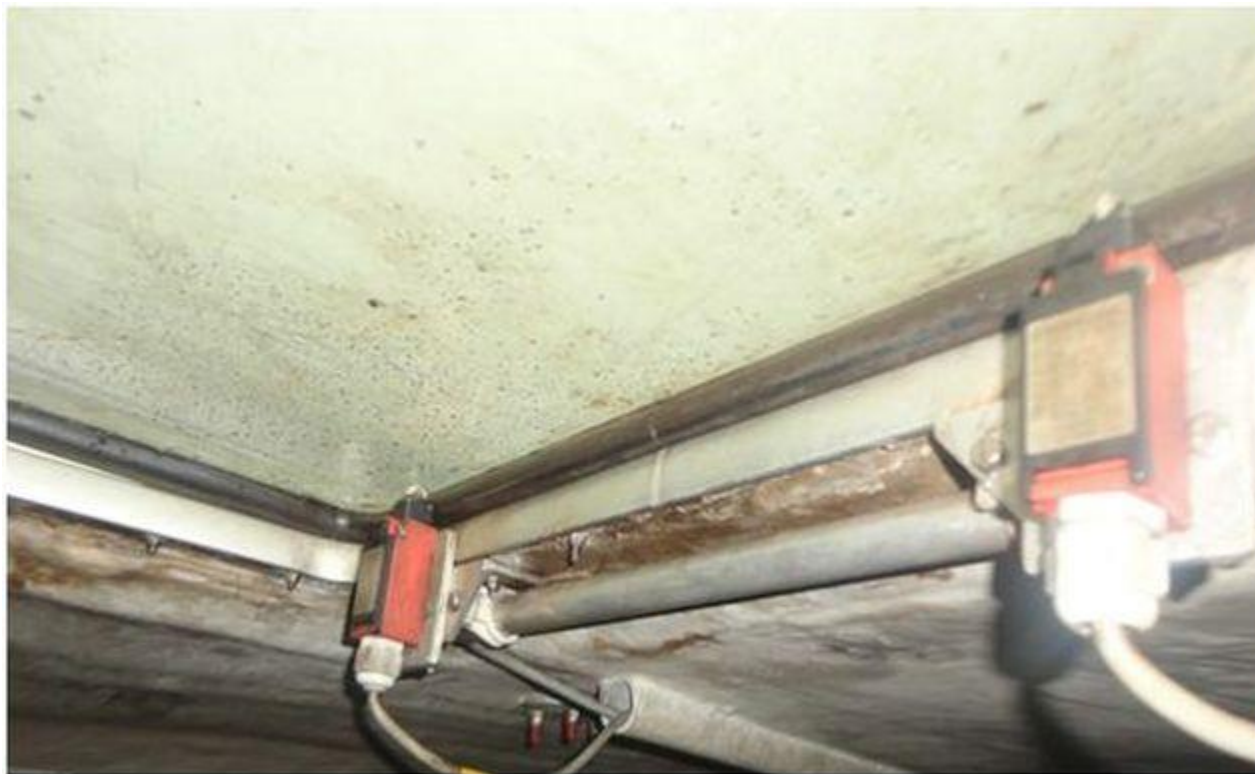
- **Explanation**
HUB HATCH SWITCH- IN THE NACELLE:

Check the hub hatch switch for misalignment, damage or loose wire connections.

Check the voltage presence through the switch with a multimeter.

Hub hatch having two different switches, one is the emergency line and the other one is the hub hatch line.

If the switch is found to be defective, replace with a new one.

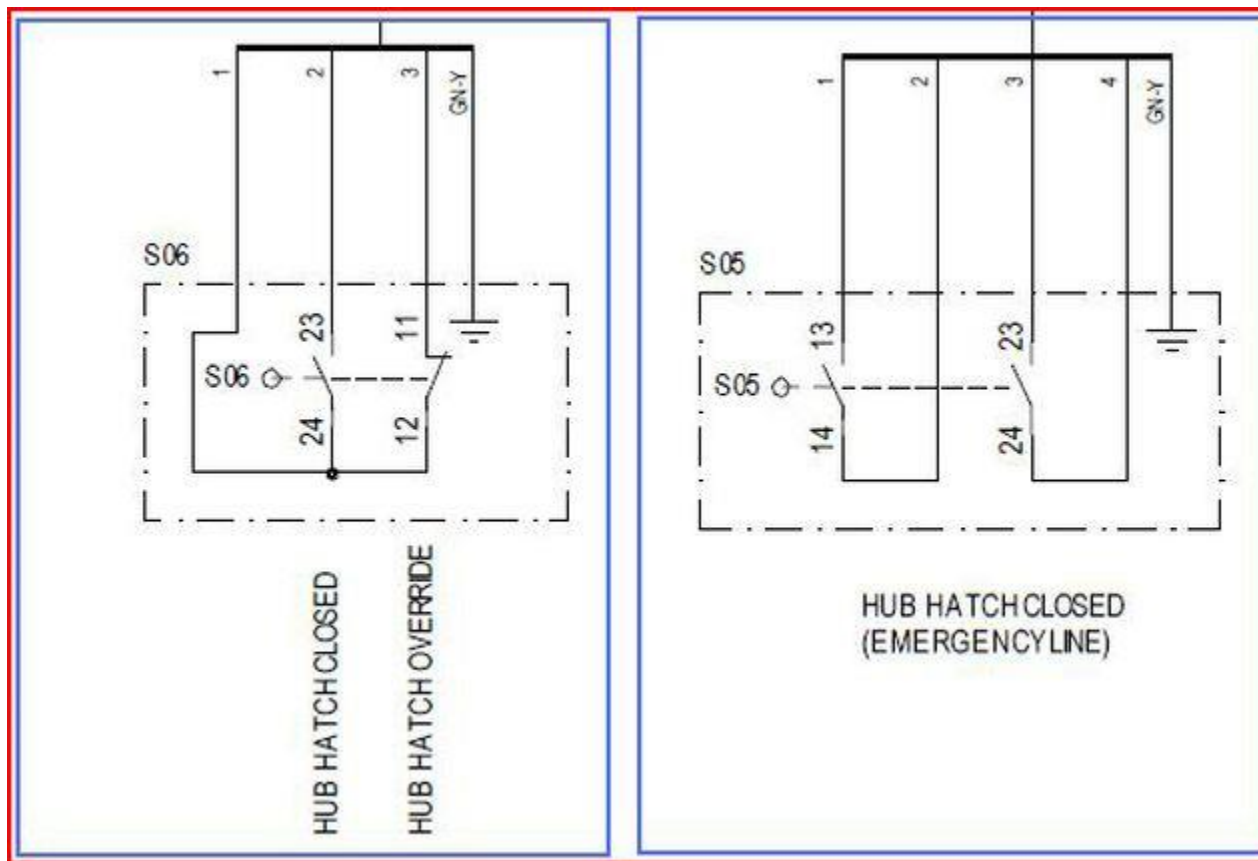
While checking the emergency line ensure the switch is 2 NO.

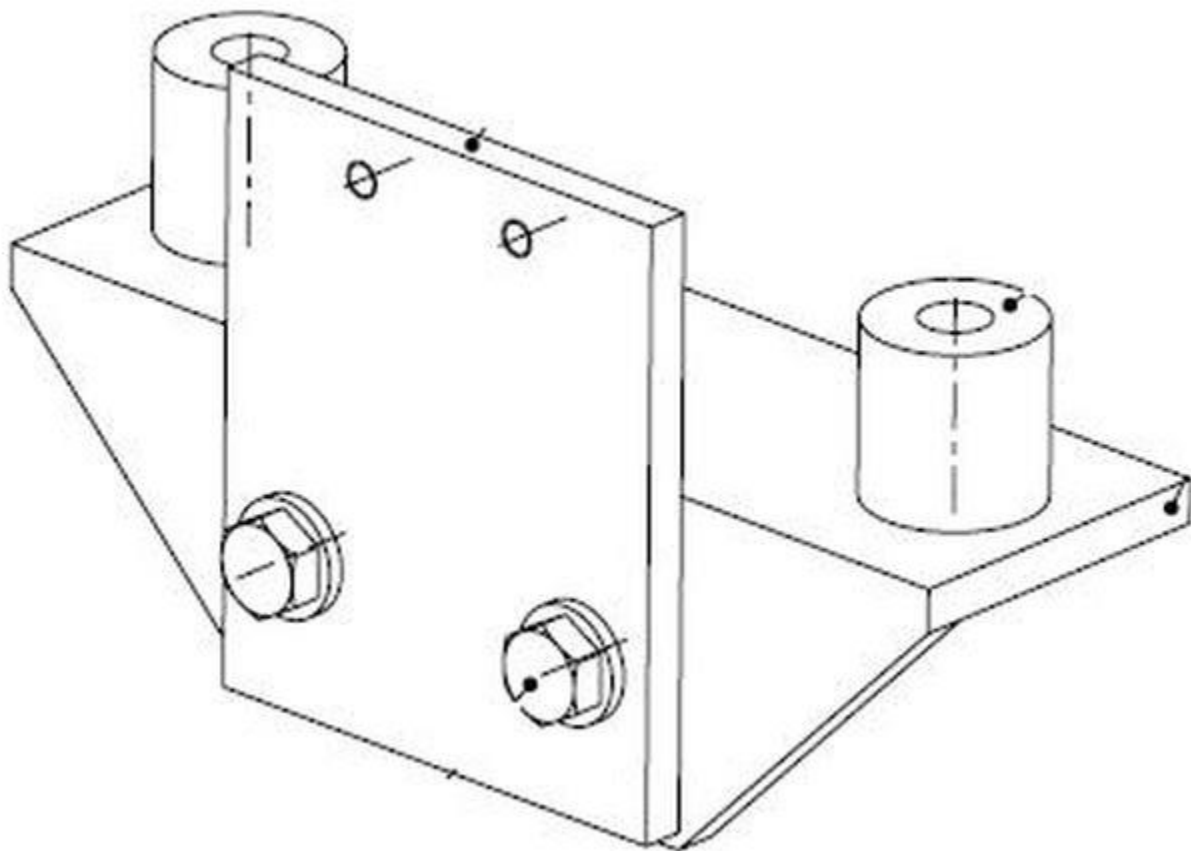
Interconnected fixing unit, check the condition and replace if necessary.

Improper alignment of the moon light door can also lead to this alarm.

Relevant spare parts	
Description	Item No.
BRACKET FOR SKY LIGHT	60072428

Check the alignment and fixing – replace the moon light door if it is defective or damaged.

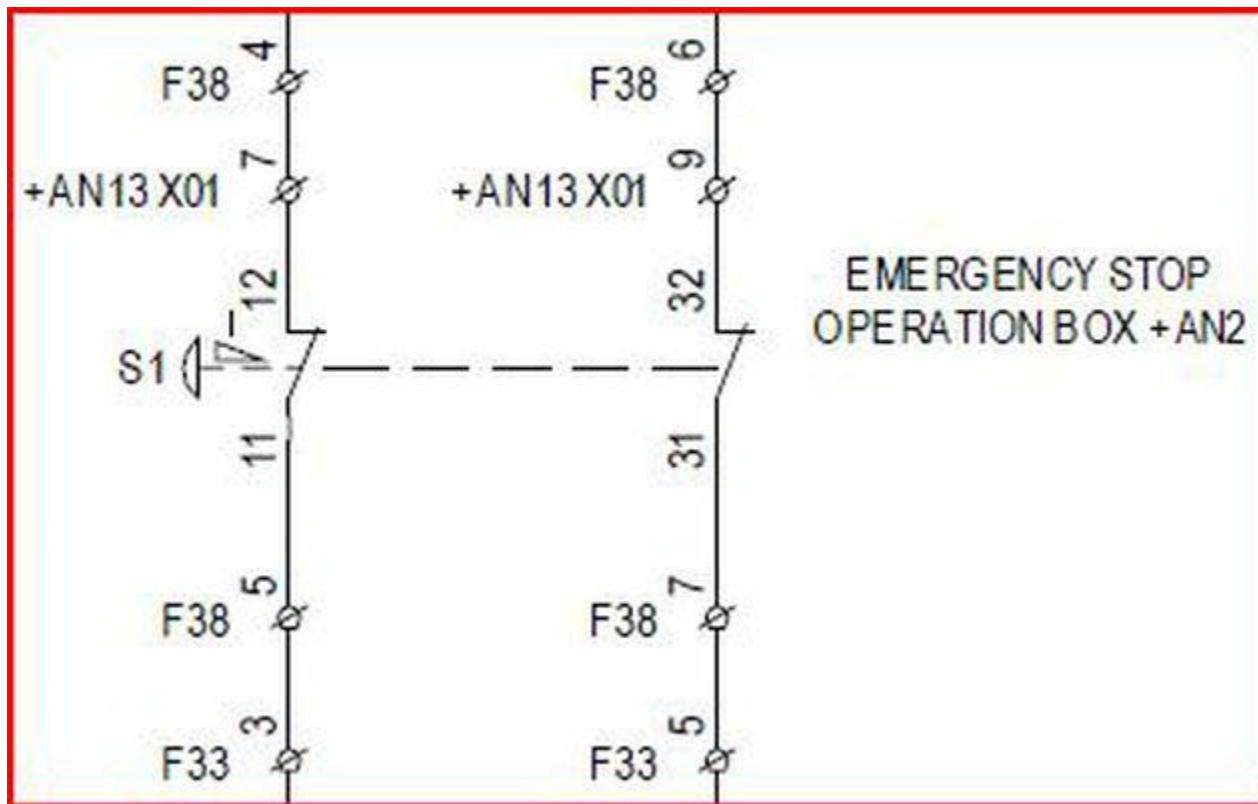
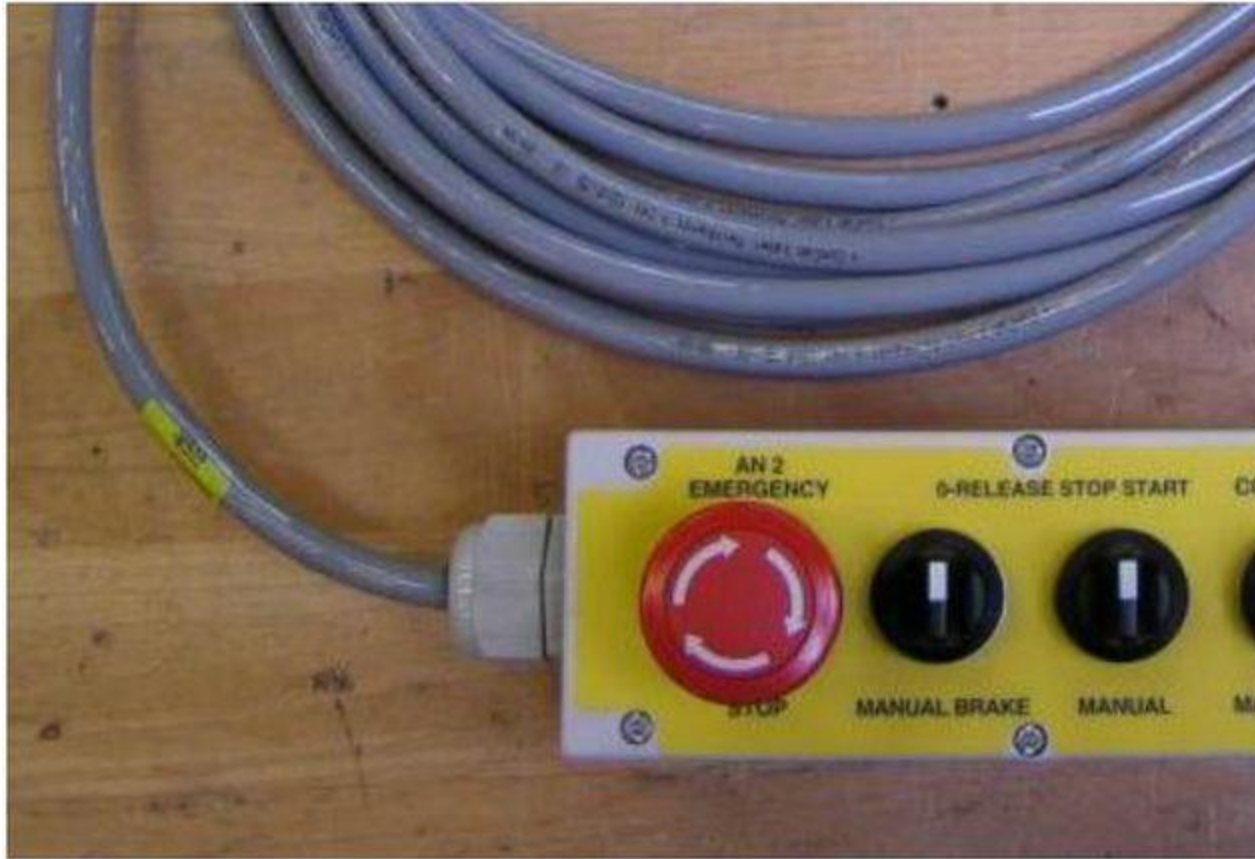
- **Explanation**
OPERATION BOX EMERGENCY STOP AN2+AN13 – IN THE NACELLE:

Check for loose connections within the operation box.

Check for the presence of voltage through the switch with a multimeter.

If the switch is found to be defective, replace with new.

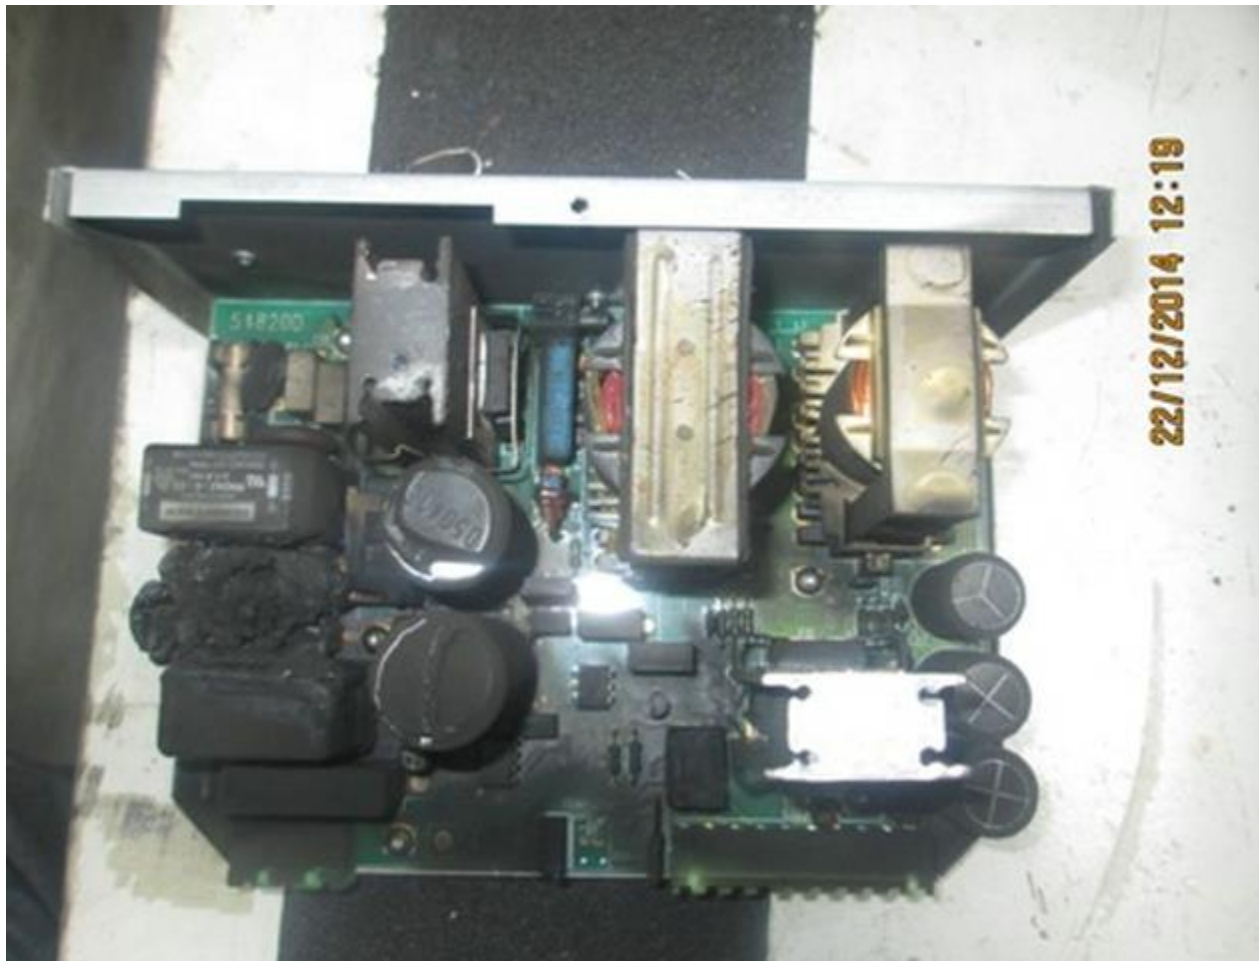
Check the power net (G01) for any loose or damaged electrical connections.

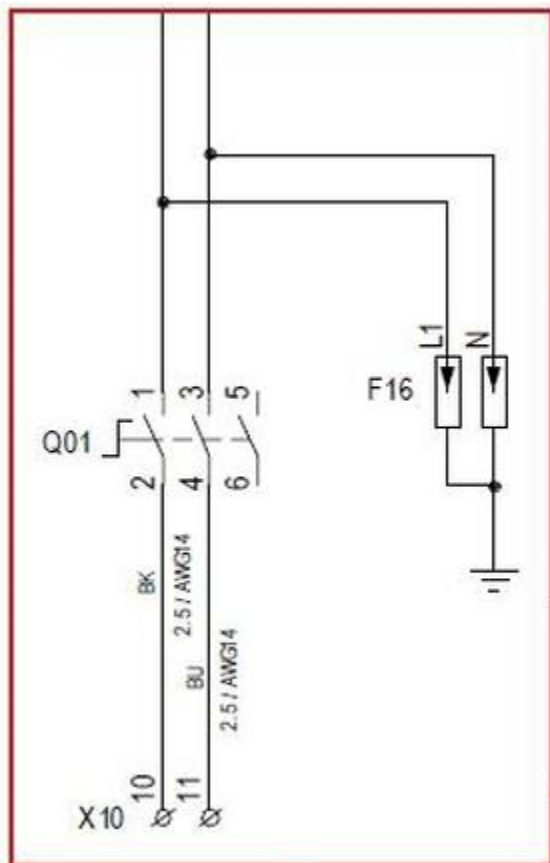
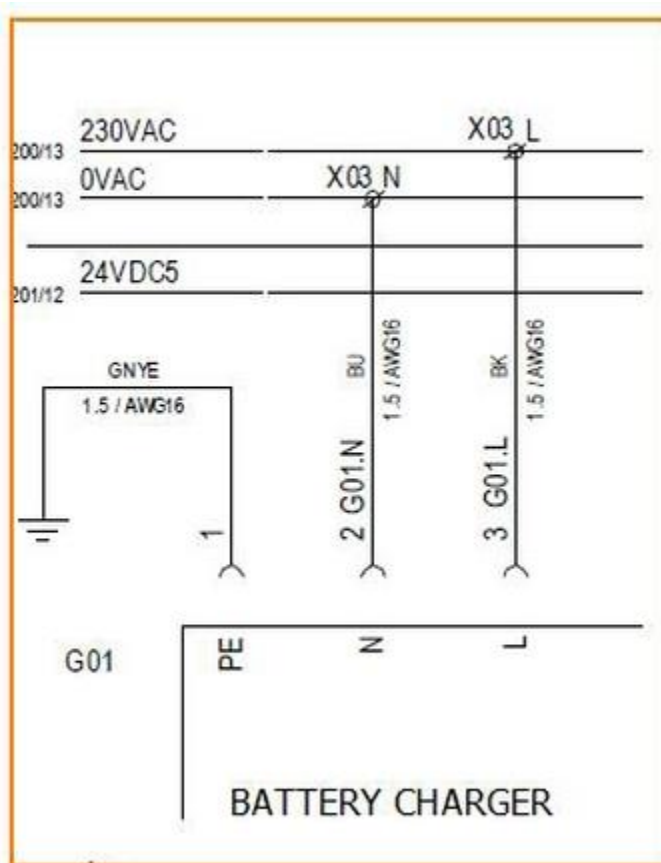
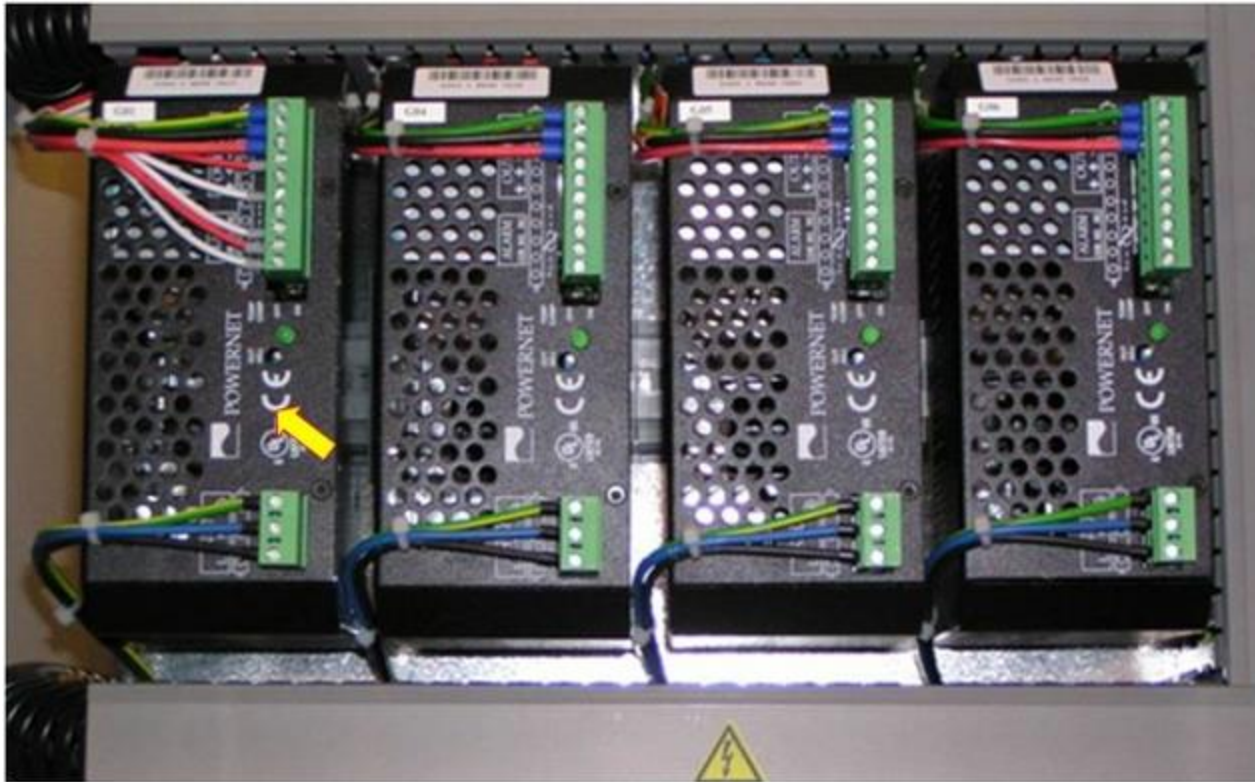
Check the INPUT /OUTPUT voltage; if the 230/115V supply is present, but the DC output is low or not present, it is likely a defective power net. If the output voltage is low, adjust the rheostat on the power net accordingly to increase the output.

If defect power net replace with new.

Relevant spare parts	
Description	Item No.
PS ADC 5483R-3 10A-27,4 NM PIN (Power Net)	188453
