Check the compensator valve setting and replace the defective valve

Check the compensator valve (relief valve) setting in the hydraulic pitch pump.

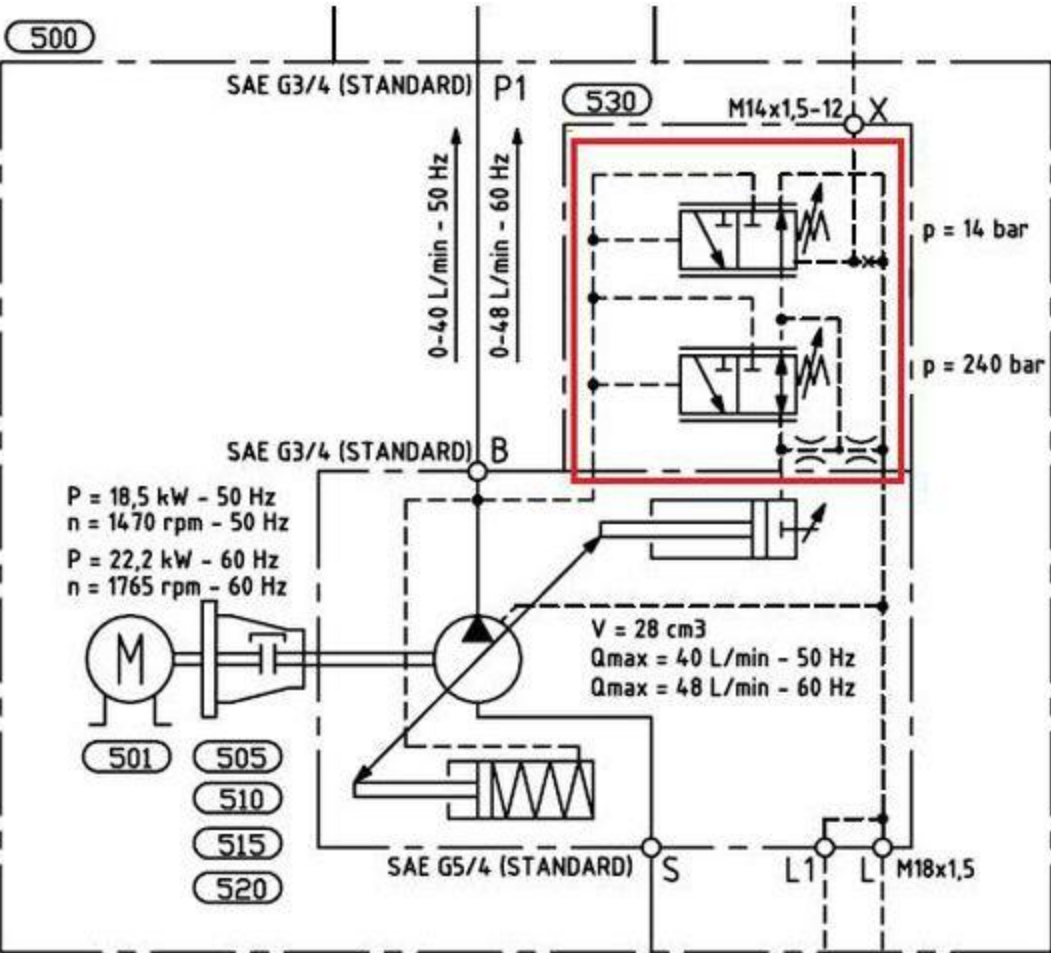
REXROTH SYSTEM:

Part number for Rexroth compensator valve:

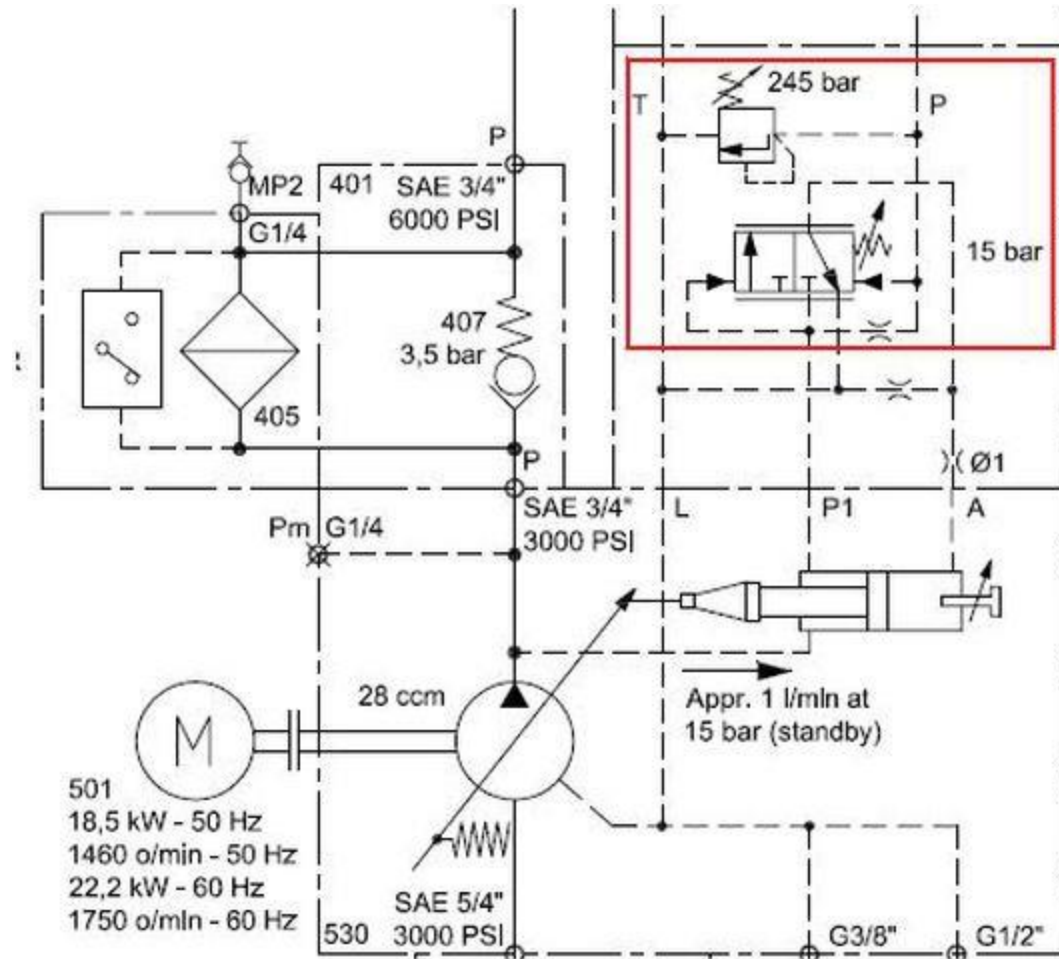
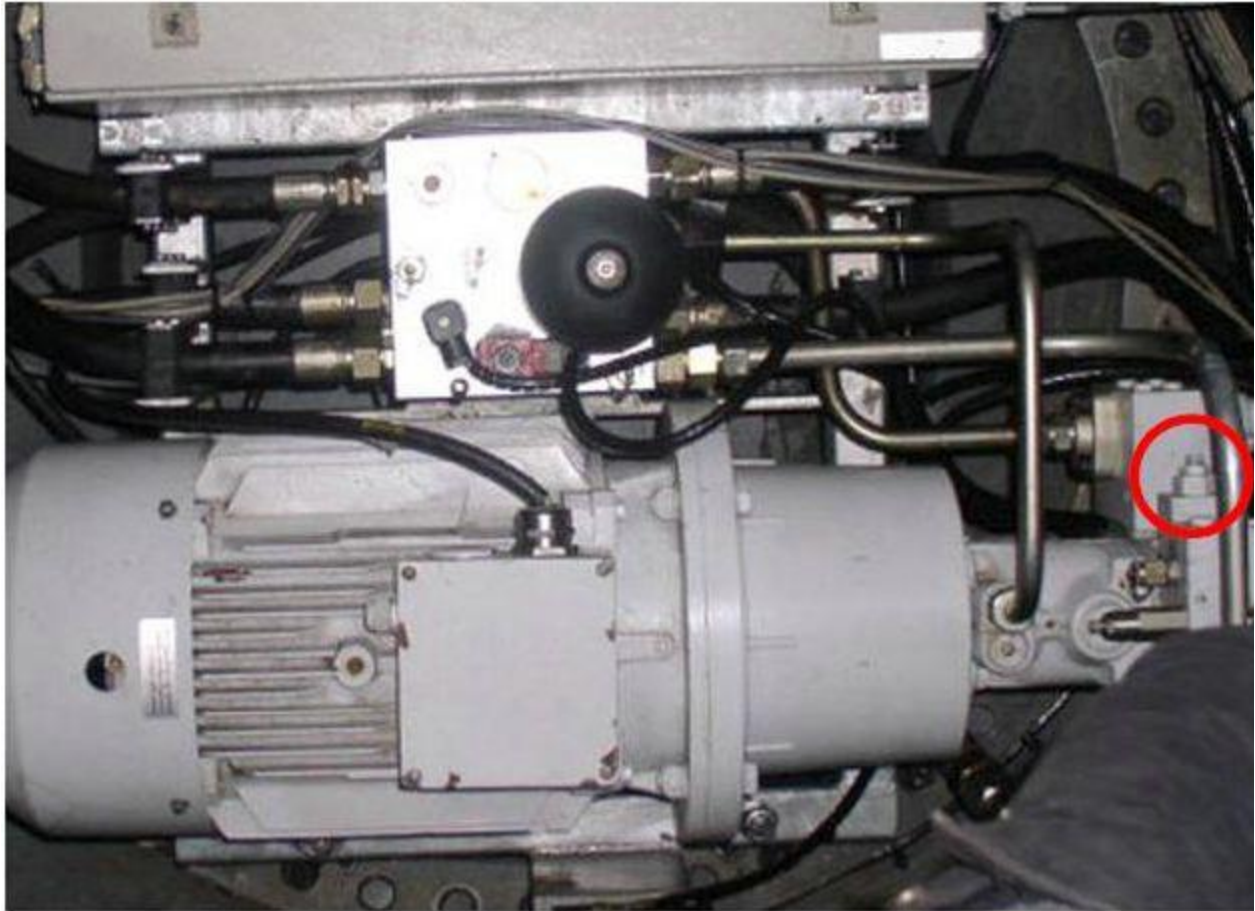
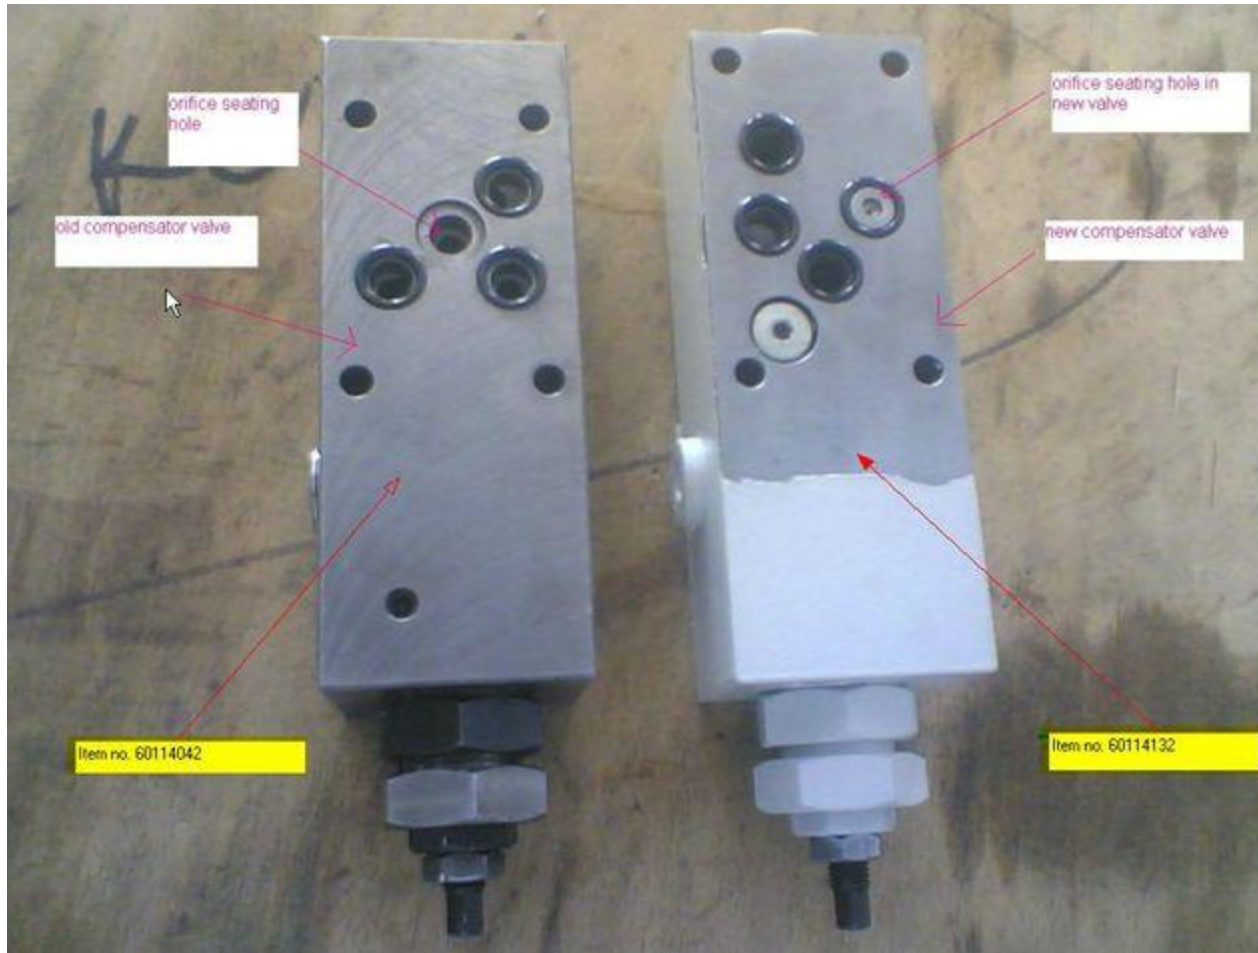
PARKER SYSTEM:

Parker hydraulic systems have two different types of compensator valves.

Ensure the valve type before replacing with a new valve.

Part number for Parker compensator valve:

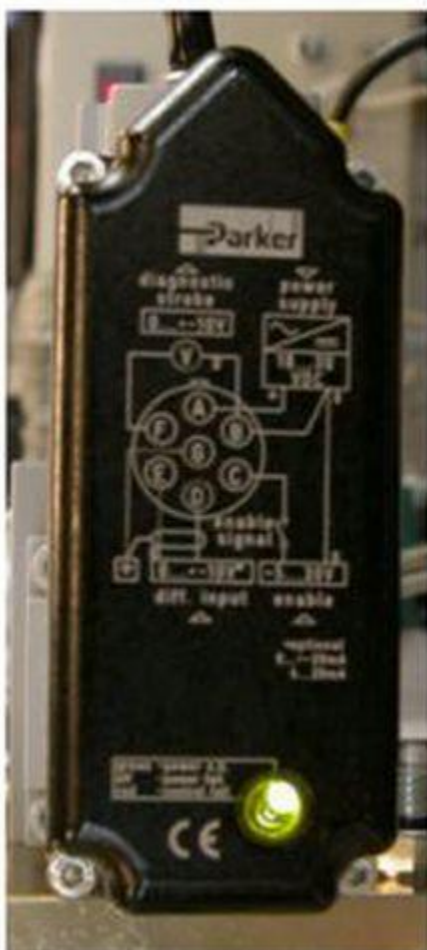
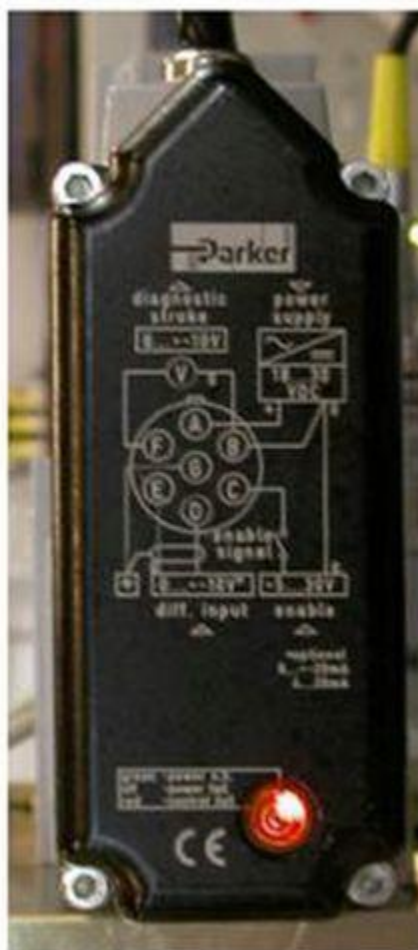
The LED should be green with the pitch system pressurized.

If it is red and there is pressure verified on test port MP, then the valve may also be defective.

Display Color	Indicates
Green	Normal operation
Off	Supply voltage outside permissible range of 18 to 30 VDC
Red	Spool position error / Low pilot pressure

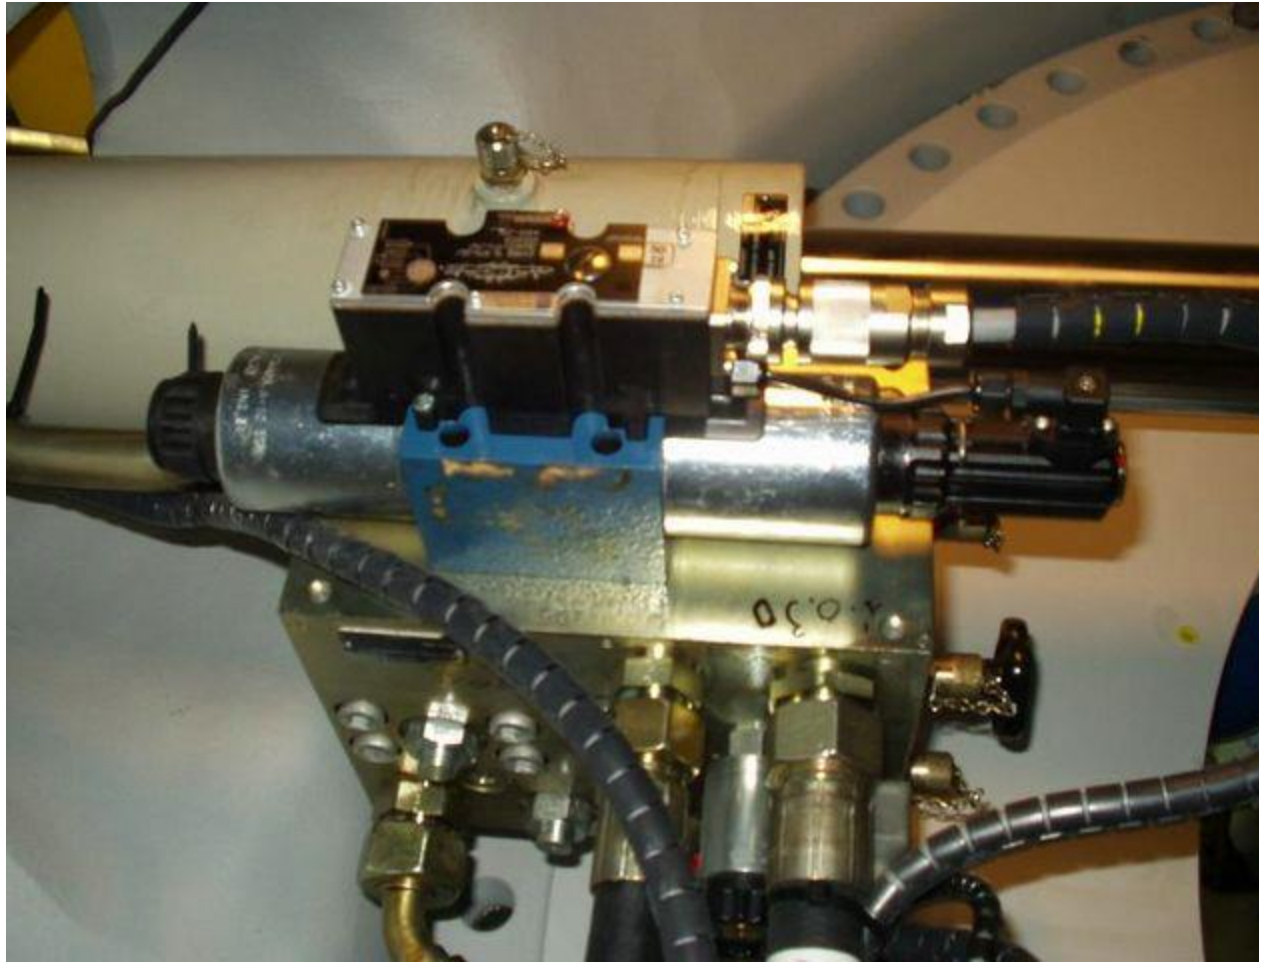
Parker Proportional Valve

Replacement of proportional valve below SWI

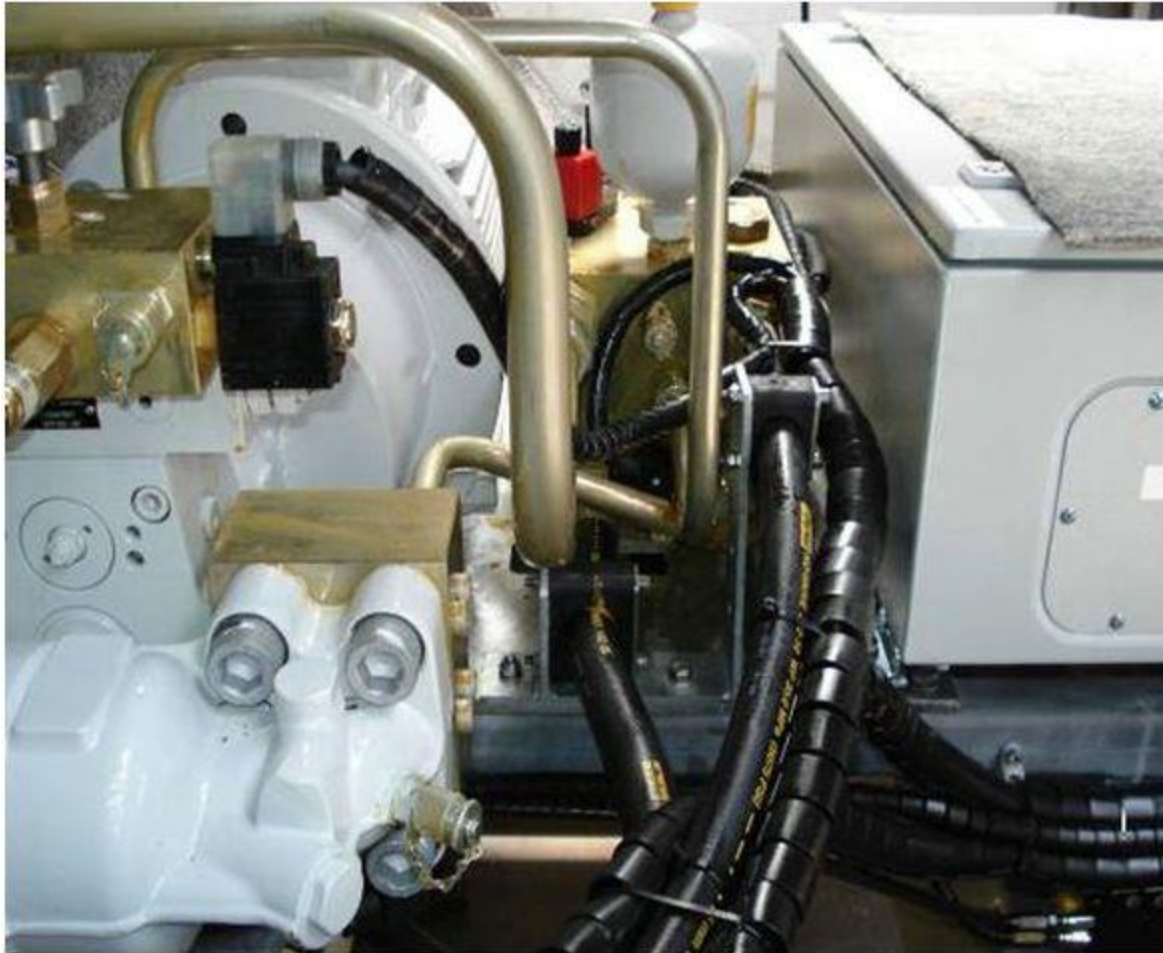
Main distribution block when pump pressurizing mode:

Check the valve operation. If any of the valves are defective, replace with new.

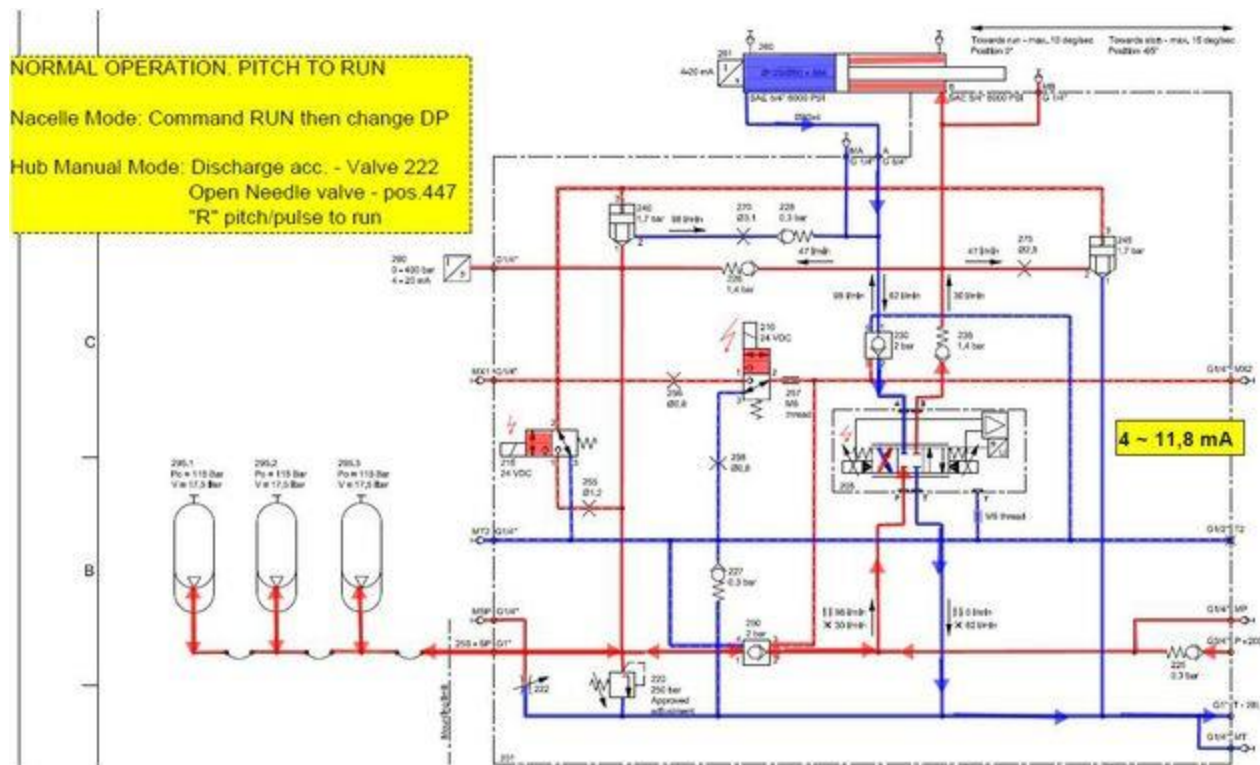
Pitch distribution block when turbine in ready for operation mode:

Check the following position valves:

Swap the valves one by one in to other manifolds and check valve operation.

If the fault shifted to other blades the valve is likely defective. If not check other valves.

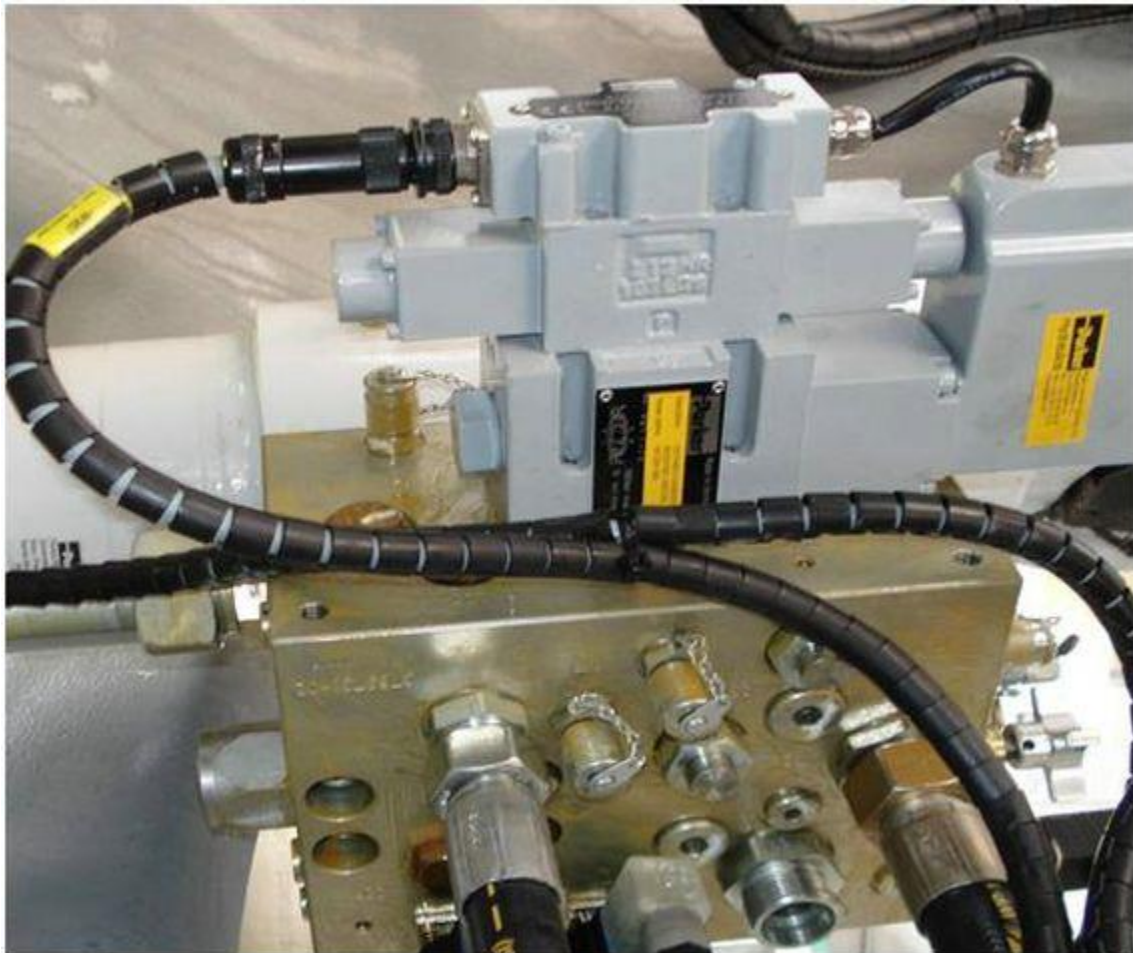
REXROTH SYSTEM -MAIN MANIFOLD:

Main distribution block when pump pressurizing mode:

Relevant spare parts		
Description	Item No.	Location
CHECK VALVE PILOT:CVEV-XCN A30	60096481	230 , 250 -
NEEDLE VALVE, NVH-2201	60104032	222
KNOB FOR NEEDLE VALVE	60112623	222A

3/2 DIRECTIONAL VALVE	60111617	210, 215 -
LOGIC ELEMENT PIL. OPERATED	60111630	240, 245 -
PRESSURE CONTROL VALVE: RDDT-QWN	60096477	220 -
CHECK VALVE CVH103P20	60112628	235 -
PROP. VALVE D31FHE01C	60112621	205 -

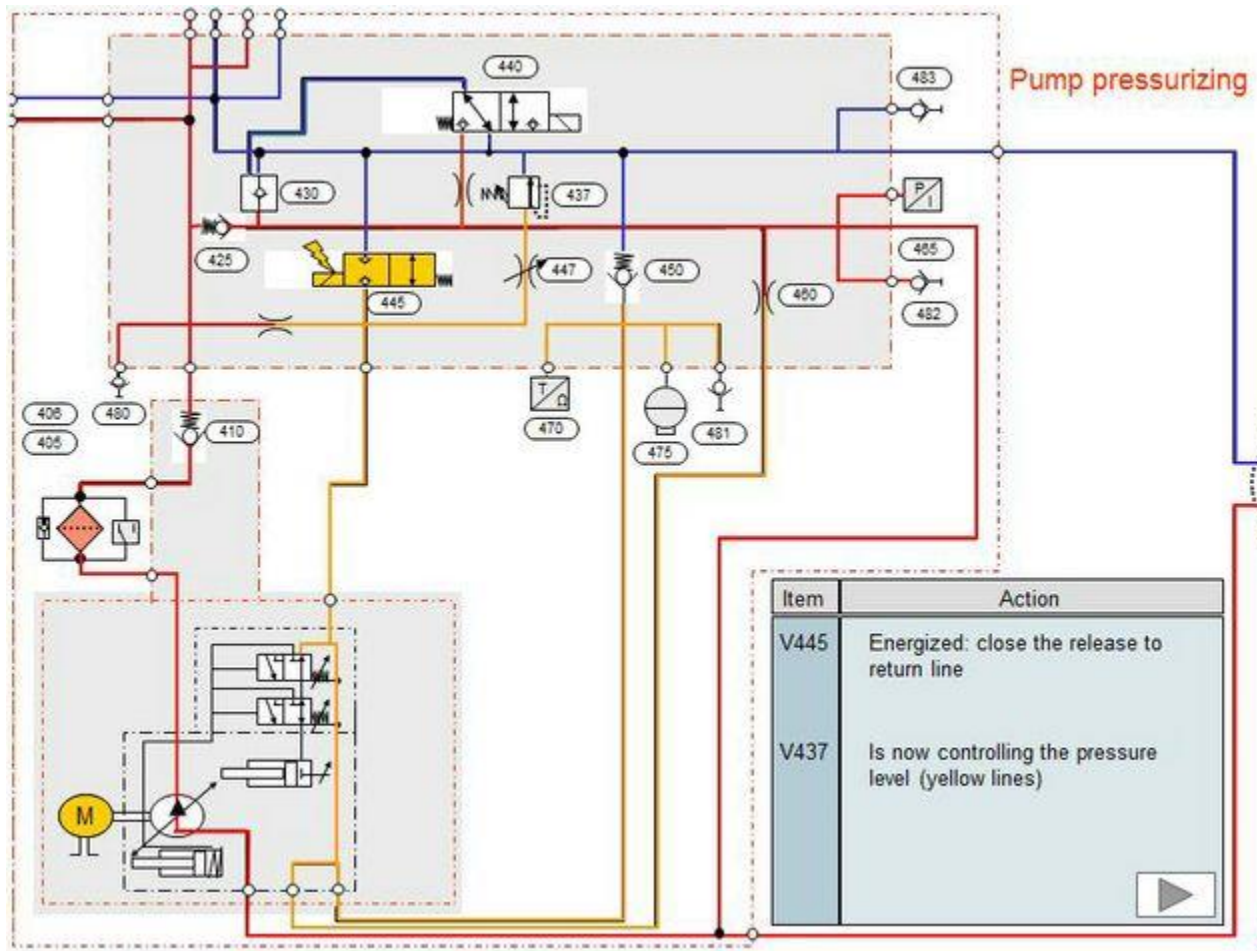
Check the following position valves:

Check the valve operation. If valves are defective replace with new.

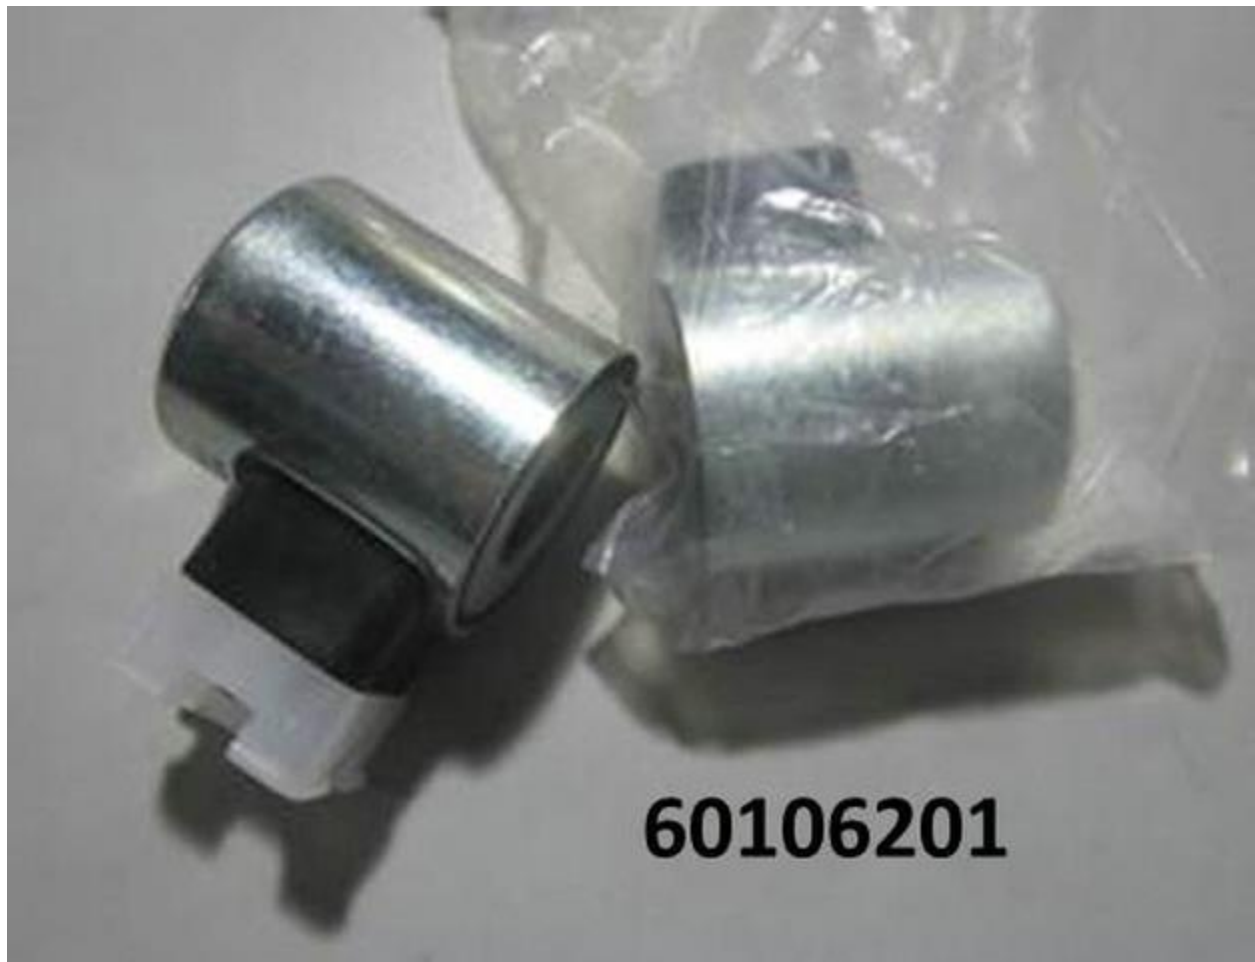
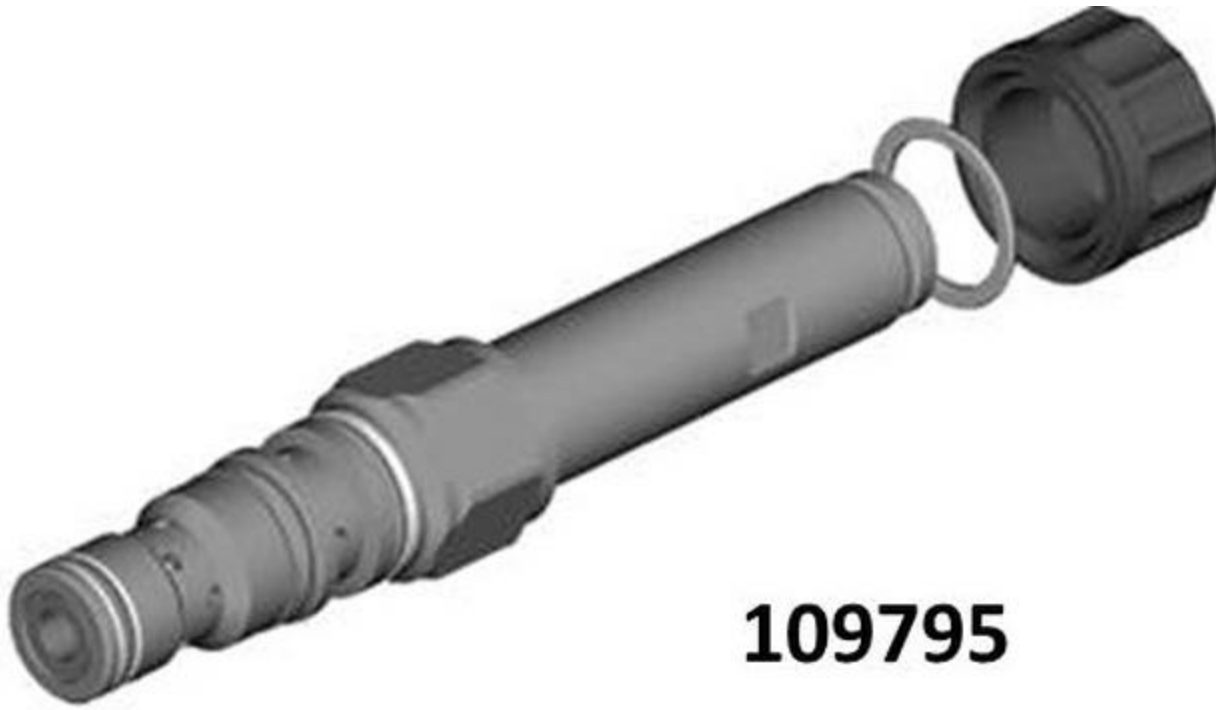
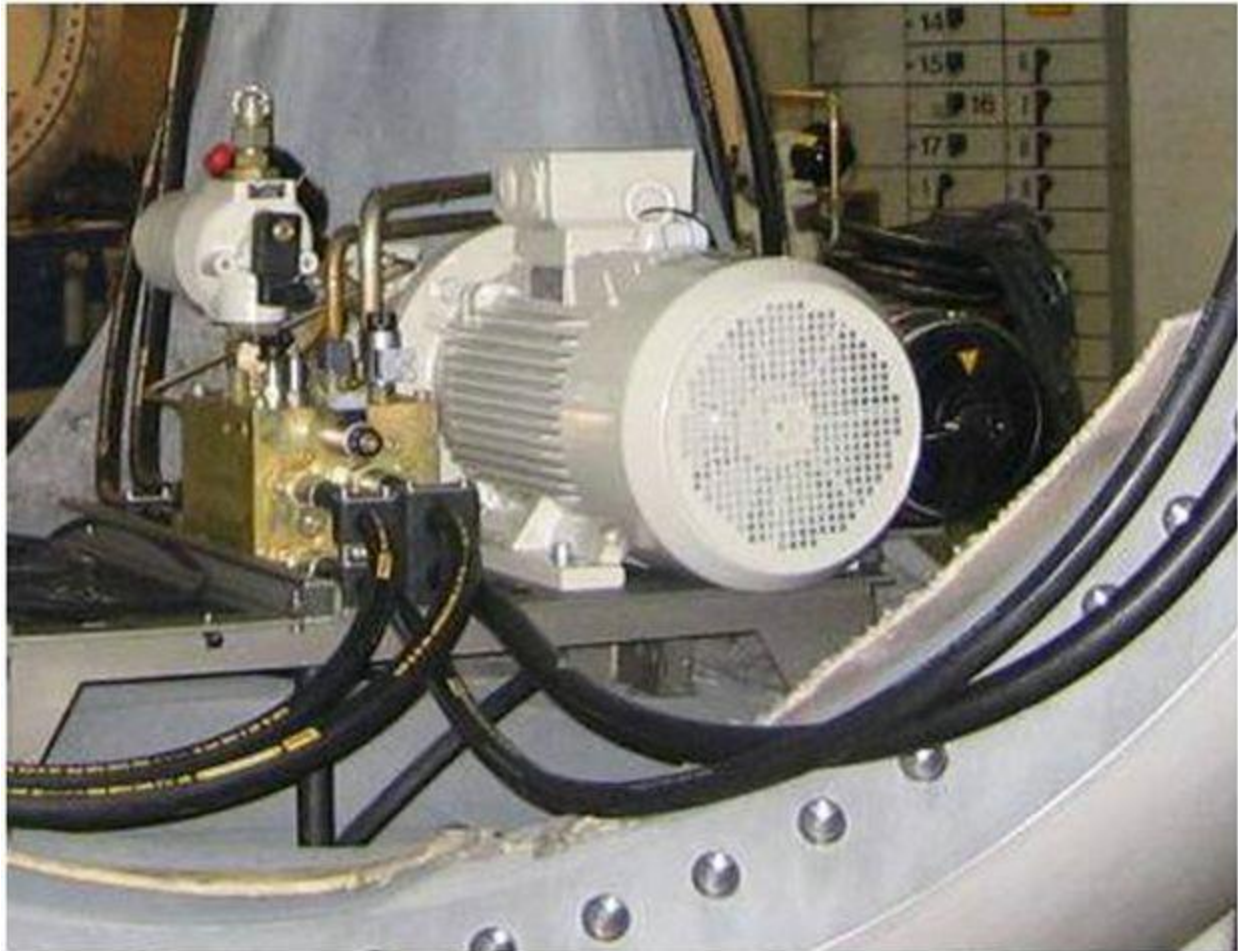
(Rexroth) Valve/Solenoid- (210 & 215)

The part No.60096475 is phased out and henceforth replaced by 109795 & 60106201.

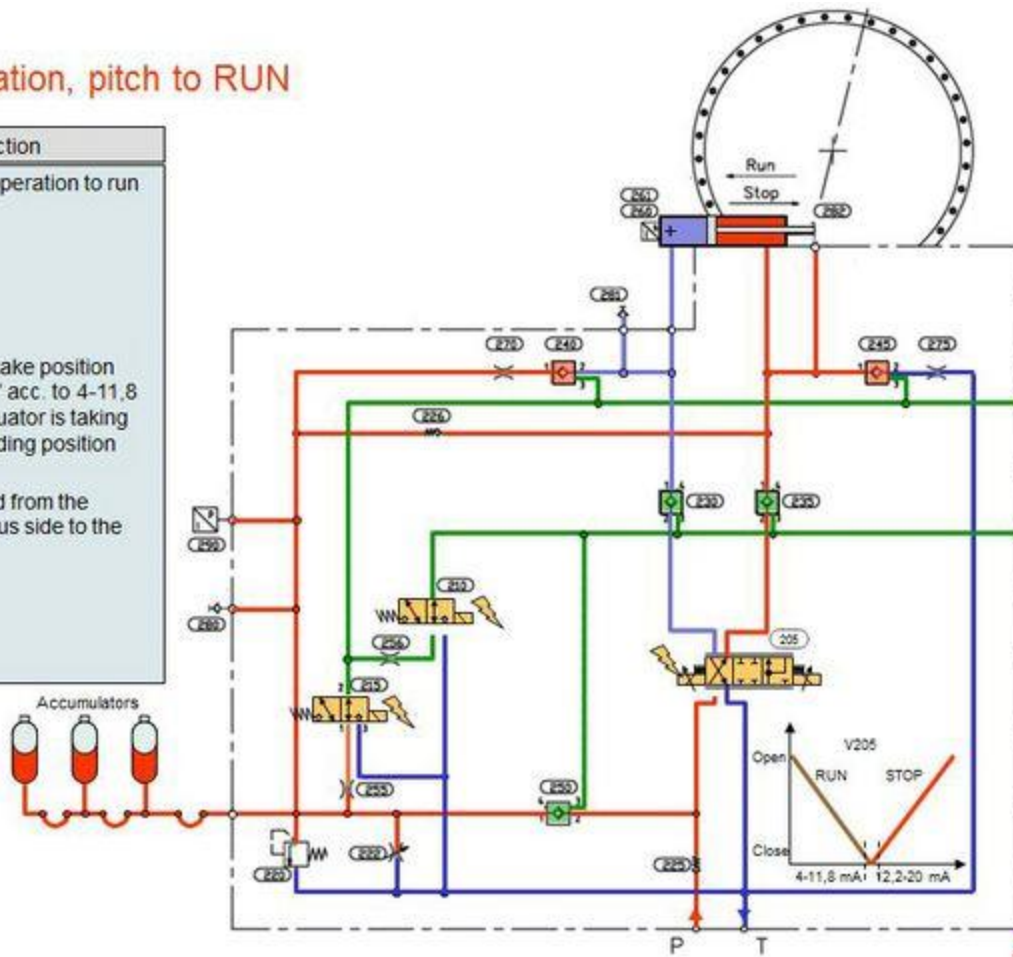
Pitch distribution block when turbine in ready for operation mode:

Normal operation, pitch to RUN

Item	Action
V215	Energized: operation to run
V240	Closed
V245	Closed
V210	Energized
V230	Open
V235	Open
V205	Prop.-valve take position "open to run" acc. to 4-11,8 mA. The actuator is taking a corresponding position
V230	Oil is drained from the actuator's plus side to the return line.
V205

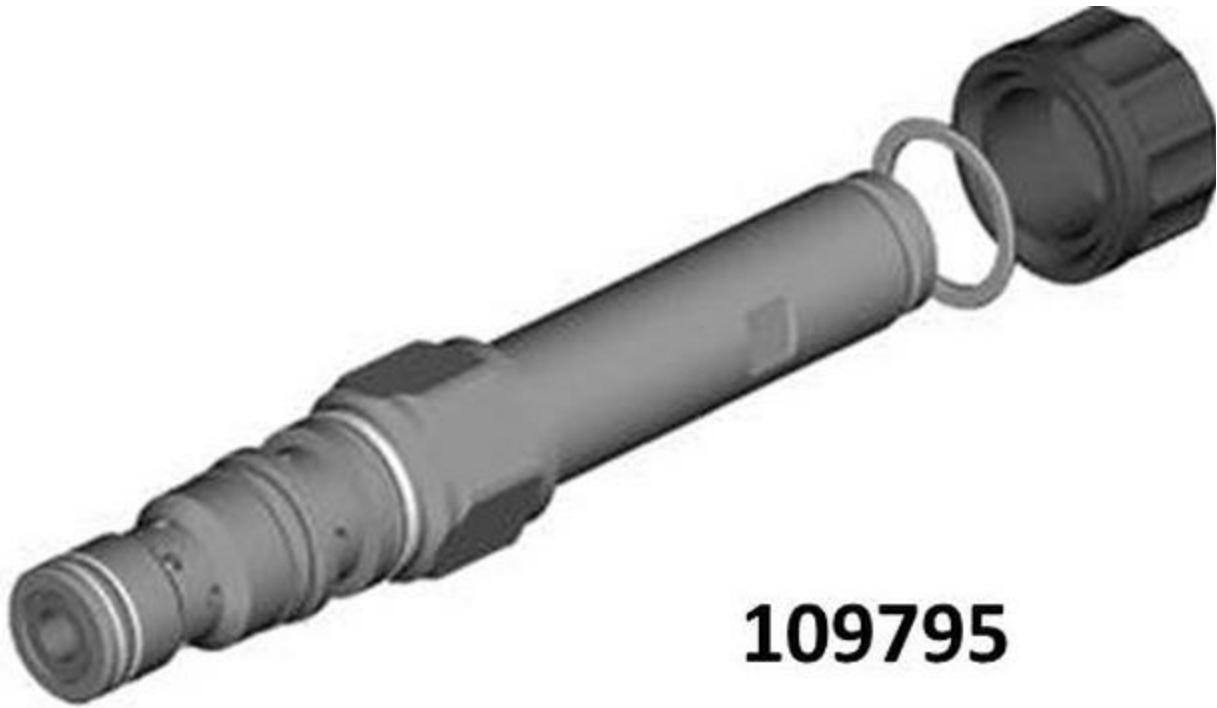
(Rexroth) Valve/Solenoid (POS 210 & 215)

The part No.60096475 is phased out and henceforth replaced by 109795 & 60106201.

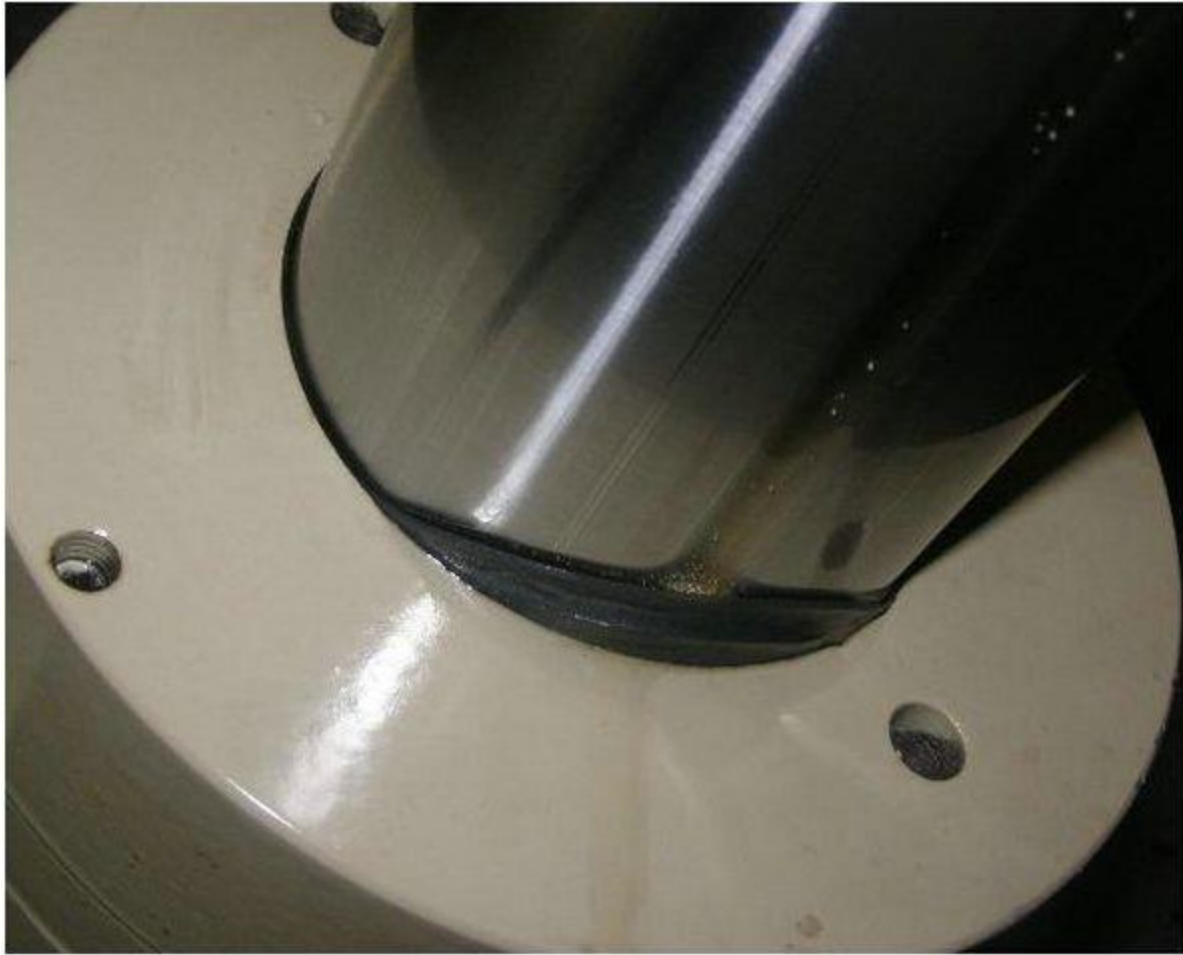
Check the actuator rod surface thoroughly for any punch mark or damage.

Check the actuator seal for any damage or seal parts pressing out between the rod and rod bushing.

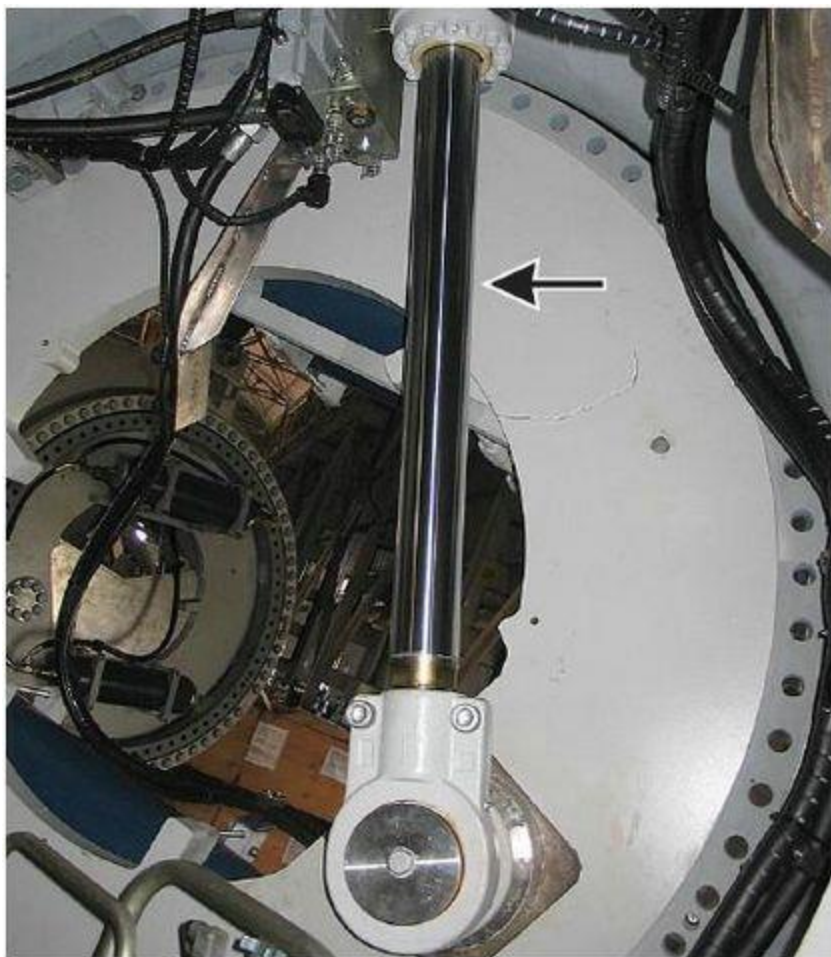
Check for oil leak when actuators are in operation with system pressurized.

Replace the seals or bushing/seals if there are any leaks or pressed out seals.
