Replace thermal bypass valve

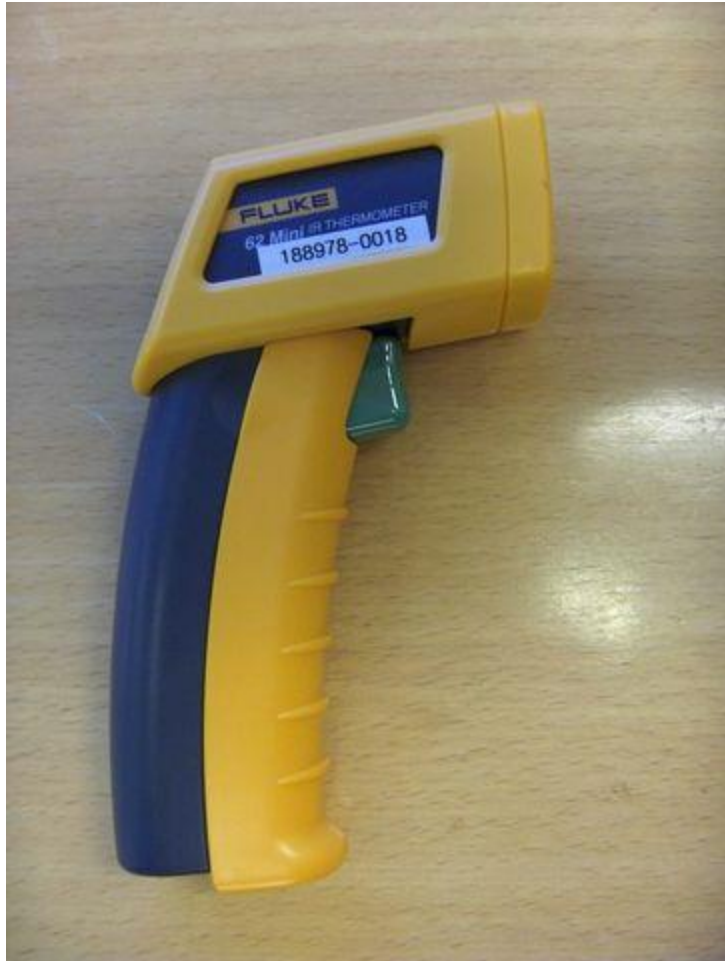
If temperature is low near heat exchanger then the by-pass valve is likely defective in the pump manifold. (VT 188978 "IR-Thermometer Fluke 62)

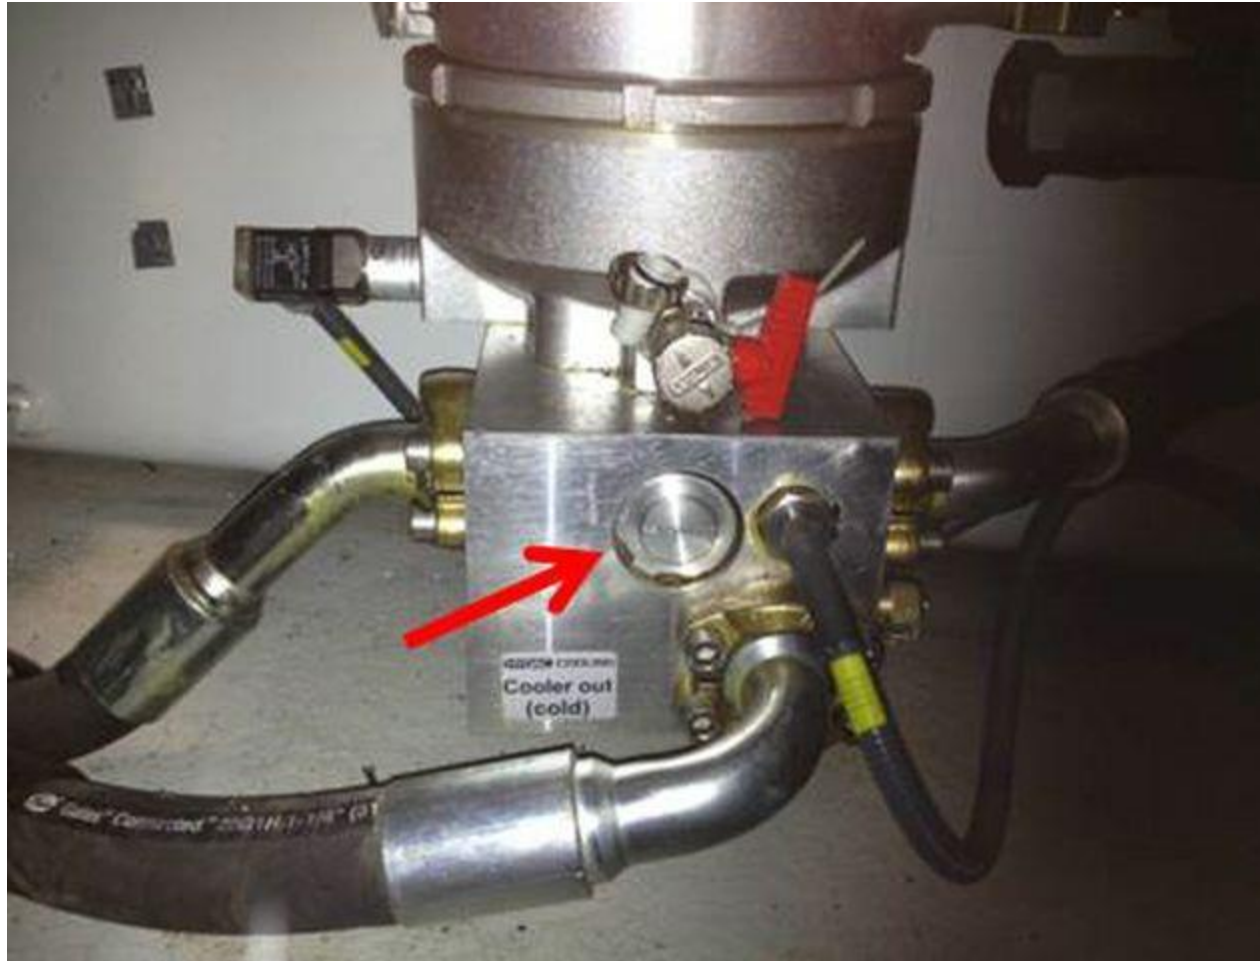
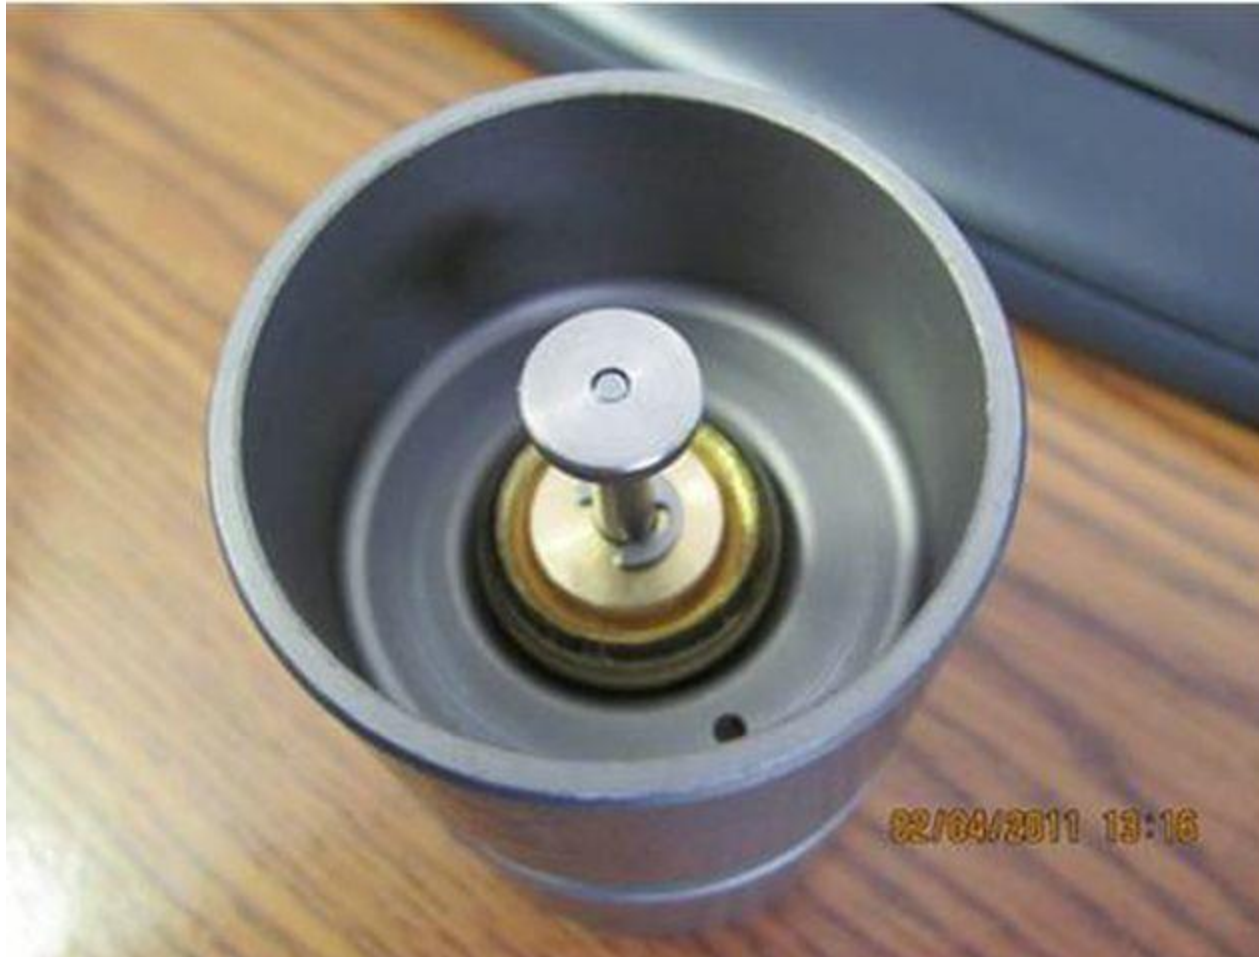
If replacing the 45 degree thermal bypass valve (60104320), the valve must have the center pin in valve body. Do not pull the center pin out of the temperature sensing bulb. If pin fell out during shipping, do not install valve in turbine. (Some valves have been received at sites with dented valve bodies, inspect the valve prior to installation and do not install a damaged valve into the pump manifold).
