Replace the defect MCB

Replace yaw motor/Replace yaw motor magnetic coil

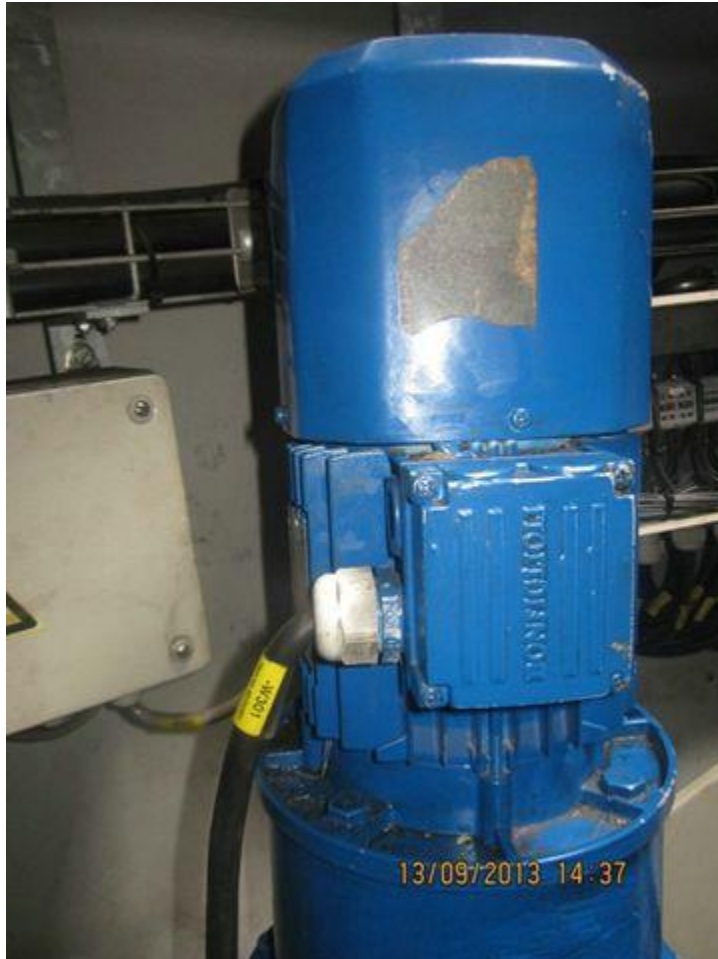
Yaw motor

- Check for any loose connection in the terminal box:
- Remove the STAR/ DELTA connections and check the Winding /coil resistance valve

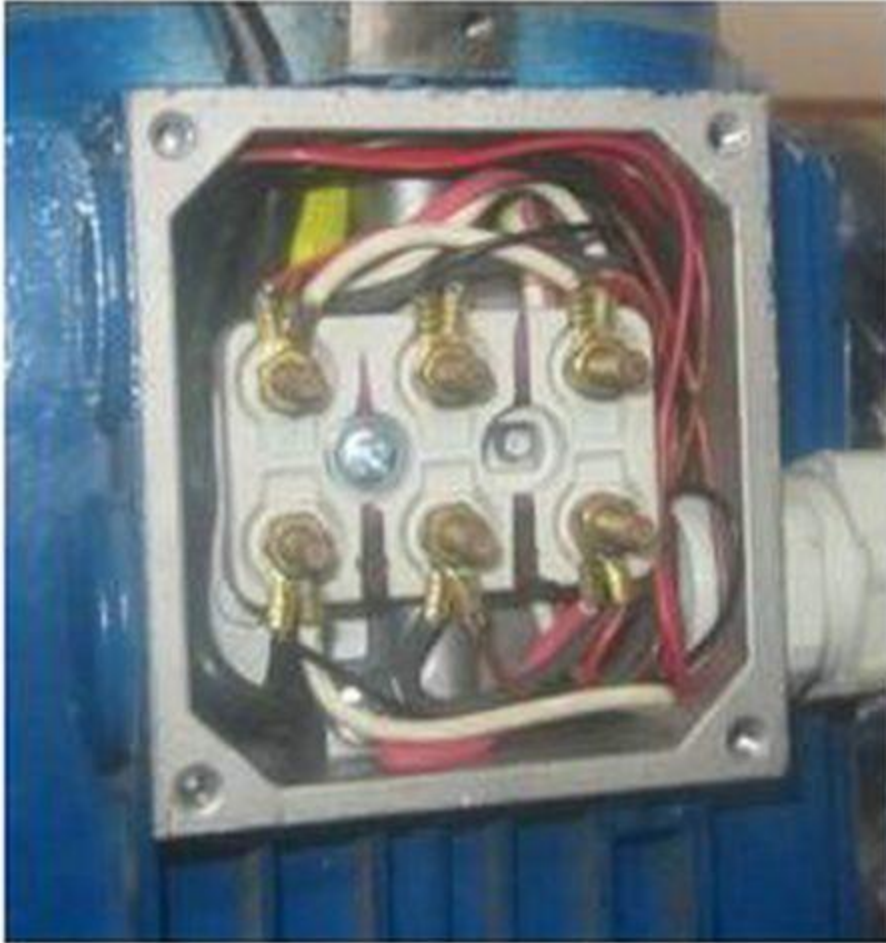
Yaw motor connection:

Remove the Yaw brake magnetic coil connection

And Measure the resistance value of the motor windings and magnetic coil.

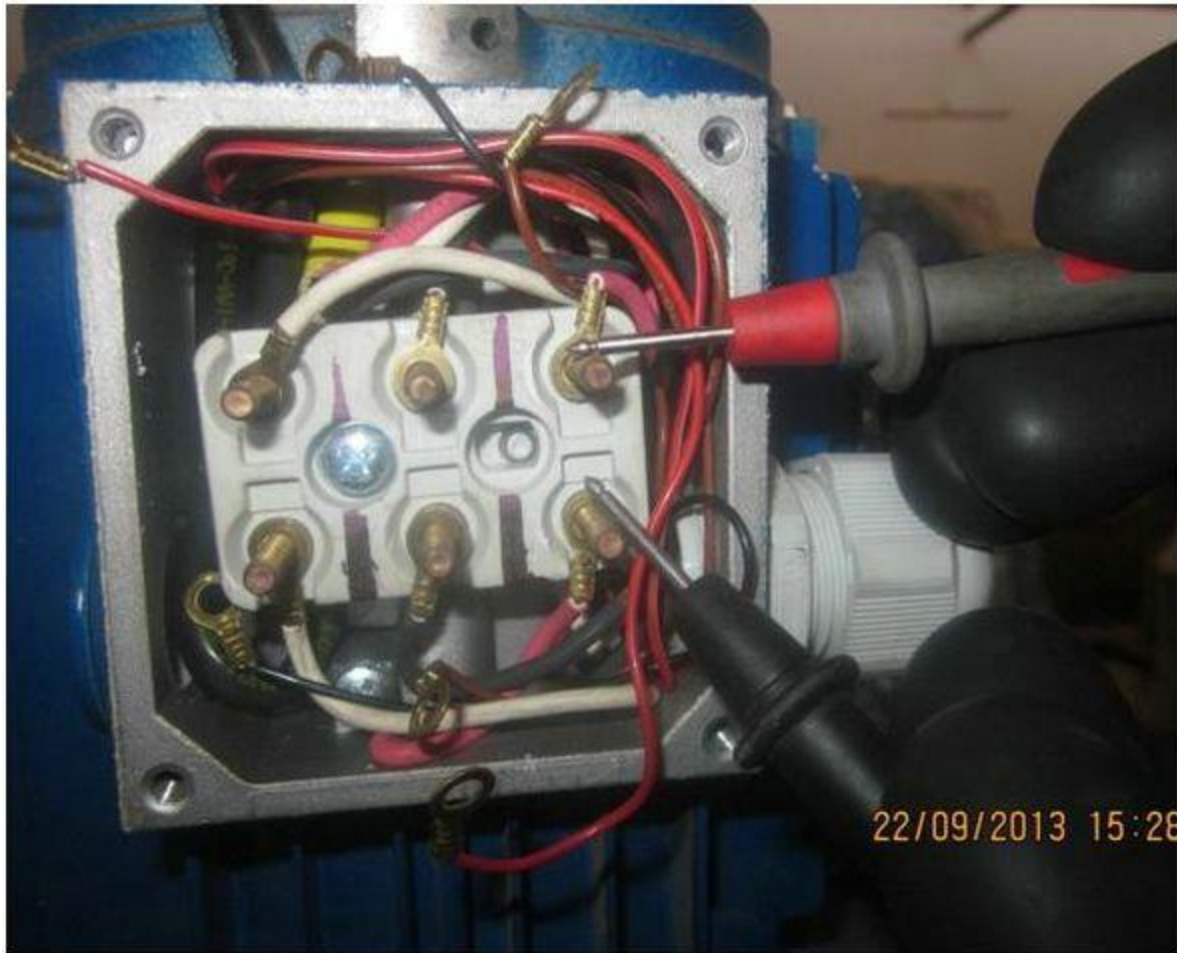
Measure phase to phase and phase to earth on all windings.

The resistance value should be $>1\text{M}\Omega$.

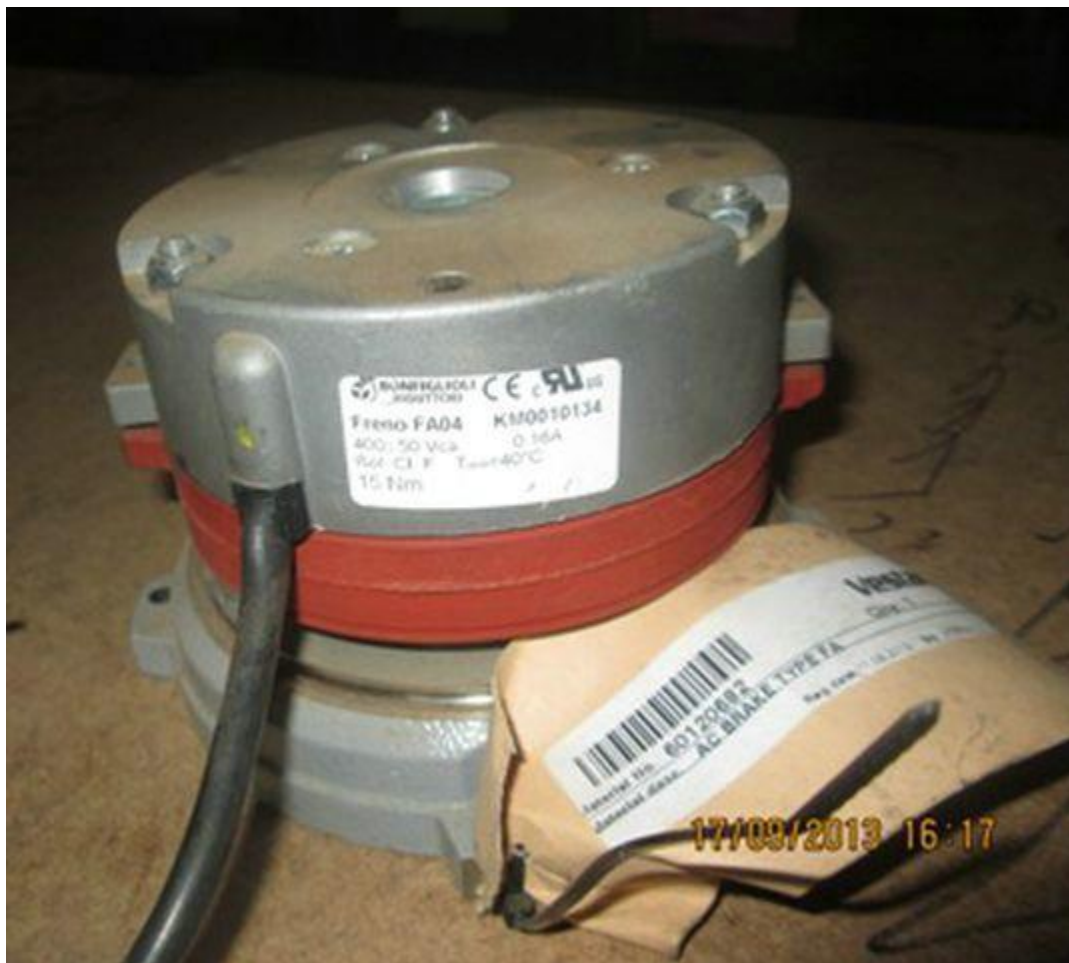
Yaw motor magnetic coil

Check & adjust the yaw magnetic brake – Refer the Service Work Instruction for Yaw System” [1000686](#)

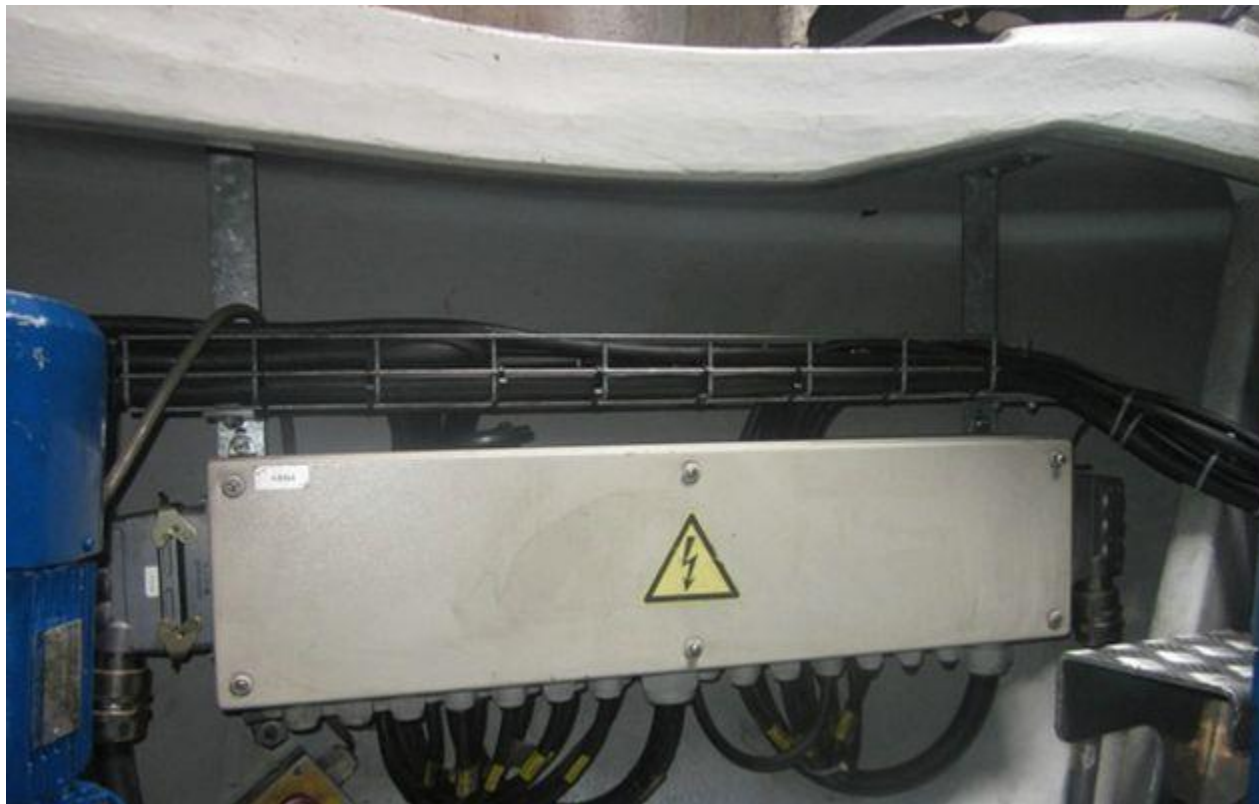
- **Explanation**
Cable coming from +AN4 to yaw motor 5 terminal box
