Replace the defective needle valve

Recharge or replace the accumulators

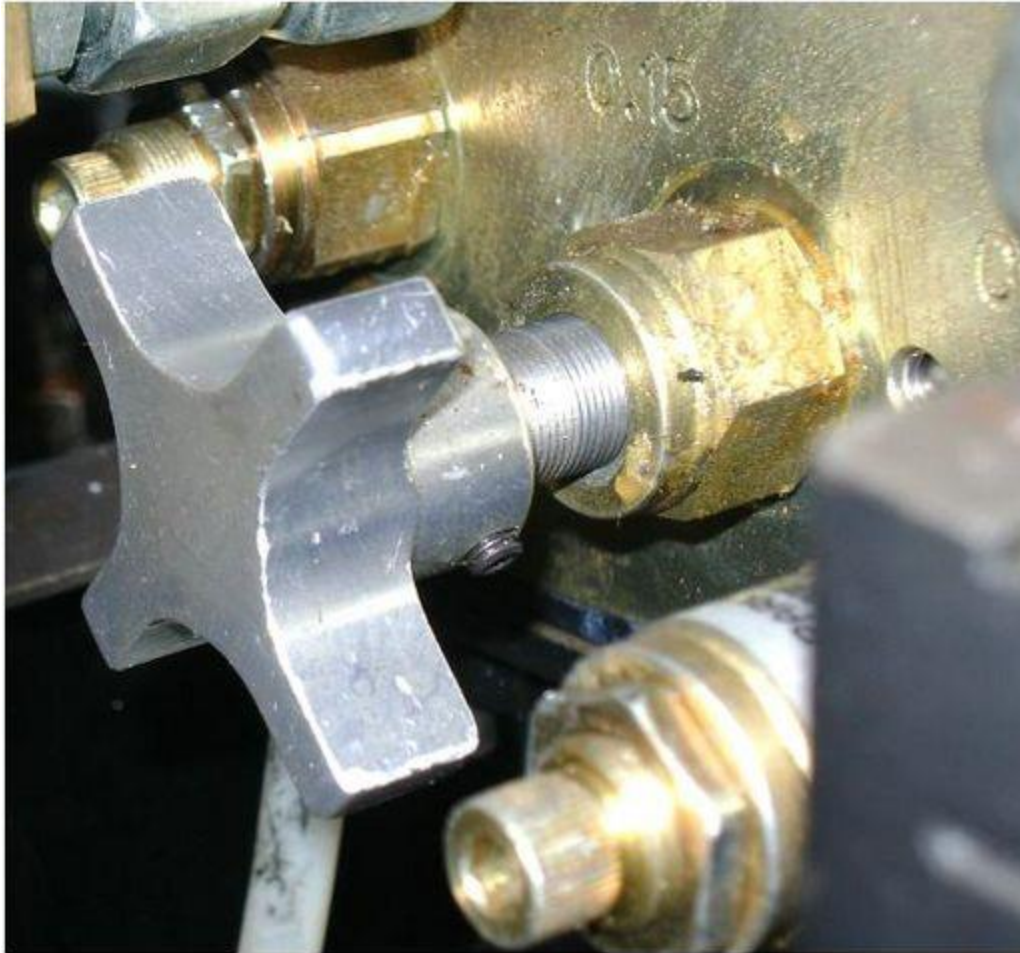
Combined hydraulic unit: **POS 15**.

Ensure that the needle valve is closed. With the pump running, listen for a whistling sound coming from the area of the valve. If needle valves are over tightened, it is possible that the valve will be damaged and a proper seal cannot be achieved.

Valve position number:

Parker hydraulic unit: **POS 0.16**

Replace the needle valve if it is found to be defective.

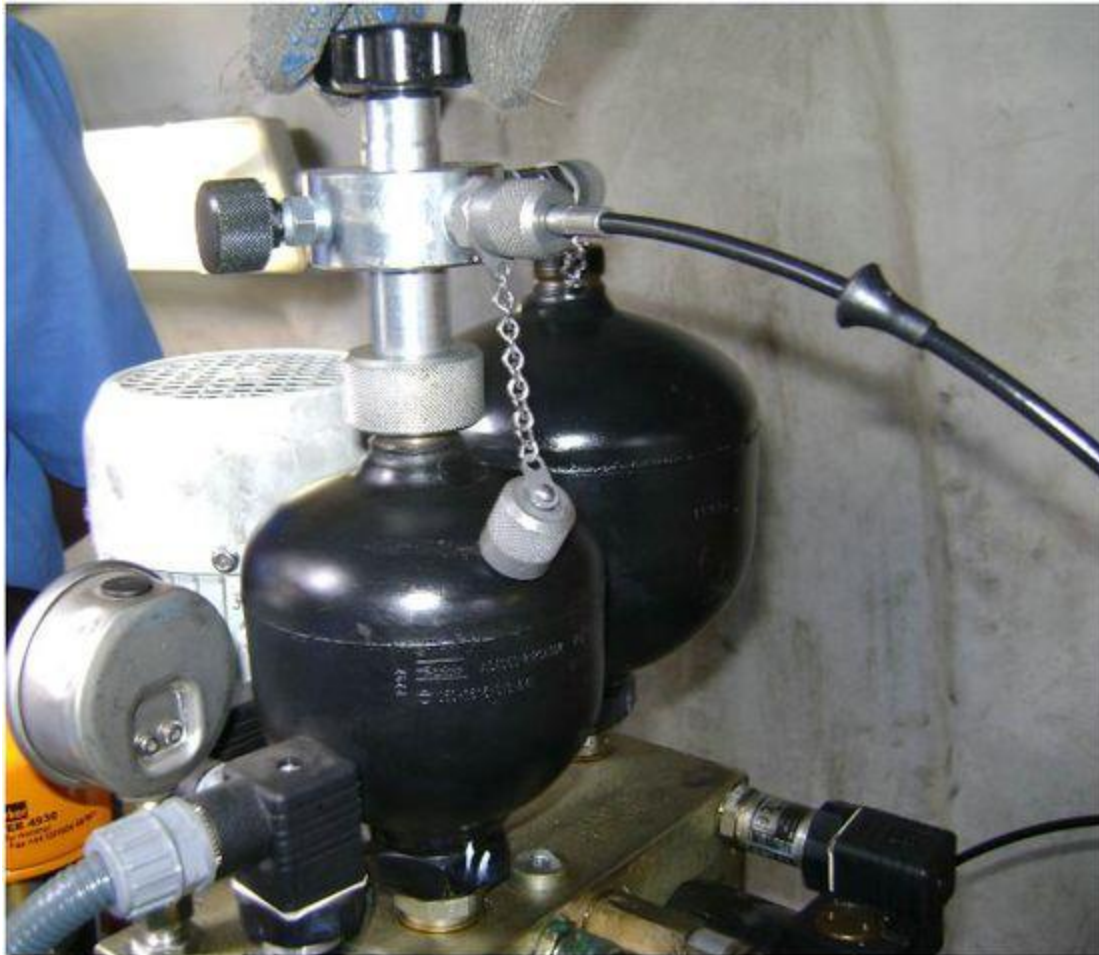
Check pre-charge of accumulator.

Reference the following service instructions depending on which type the turbine is equipped with:

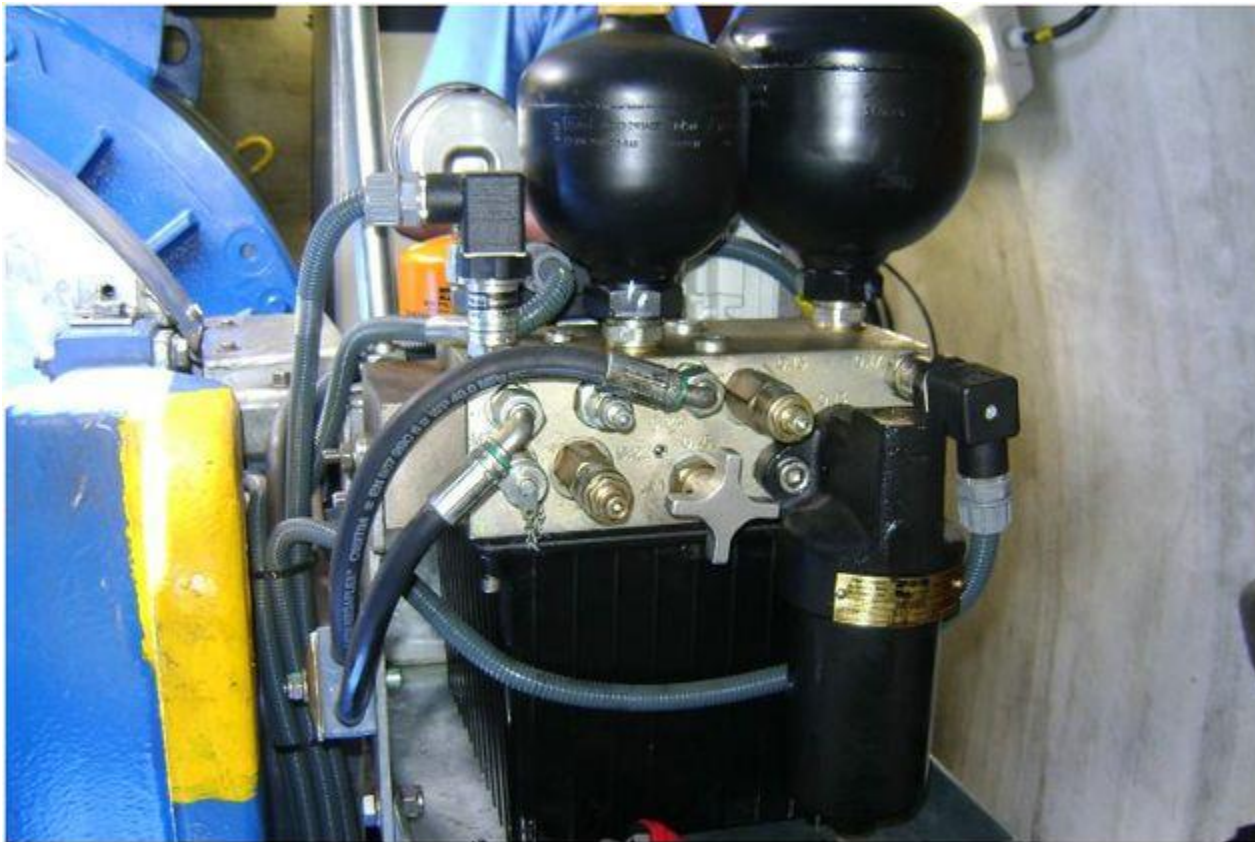
Parker system:

Check the condition of the solenoid valve **POS 0.20(NO), 0.21(NC)**

If found solenoid valve is defect, replace it.

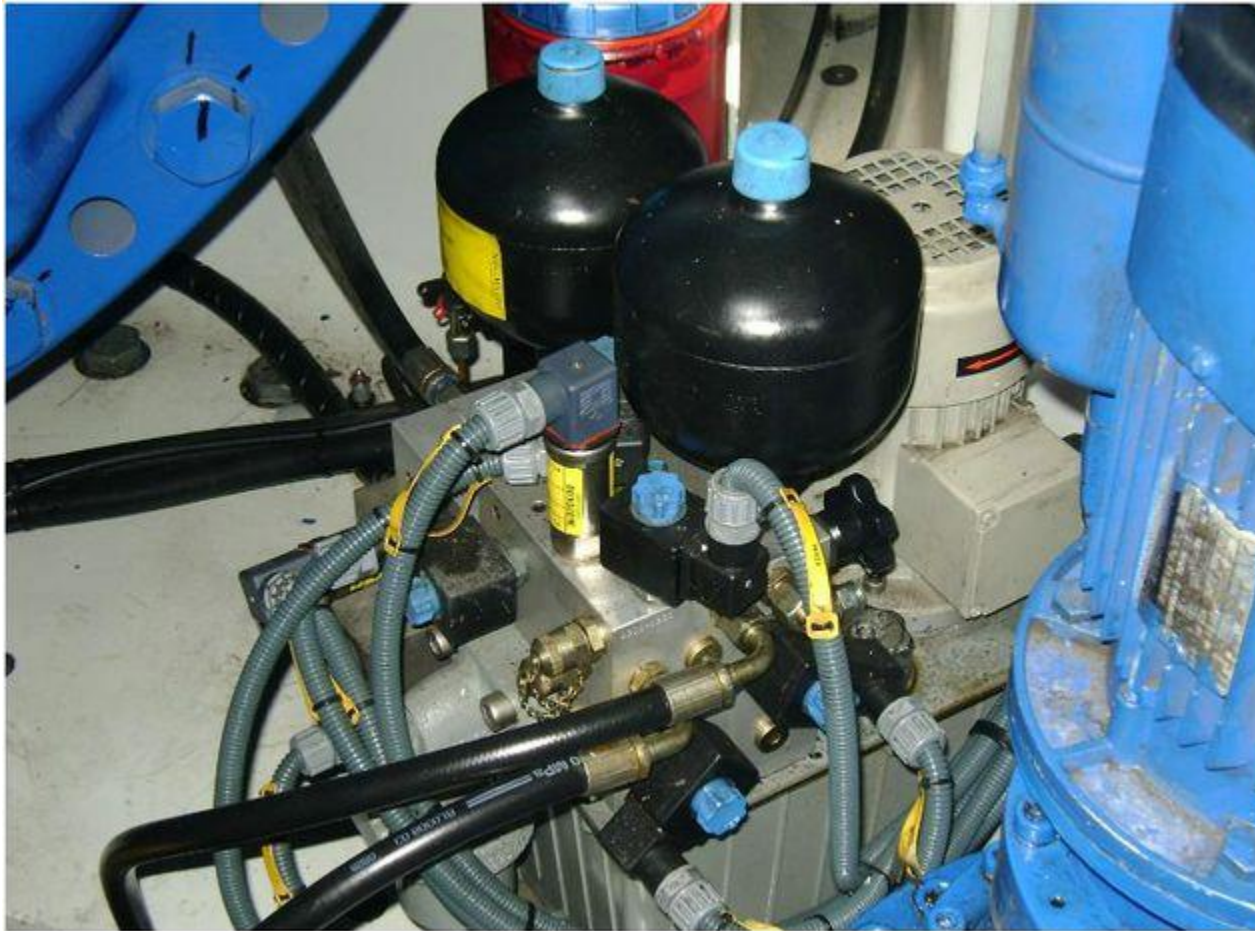
Combi (AVN) System:

Check the solenoid valve **POS 16, 07(NO), 08,14,02(NC)**

If found solenoid valve is defect replace it.

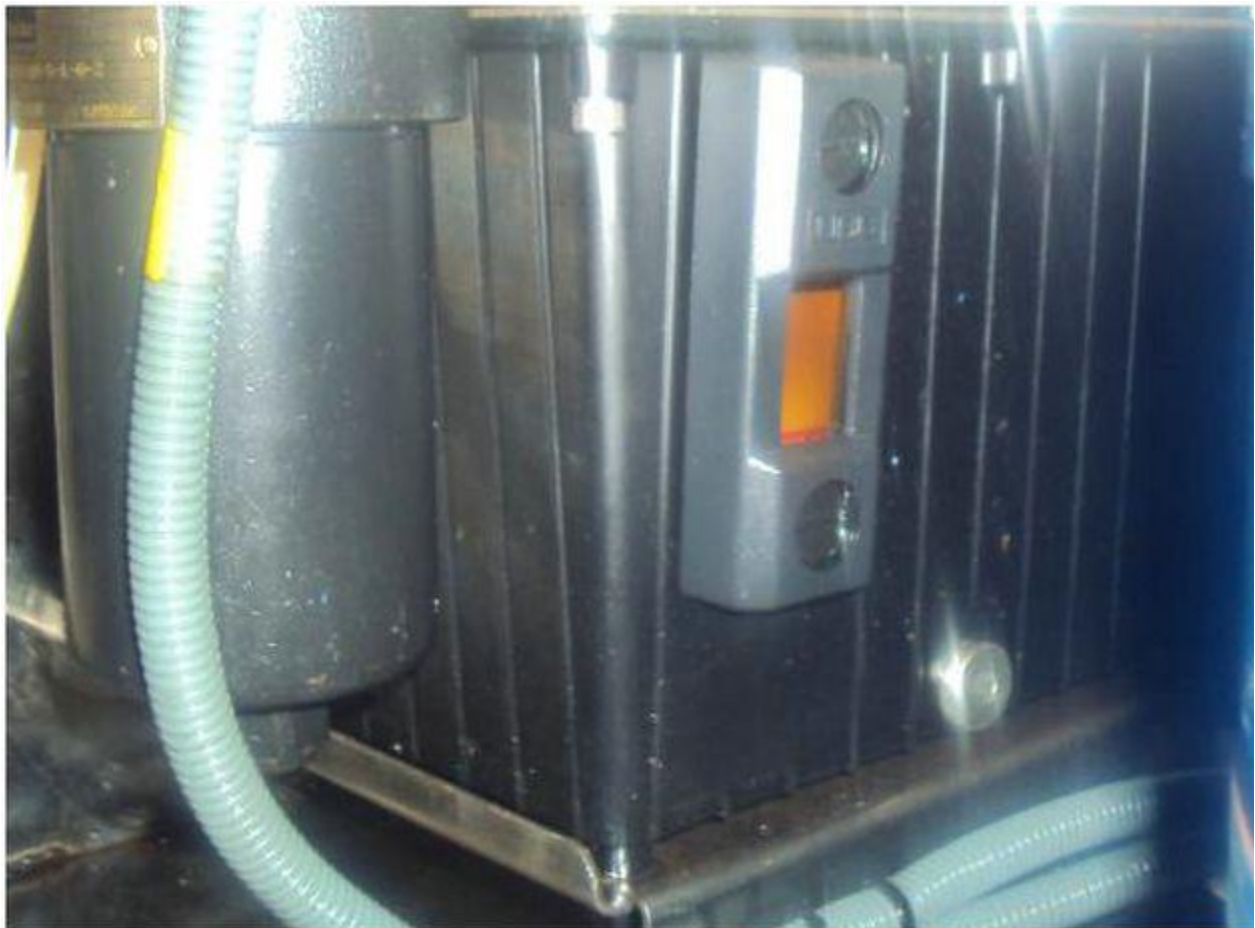
Check the oil level (With the system pressurized and brake applied oil should be visible in the oil window).

Repair any leaks that are found.

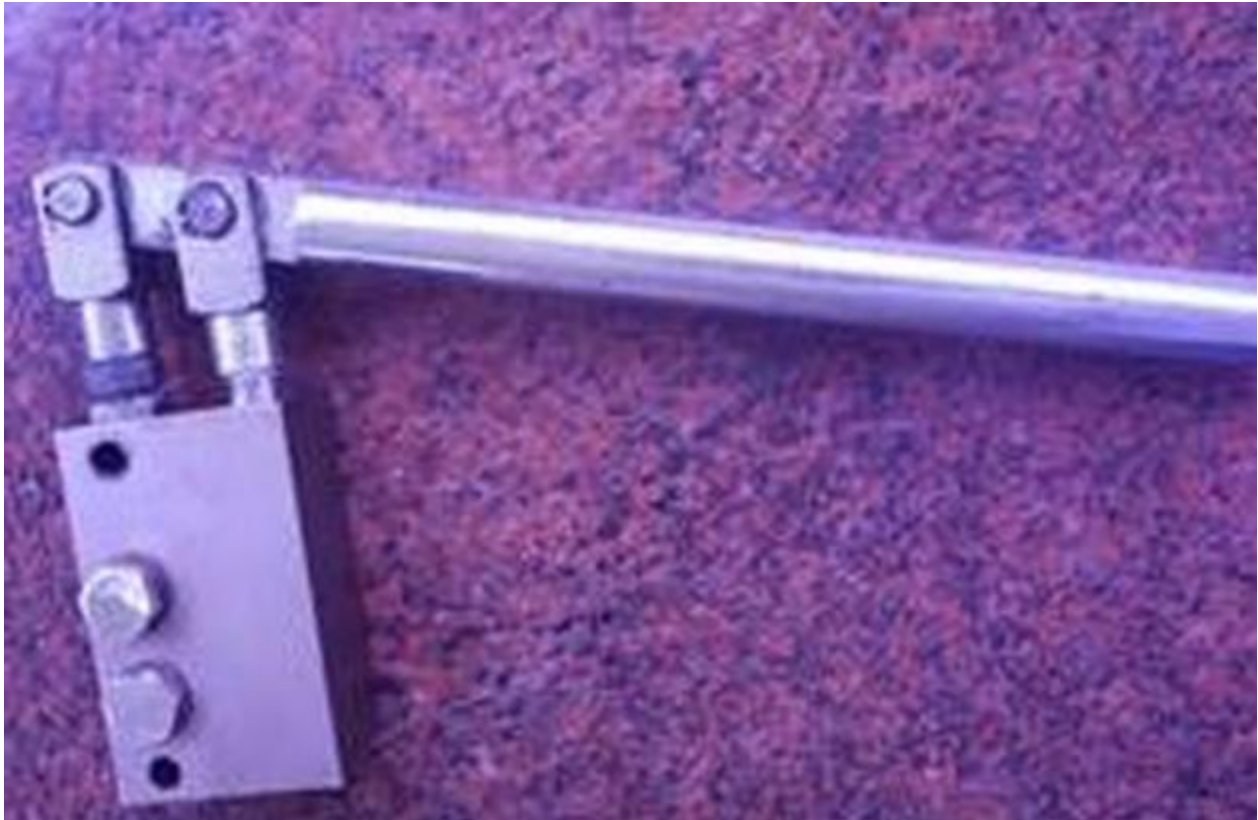
Internal oil leakage in the hand pump also will cause this issue.

Check the O-ring for any damage and replace

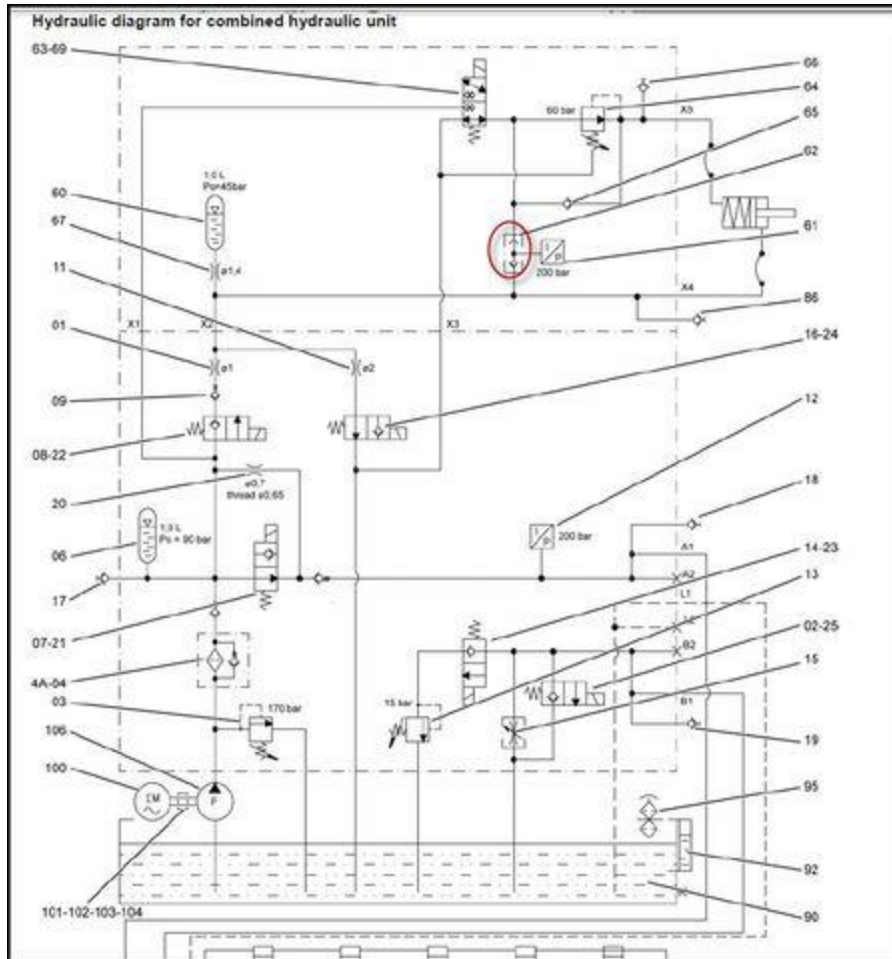
Hydraulic diagram

Turn on pressure and release brake, check pressure on test nipple pos. 86 and in TAC. If pressure level is the same, approx. 120 bar, then shuttle valve pos. 62 and pressure transmitter pos. 61 functions correctly.

If the pressure continuously drops at pos. 86 and TAC, mount another manometer on test nipple pos. 17 and remove plug from valve pos. 08. If the pressure stable at pos.17, and continuous pressure drop evenly at pos.86 and shaft brake pressure reading at TAC, confirms that valve pos. 62 is defect.

01 Orifice	11 Orifice	19 Test connector	65 Check valve	101 Bell housing	102 Spider rubber
02-25 Valve + coil	12 Press. transmitter	20 Orifice	66 Test connector	103 Coupling pump	104 Coupling motor
03 Pressure valve	13 Relief valve	60 Accumulator (A2)	67 Test connector	106 Pump	
4A-04 Filter unit	14 Valve + coil	61 Press. transmitter	86 Test connector		
06 Accumulator (A1)	15 Needle valve	62 Shuttle valve	90 Tank		
07-21 Valve + coil	16-24 Valve	63-69 Valve + coil	92 Sight glass		
08-22 Valve + coil	17 Test connector	64 Pressure red. Valve	95 Filler cap / breather		
09 Check valve	18 Test connector		100 Motor

Check the shuttle valve **POS 62**,

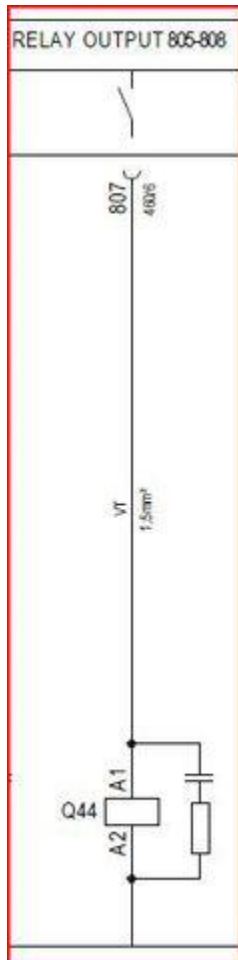
Check the Output from tower TOI 807

Check (MCB F44 - Contactor Q44 50Hz) (MCB F15 - Contactor K06 60Hz) for correct operation and proper terminations.

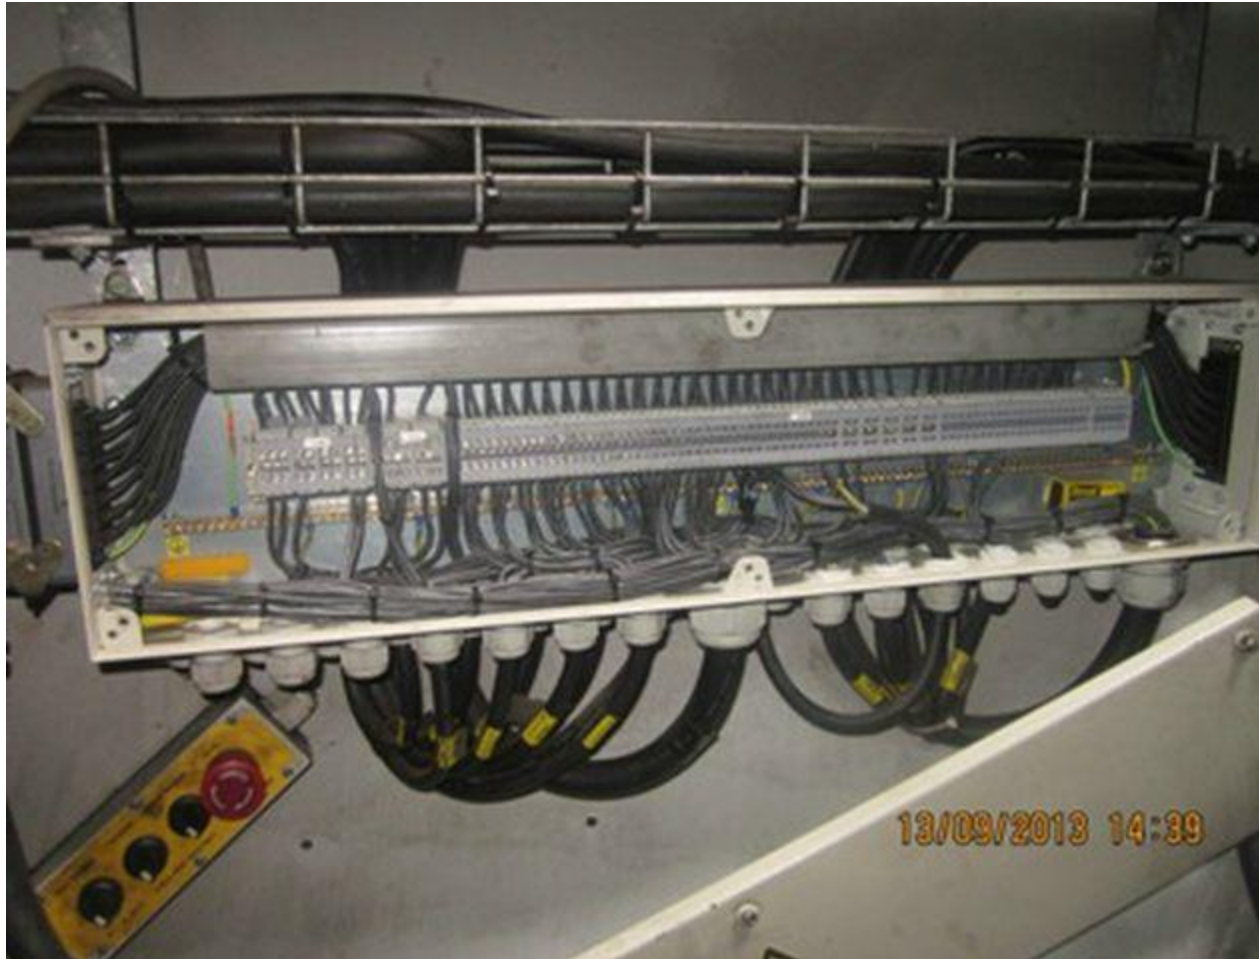
+AN4

Check the incoming cable from the control panel (+AT2) to moto box (+AN4) Connection Terminal 25,26,27.

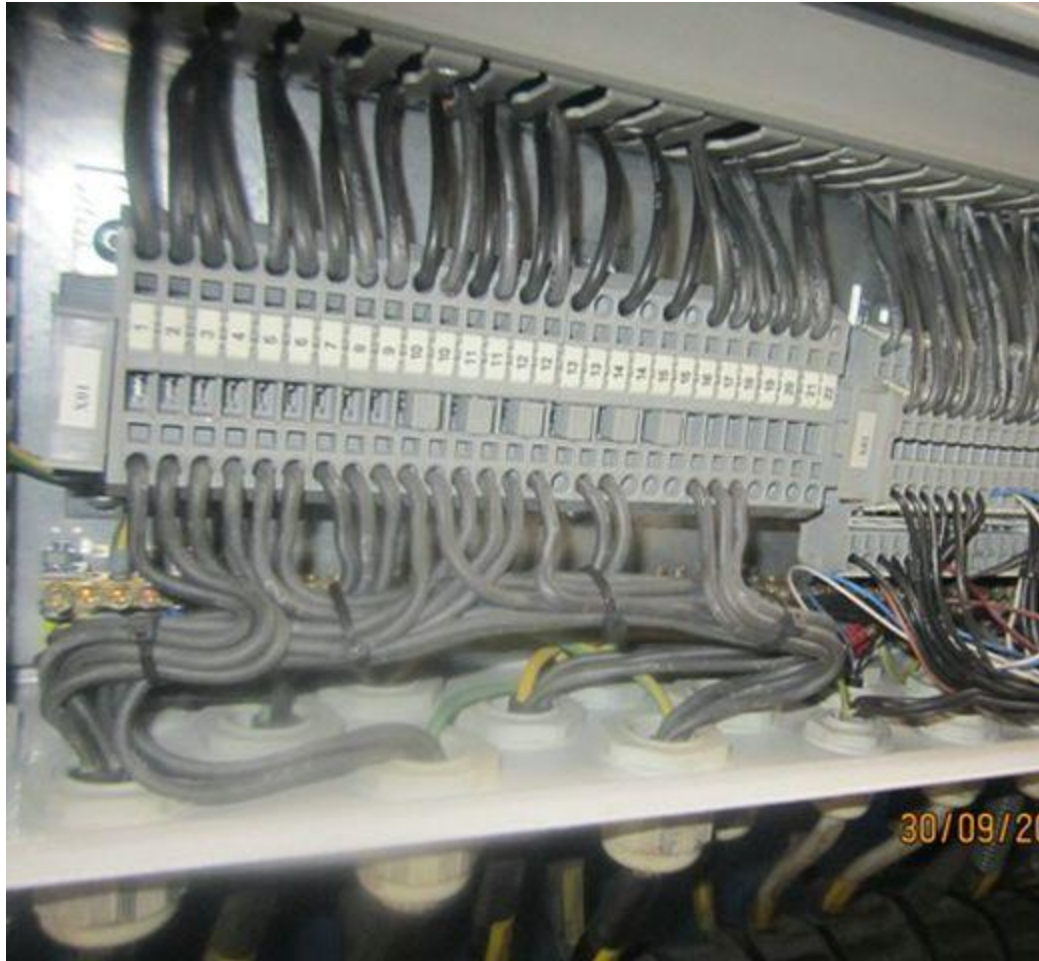
+AN12

Check the cable connection from the motor box (+AN4) to the shaft brake terminal box (+AN12 Connection terminal X01 - 07, 08, 09).

Check the motor terminal box connections.
