## Recharge the Accumulators or replace the Accumulators

**Check and realign the motor- Pump side flange**

**Replace the defect solenoid valves**

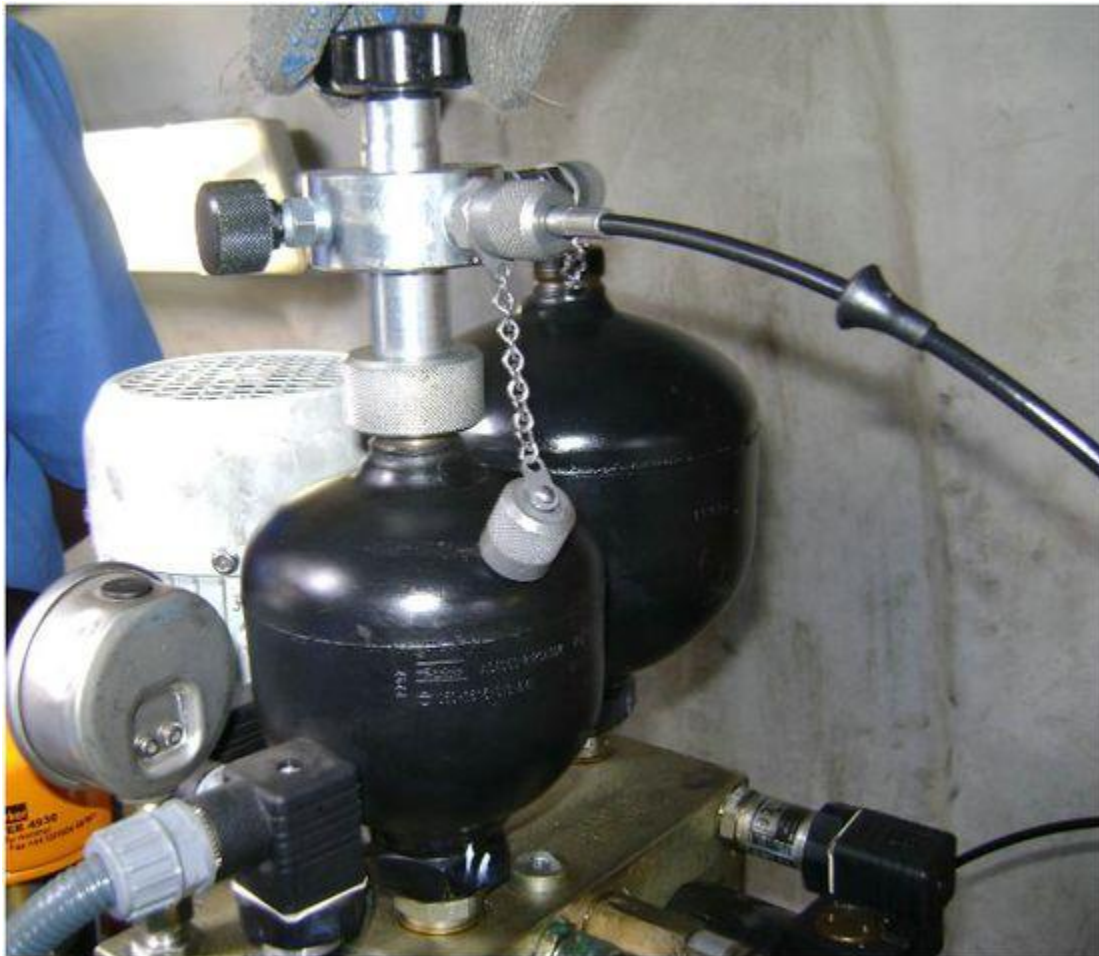
Check pre-charge of accumulator.

Reference Document: 941918 Charging of Nitrogen Accumulators for instructions. Reference the following service instructions depending on which type the turbine is equipped with:

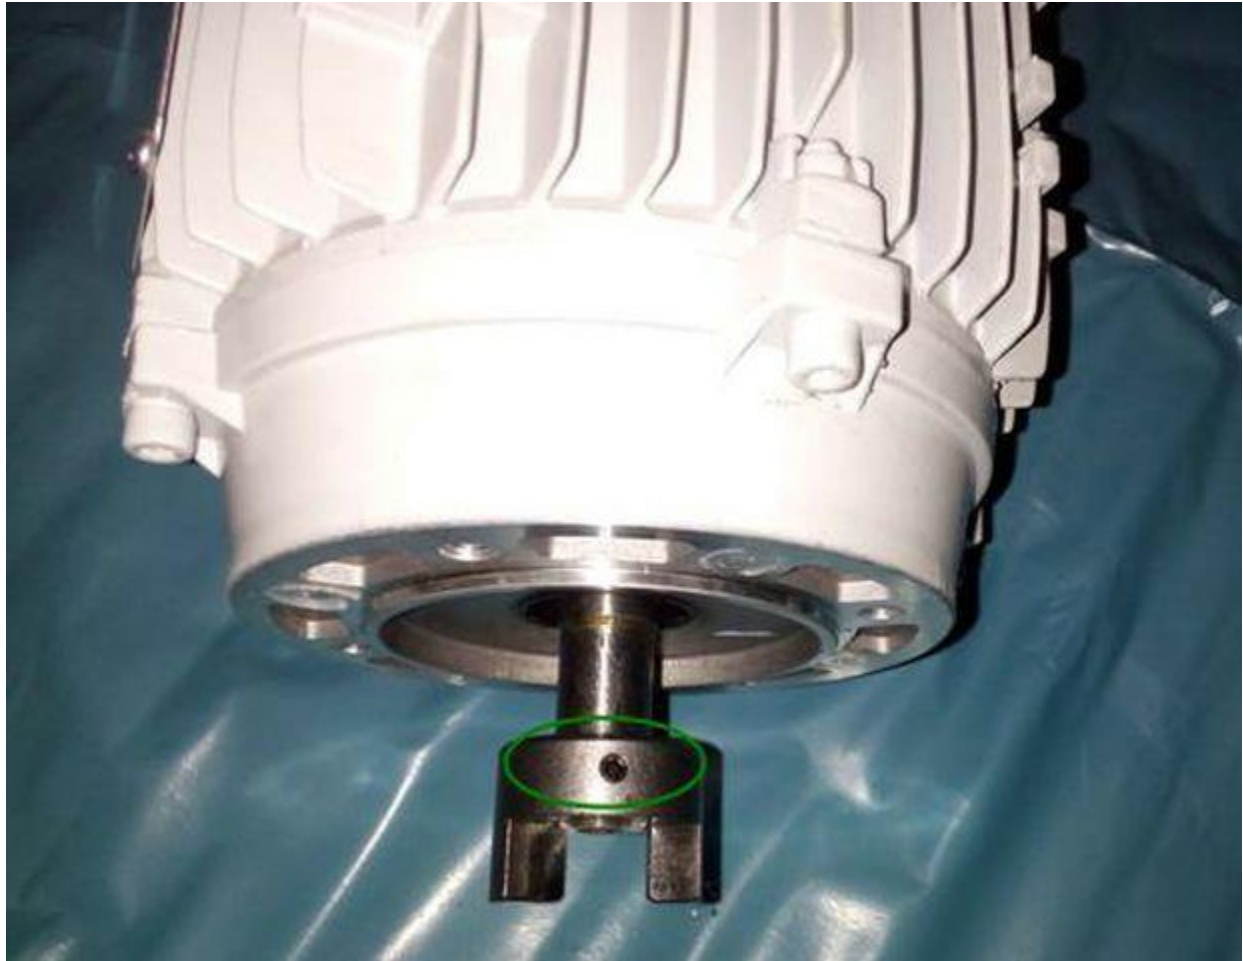
Check the motor-pump coupling for proper functioning, if the pressure is not developing while the pump is running. Then dismantle and check for proper engagement of Pump-Motor coupling assembly. In few instances, 2mm Allen screw which holding the flange with the motor shaft key way has loosen and leading to run the pump freely. If pump runs freely, then align the flange by tighten Allen screw as shown below pictures

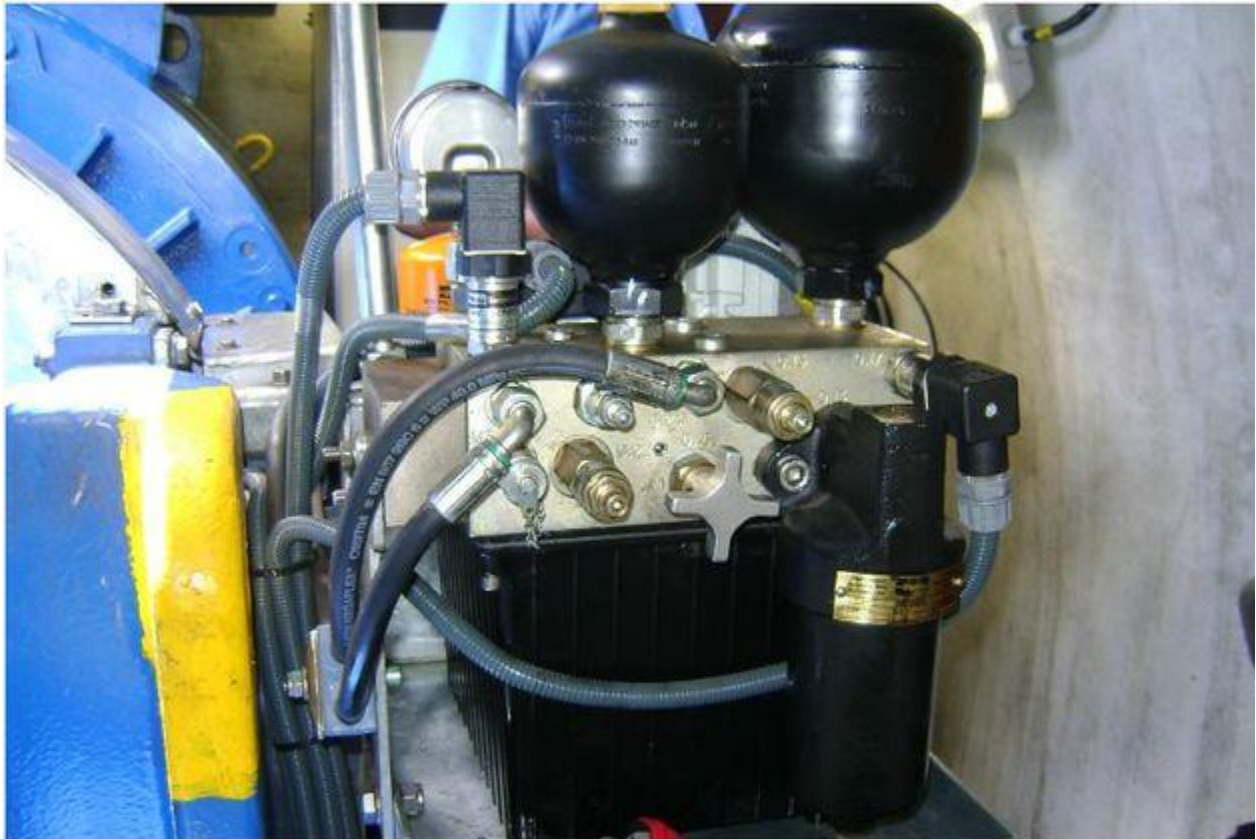
Check the solenoid valve **POS 0.20(NO), 0.21(NC)**

Replace the valve if found to be defective.

Relevant spare parts - Parker		
Description	Item No.	Position
DIRECT VALVE N.C. 2/2 DSL-08-1	<a href="#">60104031</a>	0.21(NC)
VLV DIRECT NO 2/2 DSL-08-1-CR	<a href="#">60104034</a>	POS 0.20(NO)

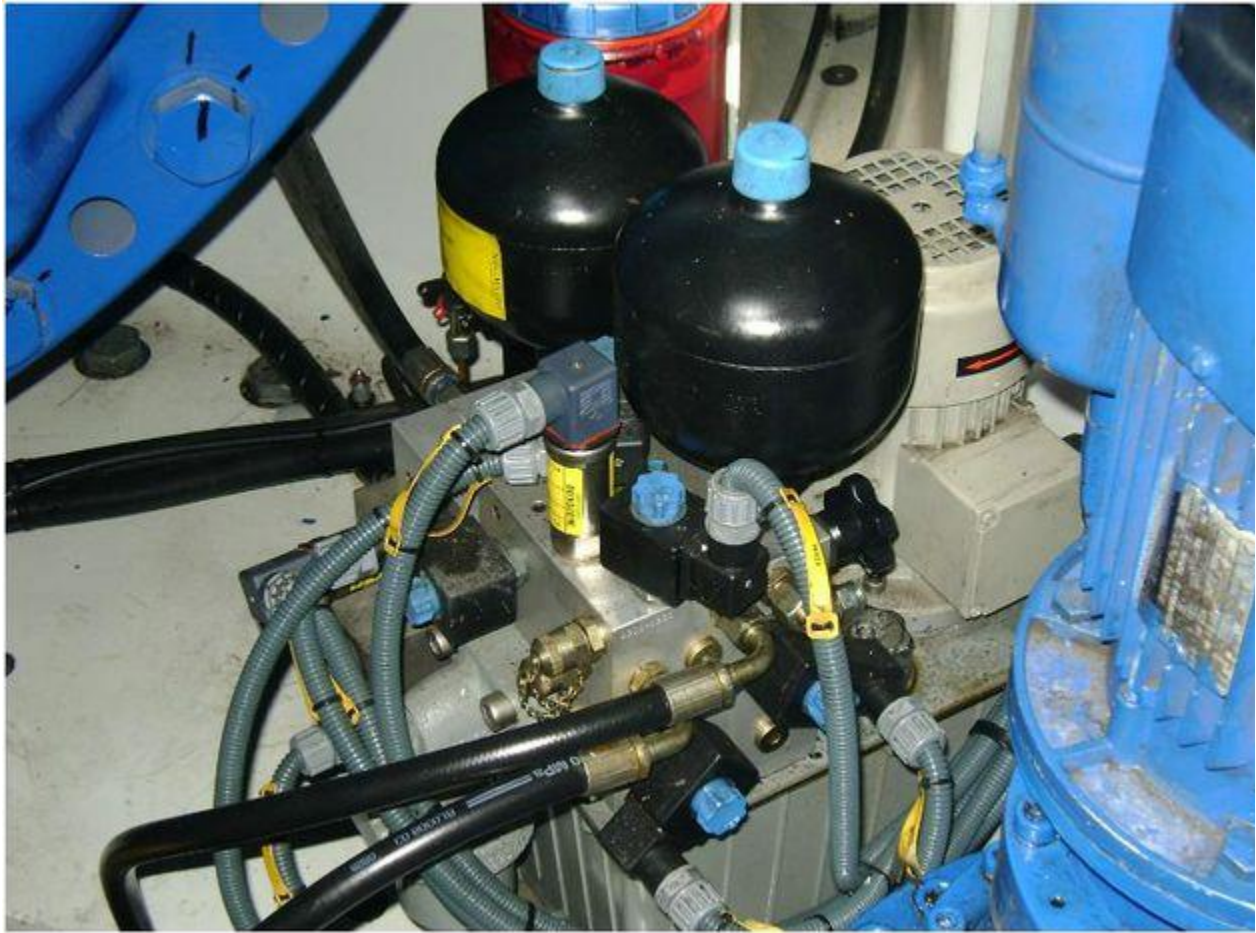
Check the solenoid valve **POS 16, 07(NO), 08,14,02(NC)**

Replace the valve if found to be defective.

Description	Item No.	Position
SOLENOID VAL NC OD150118310005	<a href="#">60095079</a>	08,14,02(NC)
VALVE SOLENOID NO OD1502181ISO	<a href="#">60095081</a>	16, 07(NO)

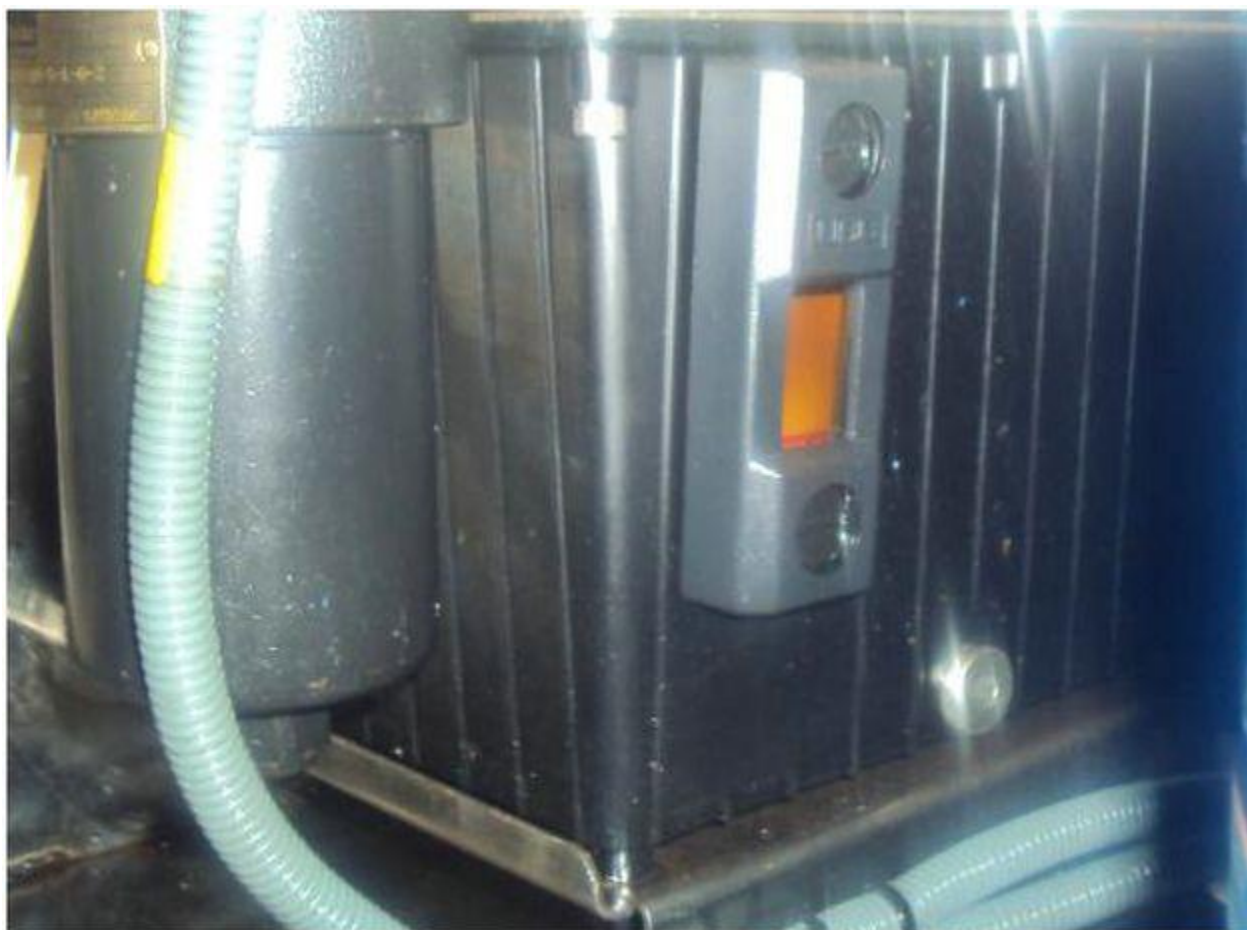
Check oil level (with system pressurized and brake applied oil should be visible in oil window)

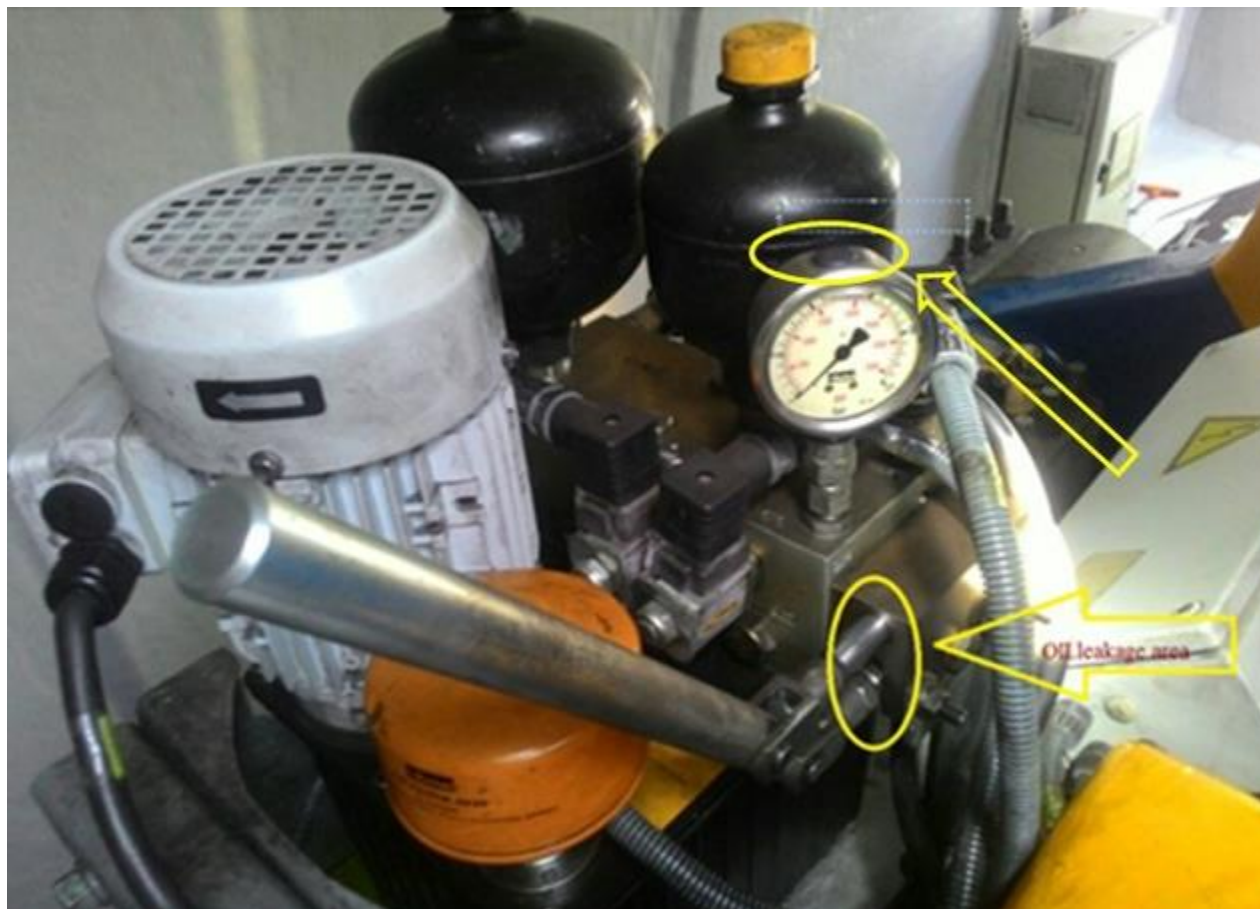
Check the oil leak in manual pump piston area and repair or replace, if oil leakage found.

Relevant spare parts (Parker)	
Description	Item No.
HAND PUMP 0012001777	<a href="#">60108203</a>
GAUGE, PRESS 1/4BSP BOT CONN 0-250 BAR	<a href="#">60108205</a>

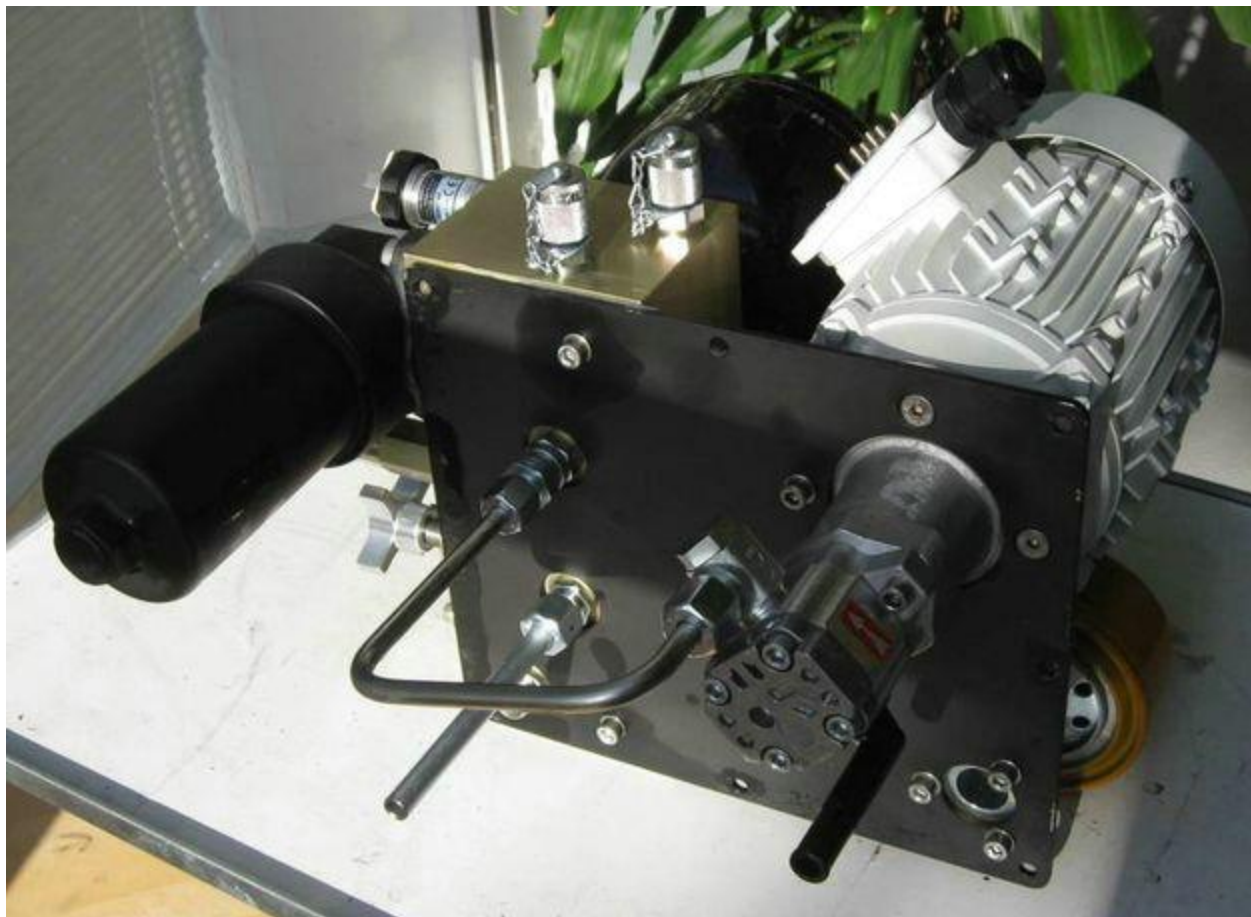
Check that the system pressure builds-up within the time limit specified in the stop and reset functions. If not, check the pump operation. If the pump is found to be defective, replace it.

Relevant spare parts	
Description	Item No.
PUMP 1 SPA 0.9 D 10 GG (COMBI - AVN)	<a href="#">60097654</a>
GEAR PUMP P1 AAn 0050 FL 20-B0 (PARKER)	<a href="#">60103470</a>

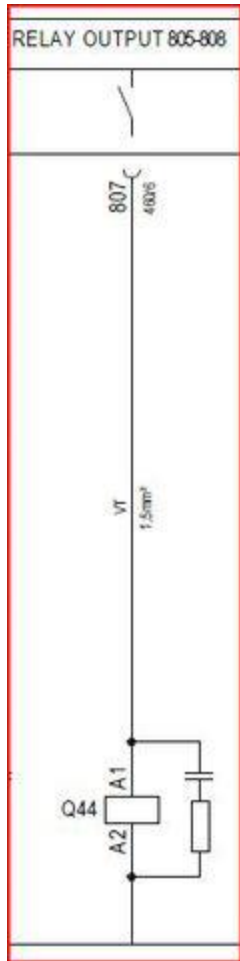
50Hz

Check the Output from tower TOI 807:
