Replace the defect components

- **Explanation**
IN THE +AN1 CABINET:

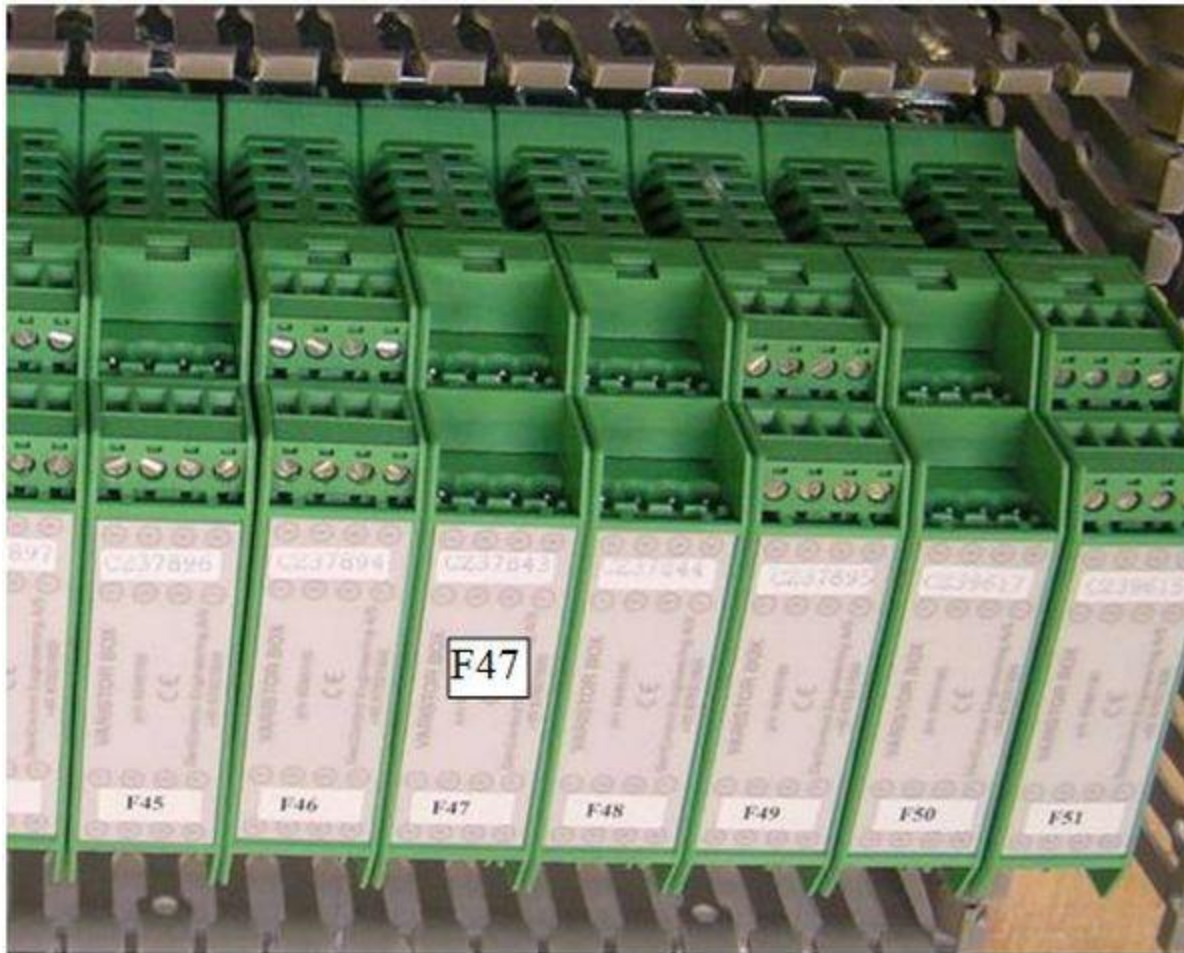
Varistor box F47:

Varistor (F47-MkIII+/F12&F13-MkII-) can be tested individually by placing a multimeter (set to measure Ω) lead on the common (earth) side of the varistor and the other on the individual varistor terminals. The resistance value over the varistor should be ∞ or in the high M Ω range. If the resistance is lower, the varistor has been damaged by an over voltage in the circuit and must be replaced

The varistor box is made up of eight varistors and has provisions for 16 wire connections (protection for 8 signals).

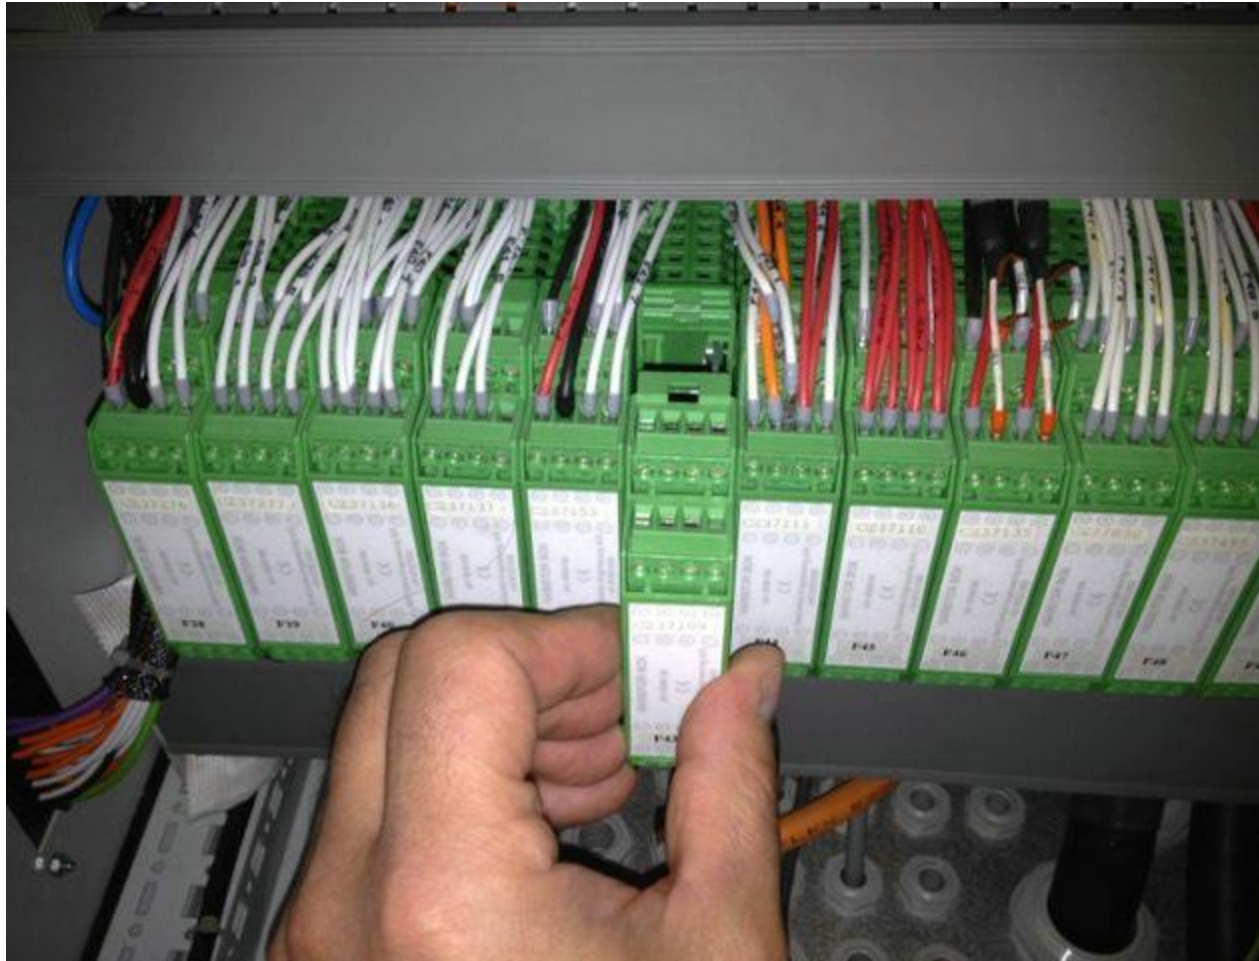
To replace the varistor, press the clip on top and bottom of the varistor box and remove the varistor assembly from housing.

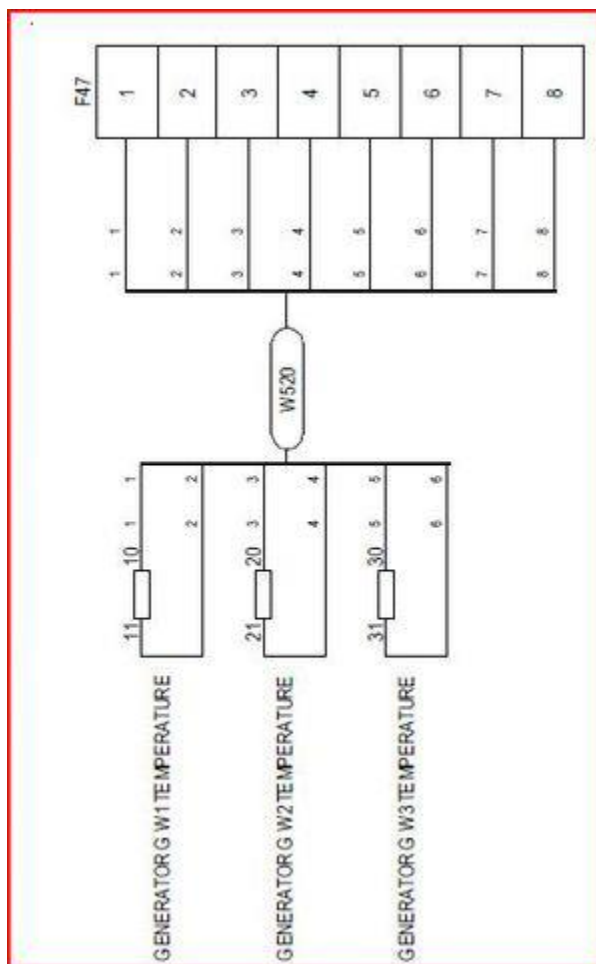
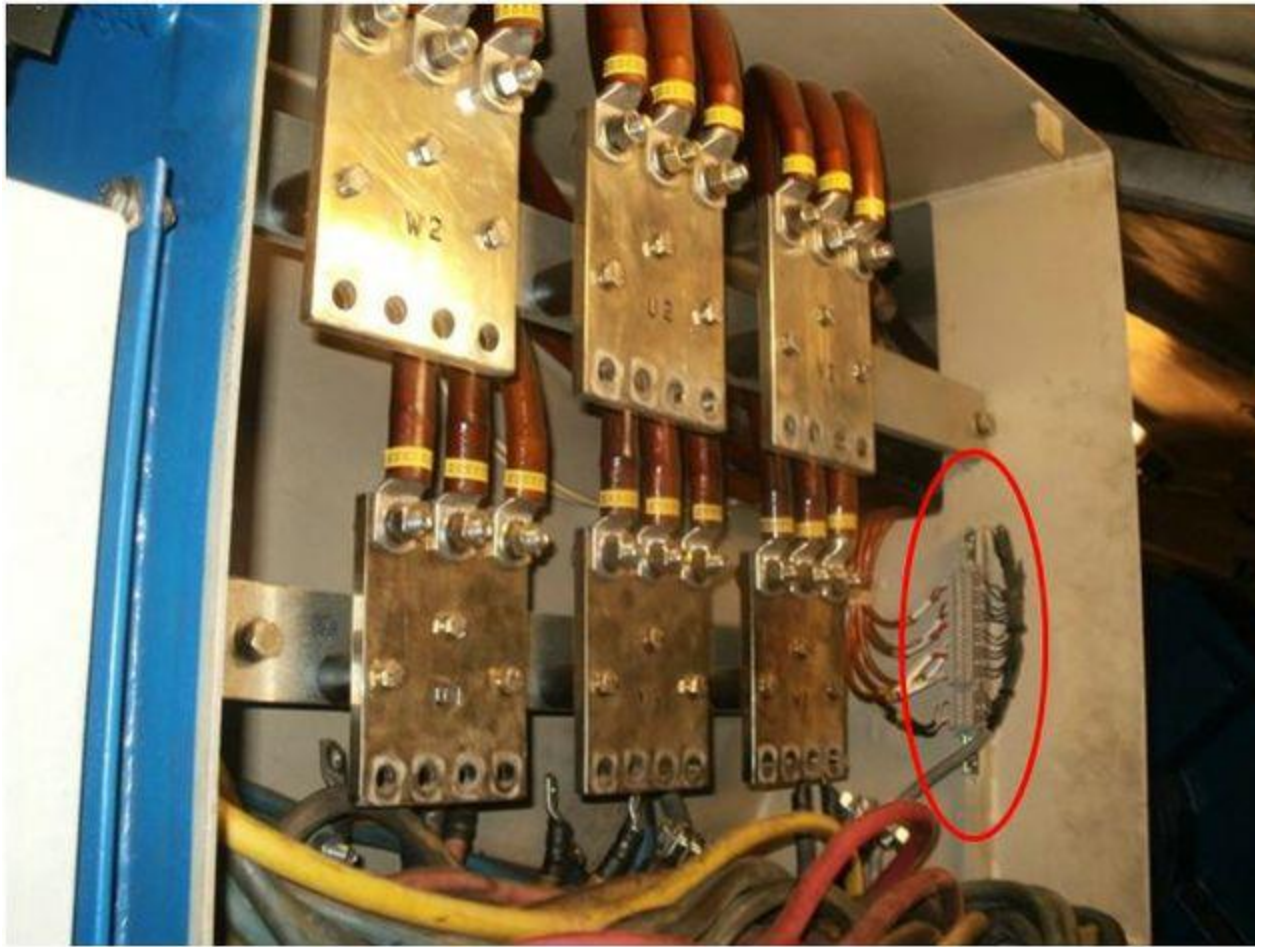
Check PT100 for any loose connections and tightness ,

Use a multimeter set to read Ω and measure the resistance across the leads of the PT100.

If the value is unreal (-40 to 200 °C), then the PT100 is faulty

Use spare PT100 sensor in the generator.
