Check the power supply unit input and out put

Inspect bearing/ manually lubricate

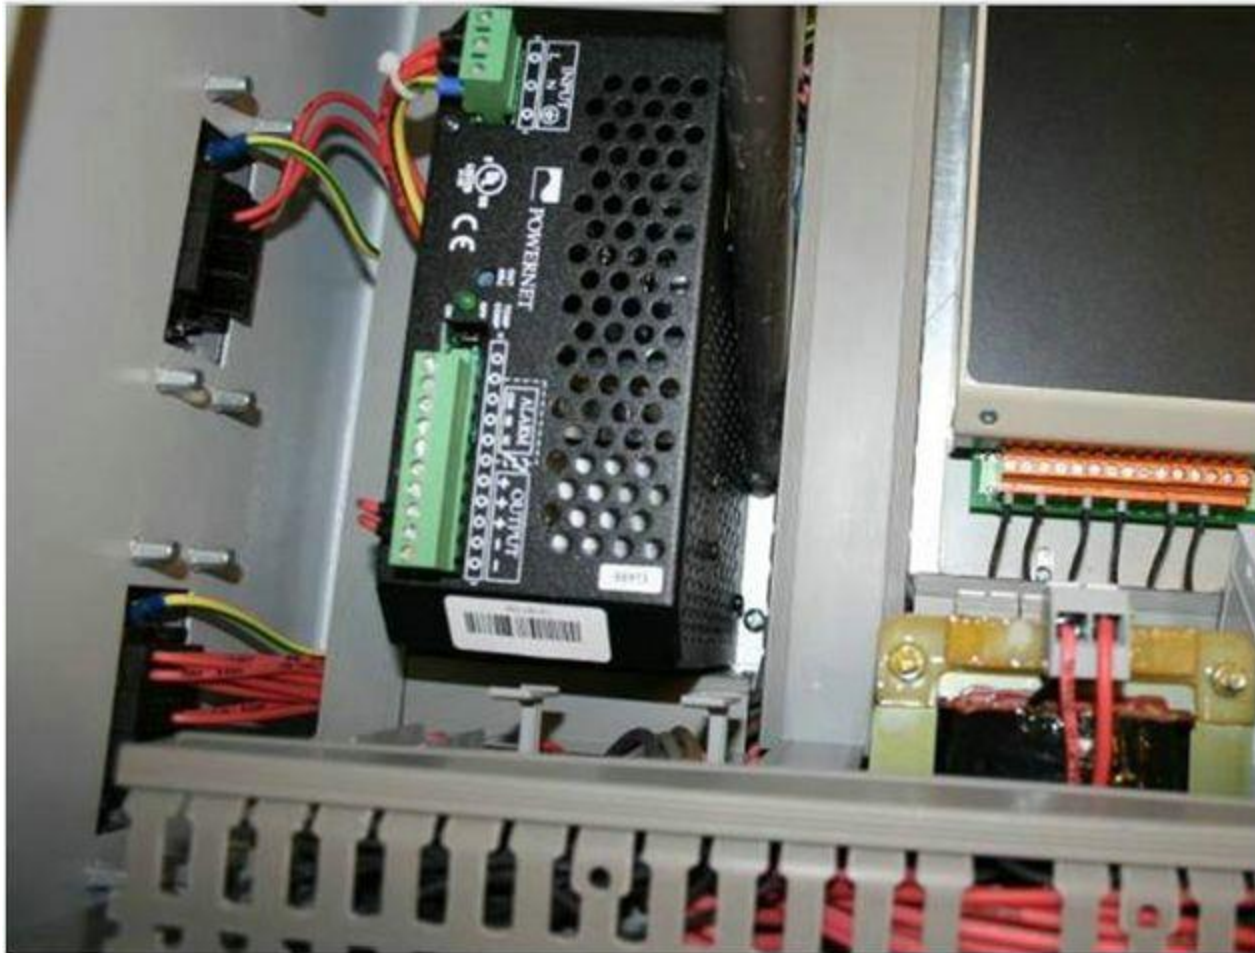
+AK4 hub panel check the LED glowing or not and check the Input and output supply voltage at G400 Power net.
There is no LED glow and output change the power supply unit

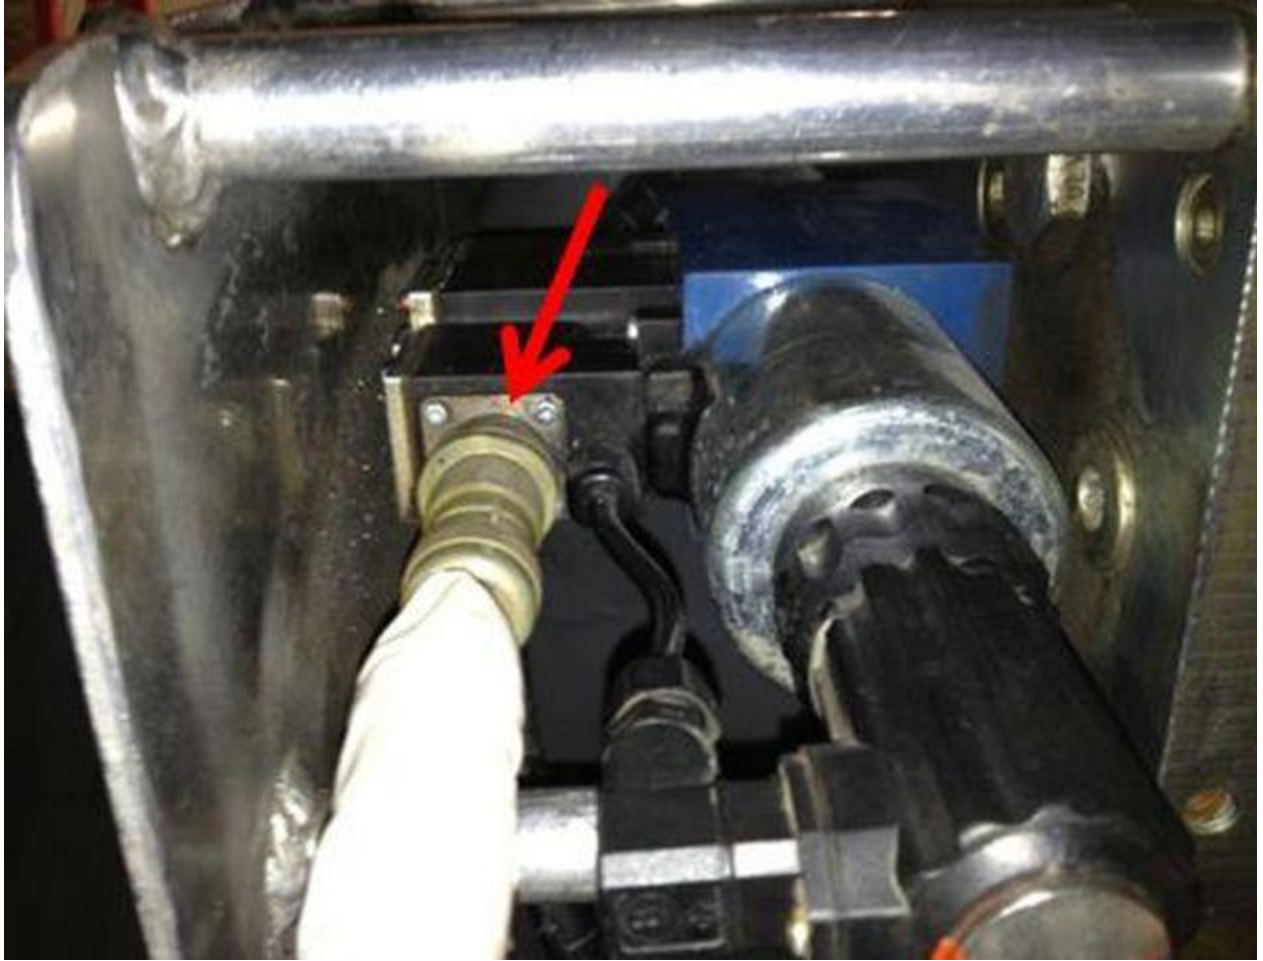
The wires in the cable to the shutdown valve (pos. 215) tend to break inside the insulation directly beneath the strain-relief near the connector.

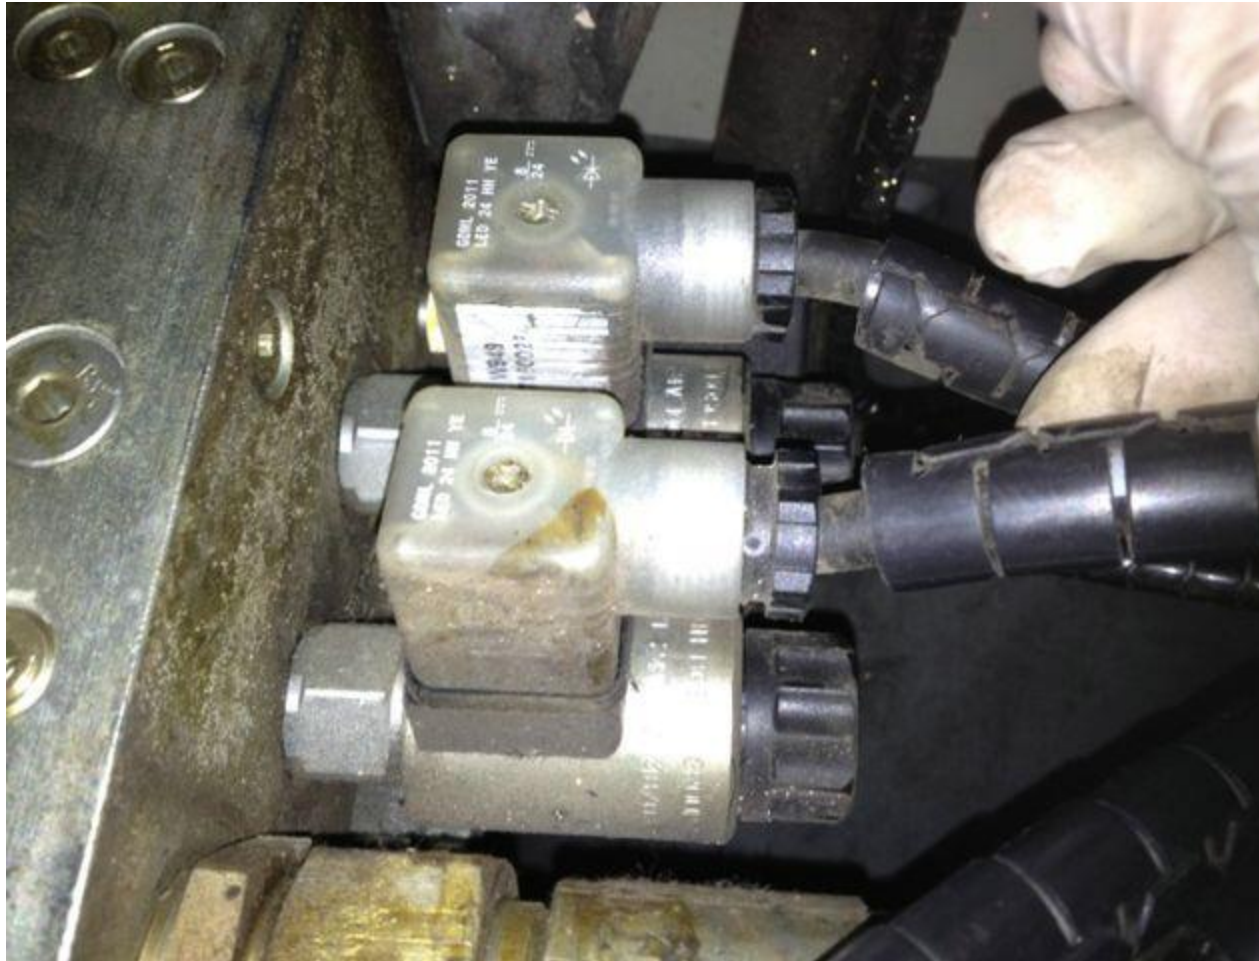
Flex the cable at this point on the cable while pitching to detect if a wire within the cable is broken.

During operation the offending blade will “flutter” a bit as the wire flexes in the hub. If it is broken badly enough you will hear the blade “hammer” as power to the valve is interrupted.
