Correct pre-charge/replace accumulator

Test/replace pressure transducer

Check and Replace the defective valve/ cable

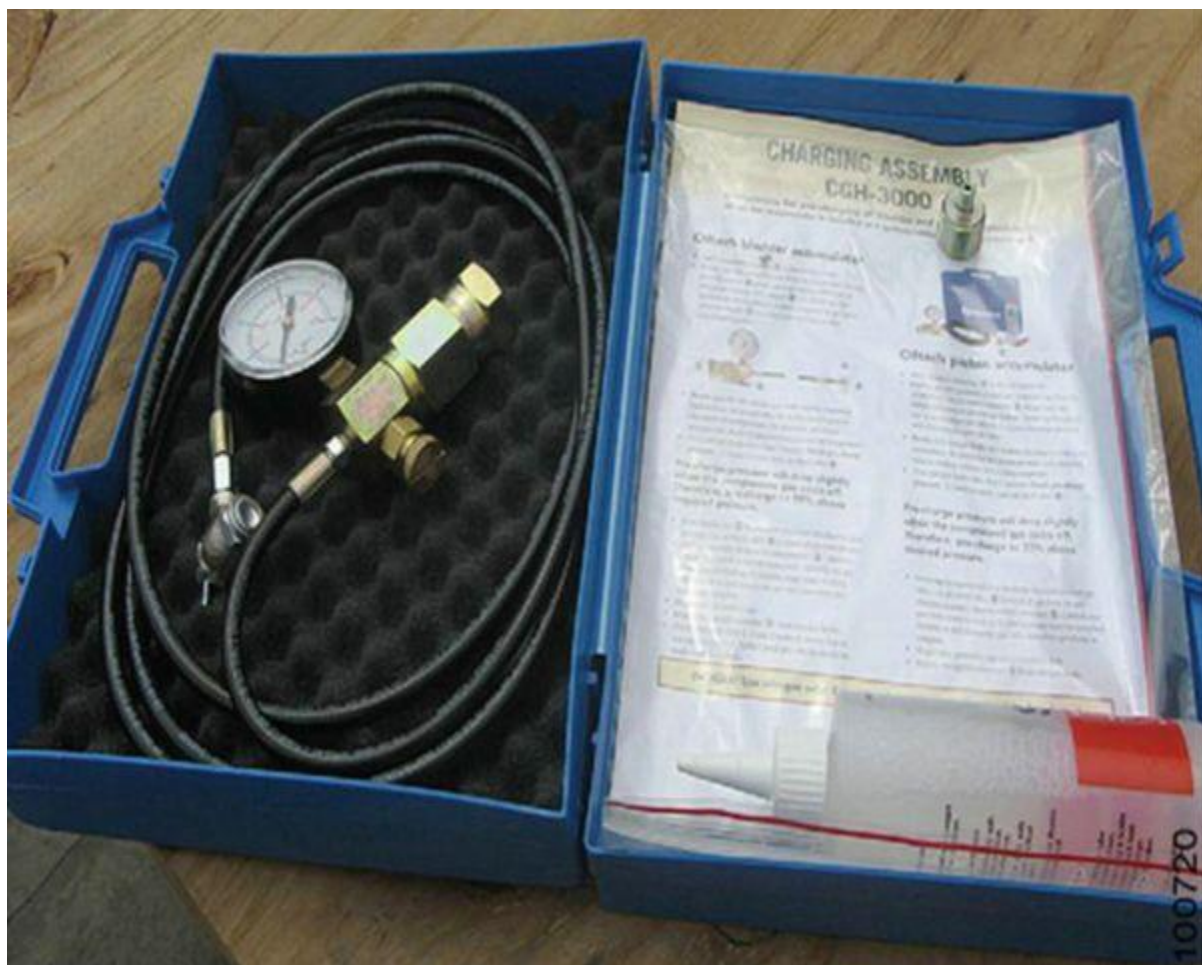
Test accumulators in accordance with 941918 Recharging of Nitrogen Accumulators. Replace or repair (if approved) any failed accumulators.

Relevant tools	
Description	Item No.
V82 accumulator charge kit	222826

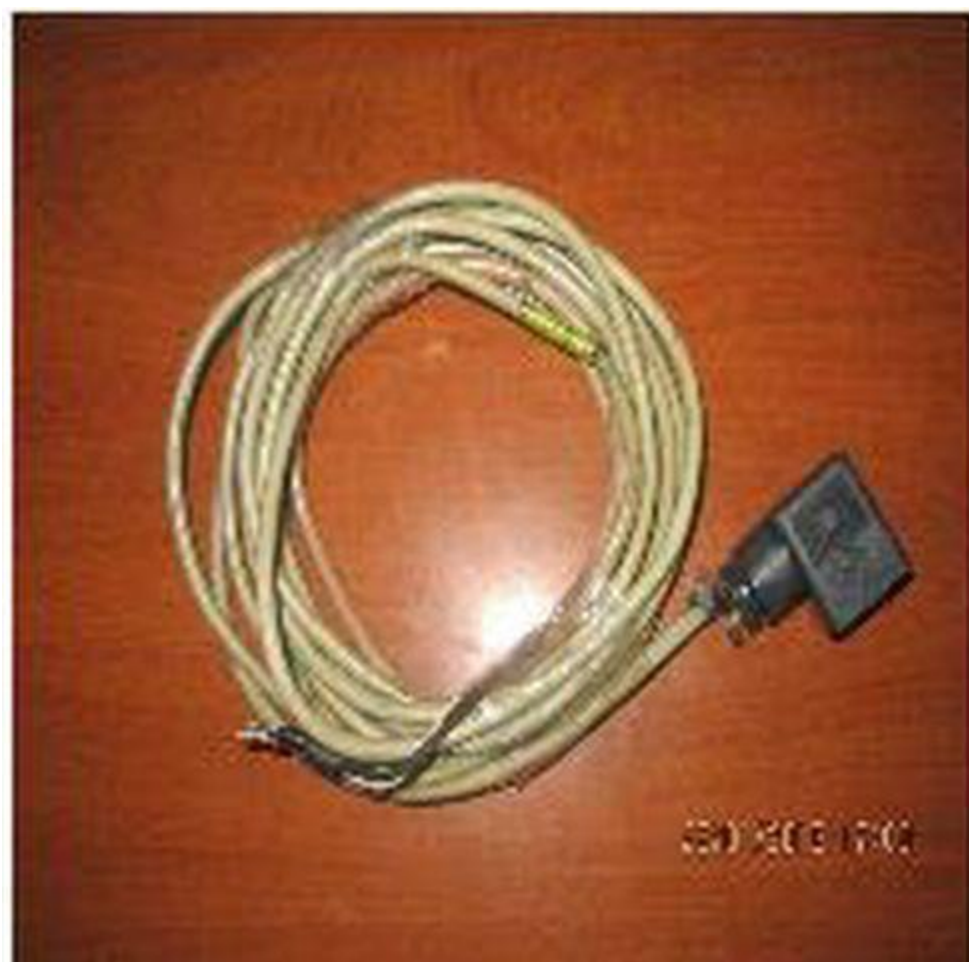
Check for the cable W920, W921 and W922 Pressure transmitter for faulty. Check the continuity test for open circuit. If found open replace the same

Relevant spare parts	
Description	Item No.
CABLE W920 T290 1 PRESSURE	60021524
CABLE W921 T290 2 PRESSURE	60021525
CABLE W922 T290 3 PRESSURE	60021526

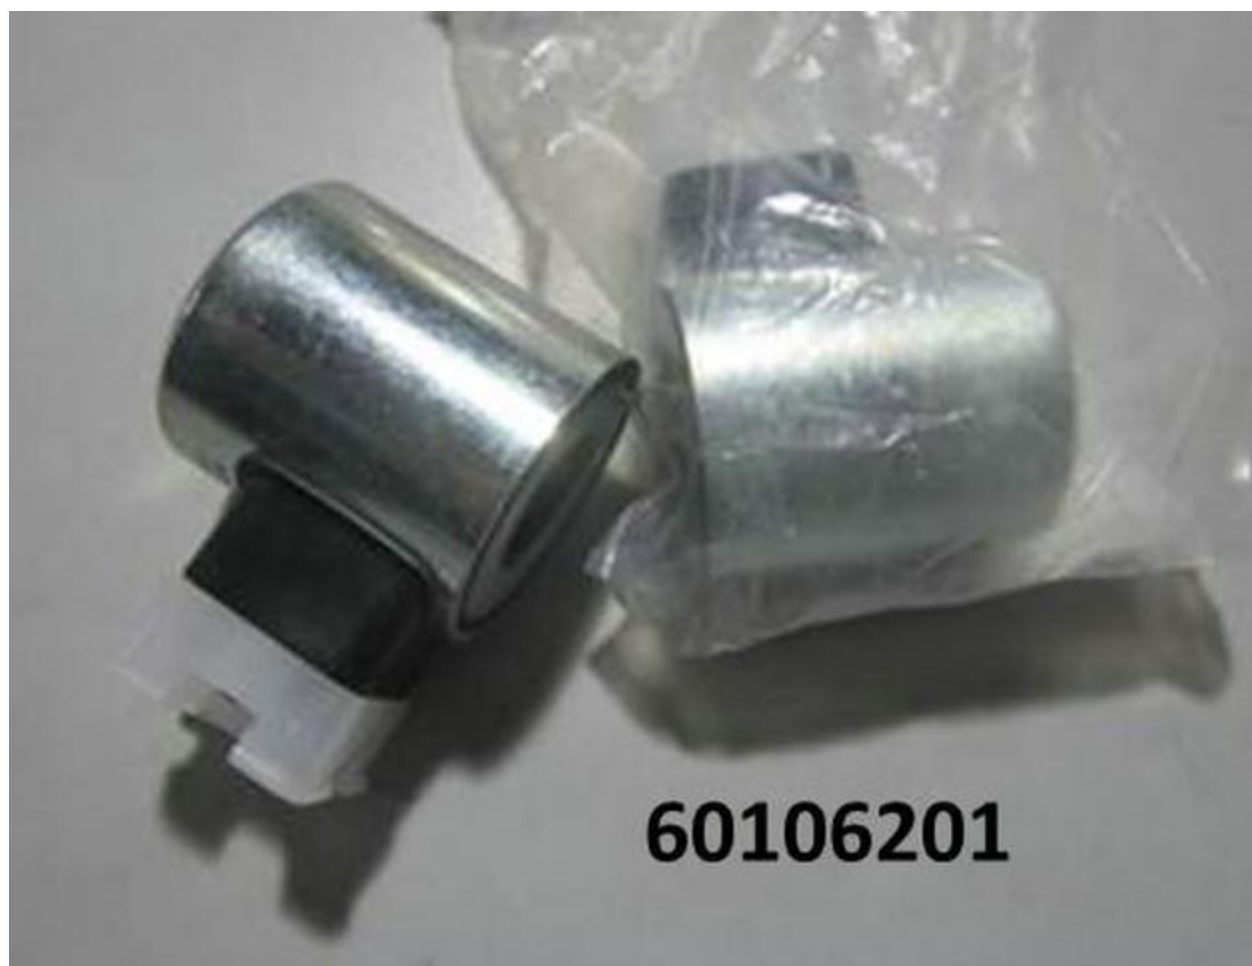
(Rexroth) Valve/Solenoid- 445

Relevant spare parts		
Description	Item No.	Status
ELECTRIAL SEATVALVE, HYDR VAL	105101	Phased out
ELECTRIC SEAT VALVE	109795	Available
COIL GZ37-4 24VDC 19W	60106201	Available

The part No.105101 is phased out and henceforth replaced by 109795 & 60106201.

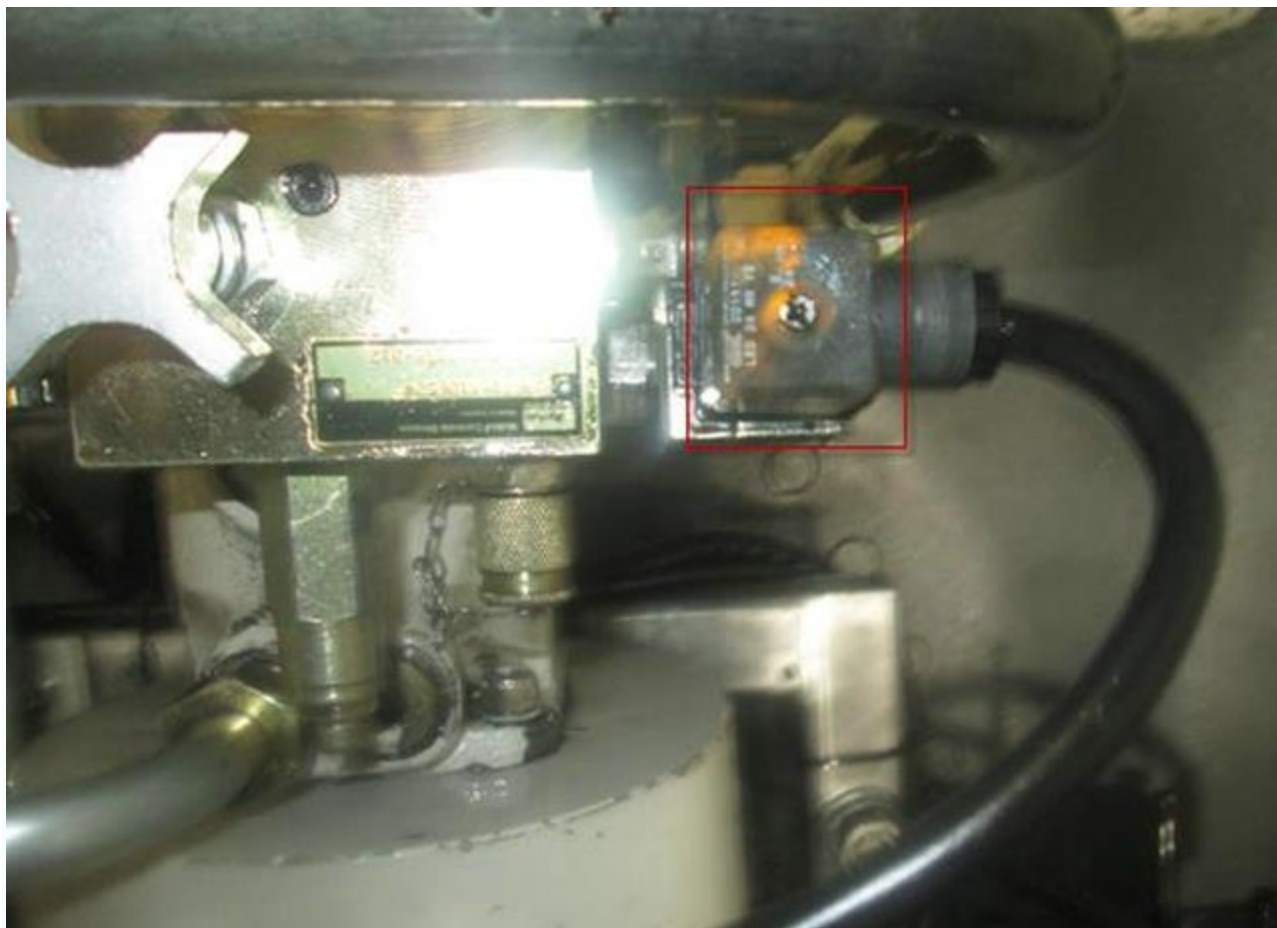
NOTE: Check the valve for proper functioning of magnetisation using screw driver while coil energised condition. Do not conclude with the lights 'ON' condition for confirming proper coil functioning. Sometimes, LED will be in 'ON' condition as shown below, but it is not necessary that coil is in good condition.

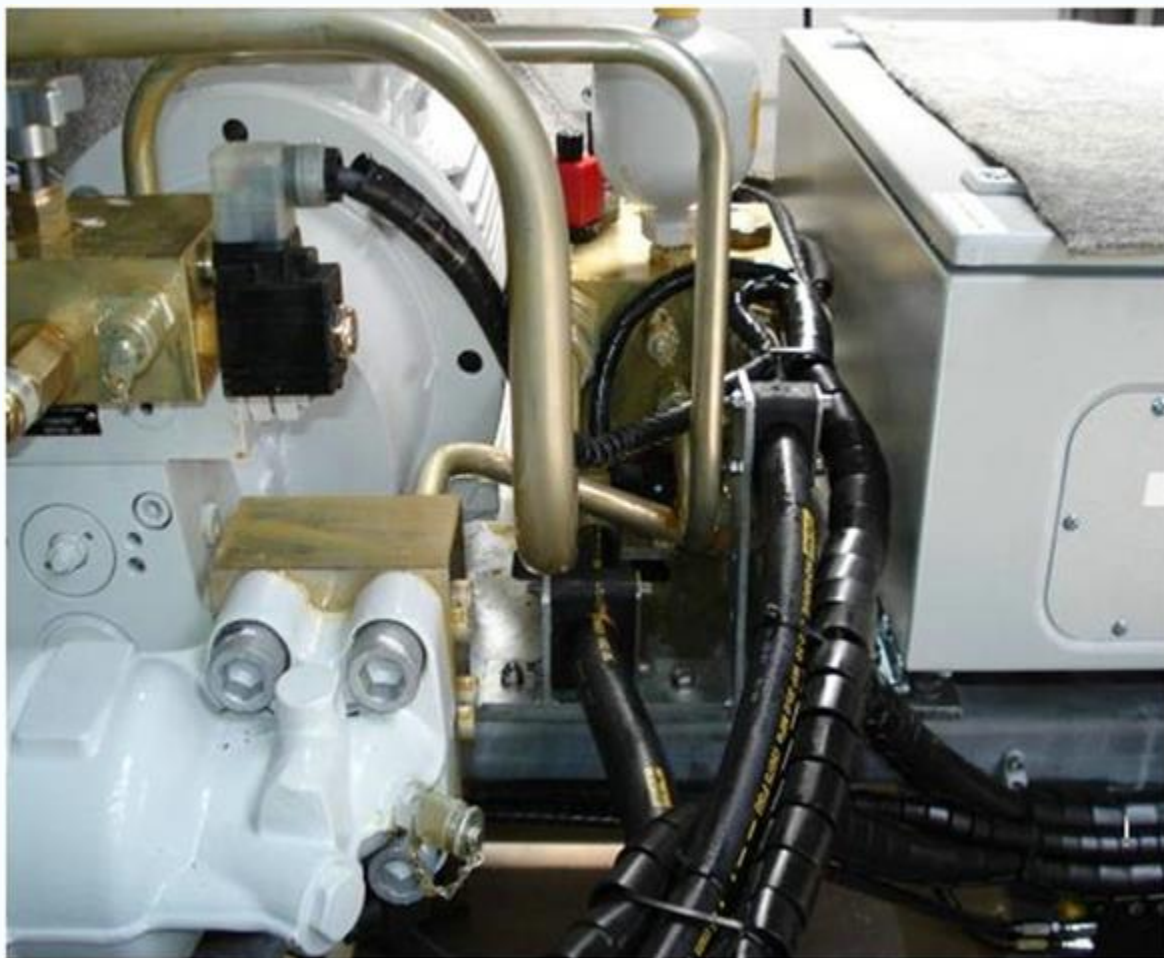
Relevant spare parts		
Description	Item No.	Position
CHECK VALVE, 0,3 BAR, 375L	60111616	410

CHECK VALVE, 0,3 BAR, 82L	60111613	425, 455
SOL. VALVE NO, DS201 NR	60112645	440
COIL, 30 WATT 24 VDC DIN PLUG	60112646	
RELIEF VALVE, RDH-08-2-S-50, 138 - 345 BAR	60112643	435
RELIEF VALVE, RDH-08-2-S-30, 69 - 207 BAR	60104030	437
SOL. VALVE NO, DSH081 NL	60112647	445
COIL 24VDC DIN PLUG S8LDD024	60104025	445A

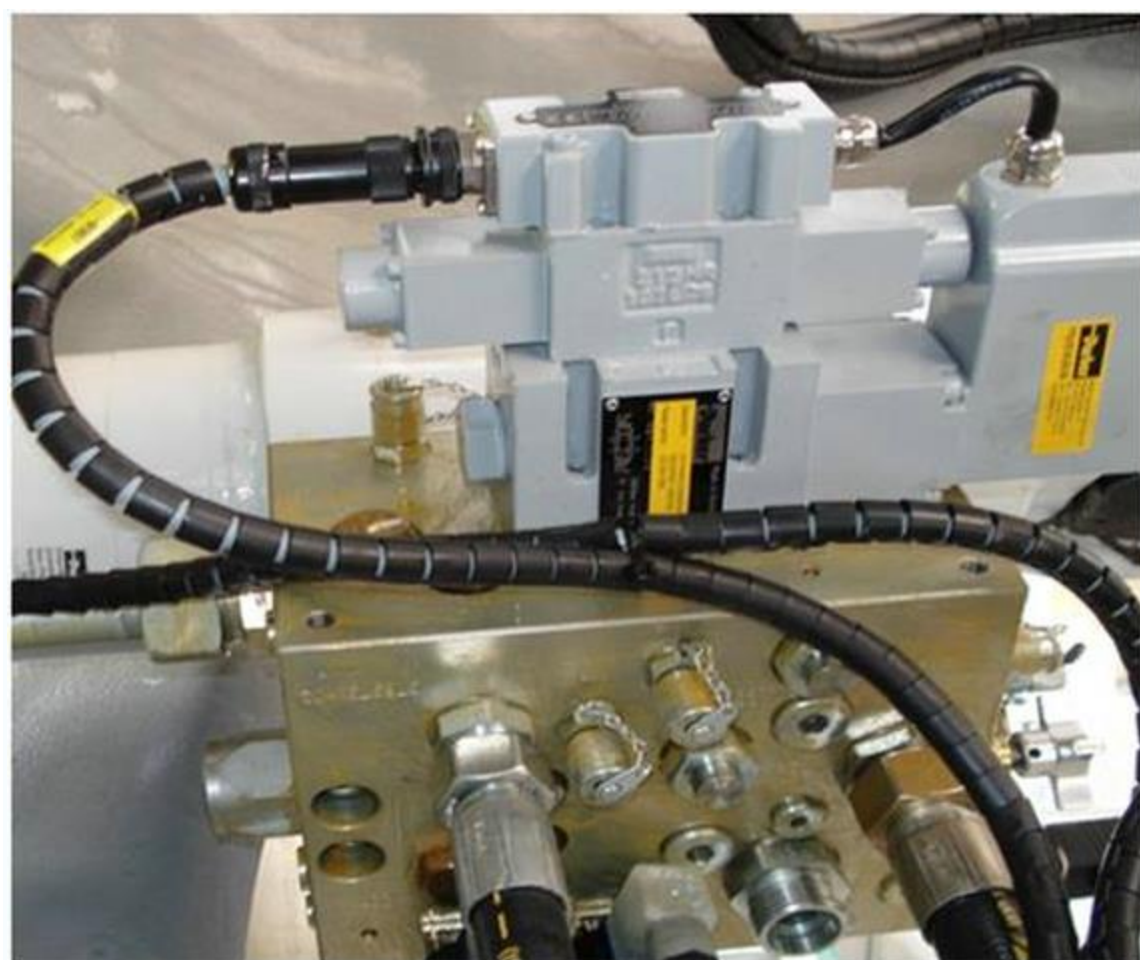
PARKER SYSTEM -PITCH MANIFOLD:

Check the below position valves,
Swap the valves one by one in to other manifolds and check valve operation.
If fault shifted to other blades the valve likely defect. If not, check the other valves.

Relevant spare parts		
Description	Item No.	Position
CHECK VALVE PILOT:CVEV-XCN A30	60096481	230 , 250 -
3/2 DIRECTIONAL VALVE	60111617	210, 215 -
LOGIC ELEMENT PIL. OPERATED	60111630	240, 245 -
PRESSURE CONTROLVALVE:RDDT-QWN	60096477	220 -
CHECK VALVE CVH103P20	60112628	235 -
PROP. VALVE D31FHE01C	60112621	205 -
