Replace the defective pitch oil PT100 Sensor

- **Explanation**
IN THE HUB:

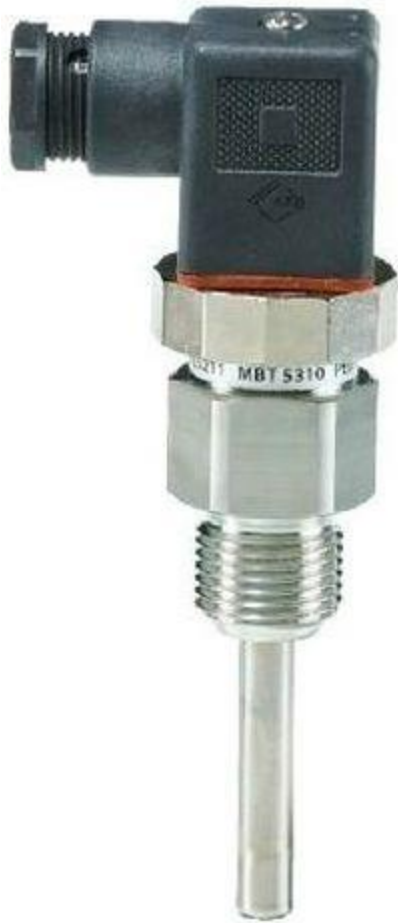
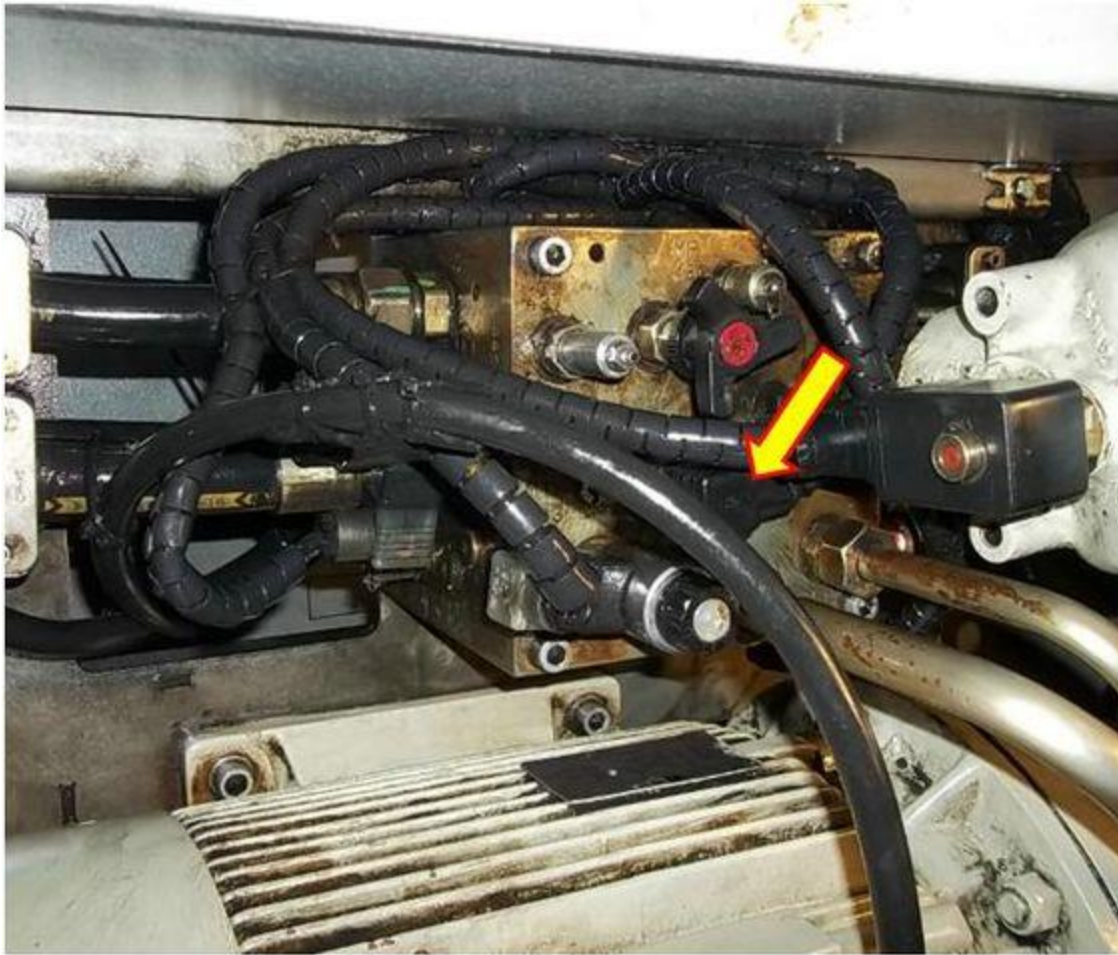
Check PT100 for any loose connections and general tightness in +AK4 panel.

Use a multimeter set to read Ω and measure the resistance across the leads of the PT100.

If the value is unreal (-40 to 200 °C), then the PT100 is faulty and must be replaced.

Relevant spare parts	
Description	Item No.
TEMP SENSOR PT100 MBT5250	60096502

Note : Ensure the Washer availability during replacement.

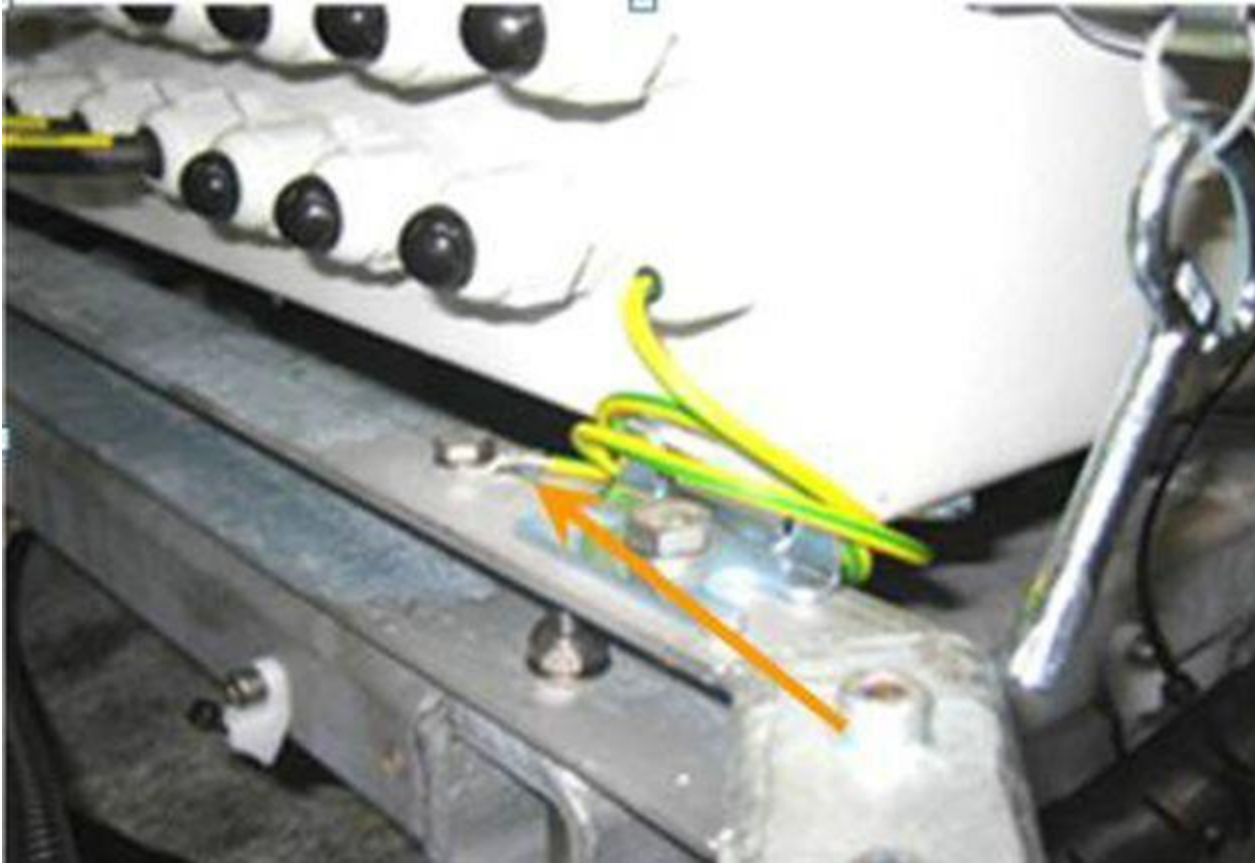
Check the cable continuity and cable insulation if any damage is found.

If defective replace the new cable.

Relevant spare parts	
Description	Item No.
CABLE W930 B470 HYDR OLIE	60021533

Check the hub earth connection for proper earthing with hub frame.

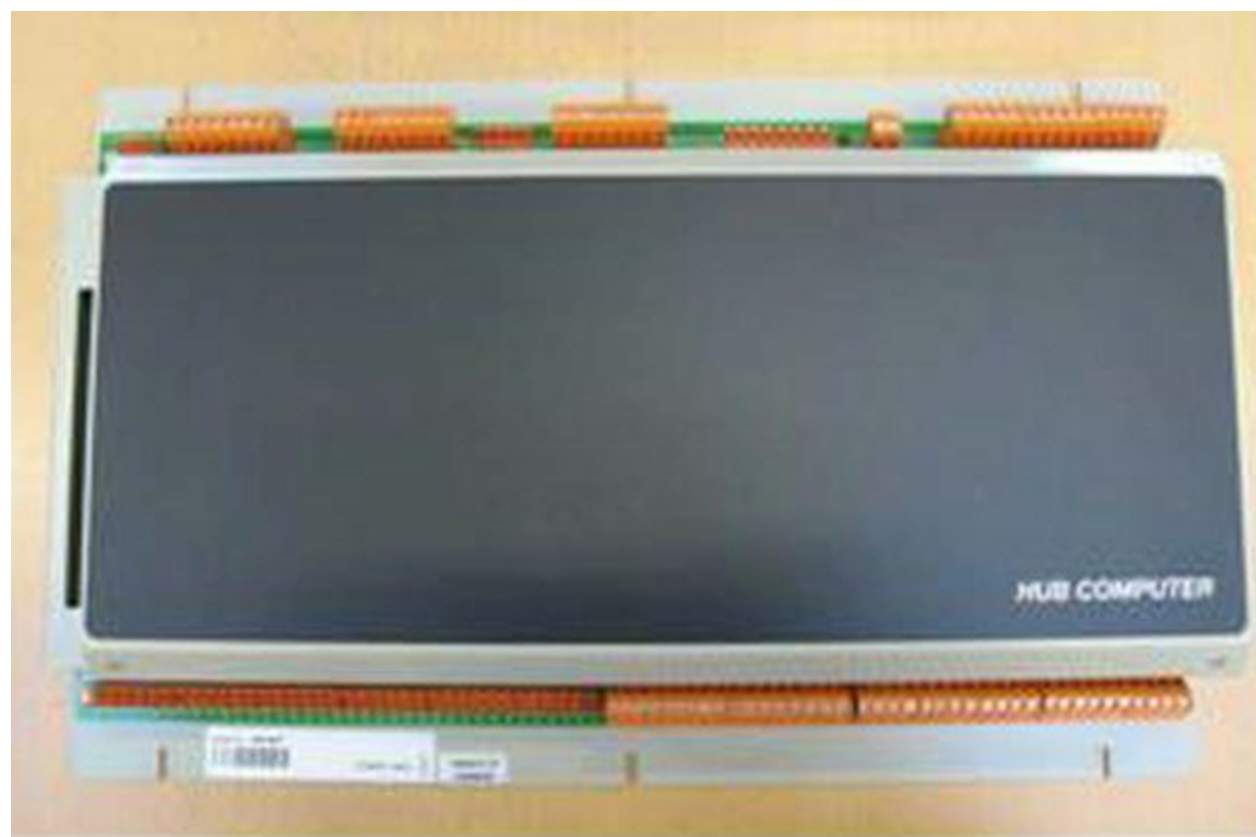
If the cable and sensor is in good condition the cause is likely a faulty
hub computer.

Relevant spare parts	
Description	Item No.
SIF HUB COMPUTER CABINET EVOII	51701801
