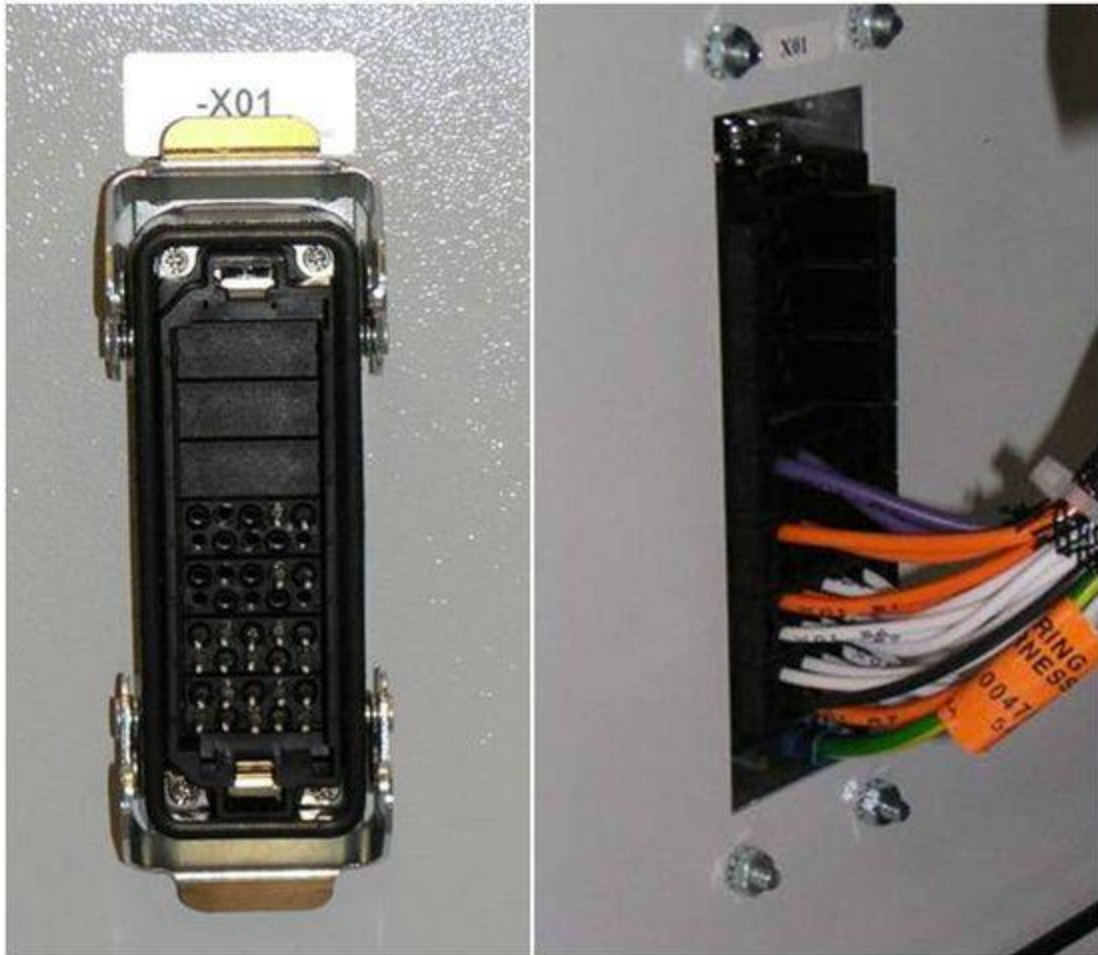
Check the panel input supply cable from the tower.

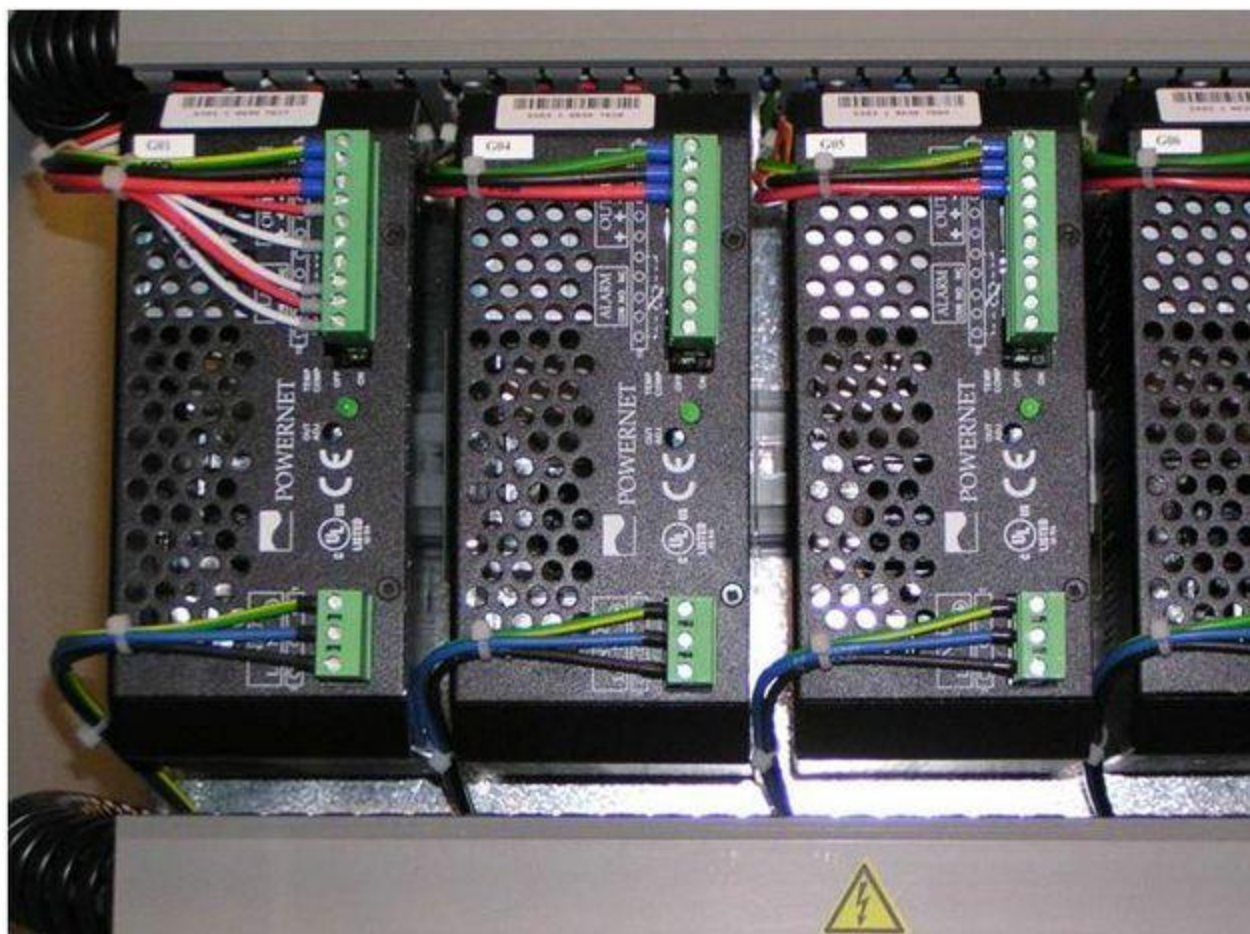
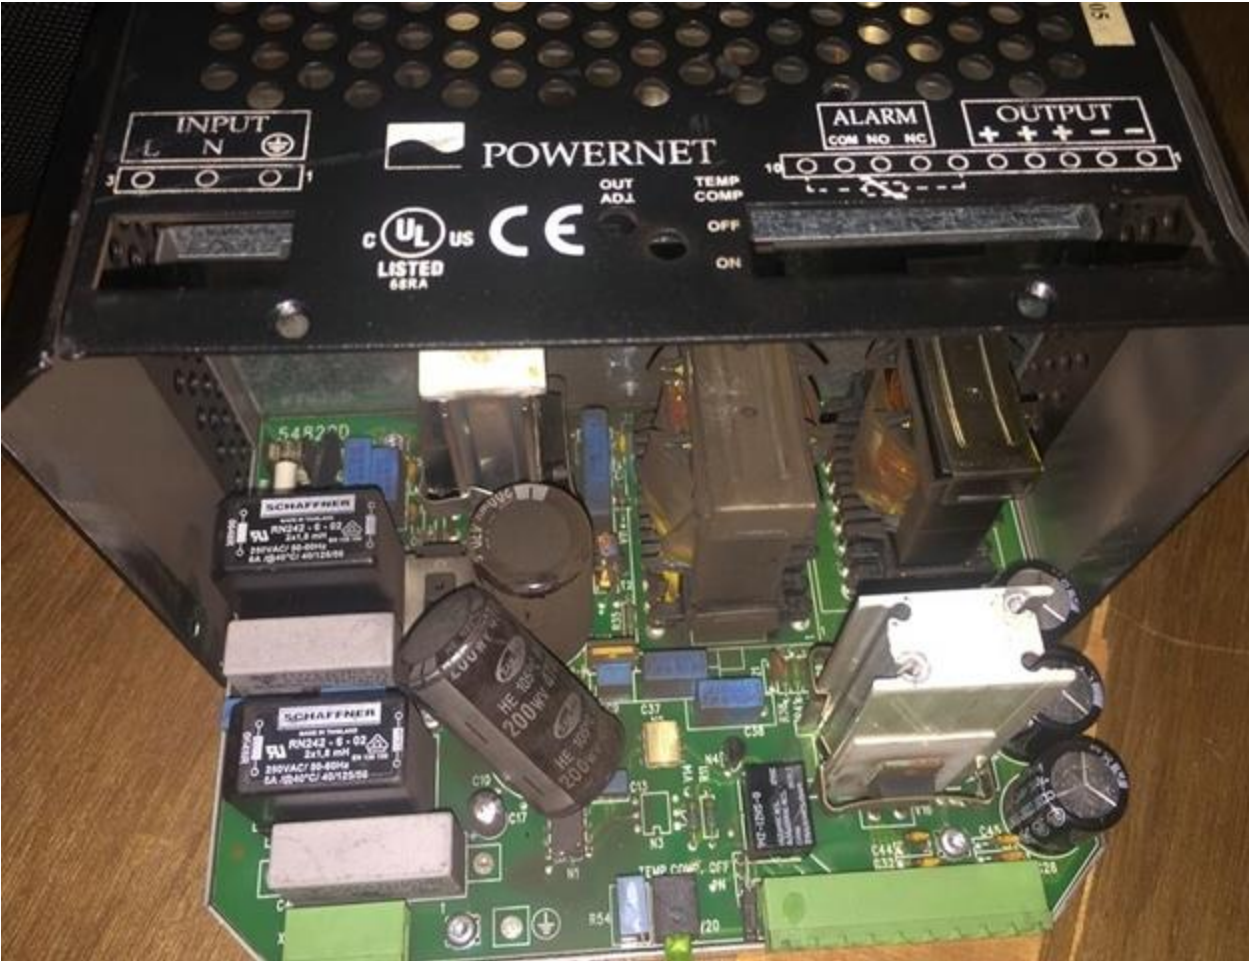
Power net G04:

Check the power net G04 INPUT/OUTPUT supply

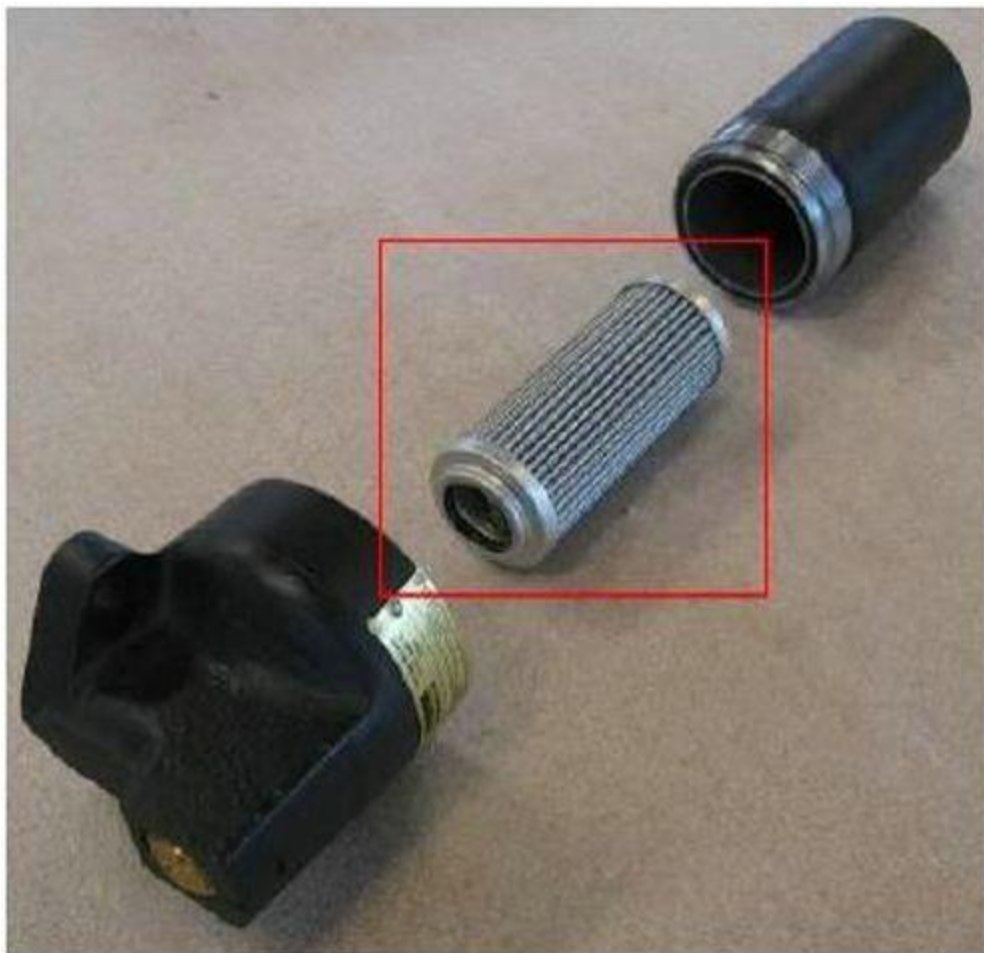
Check in-line filters for any physical damage.

Check the filter cleanliness, if the filter is found to be dirty, replace with new.

Relevant spare parts – Online Filter	
Description	Item No.
FILTER ELEMENT 928935Q	60104029

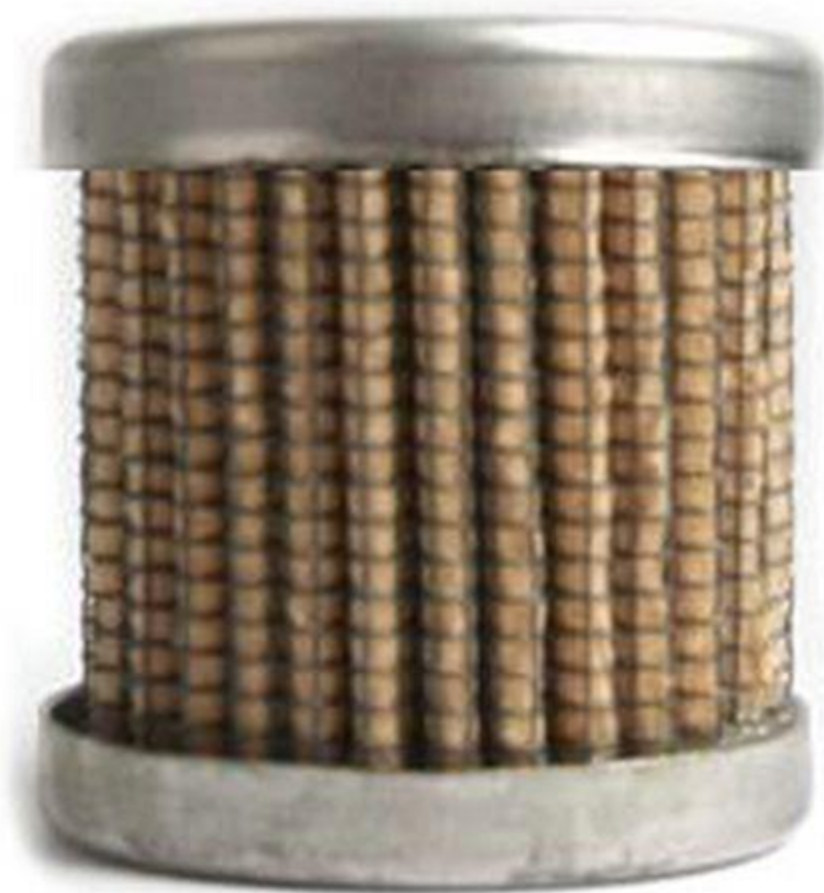
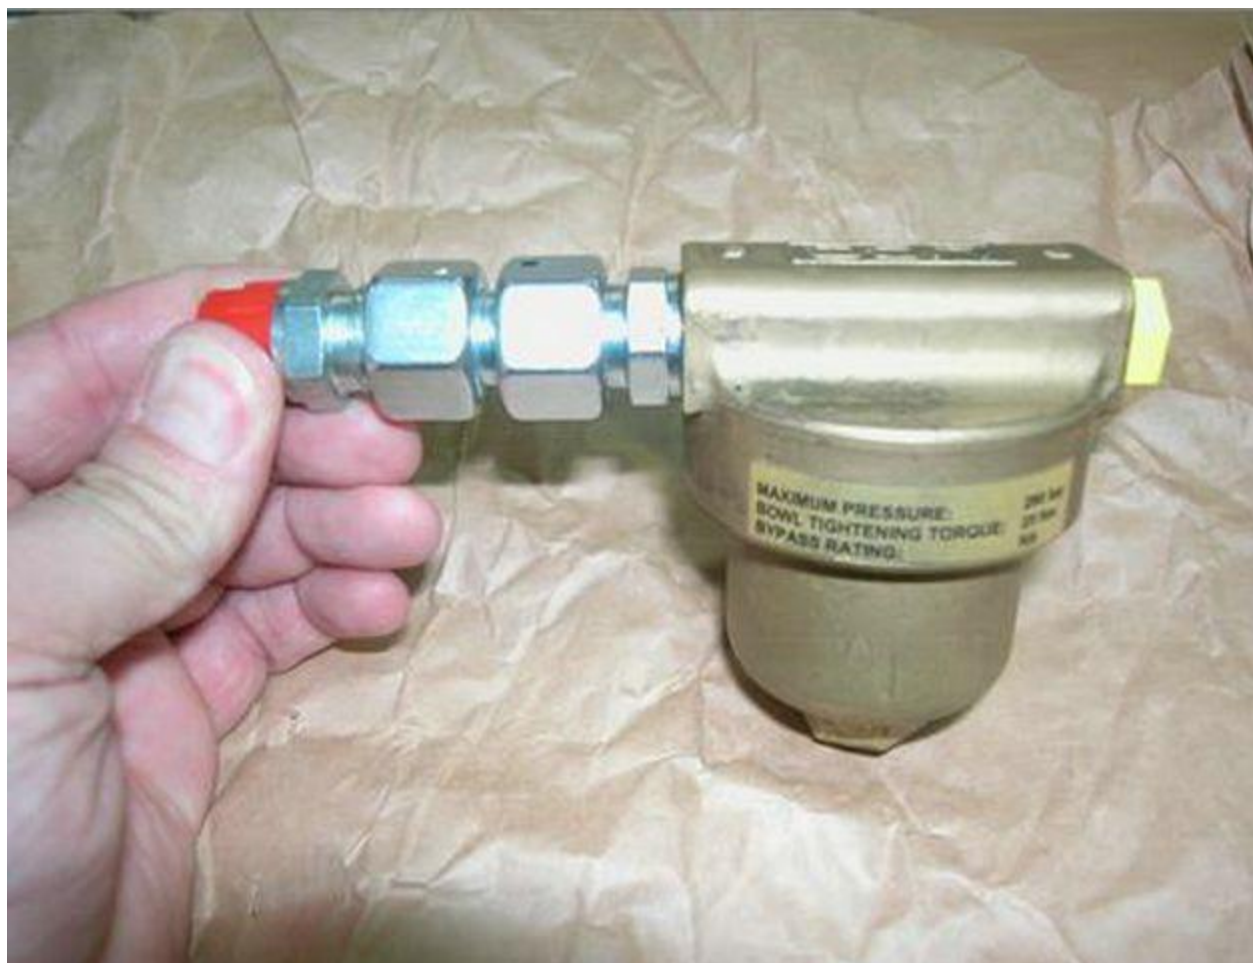
Relevant spare parts – Return line Filter

Description	Item No.
FILTER ELEMENT HPR.1619 (filter alone)	60111969

Ensure the return line filter set is mounted correctly and check that the filter by-pass screw is not loose.

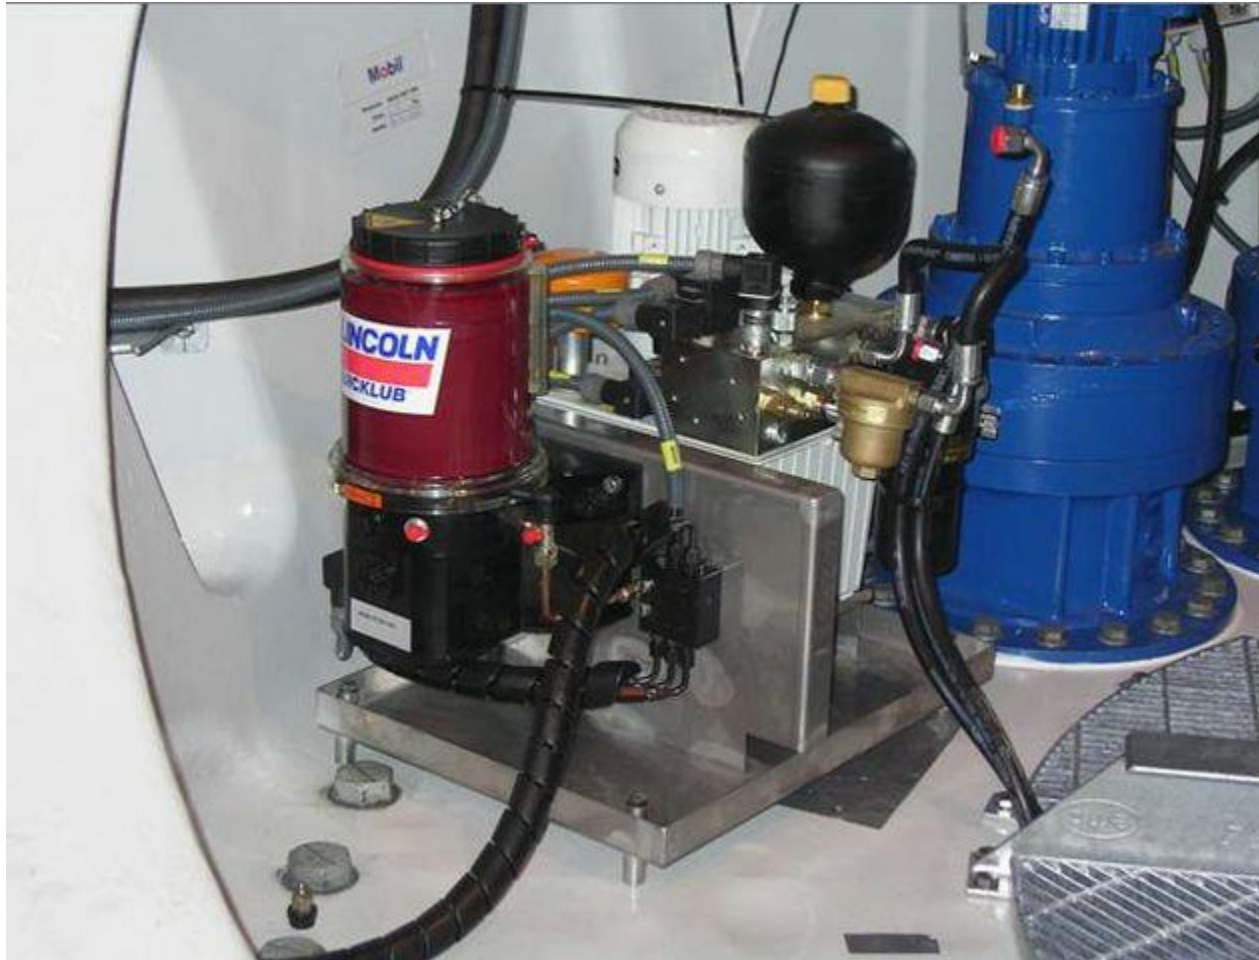
Check the **0.16** pressure relief valve setting as per I&S data. The setting depends on the brake pad type.

For relief valve setting refer installation and service date.

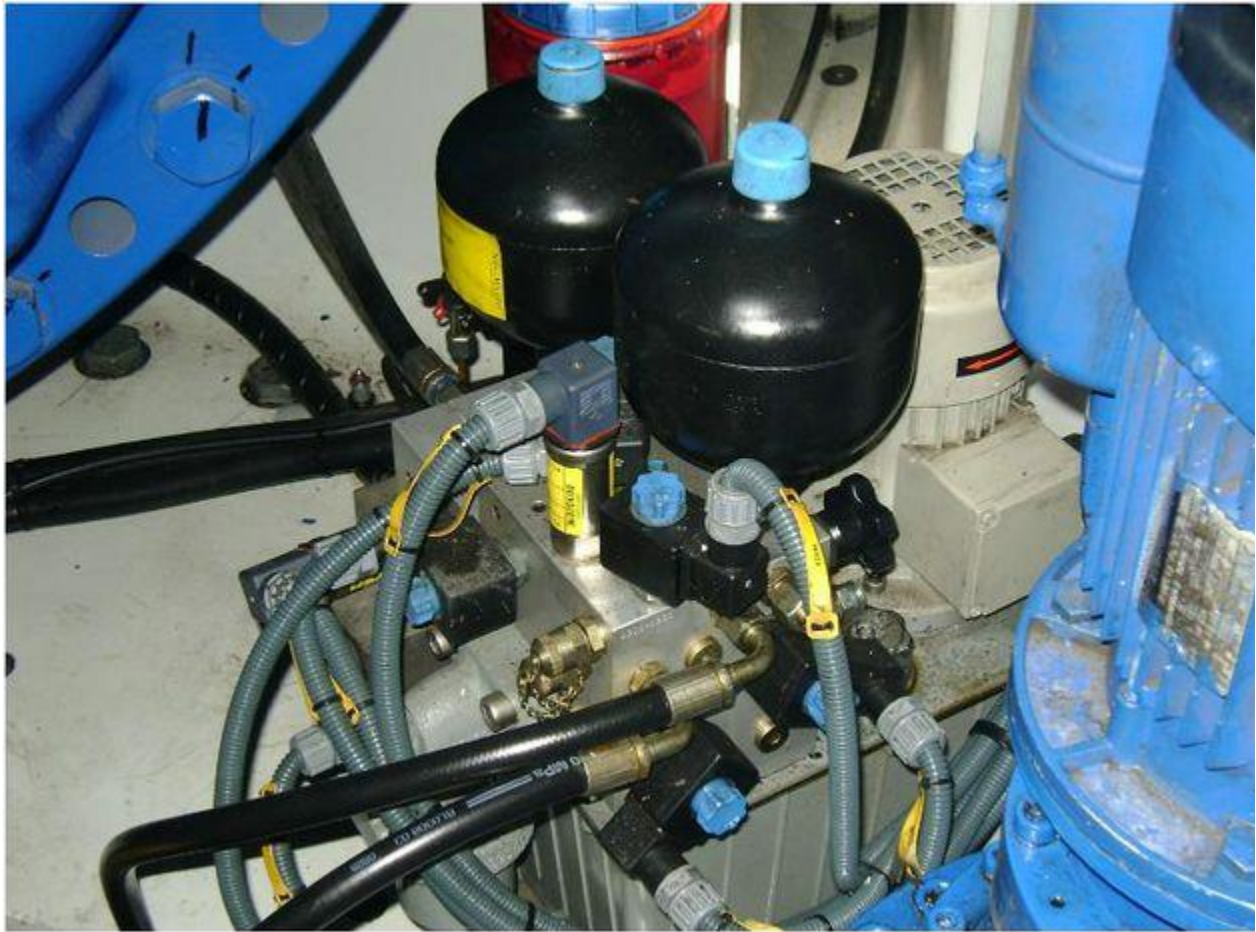
Check the solenoid valve and troubleshoot solenoid valves for correct function.

Check the solenoid valve supply, if the solenoid valve is found to be defective, replace with new.

Check the **POS: 13** pressure relief valve setting as per I&S data. The setting depends on the brake pad type.

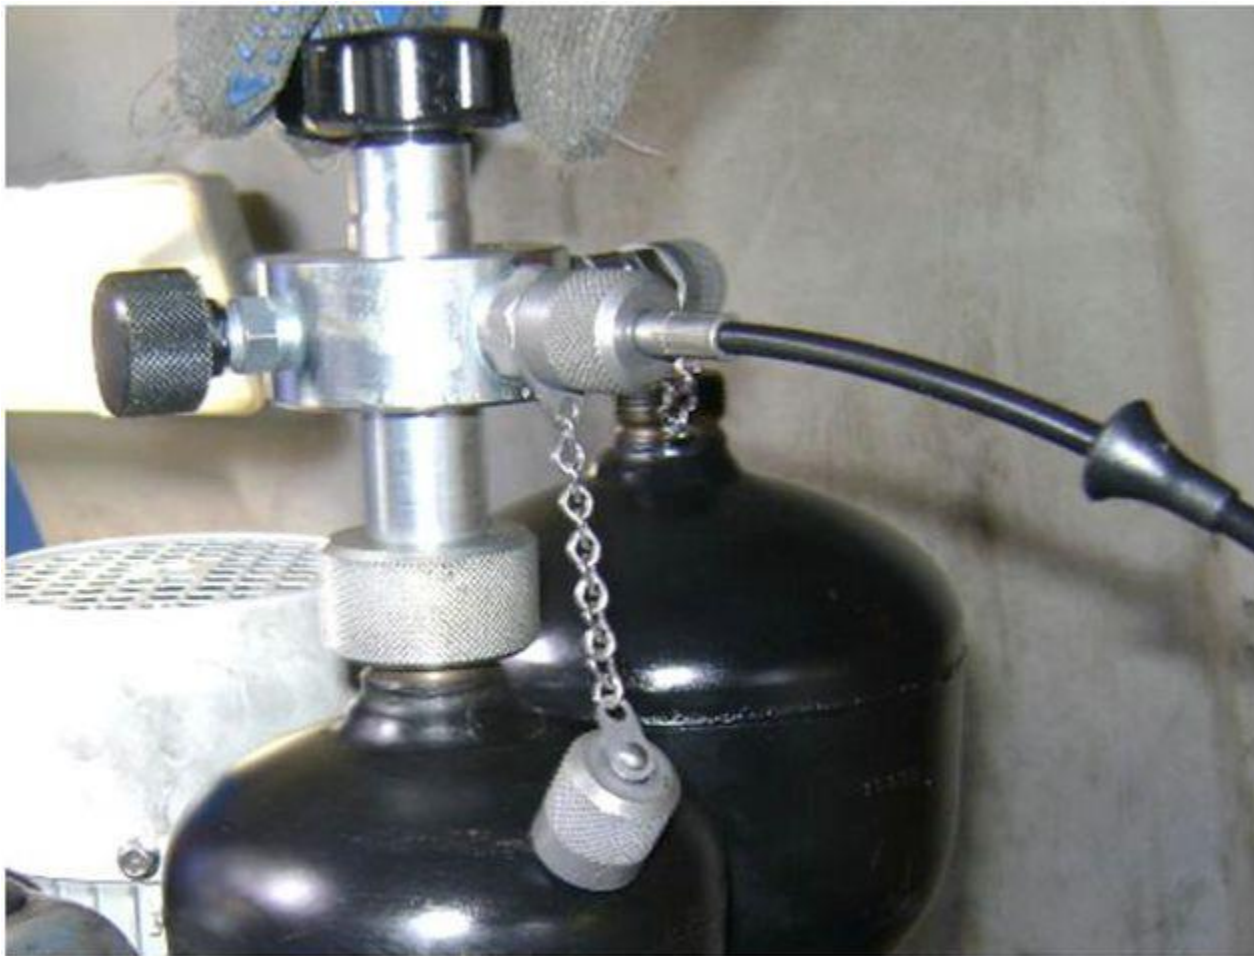
Check the pre-charge of accumulator.

If the pressure is low – recharge the accumulator.

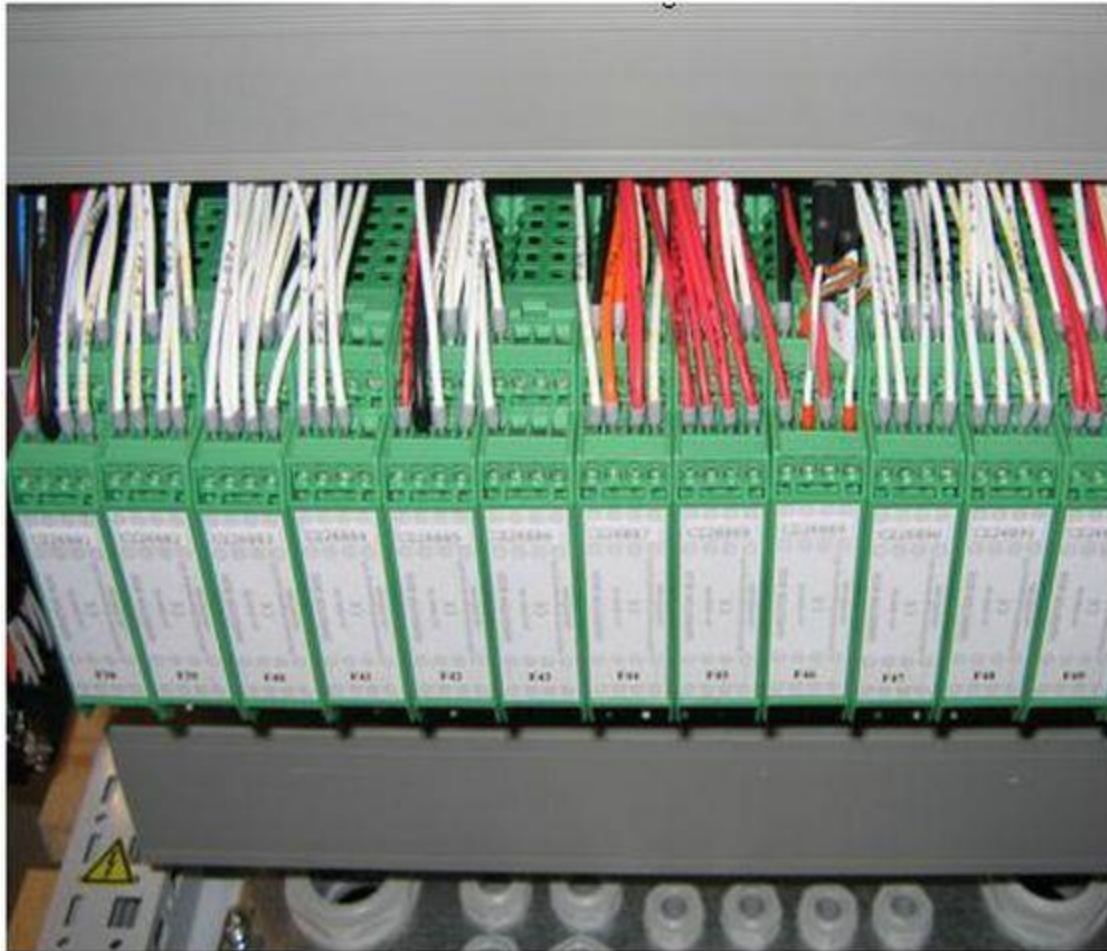
Varistors (F40) can be tested individually by placing a multimeter (set to measure Ω) lead on the common (earth) side of the varistors and the other on the individual varistor terminals. The resistance value over the varistor should be ∞ or in the high M Ω range. If the resistance is lower, the varistor has been damaged by an over voltage in the circuit and must be replaced

Press the clip on top and bottom of the varistor box and remove the varistor assembly from housing: The varistor box is made up of eight varistors and has provisions for 16 wire connections (protection for 8 signals).

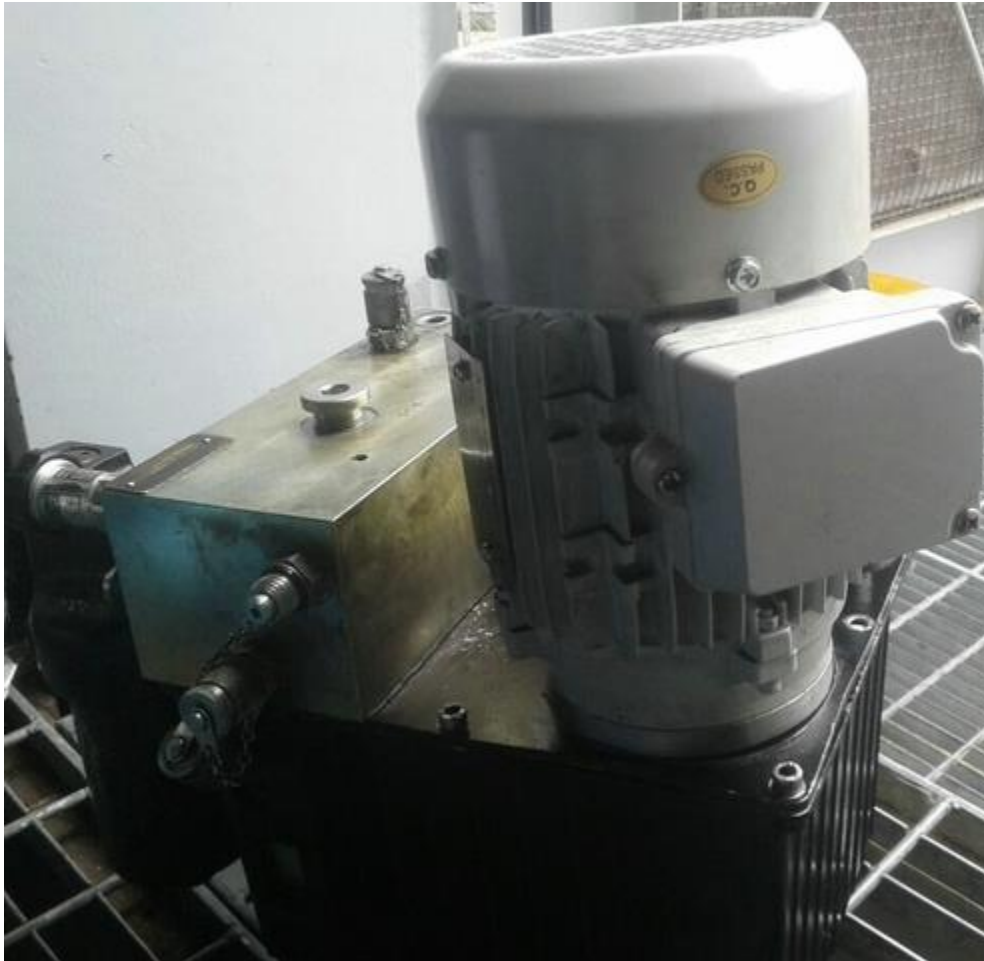
Malfunctioning of Hydraulic unit will cause this error.
