## To fix the Hat and sealing cover

## Replace yaw Motor

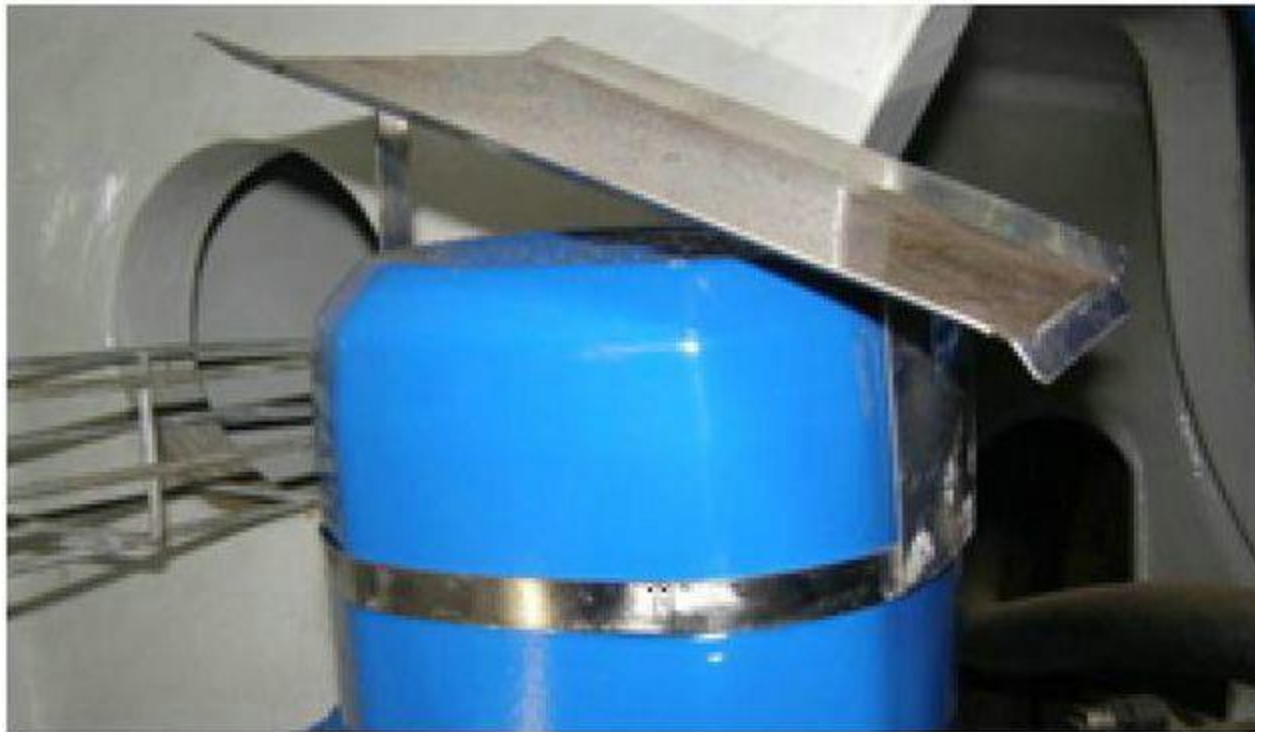
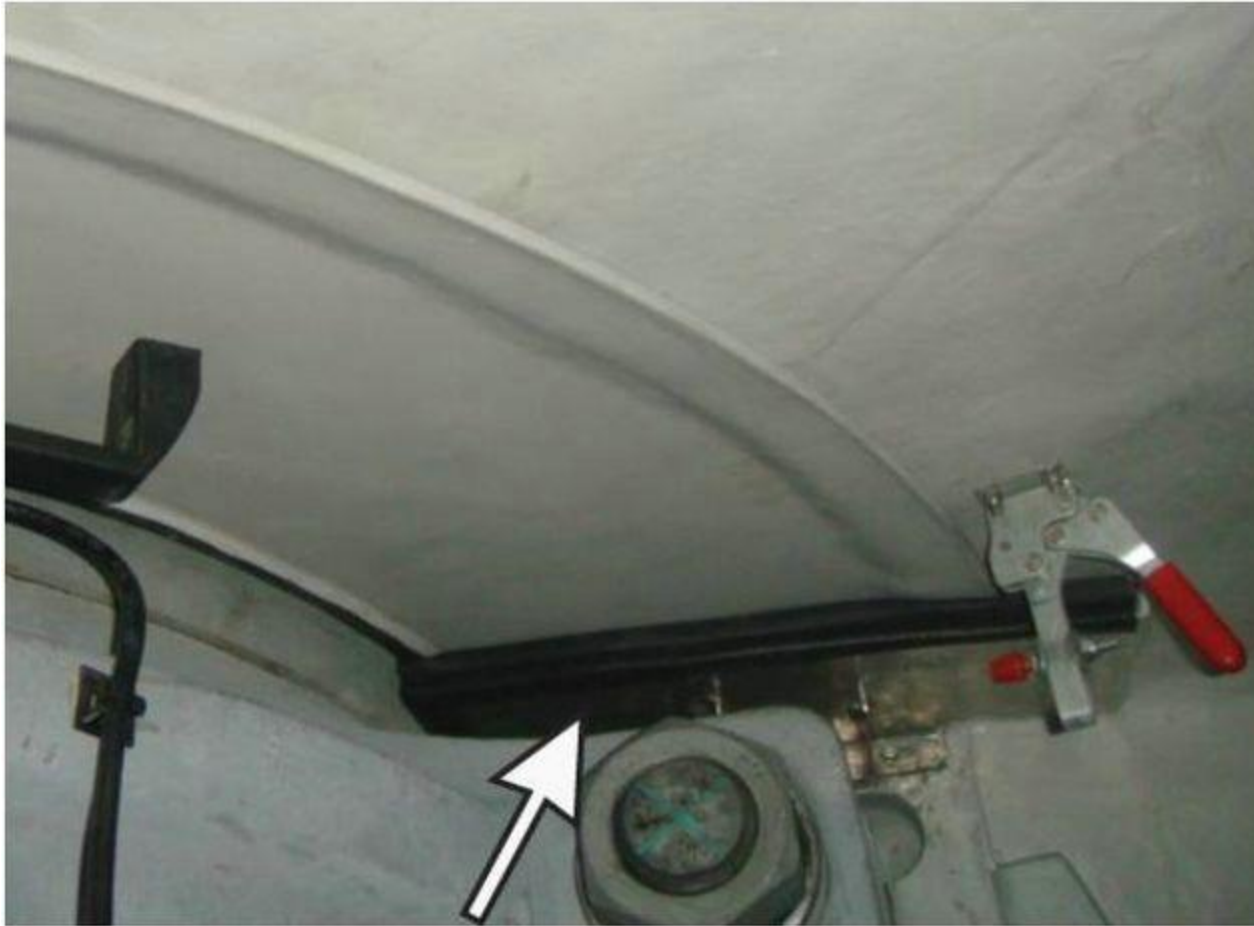
Ensure mounting hat is fixed

Relevant documentation	
Description	DMS No.
Mounting Hat on Yaw Motor	<a href="#">0004-5922</a>
Sealing Nacelle Cover	<a href="#">0004-7508</a>

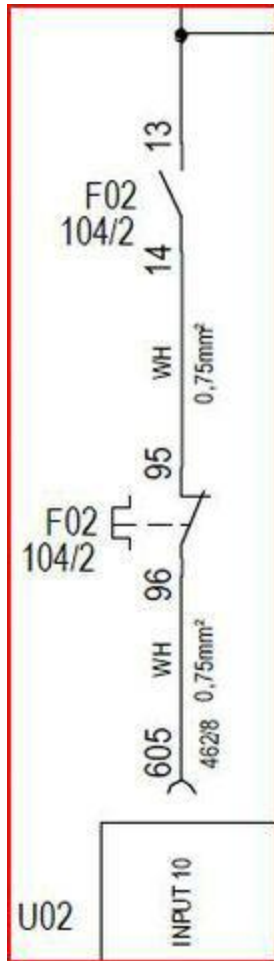
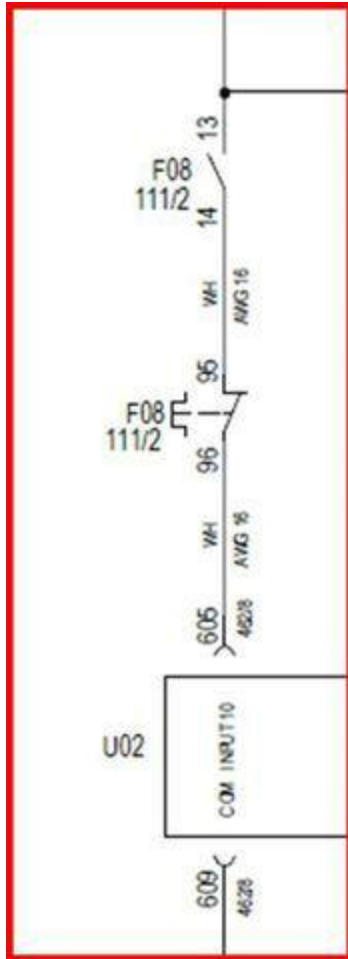
- **Explanation**  
50 Hz

60Hz

50 Hz

60 Hz

- Check the INPUT/ OUTPUT voltage (F02)
- Check the MCB function.
- Check the MCB continuity.
- Check the required current setting in the MCB
- Check for loose connection in the terminals and cable condition.
- Check the Auxiliary relay function input to TOI.

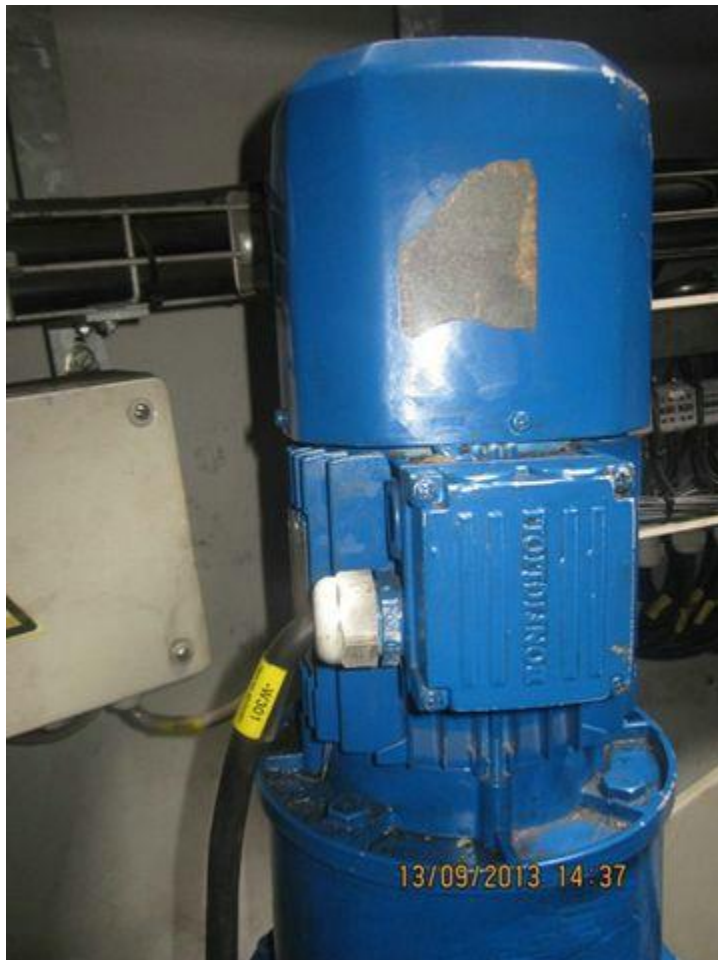
Yaw motor

- Check for any loose connection in the terminal box:
- Remove the STAR/ DELTA connections and check the Winding /coil resistance valve

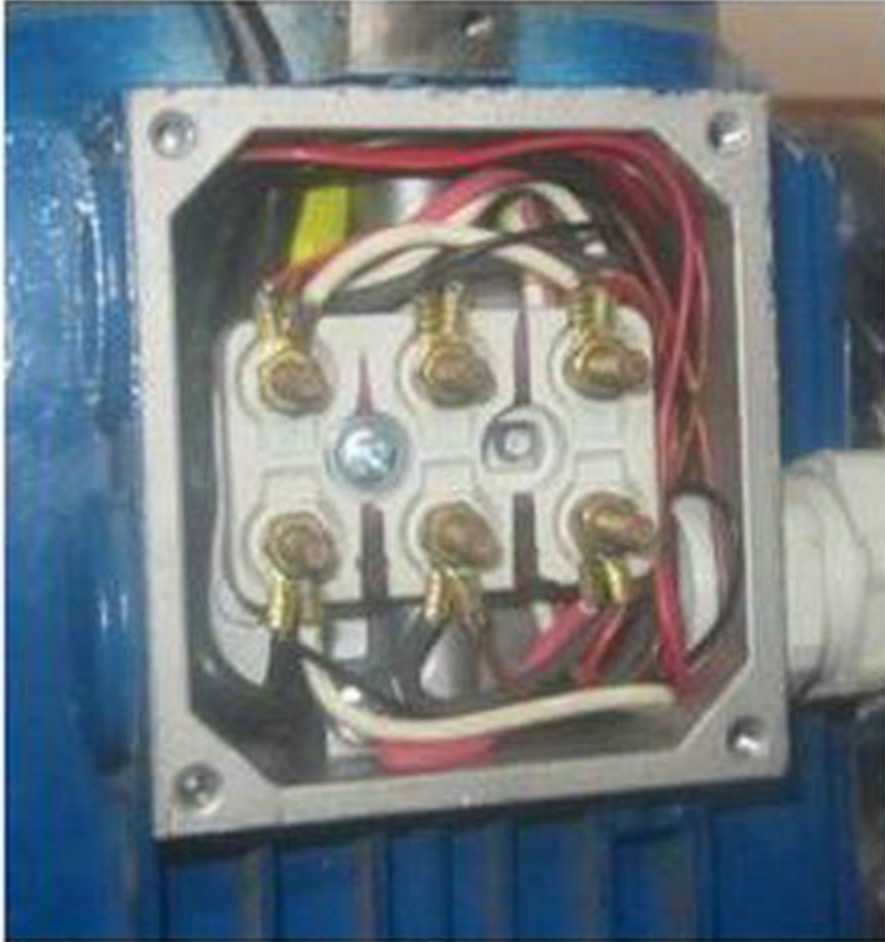
Yaw motor connection:

Remove the Yaw brake magnetic coil connection

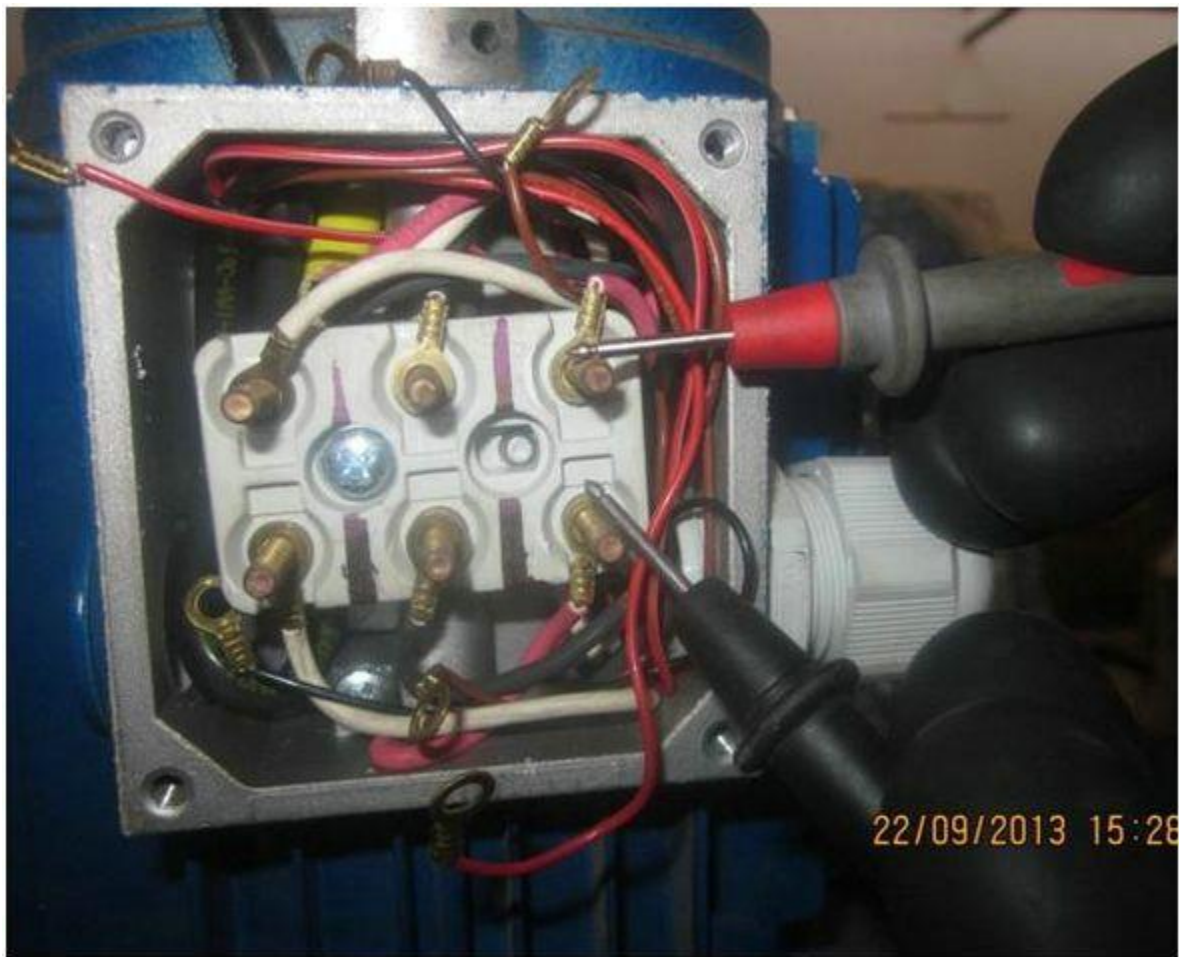
And Measure the resistance value of the motor windings and magnetic coil.

Measure phase to phase and phase to earth on all windings.

The resistance value should be  $>1\text{M}\Omega$ .

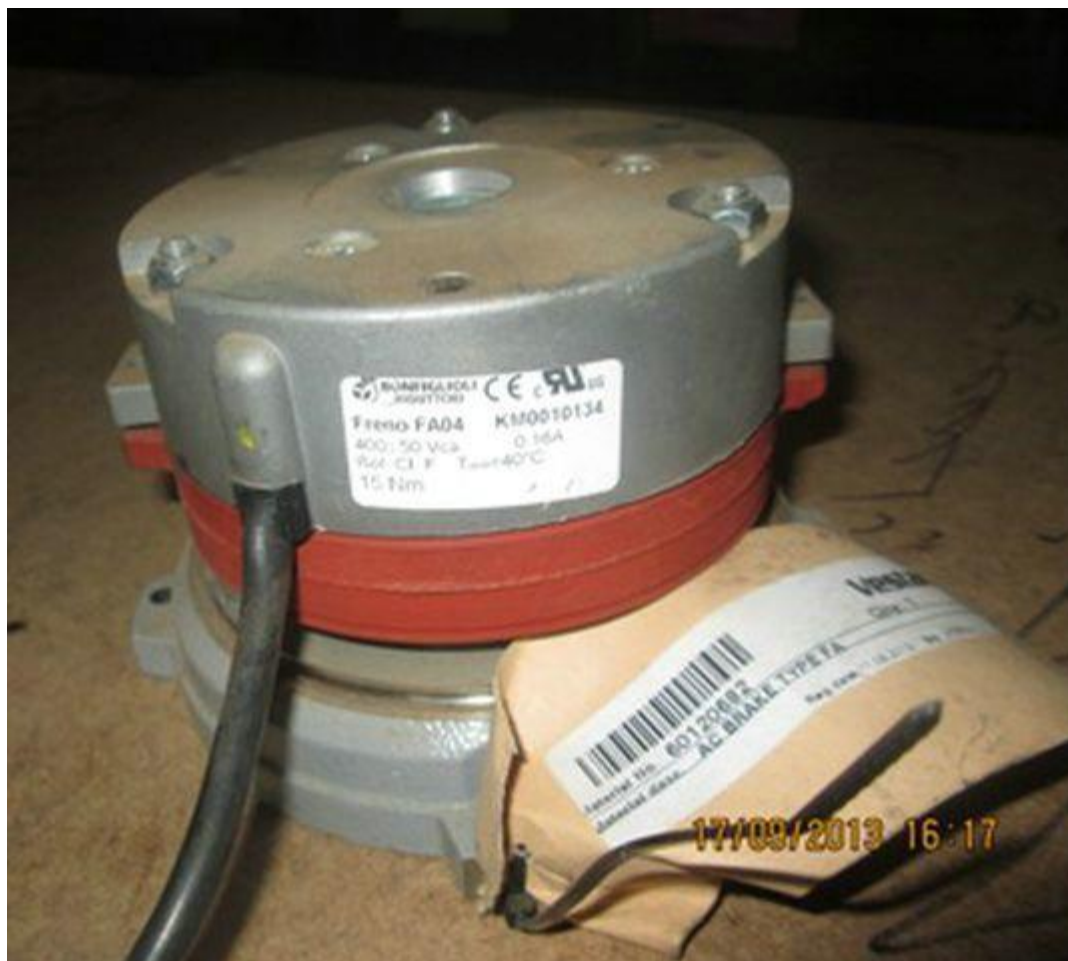
Yaw motor magnetic coil

If magnetic coil failure, we can replace coil only

Check & adjust the yaw magnetic brake –Refer the Service Work Instruction for Yaw System” [1000686](#)

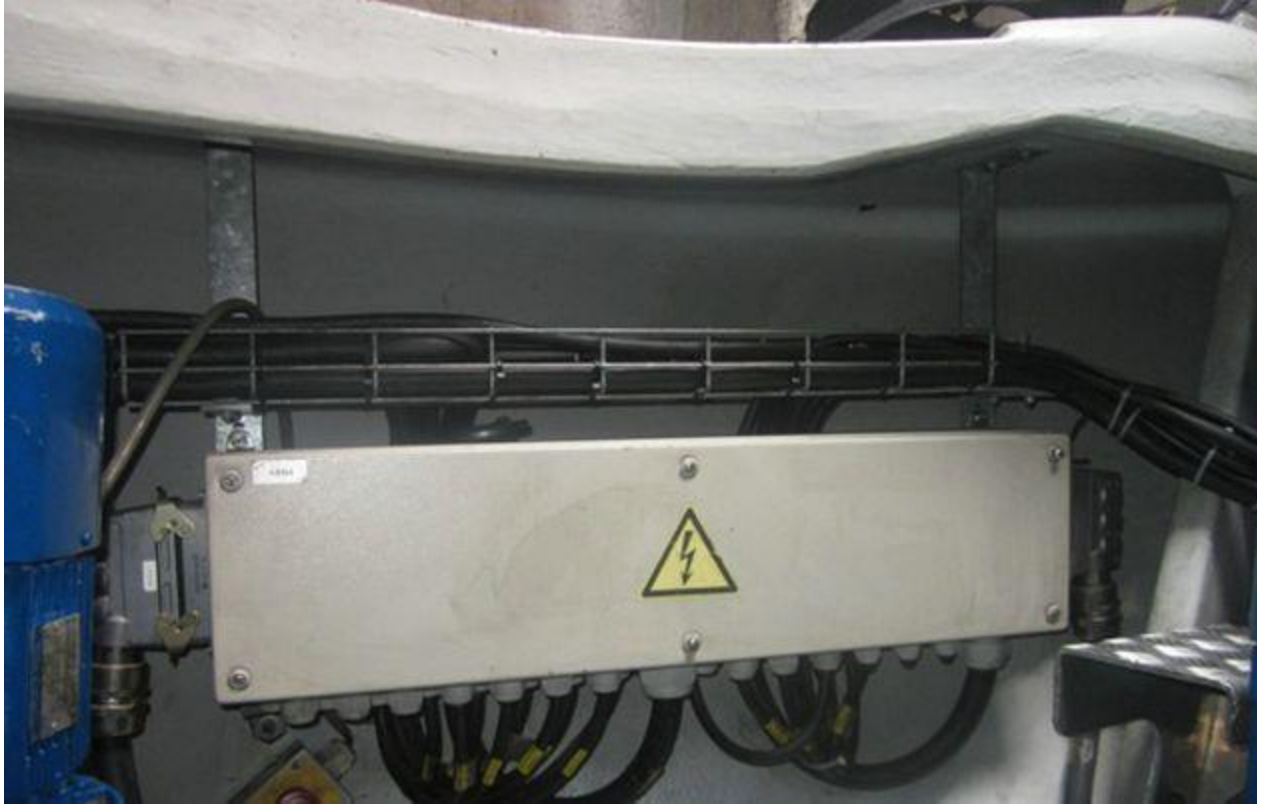
- Check the incoming cable from Control panel (+AT2) to motor box (+AN4), in some cases broken wires have been found (at the loop) inside the W309. There are spare wires in W310 and wires have to be moved for the motor in the terminals of +AT2/+AN4. Remember to mark old wires in both ends as defect. Spare wires

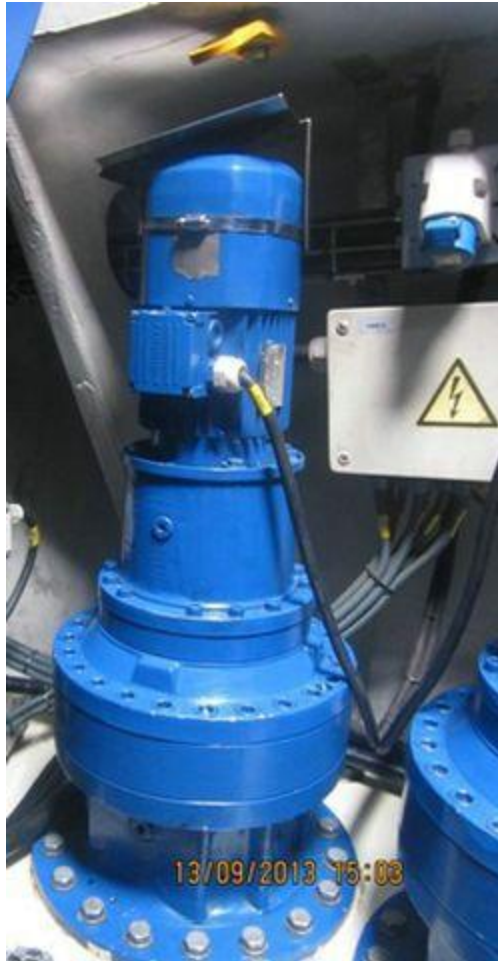
Picture view yaw gear:

- Keep the yaw motor safely
- Check the gear unit oil level (if its needed top up as per procedure)
- Master Reset the WTG and Switch on yaw controller.
- To make ensure yaw gear rotate or not.
- To ensure rotate the yaw gear unit and listen abnormal noise of any kind.
- If not rotate the yaw gear unit or create abnormal noise, change the yaw gear unit as per WKI.
- To ensure yaw gear unit bed bolt torque value as per I & S data
