Replace the defective batteries

Replace the defect solenoid valves

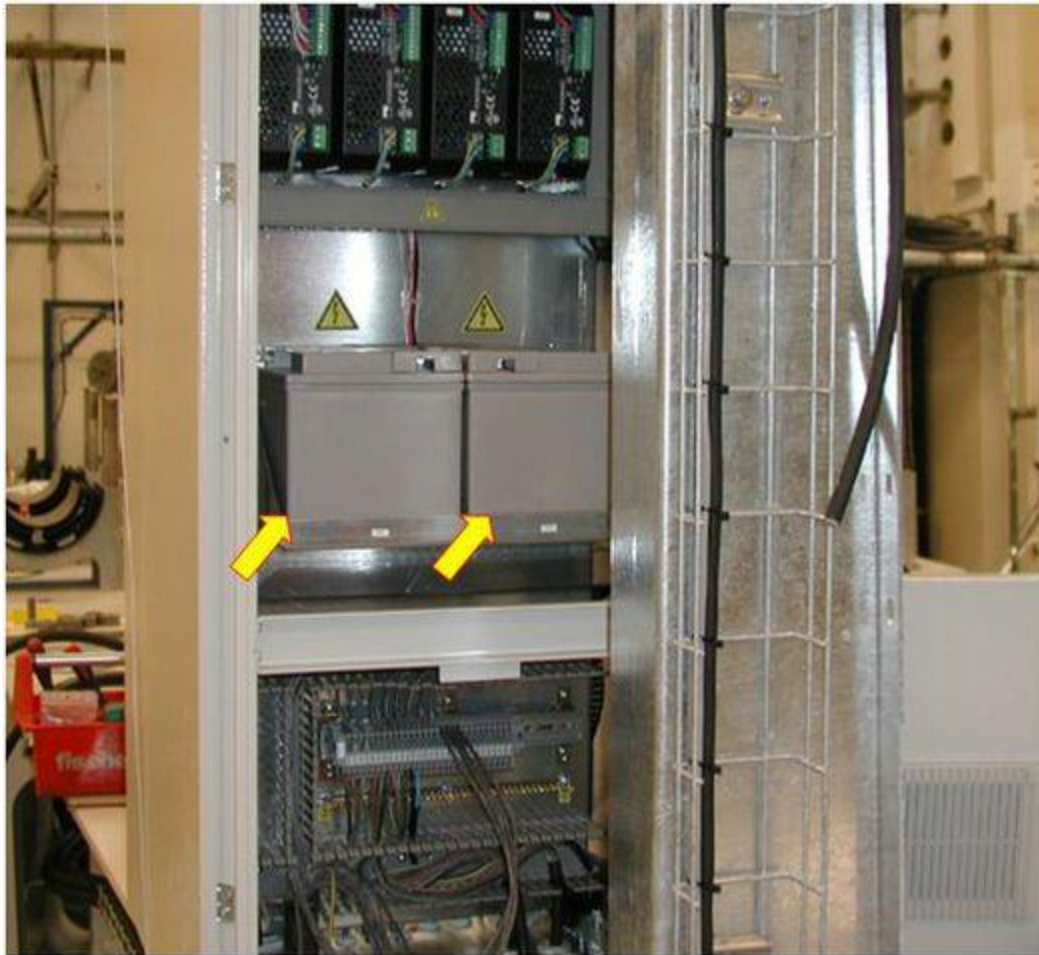
Visually inspect the batteries, look for bulging sides, leaking or corroded terminals. Check the voltage displayed on the charger. If the voltage is low, and the charging circuit has been verified, the batteries are likely failing and should be replaced. If the batteries are operational, yet have corrosion on the terminals, clean the terminals and apply dielectric grease to prevent further corrosion.

If defective, replace the batteries (G02, G03).

Check for any loose terminal connections. Repair as necessary.

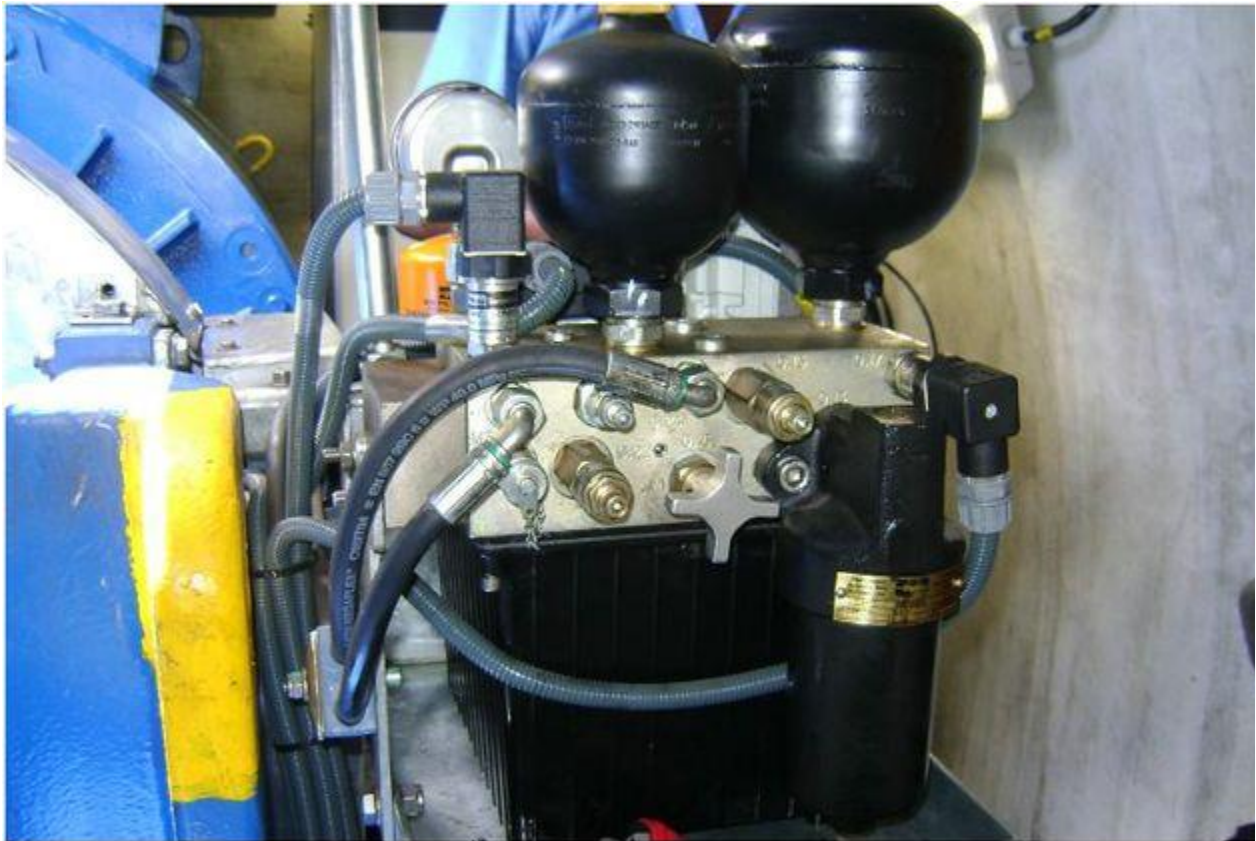
Check the solenoid valve **POS 0.20(NO), 0.21(NC)**

Replace the solenoid valve if found to be defective.

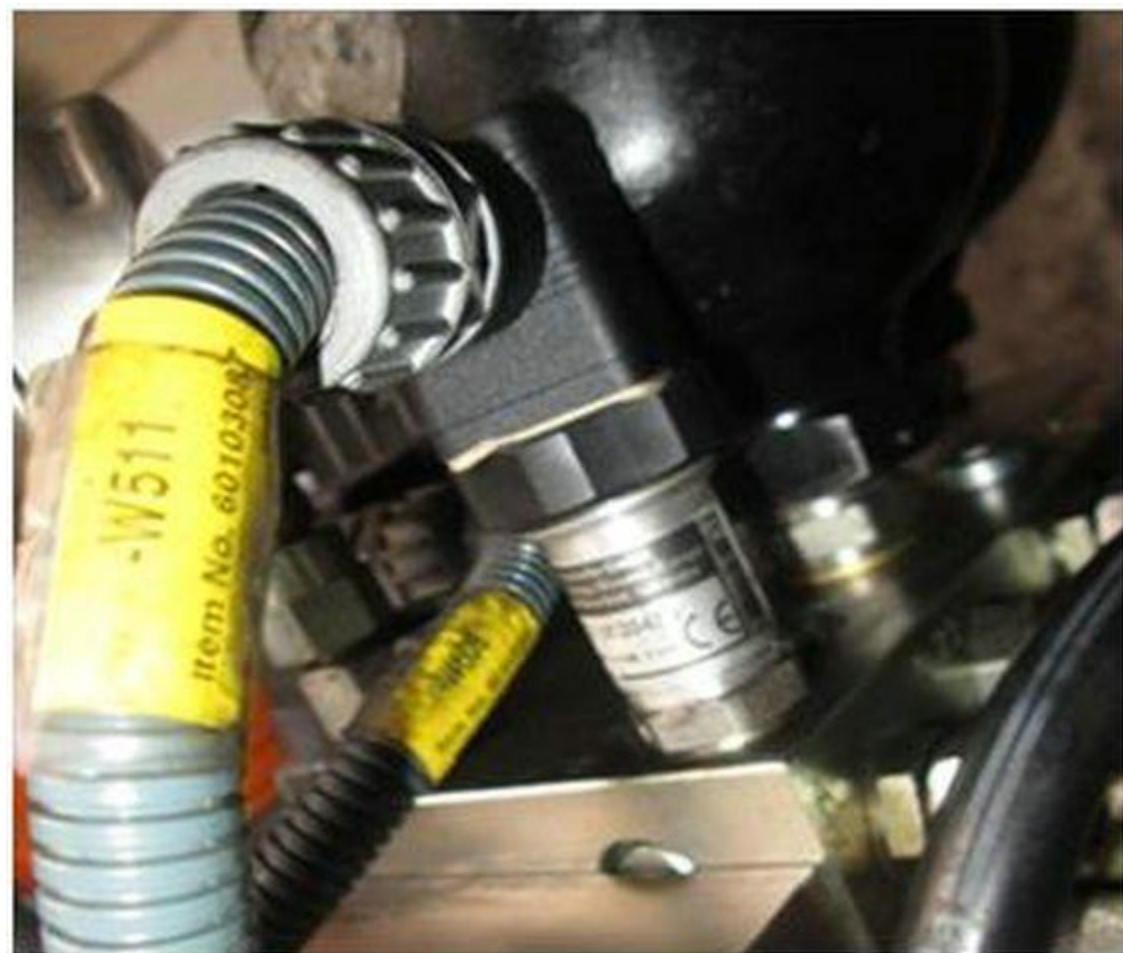
Check for any loose connections on all valve cables terminations.

Check the pressure transmitter cable (W511) connections and continuity.

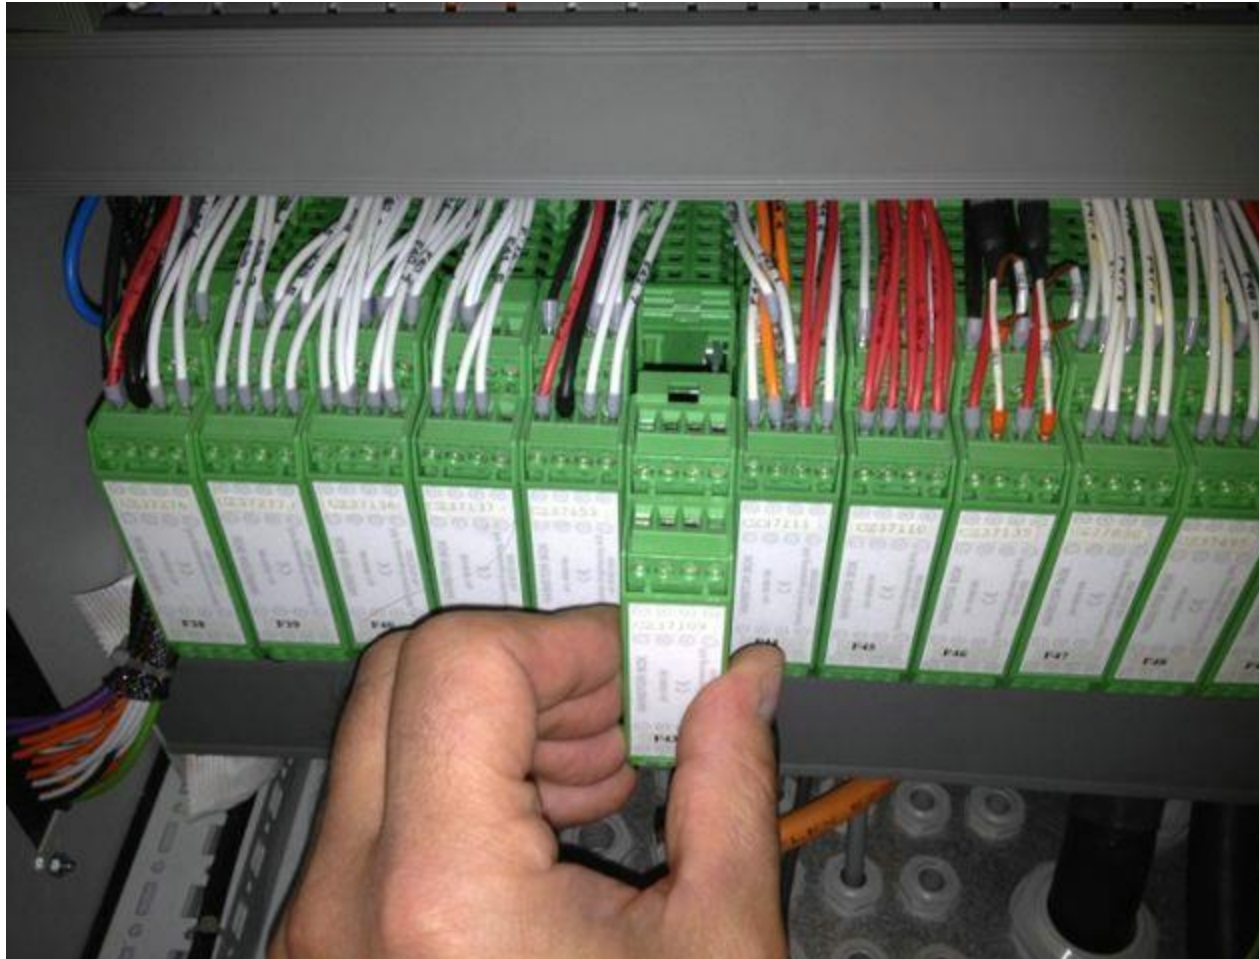
Press the clips on top and bottom of varistor box and remove varistor assembly from the housing:

The varistor box is made up of eight varistors and has provisions for 16 wire connections (protection for 8 signals).

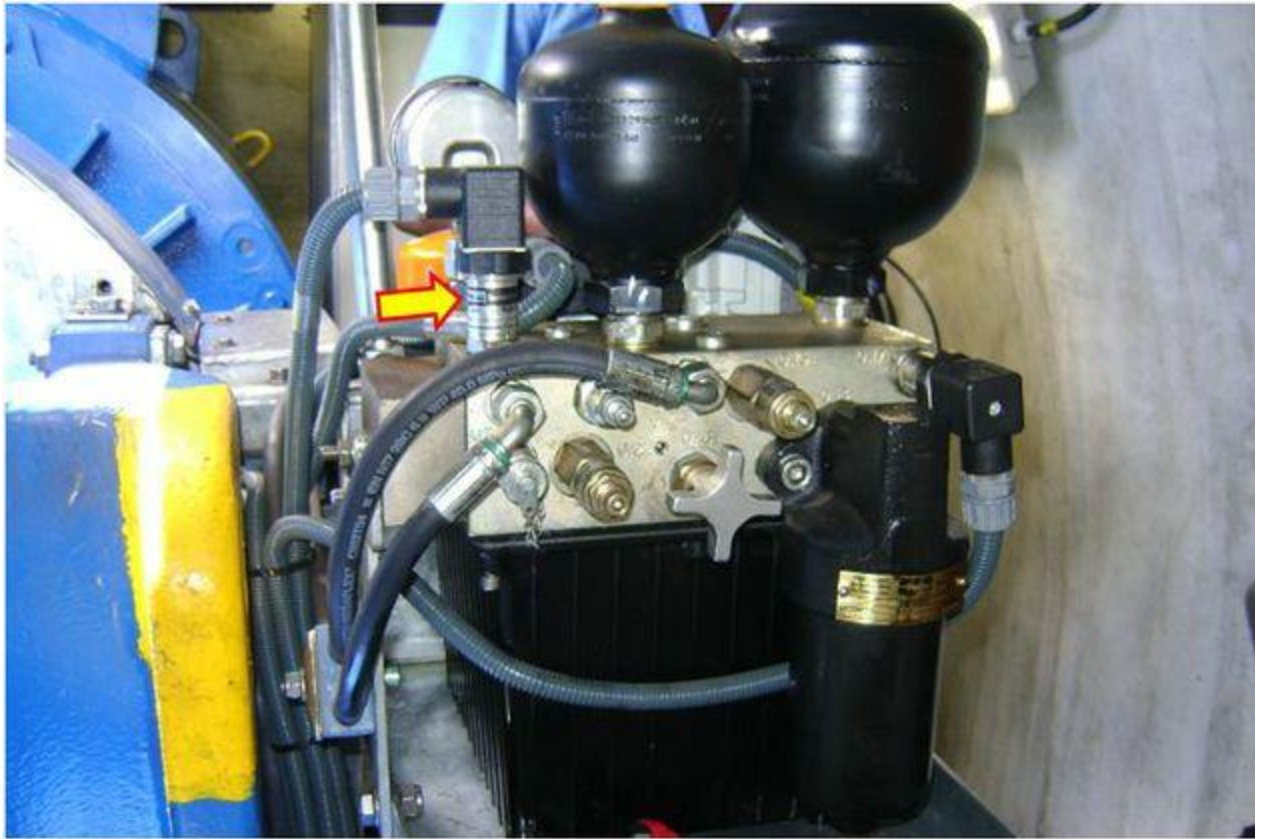
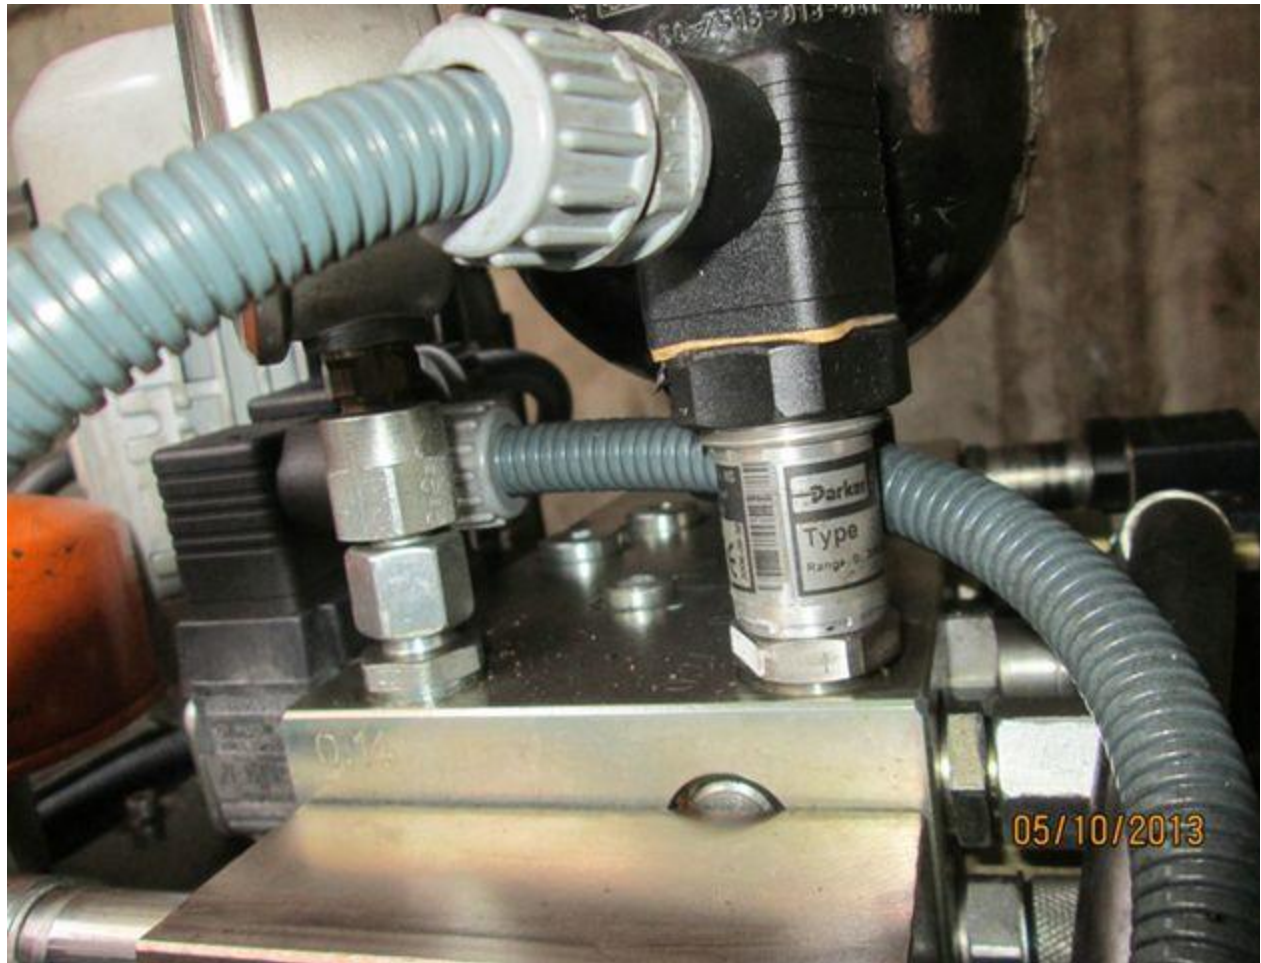
Pressure transmitter position

With the pump running, install a manometer at test port M3, measure the pump output pressure. If the actual pressure does not match that on the TAC read out either the pressure transducer or TOI is defective.
