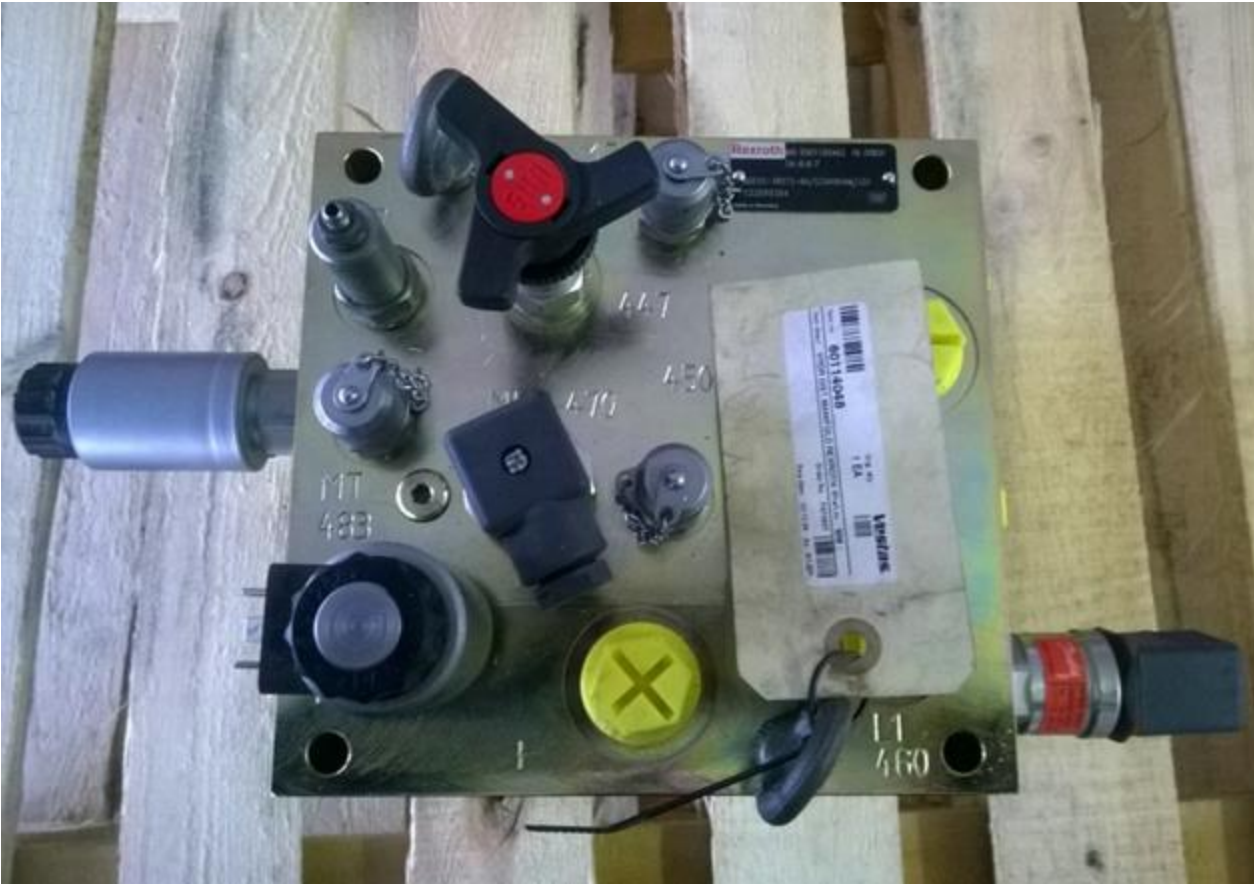
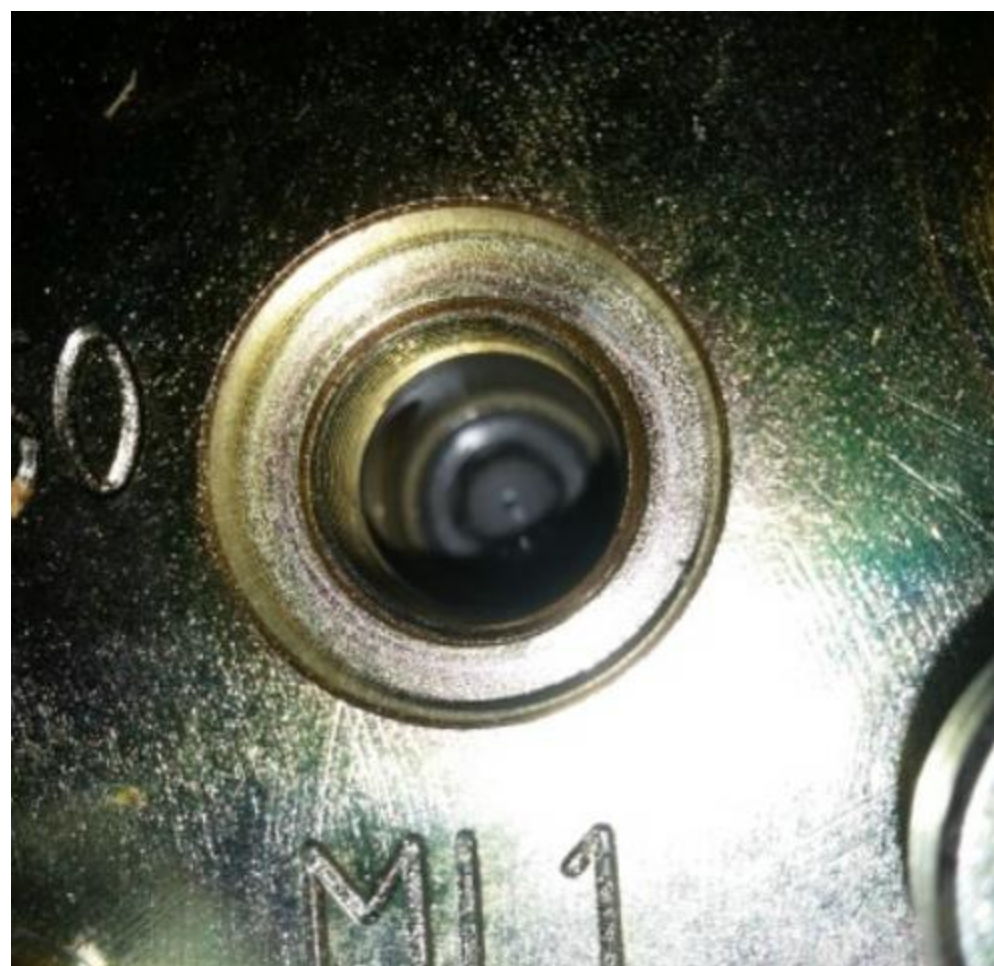
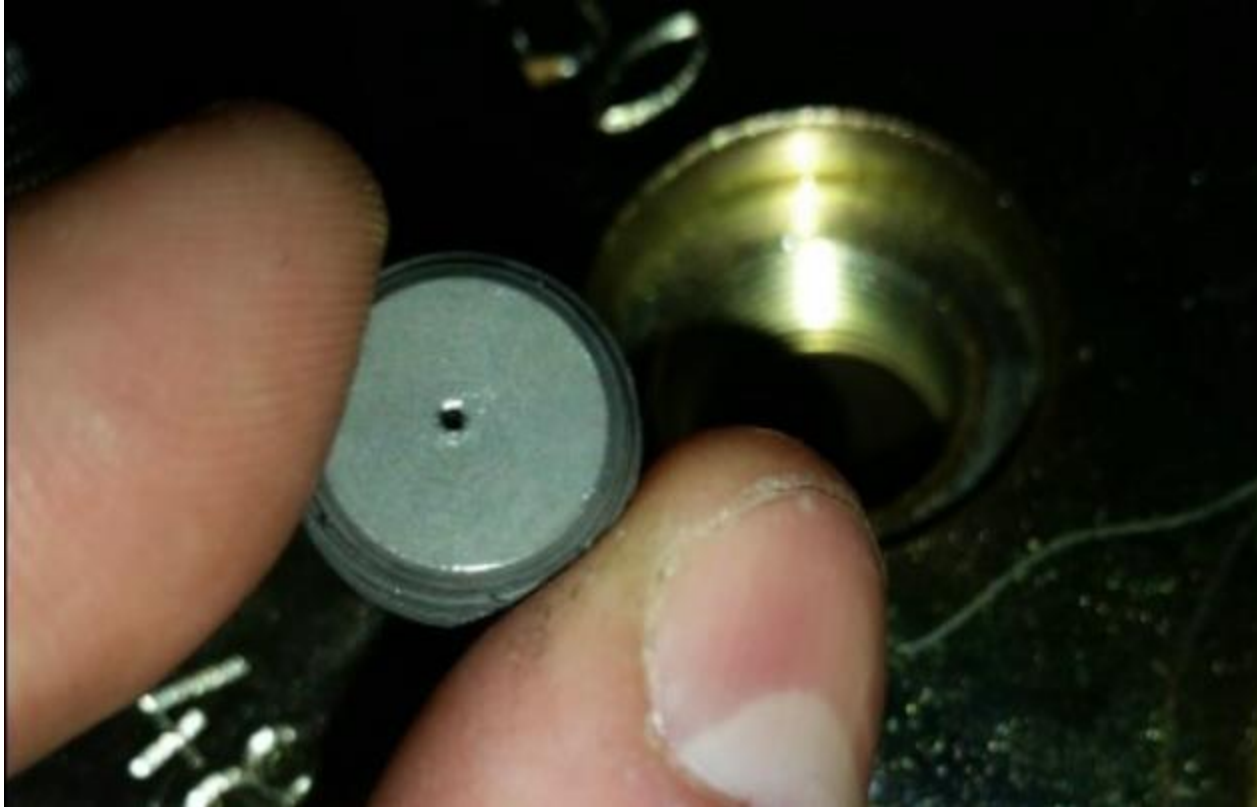
Check if dirt or part of an old seal block the orifice pos.: 450 at the hydraulic manifold (Pump unit).

If a part of an old seal or other parts block the orifice, it is not possible for the pump to build up the working pressure.

It is only running at an idle pressure of ca 14bar

Clean the orifice

Note: There is a screw with 8 mm Allen Key before you can screw out the orifice.

You need a 7 mm Allen Key to screw out the orifice Pos.: 450 !!!! (Rexroth Hydraulic)

If needed change the orifice

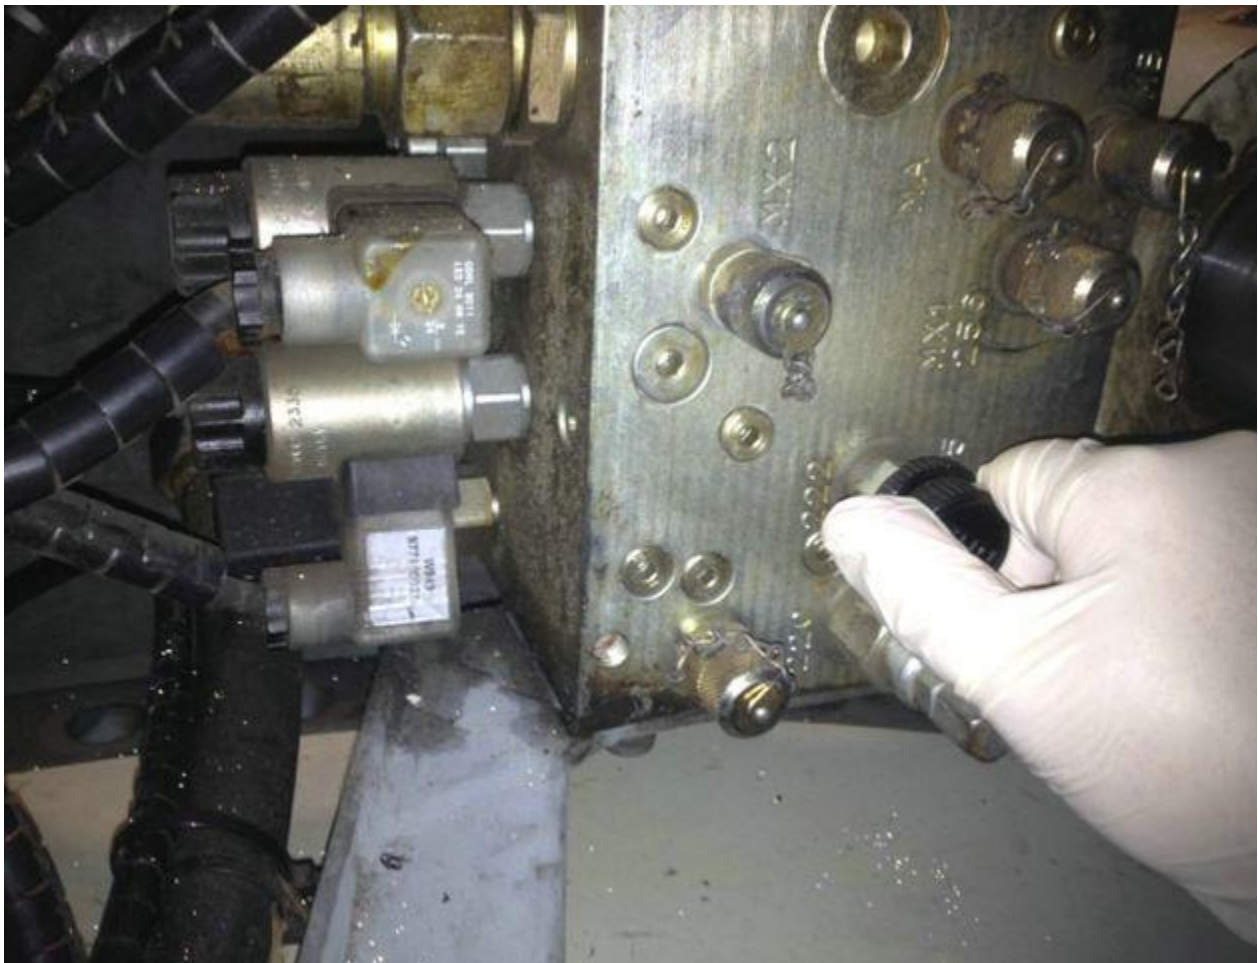
Check the hub inlet pressure at TACII with the pump running. If it is below 0.8bar (normal 0.8~2.2 bar), check the oil level in the hydraulic tank. ***Check the level after opening 222 needle valves on blade manifolds in hub.***

Note: open valves slowly to prevent hydraulic oil from being trapped in accumulators.

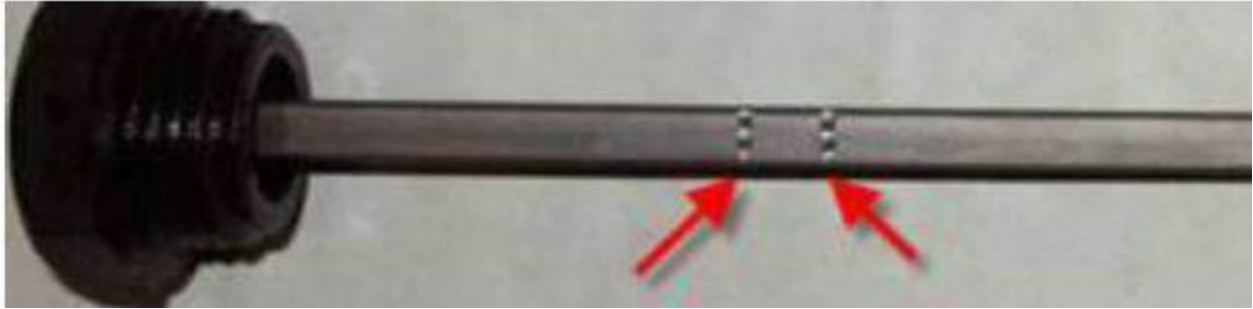
Mk3-5 turbines: Ensure the oil level is between the marks on the dip stick:

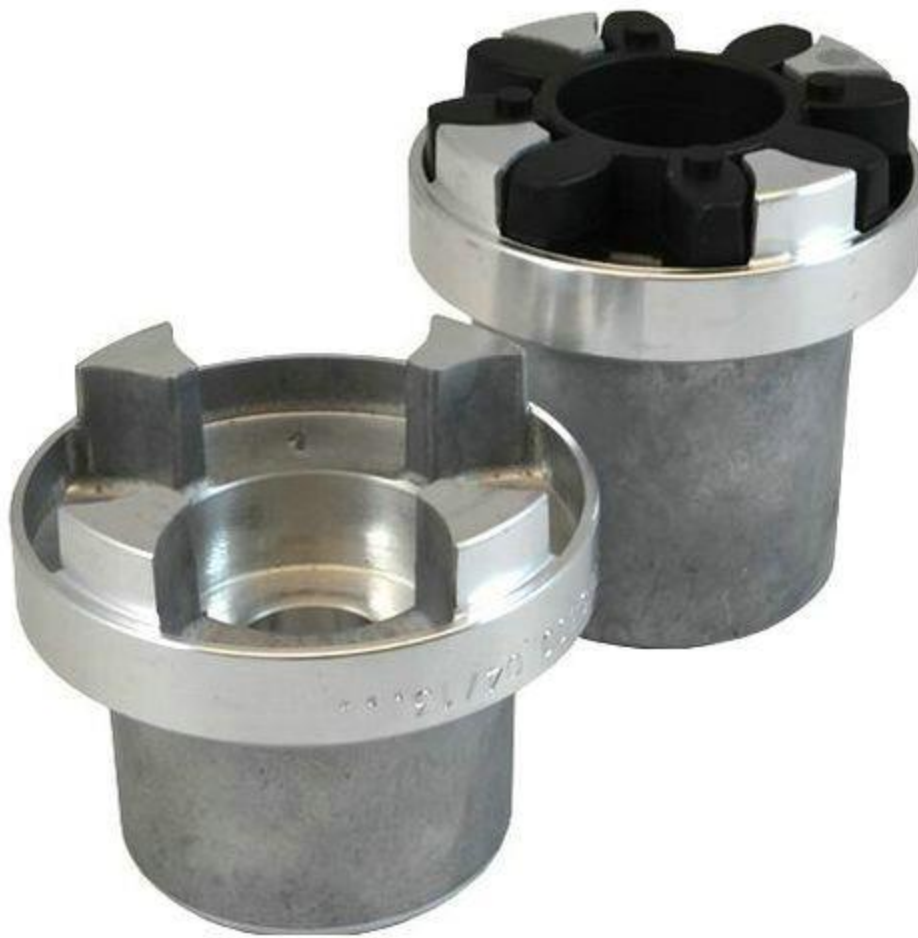
If the coupling is found to be defective or shows signs of excessive wear, replace the coupling:

Relevant spare parts	
Description	Item No.
Coupling ND 86	60120016

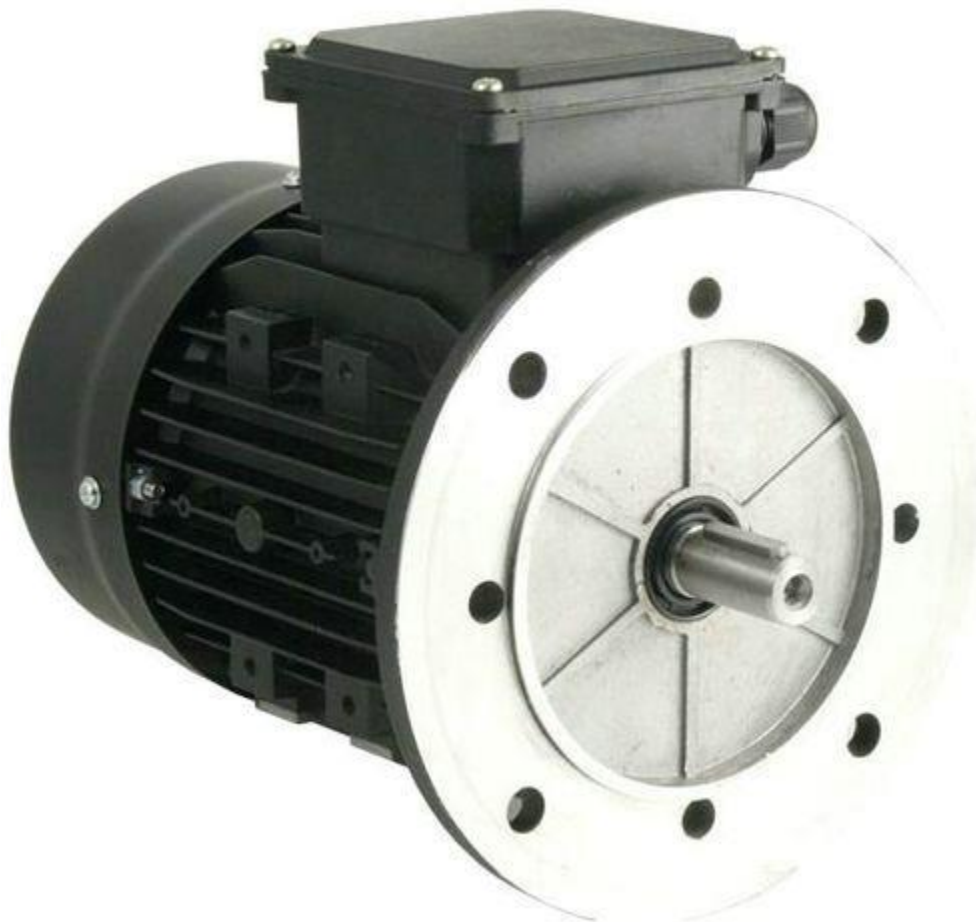
Relevant spare parts	
Description	Item No.
Coupling ND 86 Pump side	60120013
Coupling Rubber	60120014
Coupling ND 86 Motor Side	60120015
MOTOR EI. 4AP112M-6S-B5-4/6 2.	60073425

If the Motor is found to be defective replace the Motor

Relevant documentation	
Description	DMS No.
Replacement of Pitch motor	0001-8482

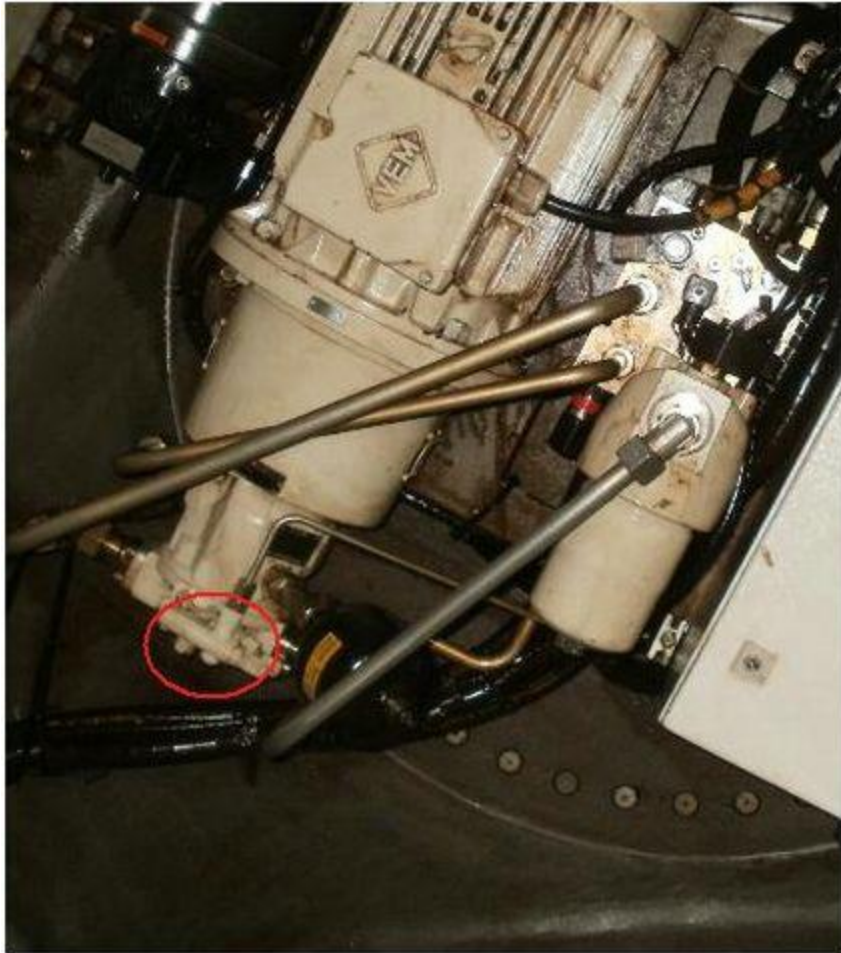
Compensator valve picture

Check the compensator valve (relief valve) setting in the hydraulic pitch pump.

REXROTH SYSTEM:

Part number for Rexroth compensator valve:

Relevant spare parts	
Description	Item No.
VALVE DFR1 RAL7032 240/14 BAR	60113742

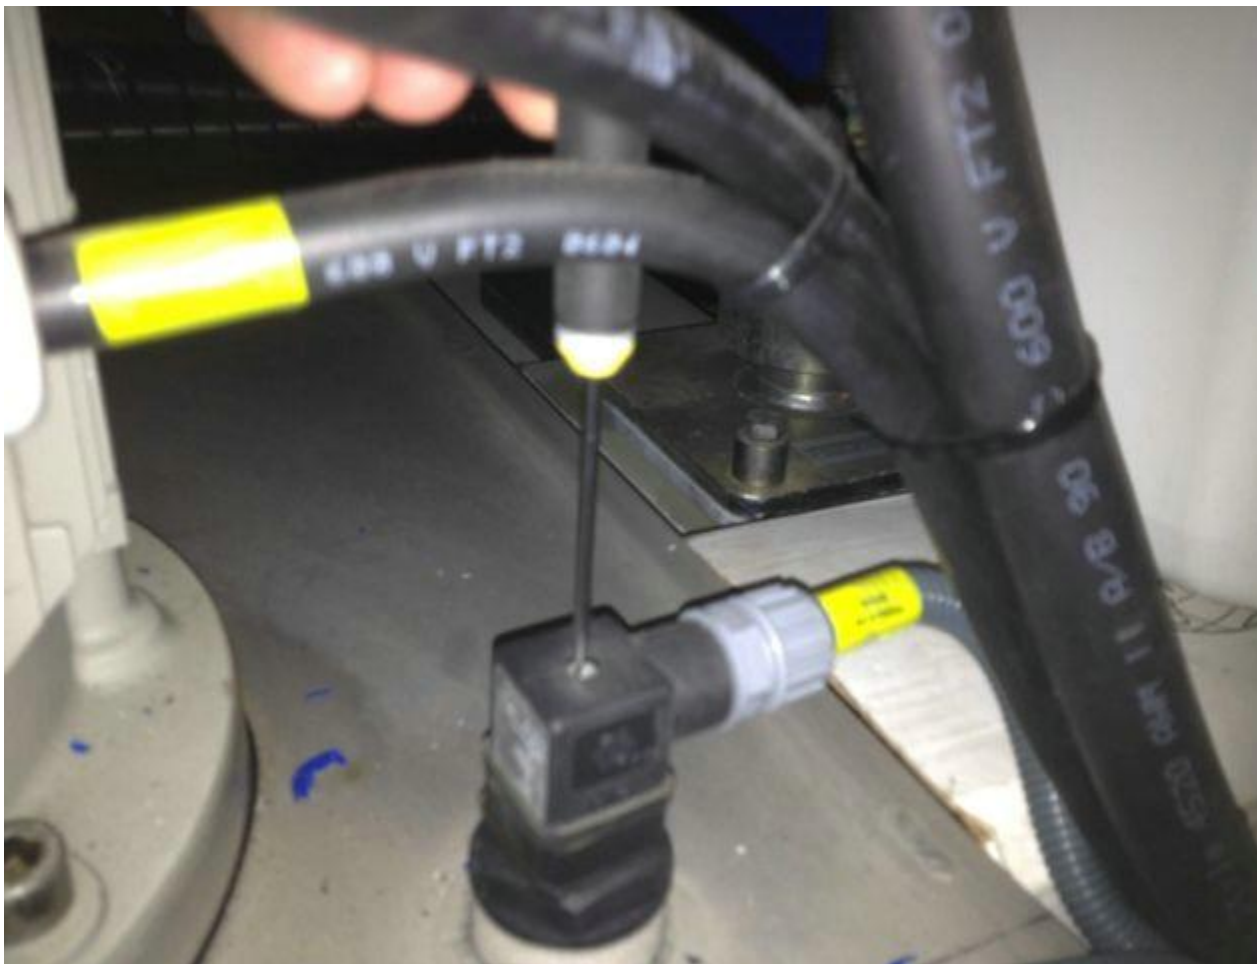
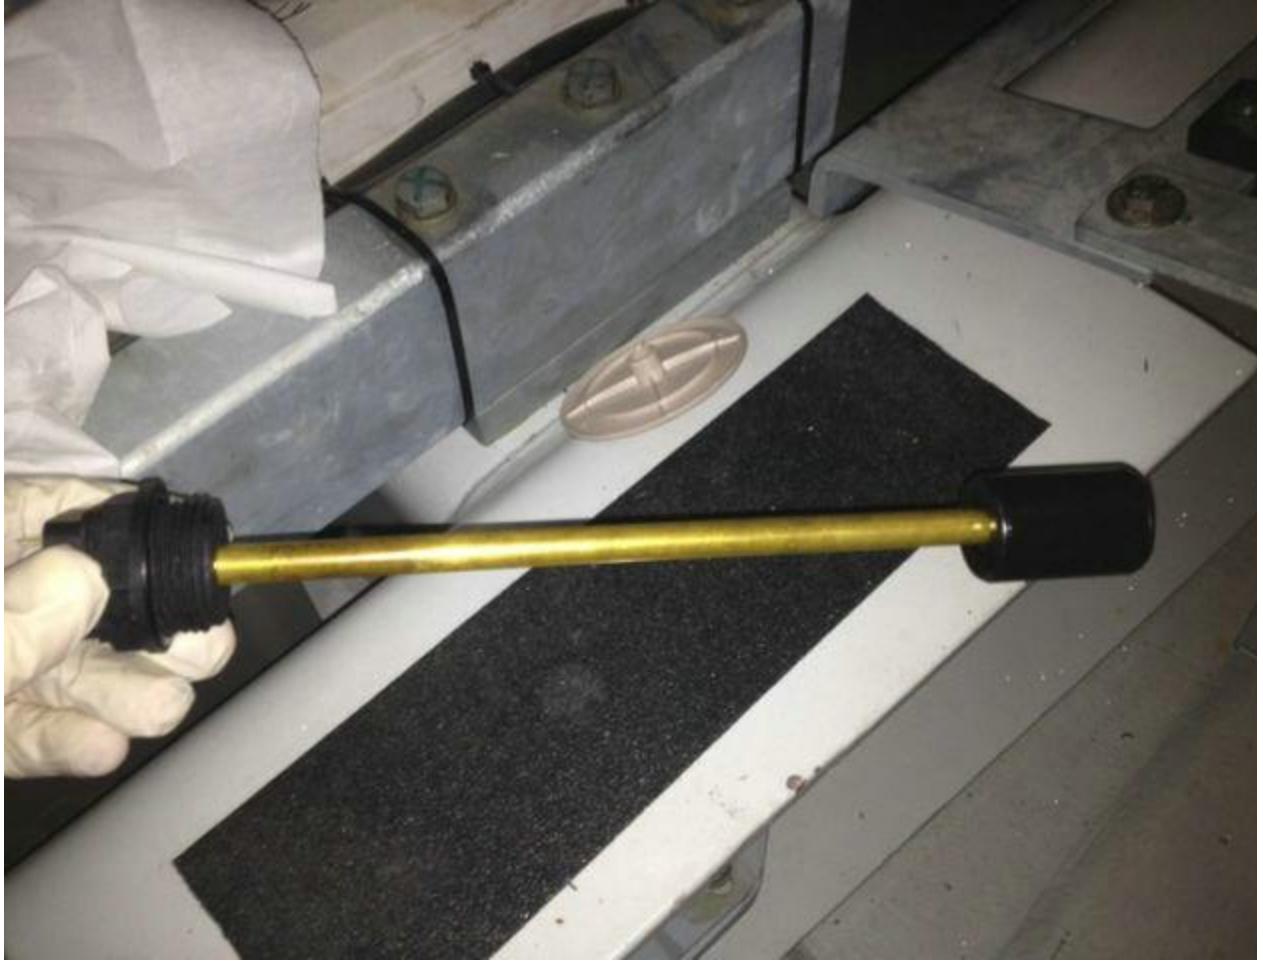
(OLD STYLE FLOAT SENSOR):

If the oil level is low and level switch is not working then error 323 will occur, check cable to level sensor and the level sensor itself. Remove level sensor from tank by disconnecting the electrical plug and turning the sensor counter clockwise

NOTE: Older plastic versions of the sensor should be replaced with the new version whenever removed from the tank as the old sensor floats are susceptible to deterioration and can come off into the tank when attempting to remove.

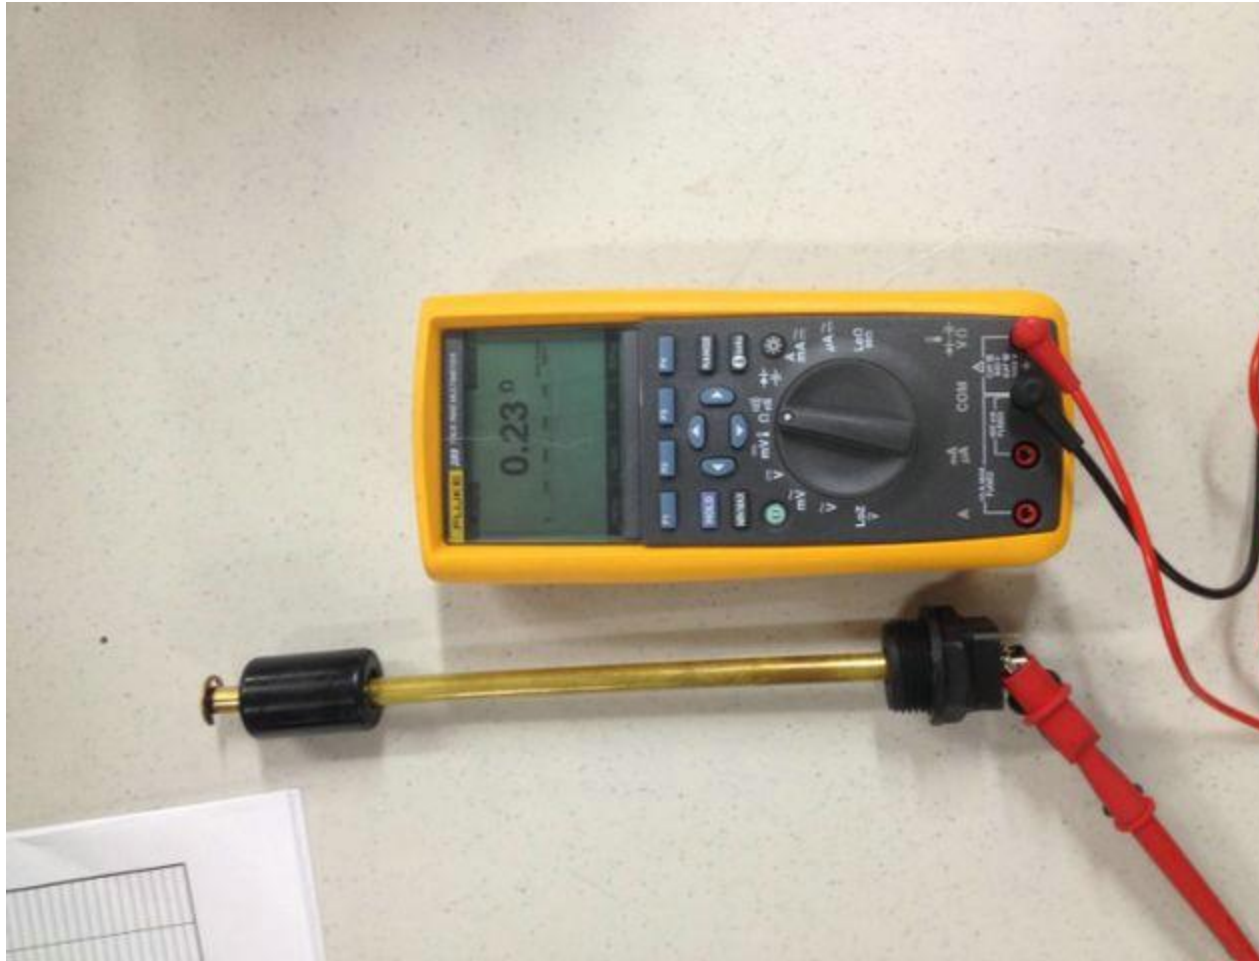
Slide the float up the sensor shaft a few centimetres

Watch the resistance value on the multi-meter.

The value should change from OL to a low Ohm value when the float is in the position pictured.

If the value does not changed or is unrealistic, replace the float sensor.

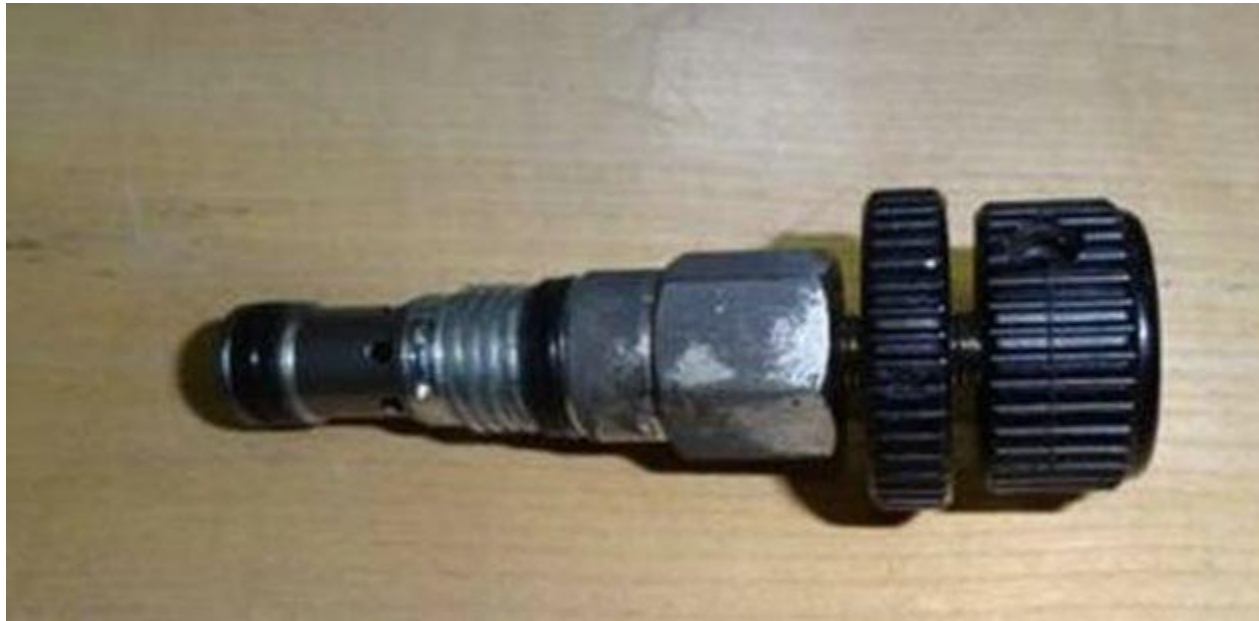
Description	Item No.
-------------	----------

THROTTLE VALVE: NFBC-KCN A3031	60096478
HANDLE FOR NFBC-KCN A30316JG01	60109005

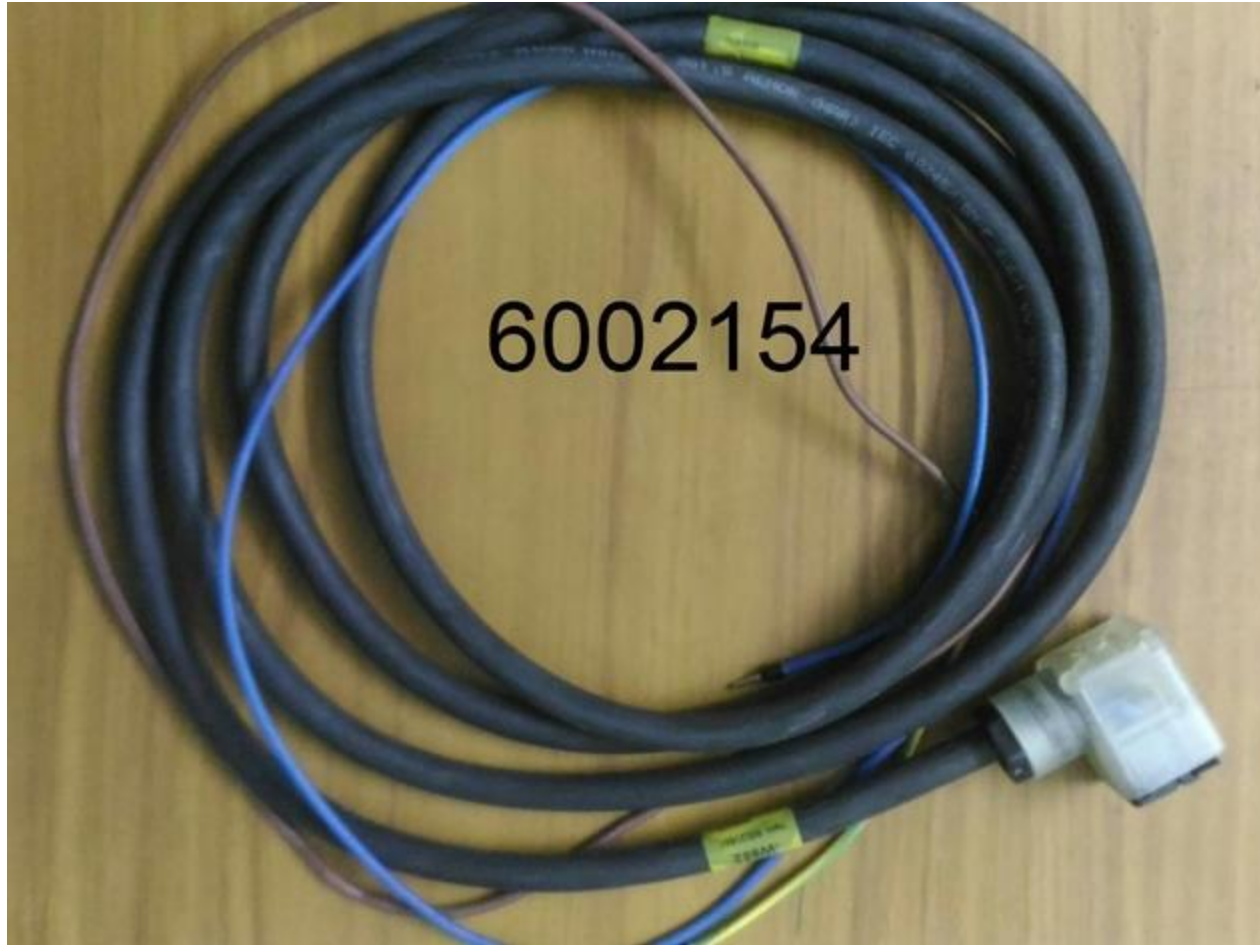
6002154

(Rexroth) Valve/Solenoid- Pos. 210 & 215

Relevant spare parts		
Description	Item No.	Status
SOL VAL KSDEU1CA/HCG24N0K4M	60096475	Phased out
ELECTRIC SEAT VALVE	109795	Available
COIL GZ37-4 24VDC 19W	60106201	Available

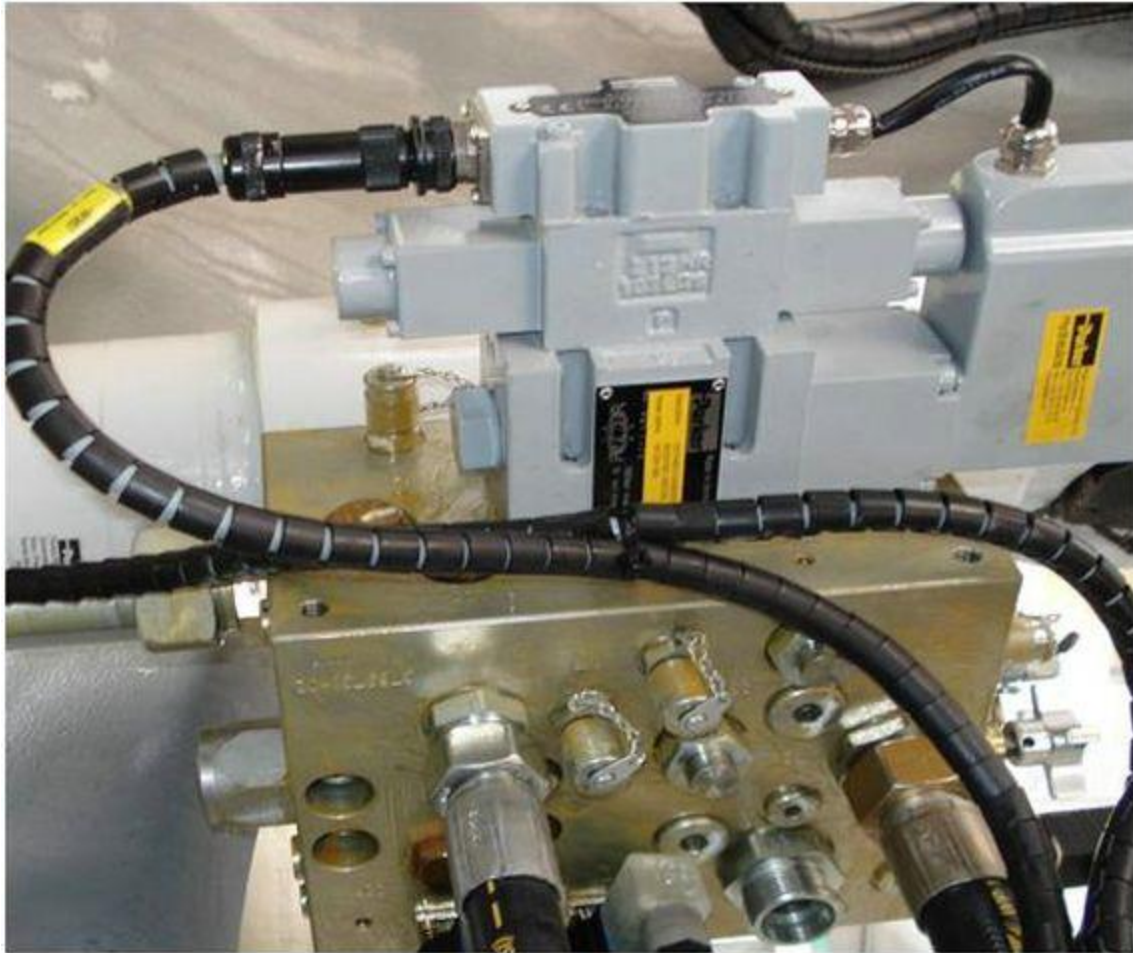
Part number for valves:

Relevant spare parts		
Description	Item No.	Valve Nos.
CHECK VALVE PILOT:CVEV-XCN A30	60096481	230 , 250
3/2 DIRECTIONAL VALVE	60111617	210, 215
LOGIC ELEMENT PIL. OPERATED	60111630	240, 245
PRESSURE CONTROLVALVE:RDDT-QWN	60096477	220
CHECK VALVE CVH103P20	60112628	235
PROP. VALVE D31FHE01C	60112621	205

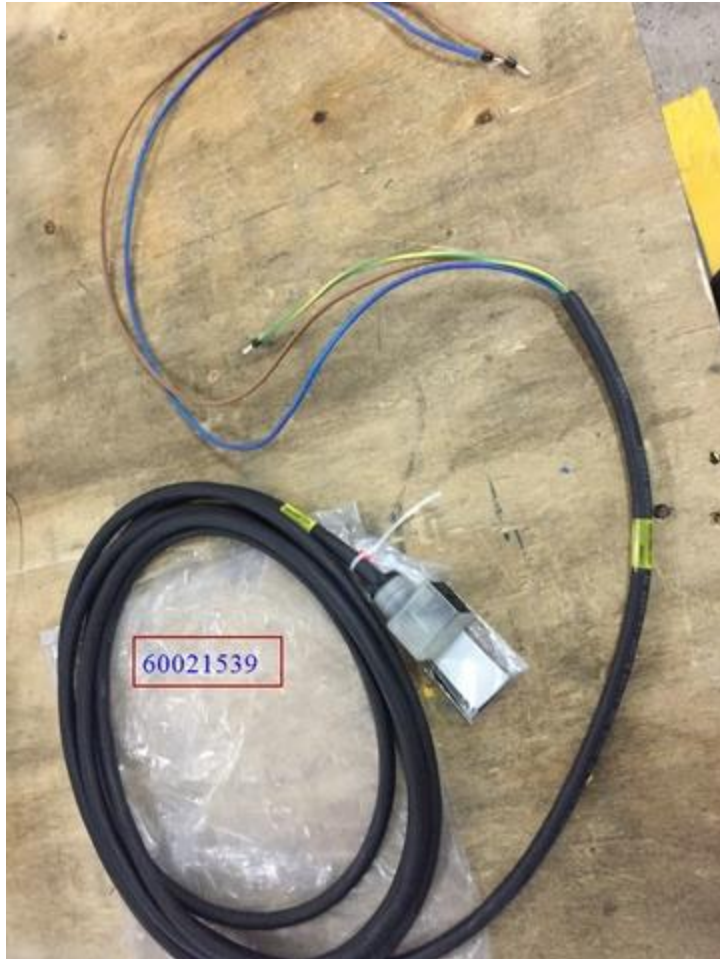
- **Explanation**
Check the cable W949 for loose connection and damage, replace if found damage or no continuity.

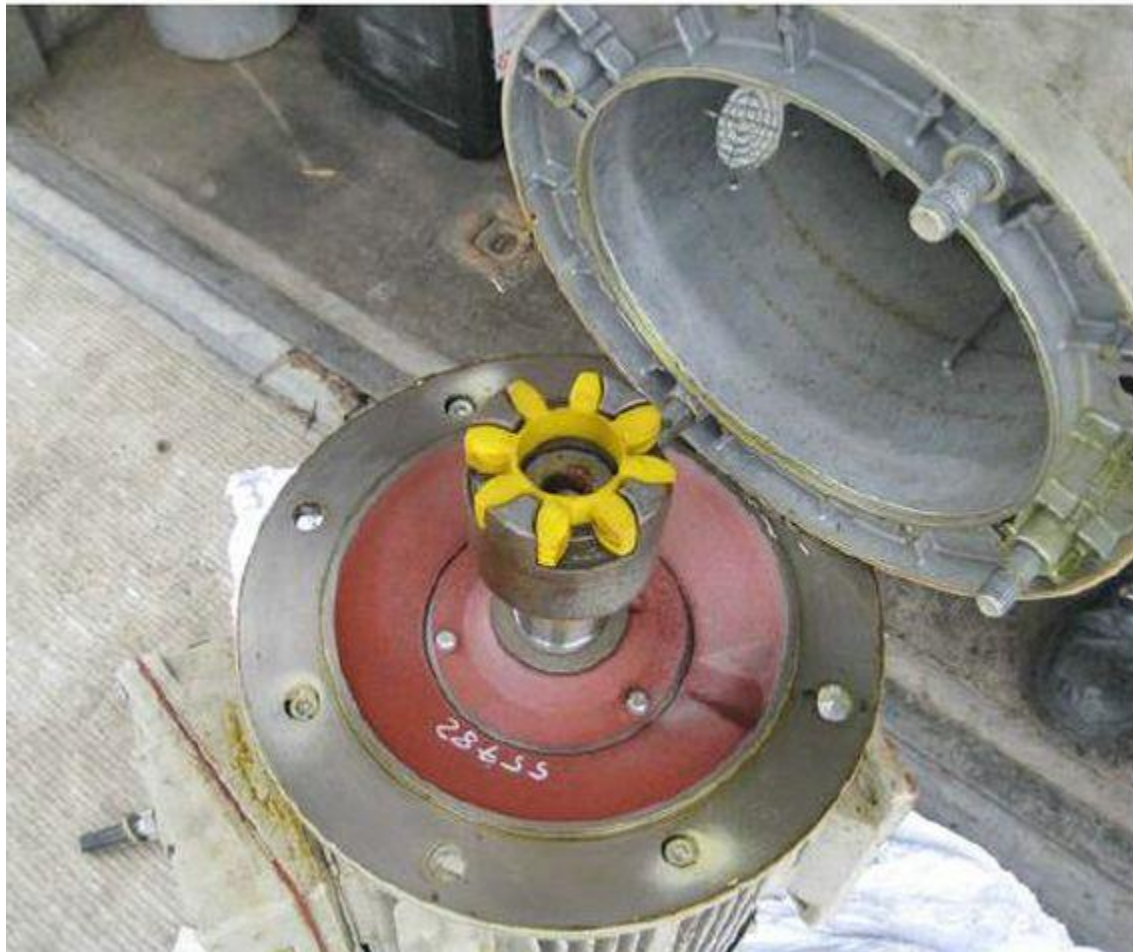
Check the coupling between the pitch main pump and electric motor.

Any defect noticed in the coupling or spider must be replaced.

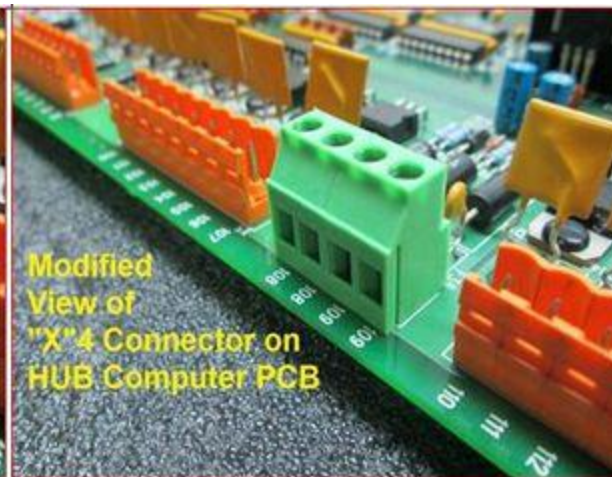
Picture 6 Proposed screw type connector

Case creator have proposes a simple fix to mitigate the problem. Namely to install a screw terminal versus the existing pin plug connector.

The proposed solution by case creator have been forwarded to the Minor Component repair Program, awaiting approval from technology responsible.

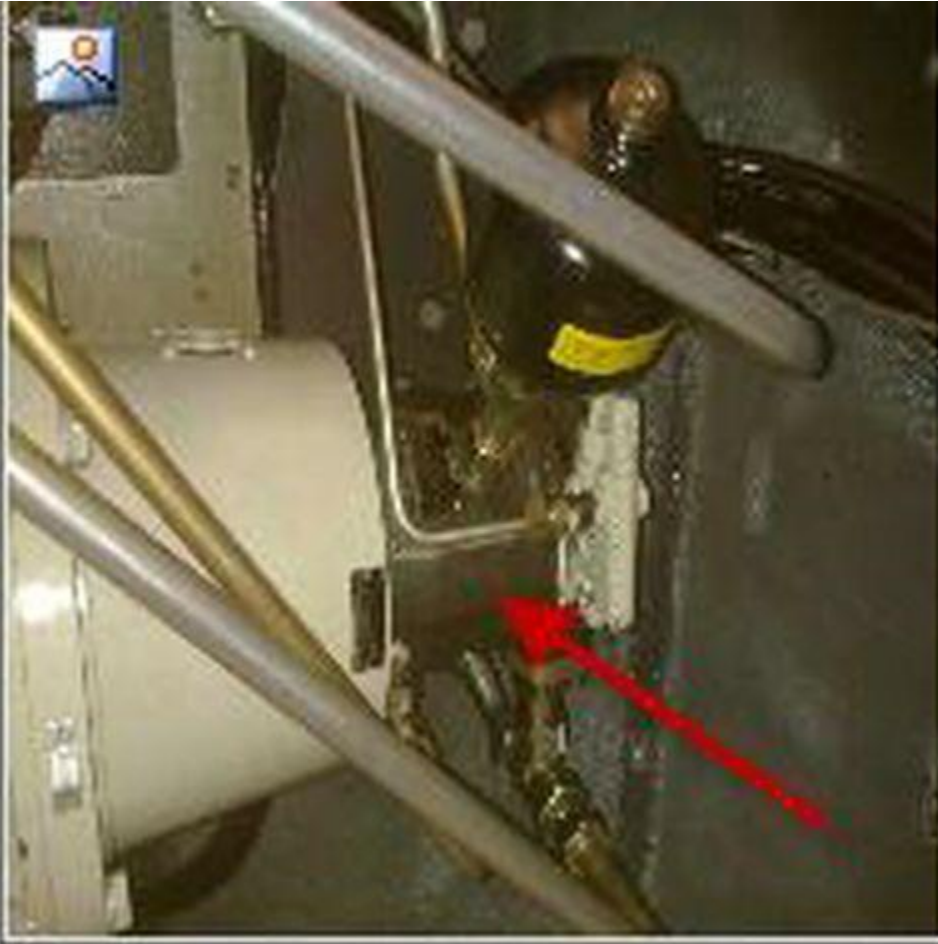
Rexroth

Relevant spare parts	
Description	Item No.
HYDR. PUMP A10VSO 28 DFR1/31R-	60098815

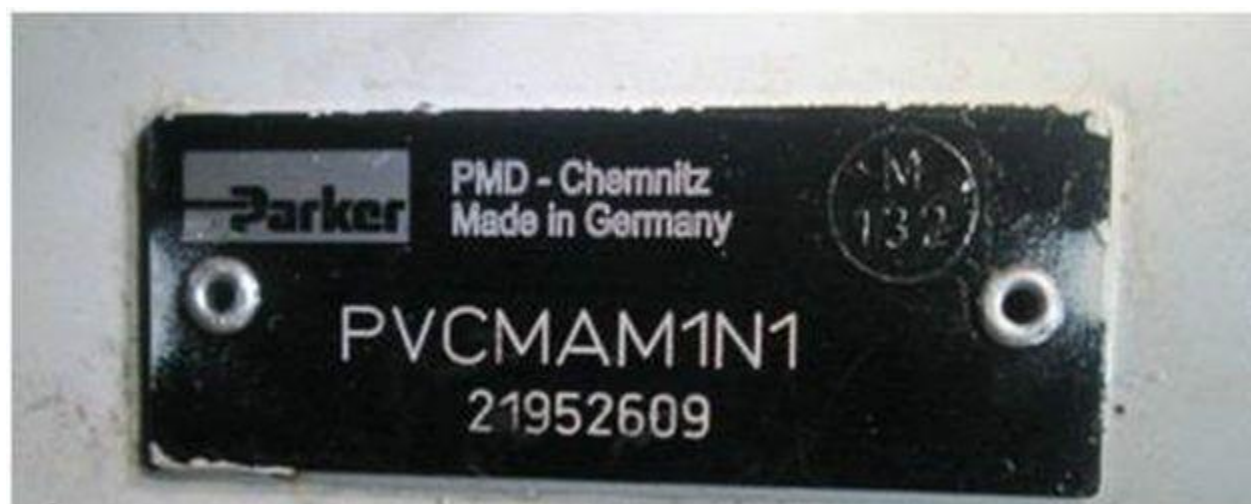
Type 2

Relevant spare parts	
Description	Item No.
HYDR. PUMP, V82 0-series	60112676

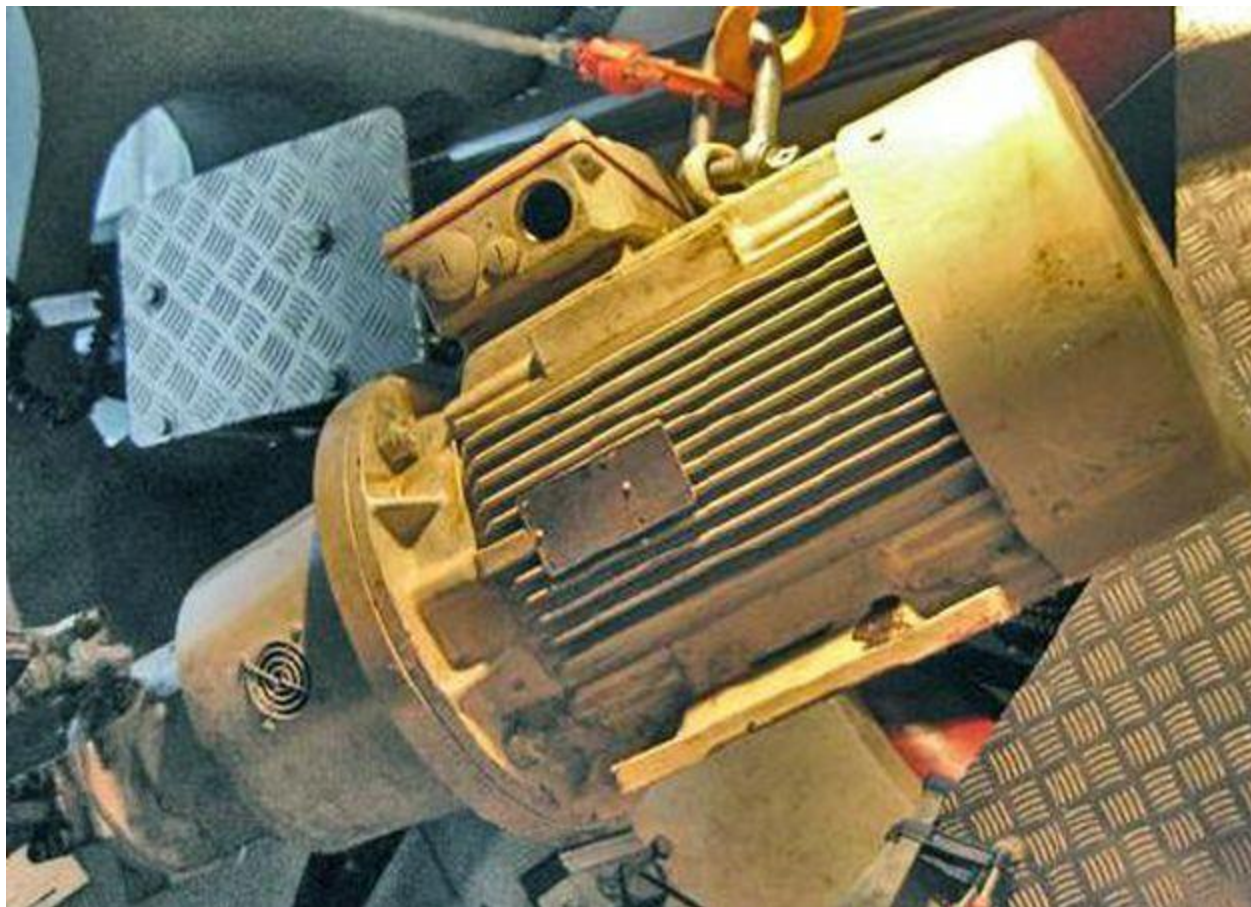
Check the motor for operation and any abnormal noise.

If any abnormal noise is observed from the bearing, the bearing must be replaced.

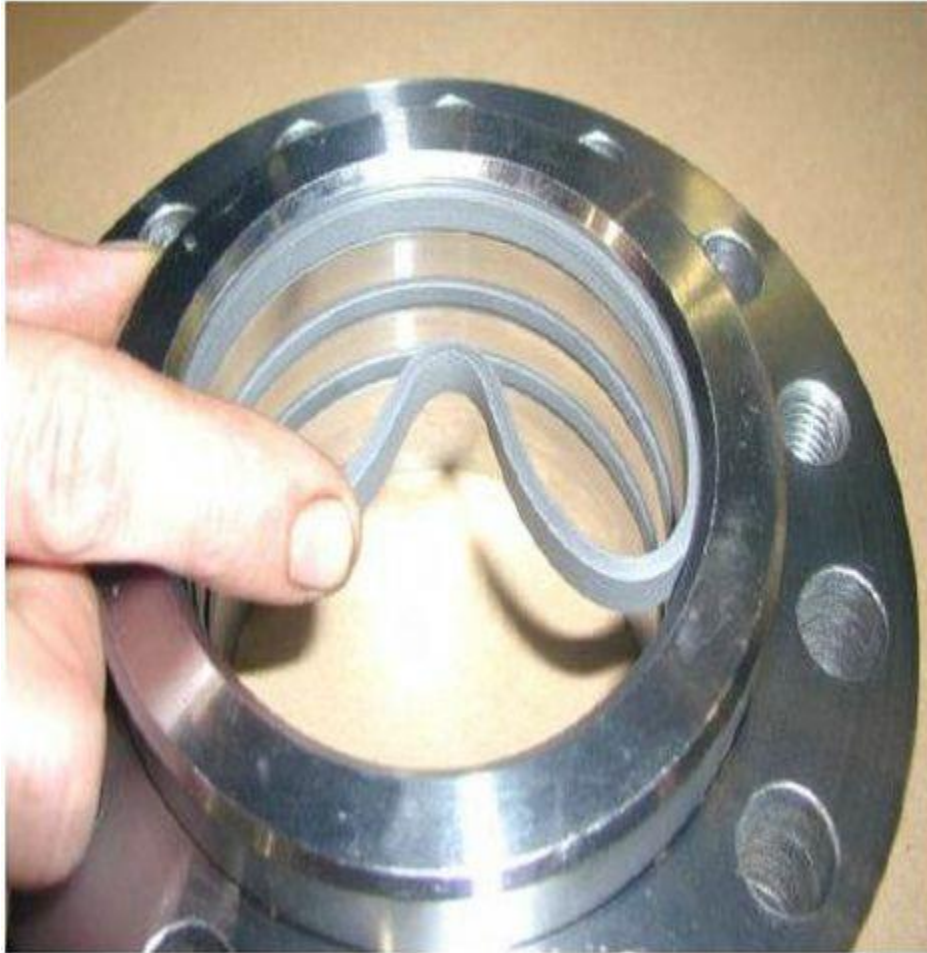
PARKER System:

Relevant spare parts	
Description	Item No.
HYDR CYL 125/90x884 COMPLETE (Actuator with manifold)	60120439
HYDR CYL BUSHING W. SEALS ø90 (Seal with Bush)	60114033

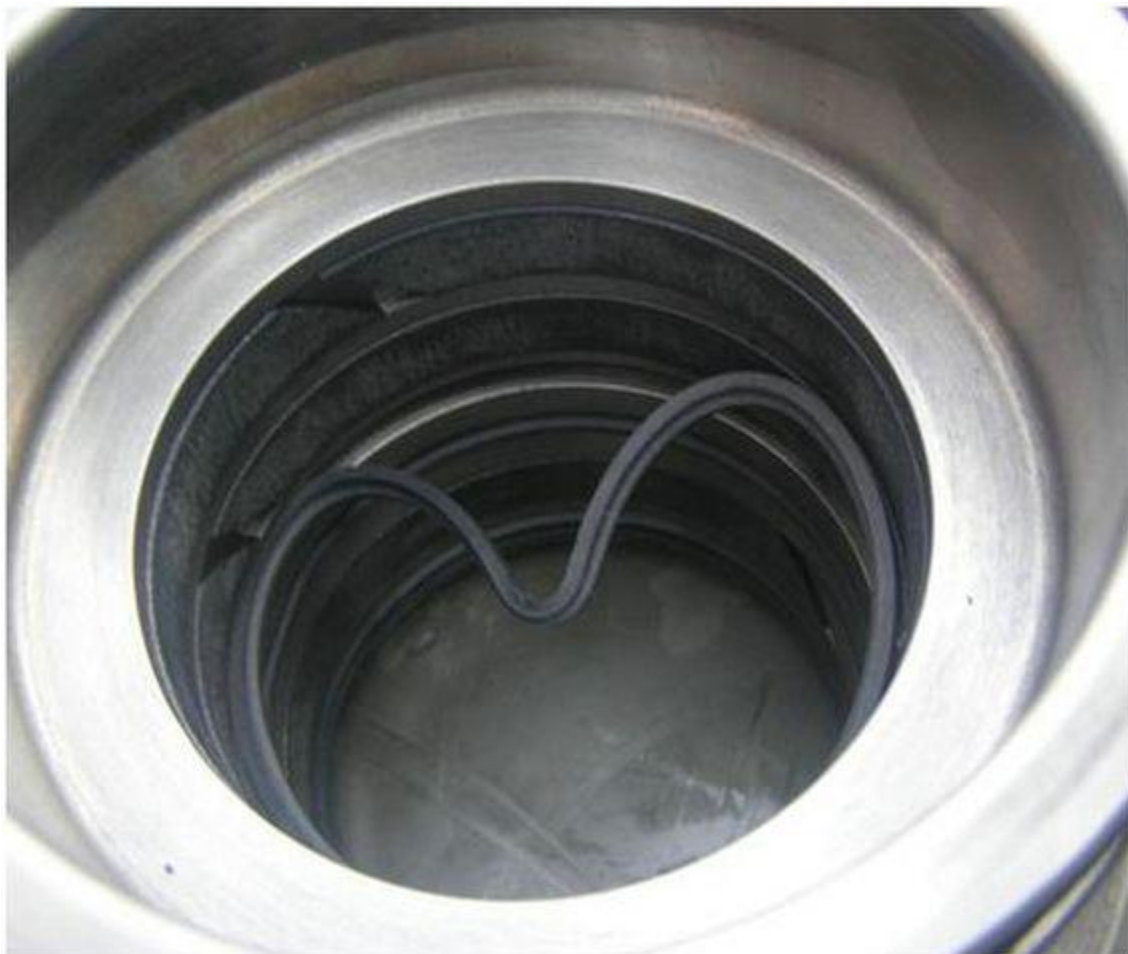
REXROTH System:

Relevant spare parts	
Description	Item No.
ACTUATOR Ø140 WITH Ø100 TRUN.((Actuator with manifold)	60096442

ACTUATOR SEAL KIT (Seal kit alone)	60110956
-------------------------------------	--------------------------

Relevant documentation	
Description	DMS No.
V82 Pitch Actuator Exchange	0021-4366
Pitch Actuator Piston Rod Replacement	0023-2047
