Replace the defective PT100 sensor

881 - PT100 fault water after cooler - V82

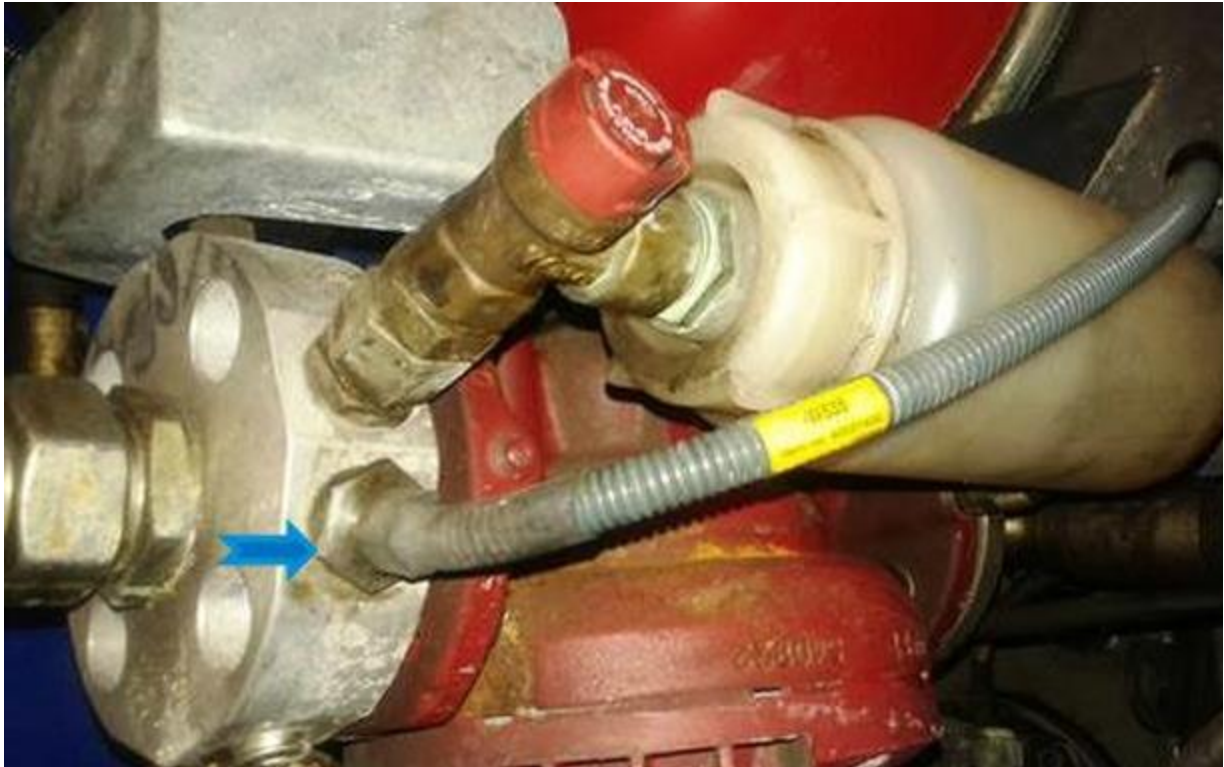
Check PT100 connections and tightness in the +AN14 panel.

Check the input in TOI U01 terminals 403 and 405

Use a multimeter set to read Ω and measure the resistance across the leads of the PT100.

Use the resistance/temperature conversion chart to determine the actual measured value.

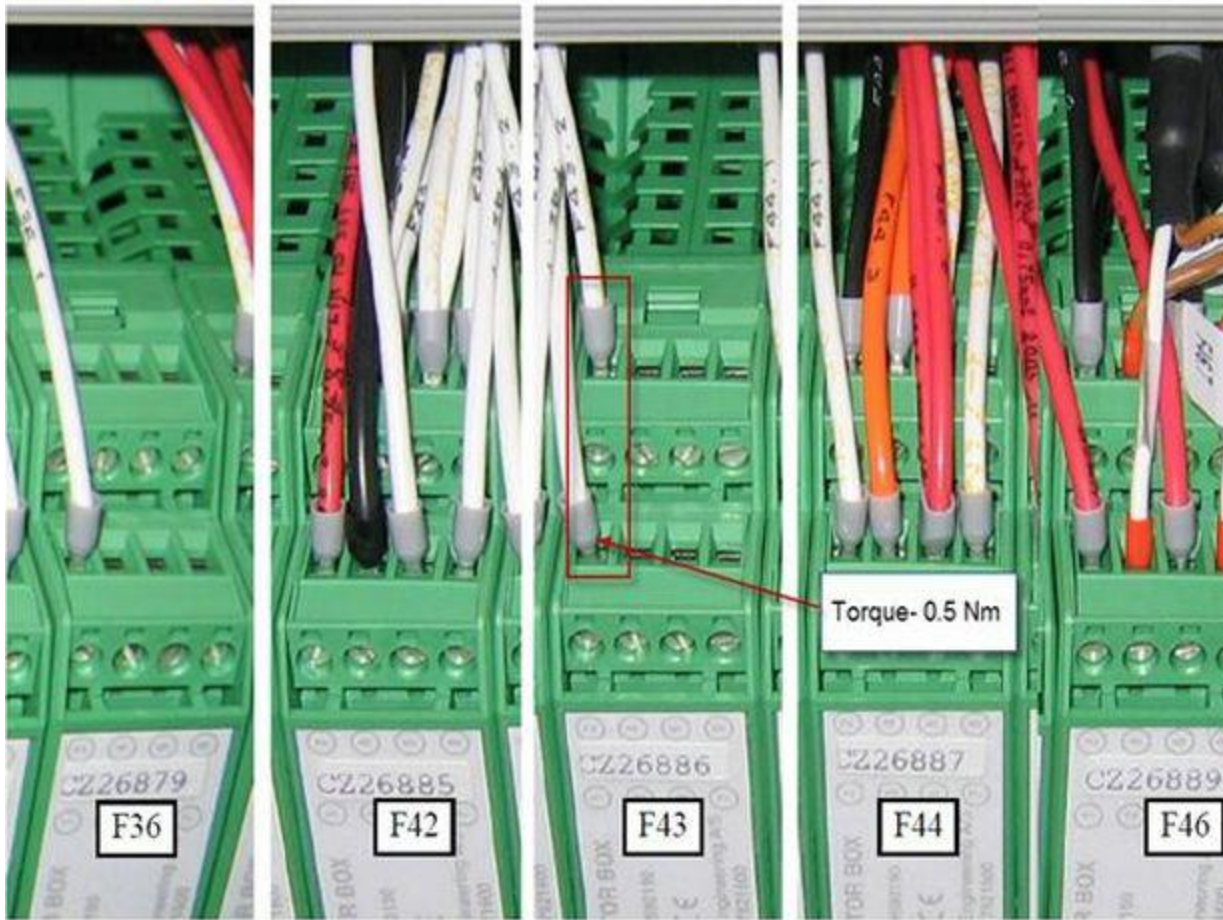
Check the Varistors incoming /outgoing PIN terminals for any loose connections.

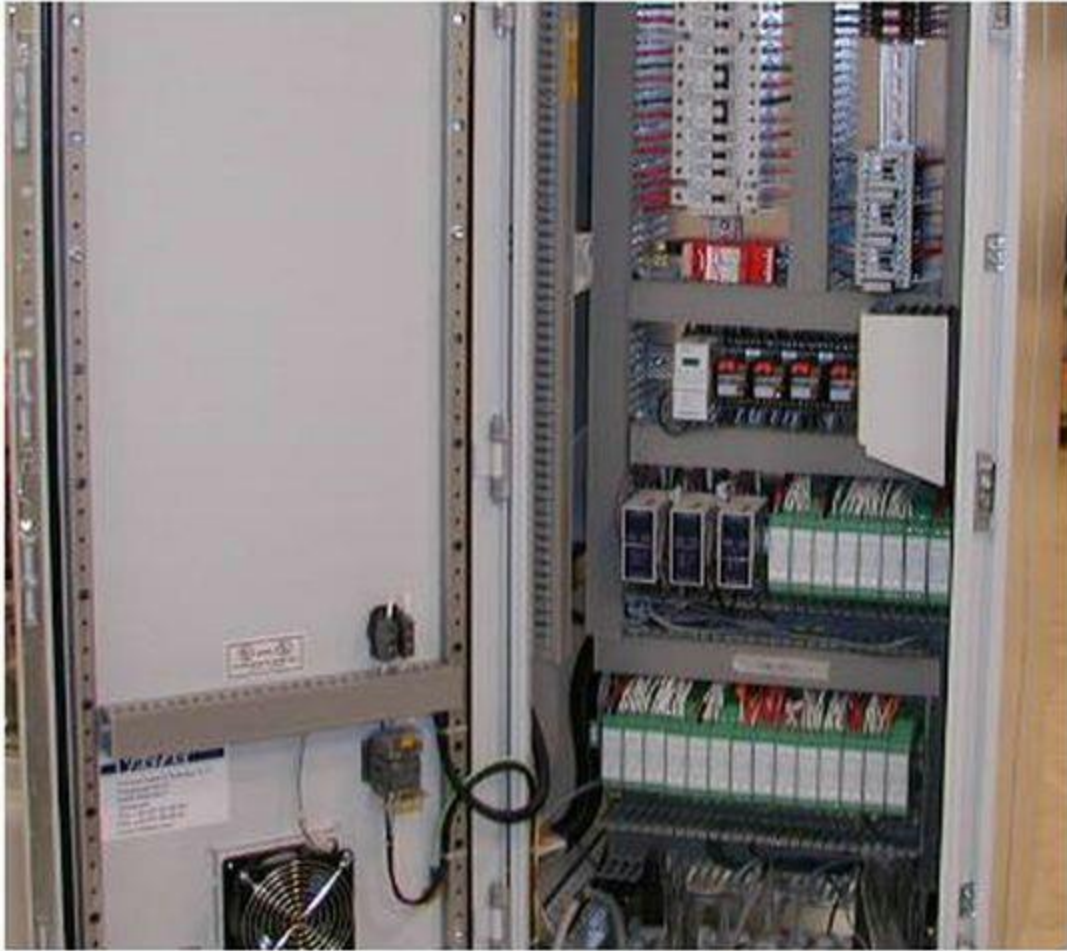
Varistors (F43 (MKIII+) / F11 (MKII-)) can be tested individually by placing a multimeter (set to measure Ω) lead on the common (earth) side of the varistors and the other on the individual varistor terminals. The resistance value over the varistor should be ∞ or in the high M Ω range. If the resistance is lower, the varistor has been damaged by an over voltage in the circuit and must be replaced.

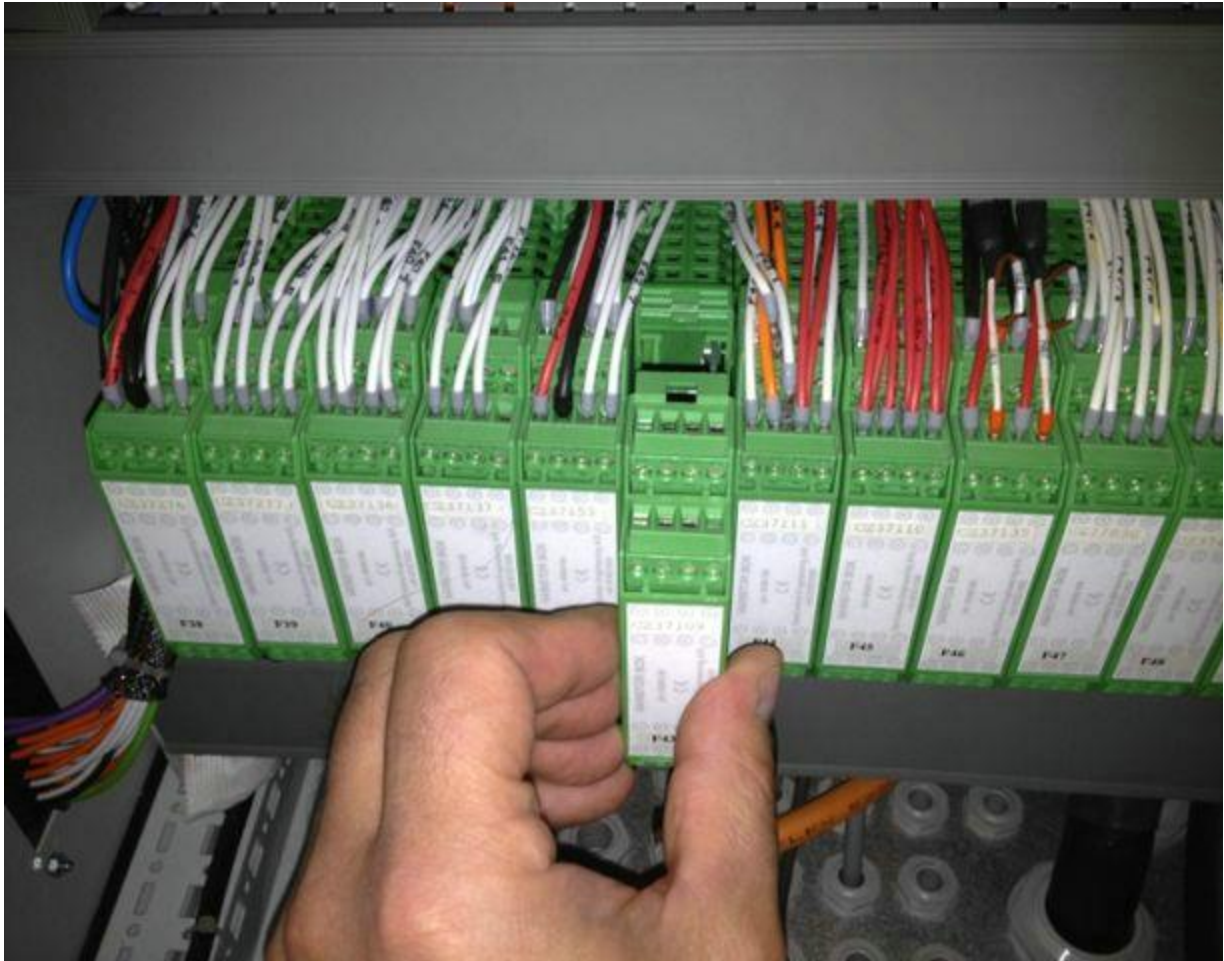
Varistor box F43/F11:

Press clip on top and bottom of varistor box and remove varistor assembly from housing:

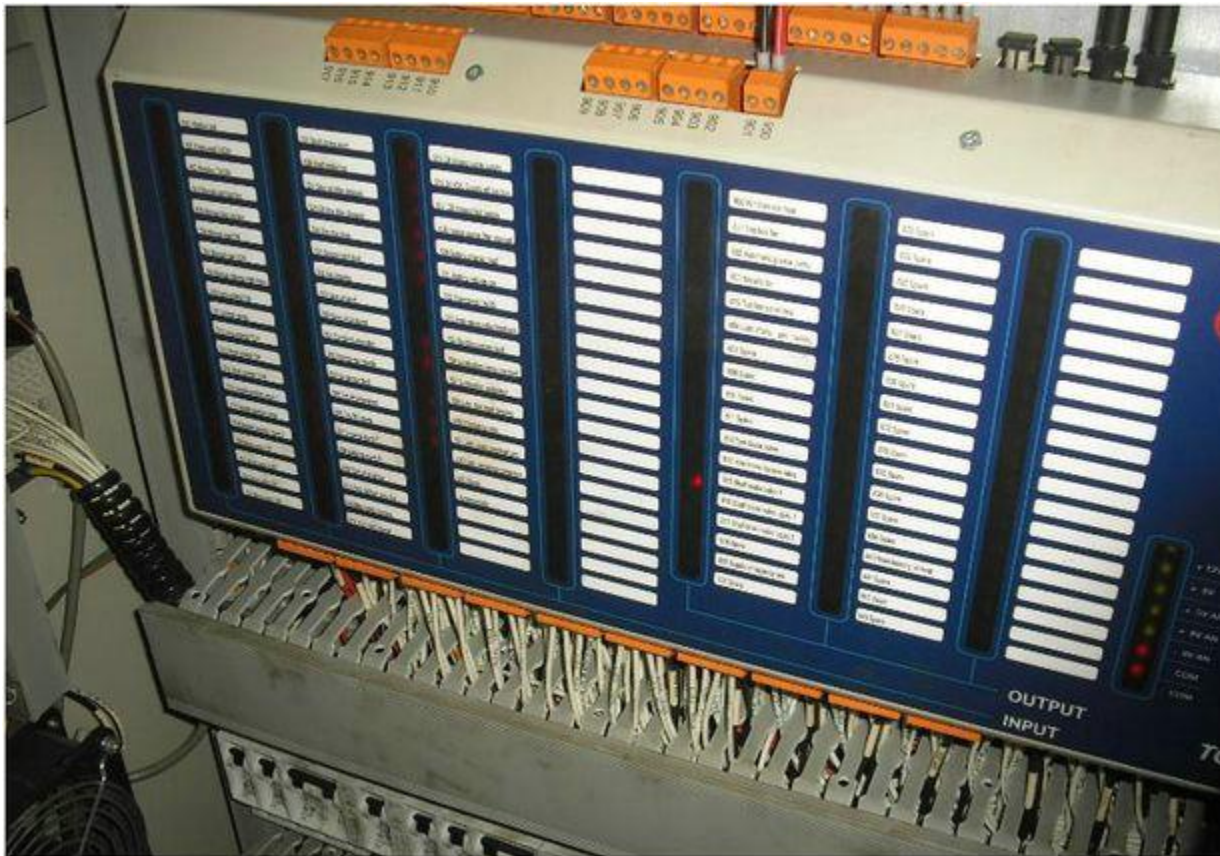
If the value does not match that taken from the TAC Temperature menu, then the cause is likely a faulty Nacelle TOI (check other panel temperature alarms, as these will likely be affected as well).

Check the temperature value in the TAC menu.
