Introduction

Currently, NCDOT manages approximately 13,700 bridges, with 8.4 percent of these bridges considered in poor condition. Despite systematic inspection protocols, traditional methods have limitations, such as insufficient monitoring of upstream scour features. UAV based sonar offers considerable benefits compared to traditional methods. The current inspection protocols involve taking soundings at specific points around bridge substructures and making additional measurements after high water events to track changes in the streambed profile. UAV sonar systems are able to capture thousands of points rapidly, yielding a much more detailed view of the streambed and bridge substructure. In this research the Appalachian State Drone team tested a UAV sonar system for bathymetric monitoring.

The information contained in this poster is part of the research project sponsored by NCDOT (Project number RP2024-32).

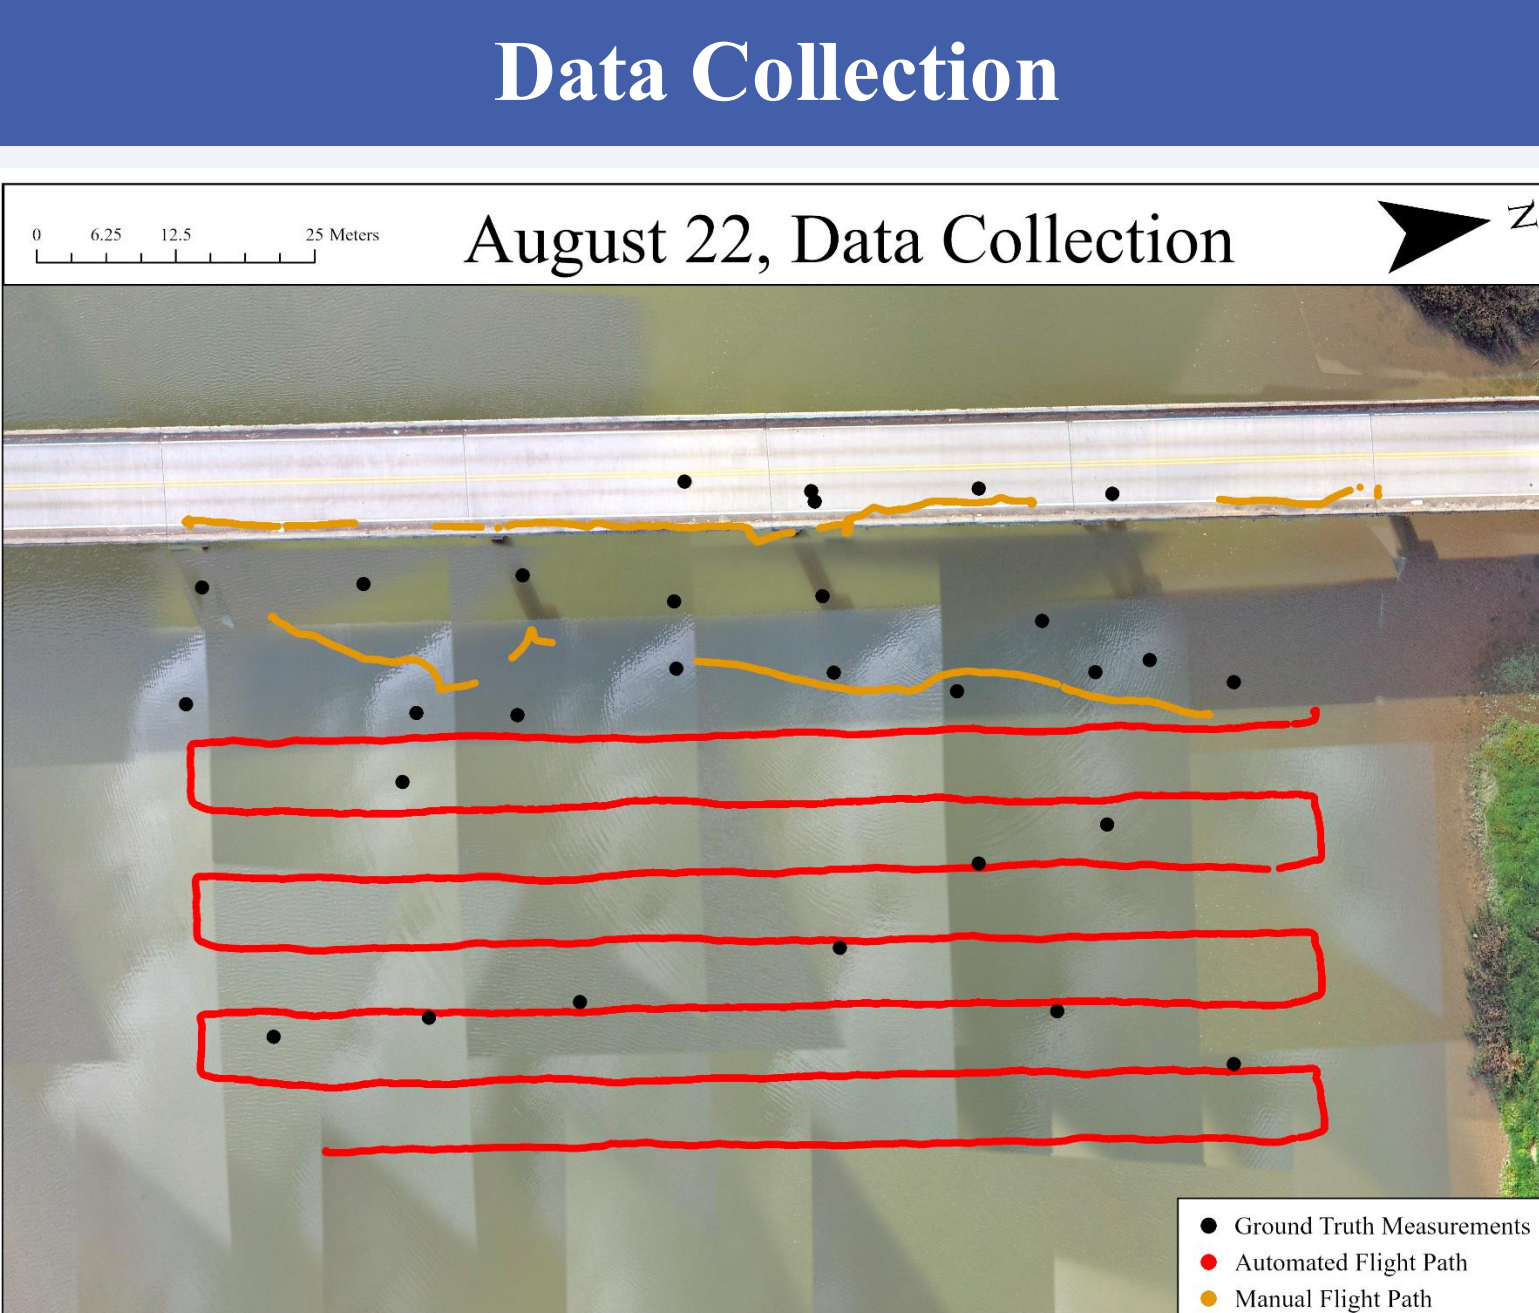
Data Collection

- UAV flight dates: 08/22/2024, 11/1/2024
- Ground data collection: 08/22/2024
- Instruments: DJI Matrice 600 Pro, ECT 400S Echosounder, Trimble DA2 DGPS

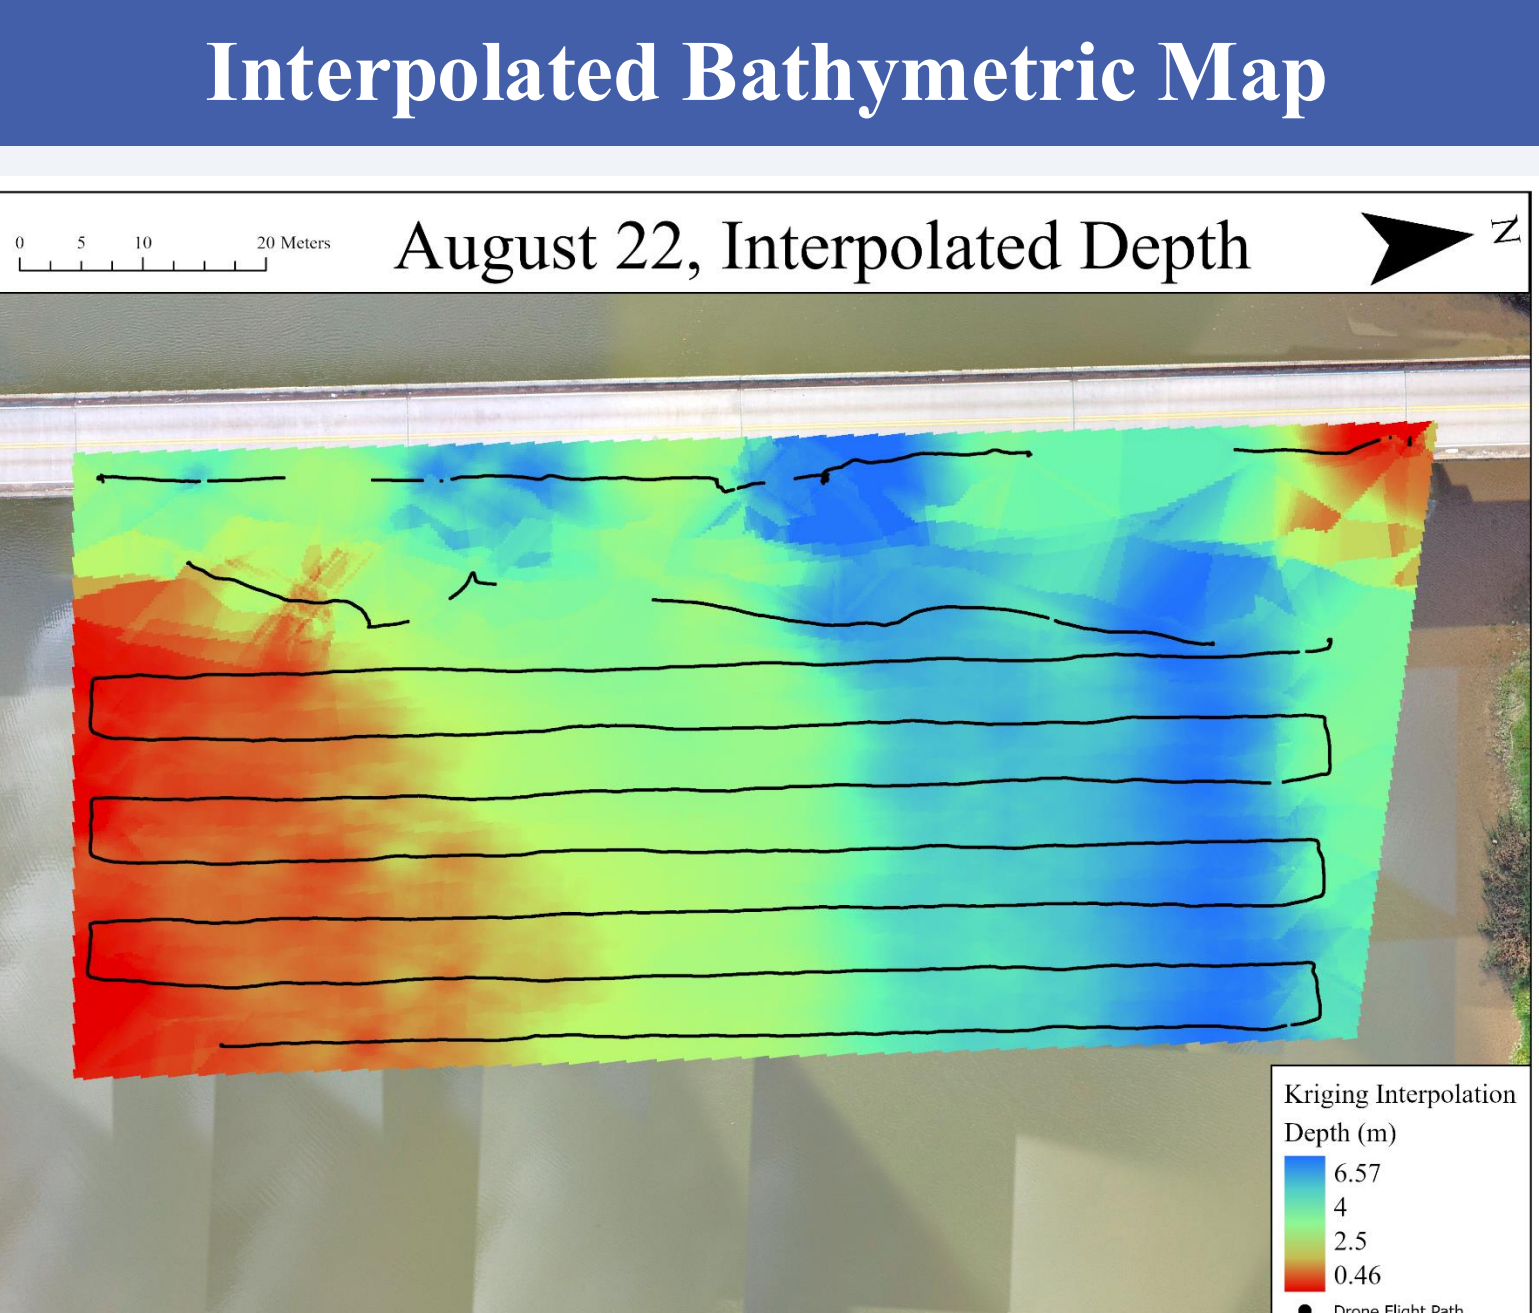
Interpolated Bathymetric Map

Universal Kriging interpolation performed in ArcGIS Pro with UAV soundings to generate bathymetric map.

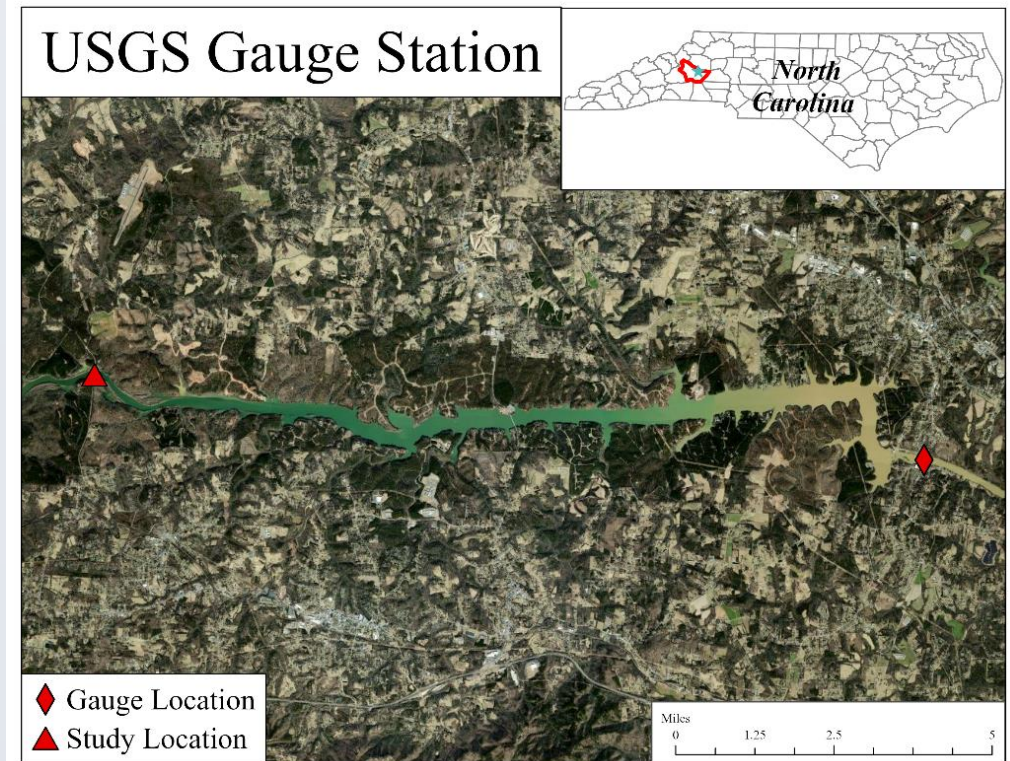
Water Depth

Date	Depth
8/22/2024 3:00 PM	10.64 ft
9/28/2024 3:00 AM	25.25 ft
11/1/2024 12:00 PM	10.61 ft

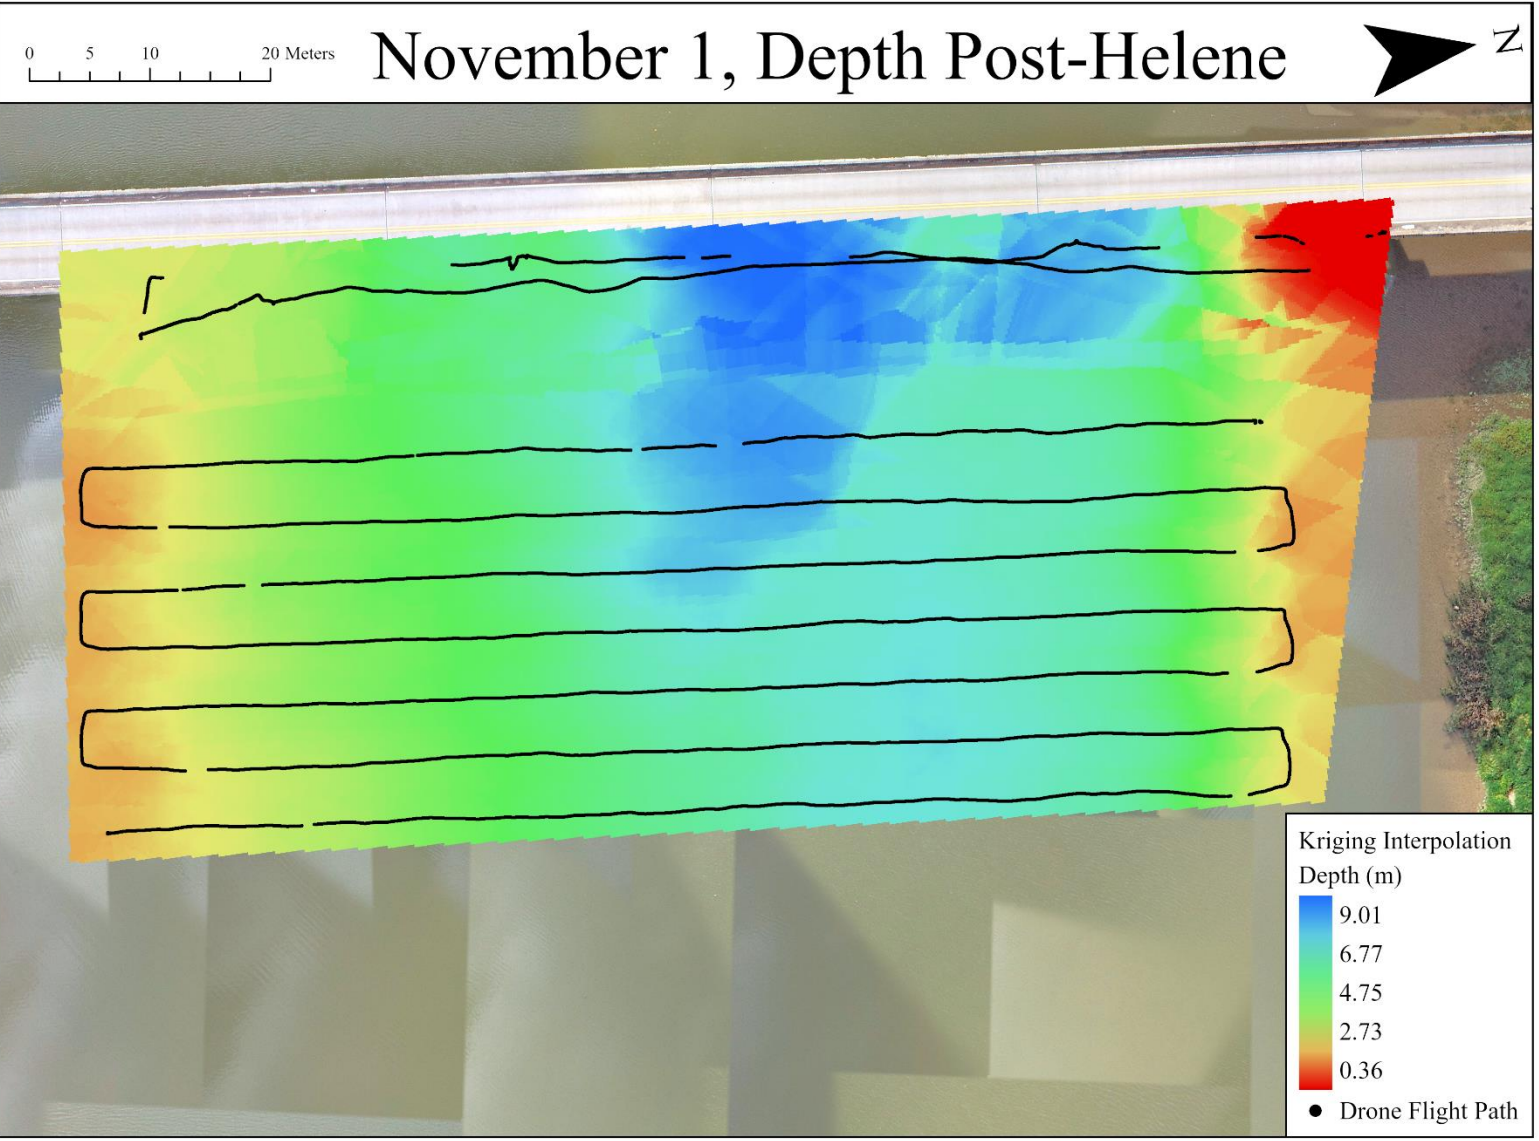
Bathymetric Map, Post-Helene

- Following Hurricane Helene, another data collection was performed to observe the change that such a severe flood event had on the bathymetry.

Maximum depth increased **2.5m (8.2ft)**, with some areas eroding over **5 meters (16.4ft)**. The highest rate of erosion was just south of the deepest location at **5.4 meters** of erosion.

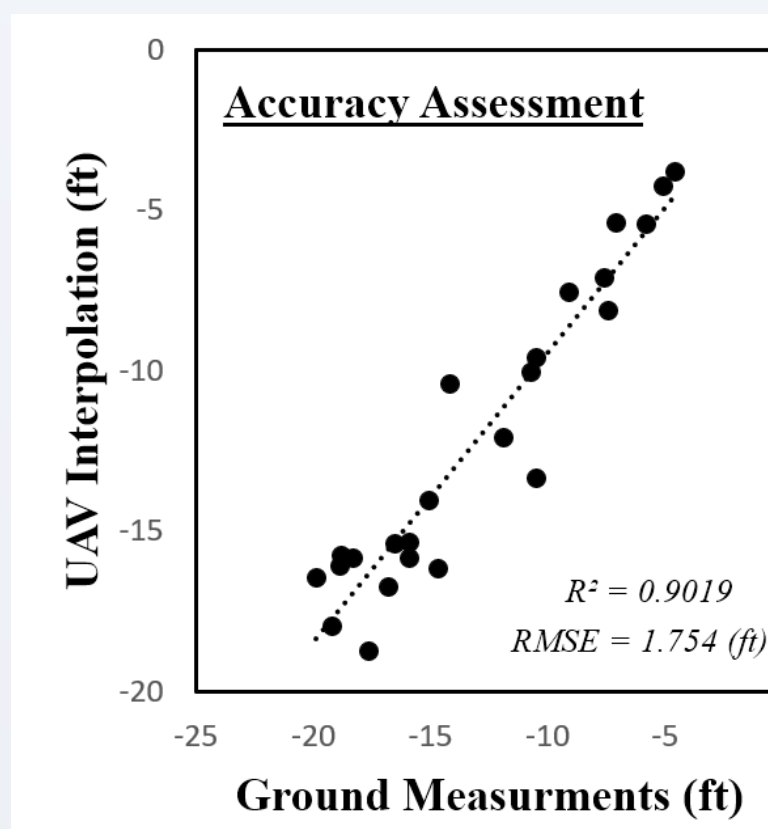
Accuracy Assessment

The assessment was performed on August 22 and compares the ground measurements which were collected from a canoe with the extracted values from the UAV interpolation. The R-squared value and root mean square error (RMSE) both showed a strong correlation between these datasets.

- This study shows that, UAV-based sonar bathymetry has a significant correlation with in-situ measurements and can **provide accurate, high-resolution data**.
