Case Study of Urban Concrete Pavement Reconstruction on Interstate 10

Eul-Bum Lee¹; Jeff Roesler²; John T. Harvey³; and C. William Ibbs⁴

DOI: 10.1061/(ASCE)0733-9364(2002)128:1(49)

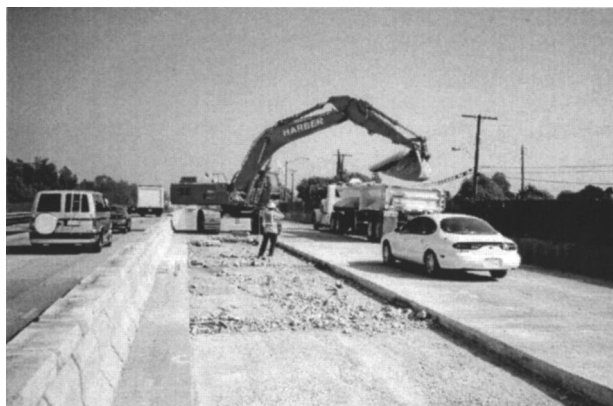
Fig. 3. Nonimpact demolition of existing Portland cement concrete slab

An excavator with a 1-m³ bucket capacity and seven end dump trucks were initially assigned to each demolition team. With the nonimpact demolition method, the excavator sat in Lane 3 in front of the concrete that it was removing. The excavator then loaded the old concrete into the end dump truck sitting in Lane 4, as shown in Fig. 3. The loading rate of the slabs into the demolition trucks (nonimpact demolition method) was quicker than that of the rubblized slabs (impact demolition method), because the excavator could more easily remove a few large pieces than many smaller pieces. The dumping area was located about 8 km from the job site. Cleaning the base with a front-end loader followed right after the slab demolition.

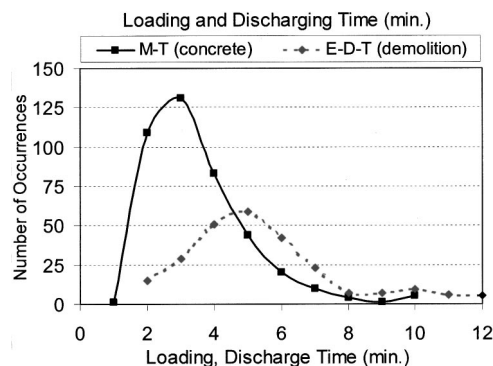
Fig. 4. Demolition loading time and concrete discharging time

The average loading time per end dump truck was 5.5 min with a 0.9-min standard deviation, as the distribution of the loading time is shown in Fig. 4. Approximately 9 end dump trucks showed up per hour per crew for demolition with a 2.3 truck standard deviation, as shown in Fig. 5. For every demolition crew, an end dump truck arrived every 7 min. When three crews operated simultaneously, a demolition truck was entering and exiting the construction zone every 2.3 min., and this created construction traffic control problems.

The average concrete discharge time per mixer truck was measured at 3.5 min with 0.7-min standard deviation, as shown in Fig. 4. This does not include waiting time and time to position the truck in the correct location. The average time for waiting, positioning, and discharging concrete was found to be 6 min.

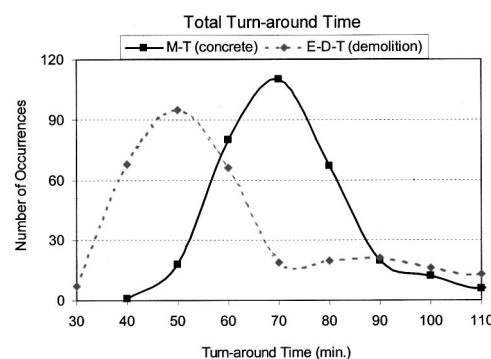
Fig. 6. Total turnaround of demolition and concrete trucks

The average turnaround of demolition trucks was measured as 64 min with a 5-min standard deviation, as shown in Fig. 6. Because the turnaround averaged more than 1 h, and the average number of demolition trucks per crew per hour was 9, total 32 demolition trucks had to be mobilized.

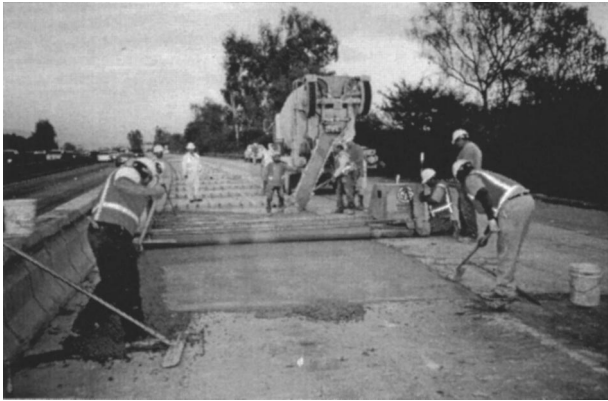
Fig. 7. Concrete discharge and paving operation

At the site, the mixer trucks were positioned on Lane 4 and discharged concrete into Lane 3 in front of the rotating concrete screed, as shown in Fig. 7. The mixer trucks leaving the site were almost always interrupted by the demolition operation in front of the paving operation.
