STRENGTH VARIABILITY OF CONVENTIONAL SLAB FORMWORK SYSTEMS

By Saeed Karshenas¹

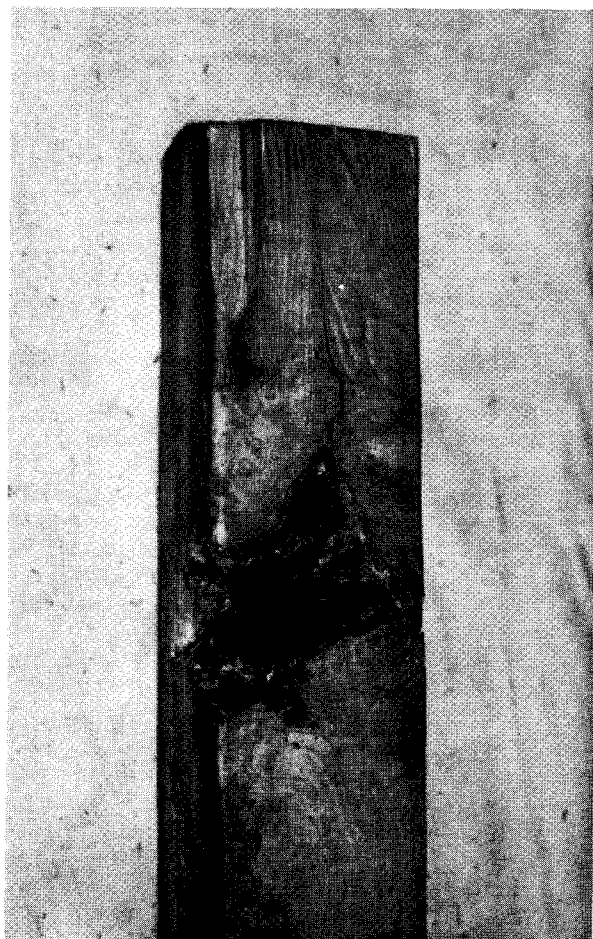
FIG. 4. Shore Sample with Large Knot Hole

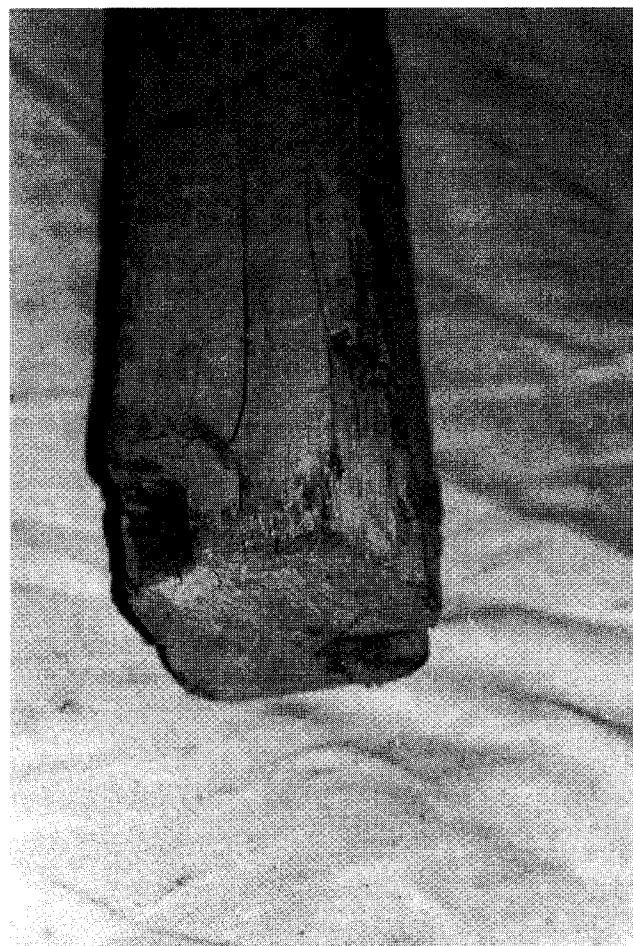
FIG. 5. Deteriorated Shore with Nonflat End

Another factor that can result in premature failure of a shore is damaged or improperly prepared shore ends. Fig. 5 shows the deteriorated and nonflat end of a highly reused shore. If the ends of a shore are not flat and at right angles to the longitudinal axis of the shore, after installation the shore ends will not be in full contact with the supports, which can result in premature crushing or splitting of the shore ends. Fig. 6 shows premature crushing of an imperfect shore end.

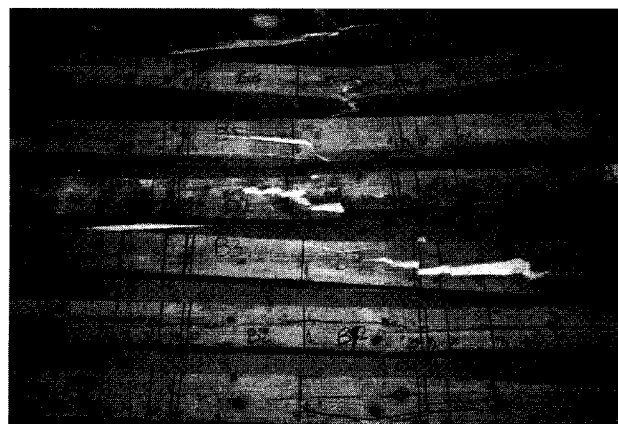
FIG. 7. Stringer Samples after Failure in Bending

Among the flexural properties of the used stringers, moduli of rupture and moduli of elasticity were determined. The mean and COV of the observed moduli of rupture were 42.4 MPa (6.1 ksi) and 0.38, respectively. Some of the results of an in-grade testing program conducted by the Forest Products Laboratory (Evans and Green 1987) for 50 × 200 mm Douglas-Fir Larch lumber in new condition are given in Table 5. The observed stringer moduli of rupture statistics are very close to those shown in Table 5 for Douglas-Fir Larch No. 1 in new condition. This shows that reuse has not substantially affected the bending strength of stringers. An investigation of various probability models showed that among normal, lognormal, and Weibull distributions, normal distribution best represents the observed data. Fig. 7 shows some of the stringer samples after failure in bending.
