Inspection of Luling Bridge Cable Stays: Case Study

Mary E. Elliott¹ and Ernest Heymsfield²

Abstract: Most cable-stayed bridges in the United States have been built in the last 30 years. As the number of existing cable-stayed bridges increase, one problem continues to arise—how to inspect the cable stays for corrosion and deterioration. An inherent difficulty in developing an inspection procedure for cable-stayed bridges is that each cable-stayed bridge is unique in its cable configuration. The Louisiana Department of Transportation and Development (LADOTD) has built two separate trolleys to aid their inspectors and maintenance crew with visual inspection and maintenance of the cable stays on the Luling Bridge over the Mississippi River in St. Charles Parish near New Orleans, Louisiana. With the use of the two trolleys, LADOTD bridge inspectors are able to inspect the cable stays at hands-on distances. The cable-stay inspection procedure adopted by the LADOTD is inexpensive and time efficient, and it minimally impacts bridge traffic. This manuscript reviews the inspection procedure adopted by the LADOTD to inspect the cable sheathing at the Luling Bridge.

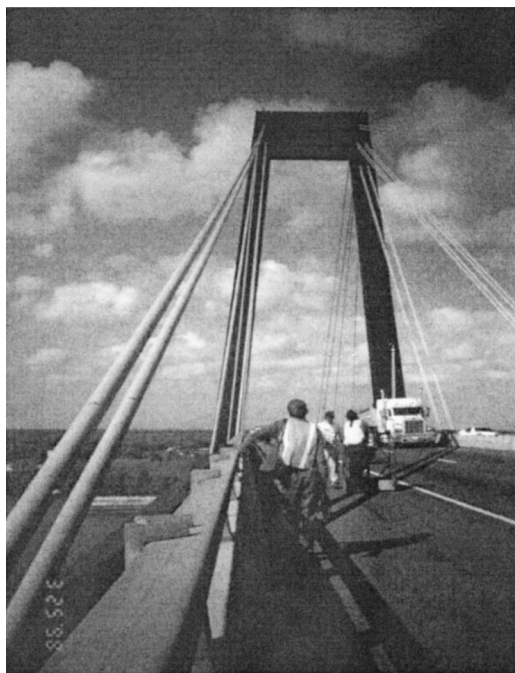
Fig. 3. Configuration of cables of Luling Bridge over main span

Due to the cable-stay configuration, one trolley was built to ride along the top two horizontally parallel cables of the four-cable configuration of the side spans, and a second trolley was built to ride along the side of two vertically parallel cables of the two-cable configuration of the main span (Fig. 3). The inspection of the cable stays began on March 2, 1998, and continued intermittently throughout the months of March and April. The inspection was expected to require one week to inspect all 72 cables of the Luling Bridge using the two trolleys; however, the completion of the inspection was delayed due to required equipment modifications and other previously scheduled projects. These equipment modifications were required due to changes in the cable-stay diameter from the time of the previous inspection. Since an earlier inspection in 1985, the polyethylene pipes were wrapped with white PVF tape (Tedlar tape). This procedure was done to protect and reduce temperature variation of the stays. However, the white PVF tape added extra thickness around the stays and therefore changed the dimension between the stays as well as the surface the tires of the trolley gripped. The extra thickness resulted in the trolley "walking" sideways and damaging the PVF tape during the 1998 initial inspections. To correct this problem, modifications to the wheels of the original trolleys were required and were made by changing the type of wheels used and altering the width of the wheelbase.

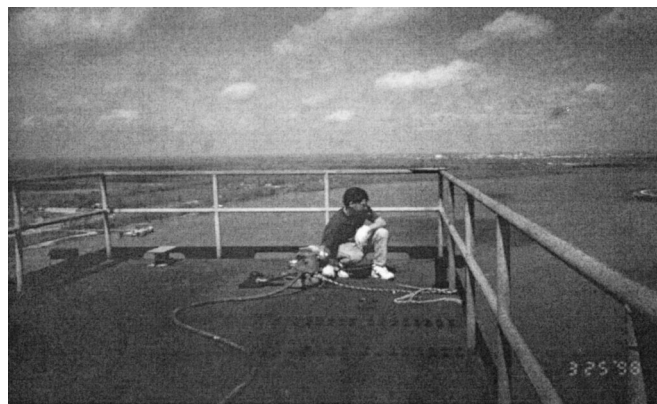
Fig. 5. Winch on top of tower, which is used to pull trolley up cables

wire rope to the tower platform level. Using a crane, the four-cable trolley is lowered and set onto the top two horizontally parallel cables of the four-cable group. The tower winch is secured to the tower brackets, and the wire rope is threaded through the pulleys at the top of the tower and attached to the trolley located initially at the cable-stay base. A second wire rope is used with one end attached to the roof of the trolley and the other end to a winch in the trolley basket. The installed basket winch allows the basket to be lowered to inspect cables below the cables that the trolley is riding on. To connect the basket to the trolley carriage, the trolley is pulled up the cable stays by the tower winch to slightly above the bridge deck. At this level, the basket winch is used to position the basket within the trolley. The tower winch is controlled by an operator on the tower platform, while the basket winch is controlled by an inspector in the trolley basket.

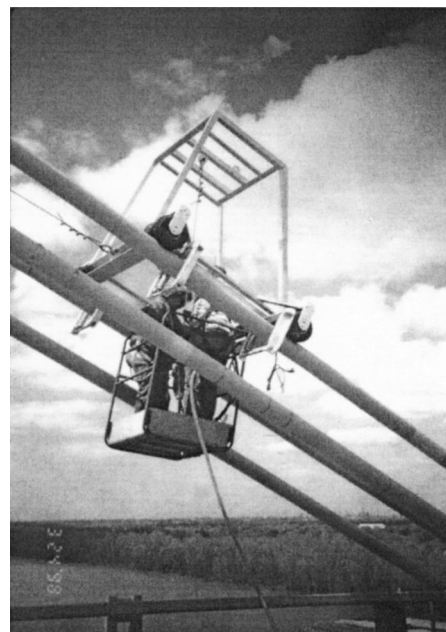
Since the basket within the trolley can be lowered to any height, the four-cable trolley can be used to inspect all eight cables of the bridge side spans; however, this warrants calm wind conditions (Fig. 6). Therefore, in other than calm wind conditions, inspection needs either to be limited to the cable stays the trolley

Fig. 6. Lowering basket to inspect lower cable stays

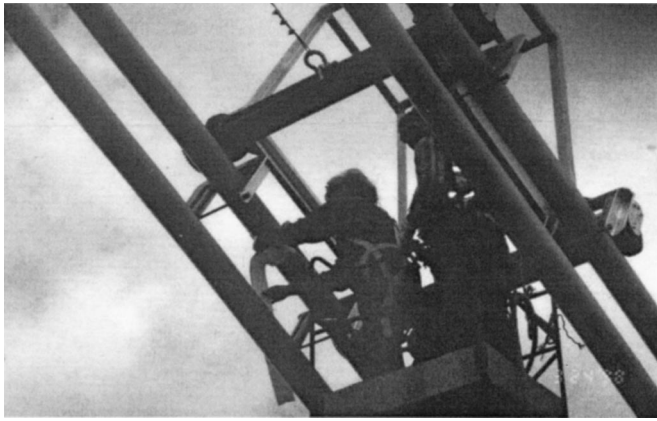
Fig. 7. Repairing cable stays with PVF tape

In 1985, the LADOTD noticed some cracking of the high-density polyethylene sheathing used to encase the cables. To remedy this cracking, the original black polyethylene pipes were repaired and then wrapped with white PVF tape (Tedlar tape). The new tape provided protection of the polyethylene pipes, and in addition the white color resulted in reduced temperature variation of the cable stays.

is riding on or to be postponed. When cracking in the sheathing is detected during the inspection process, repair work can easily be made from the trolley by retaping the crack area with PVF tape (Fig. 7).
