URETEK Injection Process™ for Pavement Preservation Projects

VDOT I-81 Botetourt County 5 year Update

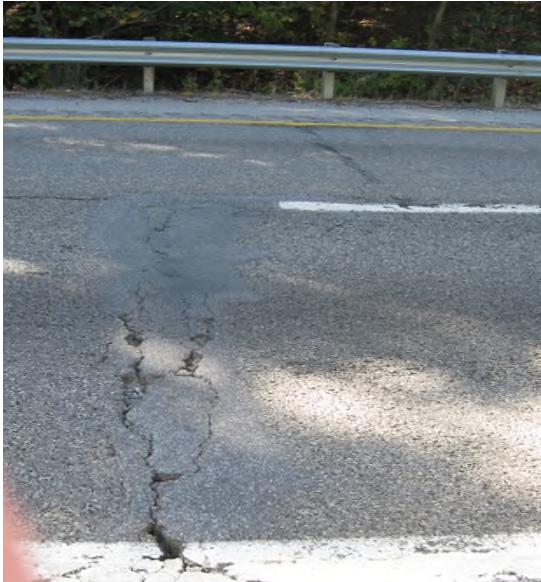
- Composite Pavement on karst topography.
- Original concrete slabs were over 65 feet long and started to exhibit transverse cracking within 4 years of use.
- Asphalt overlays were experiencing reflective cracking within two years of being milled and overlaid.
- Concrete was continuing to deteriorate and flexing under heavy loads.

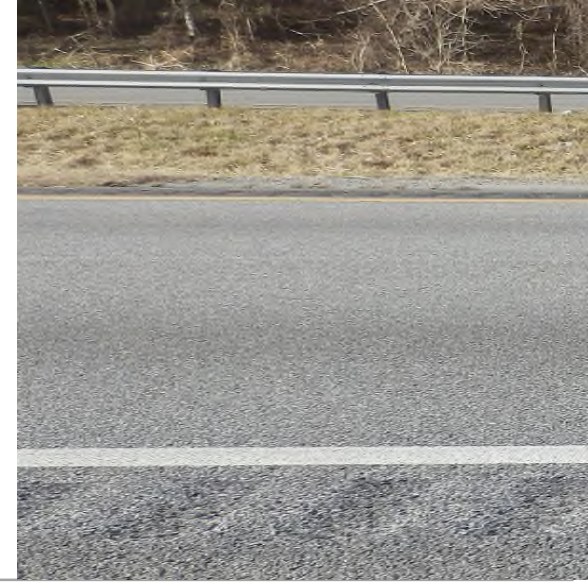
- On the I-81 project URETEK USA successfully worked two more stretches of roadway over the next year for a total of over 32 lane miles, lengthening life of the pavement.
- **The shot above was taken in January of 2015, over 5 years since the first section of I-81 was injected then milled and overlaid. There is not one transverse crack showing in the asphalt along the 18 lane miles.**
