RE: Laurel Mountain Resources, LLC KDSMRE Permit #813-0359, Big Caney Creek Unnamed Tributary Reach 13 Construction Completion Notification

YEAR ONE MONITORING REPORT
UNITED STATES CORPS OF ENGINEERS
Big Sue Branch Unnamed Tributary Reach 13
KDNR PERMIT NO. 813-0360

Laurel Mountain Resources, LLC Big Caney Creek Unnamed Tributary Reach 13 Mitigation Year One Monitoring Report

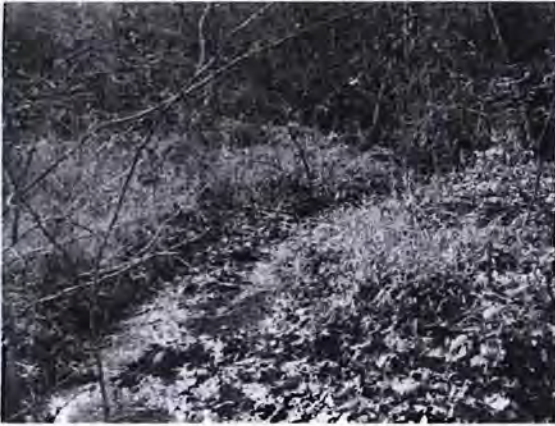
Figure 1. Reach 13 Unnamed Tributary 11/10/11
Pic. 754 Facing Upstream, 37.58127, -83.16577

Pictures of the mitigation site illustrating the current condition (figures 1-4), as well as the map showing the locations of the photos (figure 5) and site location map (figure 6) are included. Mitigation that is not meeting the stated standards is the riparian survival rate, damaged stream enhancement structures, and eroding banks as aforementioned.

The unnamed tributary to Big Caney Creek Reach 13 mitigation site is meeting all performance standards with the exception of tree survival rate and structure stability. LMR will return to the site and transplant more trees and perform necessary maintenance during the dormant season of 2012. Once these conditions are corrected the LMR mitigation site will continue to trend toward the stated mitigation performance standards in the approved Clean Water Act Section 404 permit.
