THREAD LOCATING AND TRACKING PROBLEM

Khurshid Shaymardanov

Data Science

General Assembly

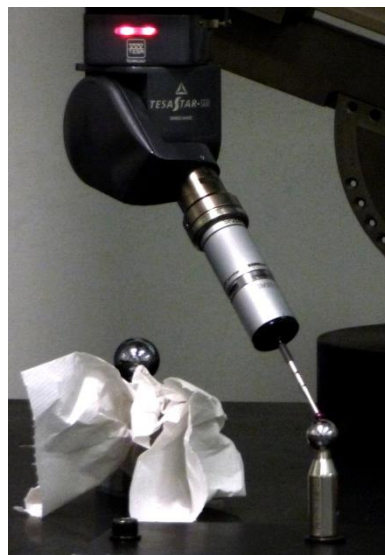
Tip Calibration

Probe file=2X30MM+EXT Date=9/23/2019 Time=11:05:15 AM

TOOL CENT X 171.629 Y 487.328 Z -625.417 D 24.998
 T1AoBo THEO X 0.000 Y 0.000 Z 266.000 D 2.000
 T1AoBo FAST X 0.000 Y 0.000 Z 265.998 D 2.000 PrbRdv -0.005
 T1AoBo MEAS X 0.000 Y 0.000 Z 266.000 D 2.000 PrbRdv
 0.000 StdDev 0.000

Probe file=1BY20+35EXT Date=9/23/2019 Time=9:25:17 AM

TOOL CENT X 171.465 Y 487.376 Z -625.480 D 24.998
 T1AoBo THEO X 0.000 Y 0.000 Z 274.000 D 1.500
 T1AoBo FAST X 0.000 Y 0.000 Z 273.998 D 1.500 PrbRdv -0.004
 T1AoBo MEAS X 0.000 Y 0.000 Z 274.000 D 1.500 PrbRdv 0.000
 StdDev 0.000

Probe file=1,5X30+20MM EXT Date=9/20/2019 Time=4:36:40 PM

TOOL CENT X 171.399 Y 487.343 Z -625.593 D 24.998
 T1AoBo THEO X 0.000 Y 0.000 Z 269.000 D 1.500
 T1AoBo FAST X 0.000 Y 0.000 Z 268.999 D 1.500 PrbRdv -0.007
 T1AoBo MEAS X 0.000 Y 0.000 Z 269.000 D 1.500 PrbRdv 0.001
 StdDev 0.001

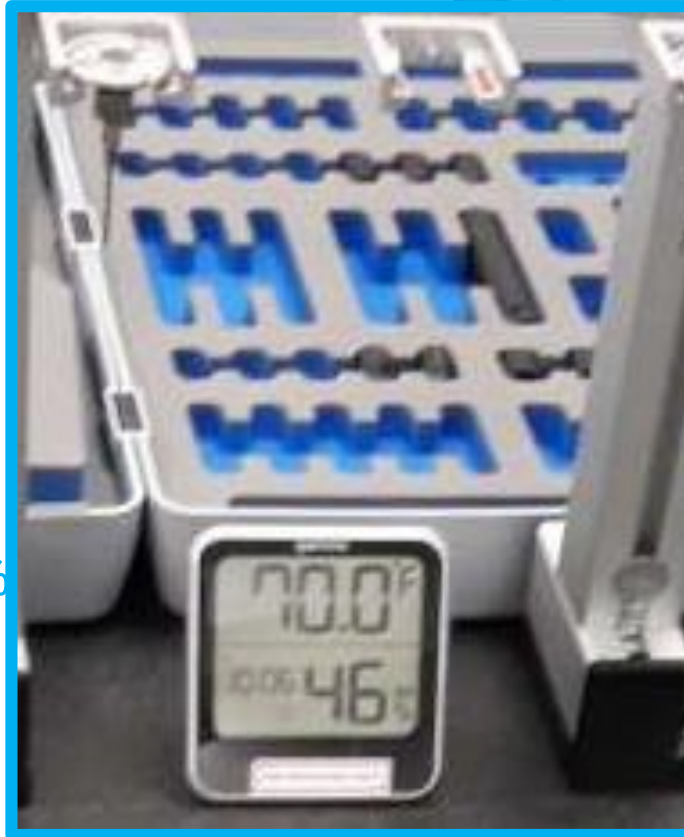
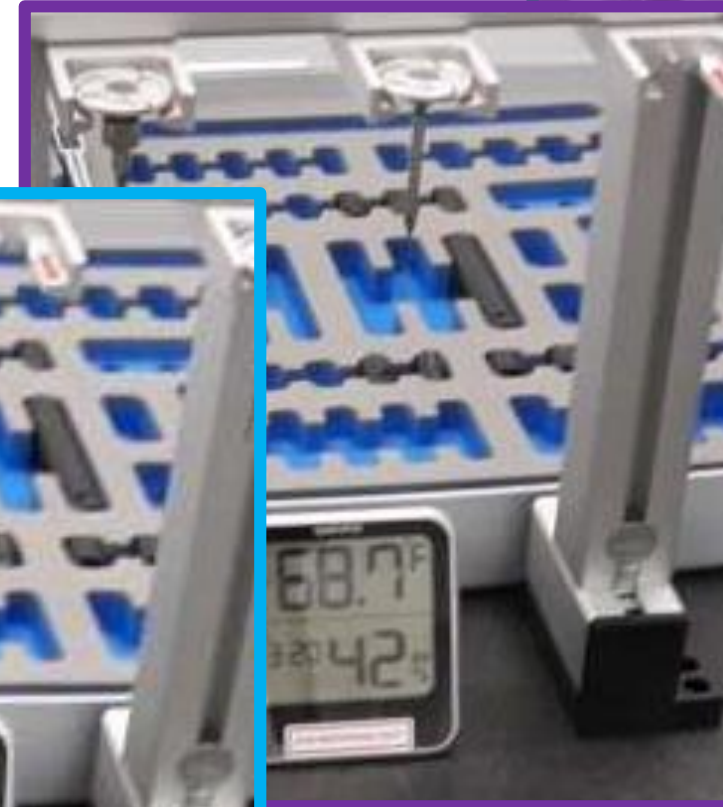
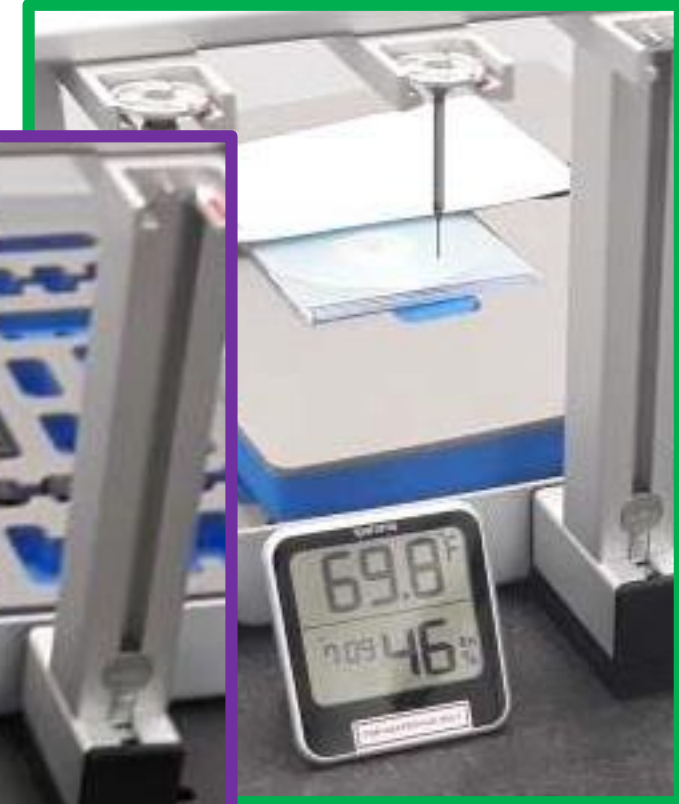
Room temperature and humidity

Room Condition during initial tests:

- 9/13/2019, 6.37 pm: 69.8 F, 46 RH%
- 9/13/2019, 6.50 pm: 70.0 F, 46 RH%
- 9/13/2019, 7.01 pm: 70.0 F, 46 RH%
- 9/13/2019, 7.09 pm: 69.8 F, 46 RH%
- 9/20/2019, 3.20 pm: 68.7 F, 42 RH%

Room Condition during final tests:

- 9/23/2019, 10.06 am: 70.0 F, 46 RH%
- 9/23/2019, 11.22 am: 70.0 F, 45 RH%
