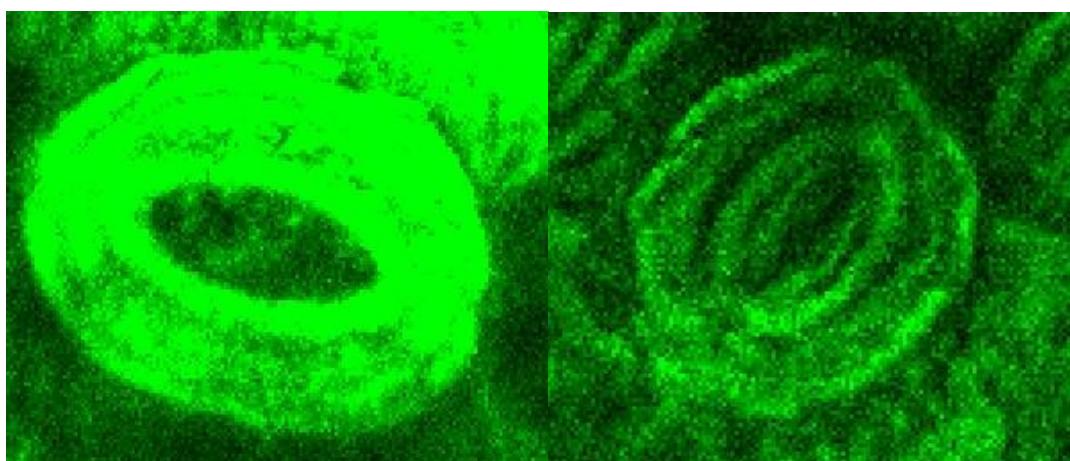
Figure 6. CLSM of a stoma from a portion of the untreated leaf sample (left) and the sample after the oxidative hydrolysis under conditions of Run #4 (right).

Images were taken for the untreated sample and obtained after runs #4, #6, and #S1. Mean fluorescence intensity was estimated from the images using the ImageJ software by averaging over the Z-axis converted to a 0-255 grayscale (8-bit). It was found that the mean intensity correlated well with the amount of lignin in the sample (**Error! Reference source not found.**). The fluorescence intensity of the samples decreased after the acid-oxidative hydrolysis, proportional to the severity factor. However, despite having the highest severity factor, the sample treated with sulphuric acid showed the highest lignin content and fluorescence intensity, indicating the low degree of delignification and partial dissolution of cellulose.
