Oregon Source Control Conference

Case Study: Premier Edible Oils

May 19, 2017
Portland, Oregon

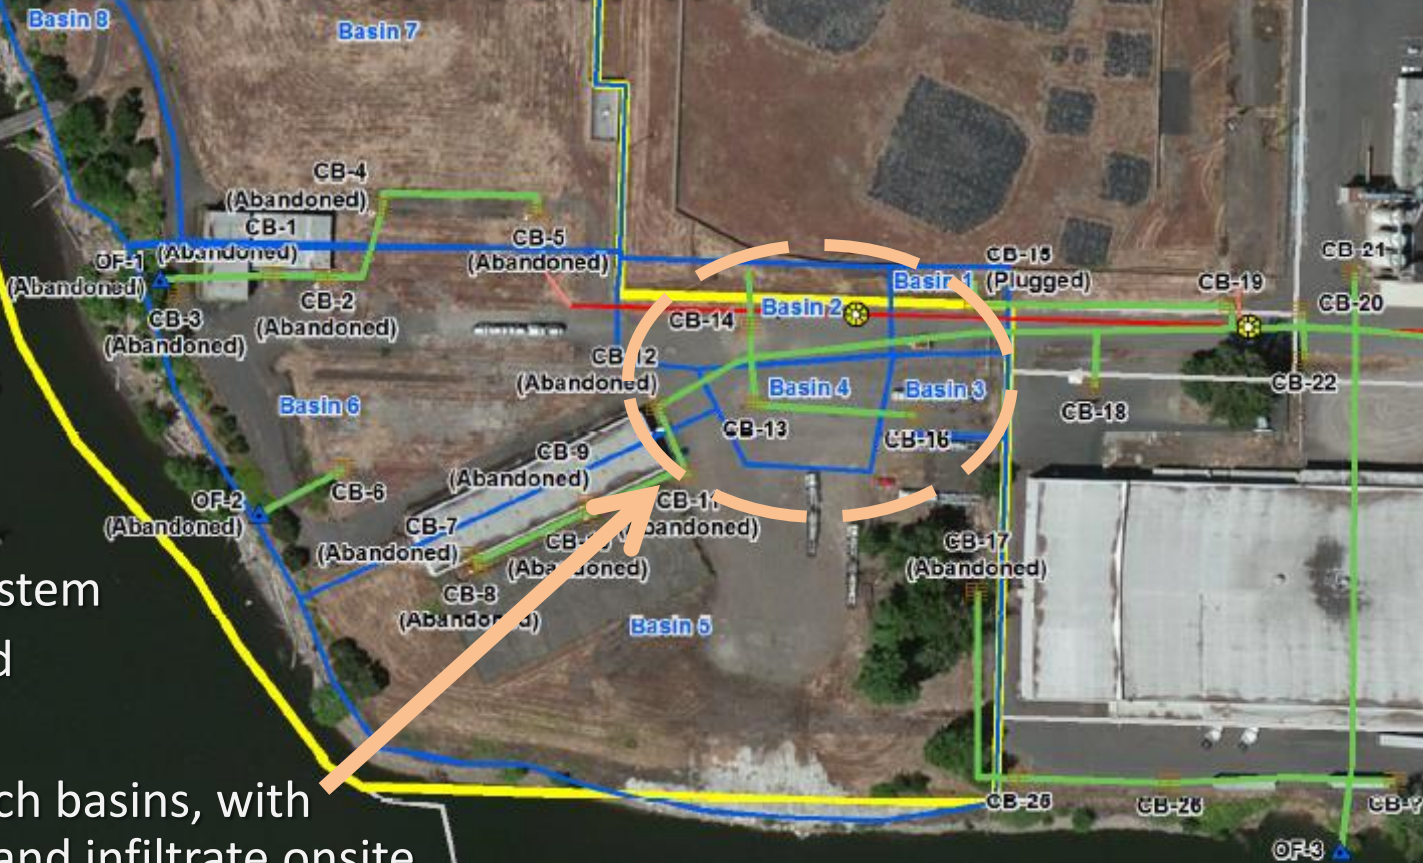
STORMWATER PATHWAY

Historical discharges
to river and slip

Majority of storm system
has been abandoned

Three remaining catch basins, with
plans to disconnect and infiltrate onsite

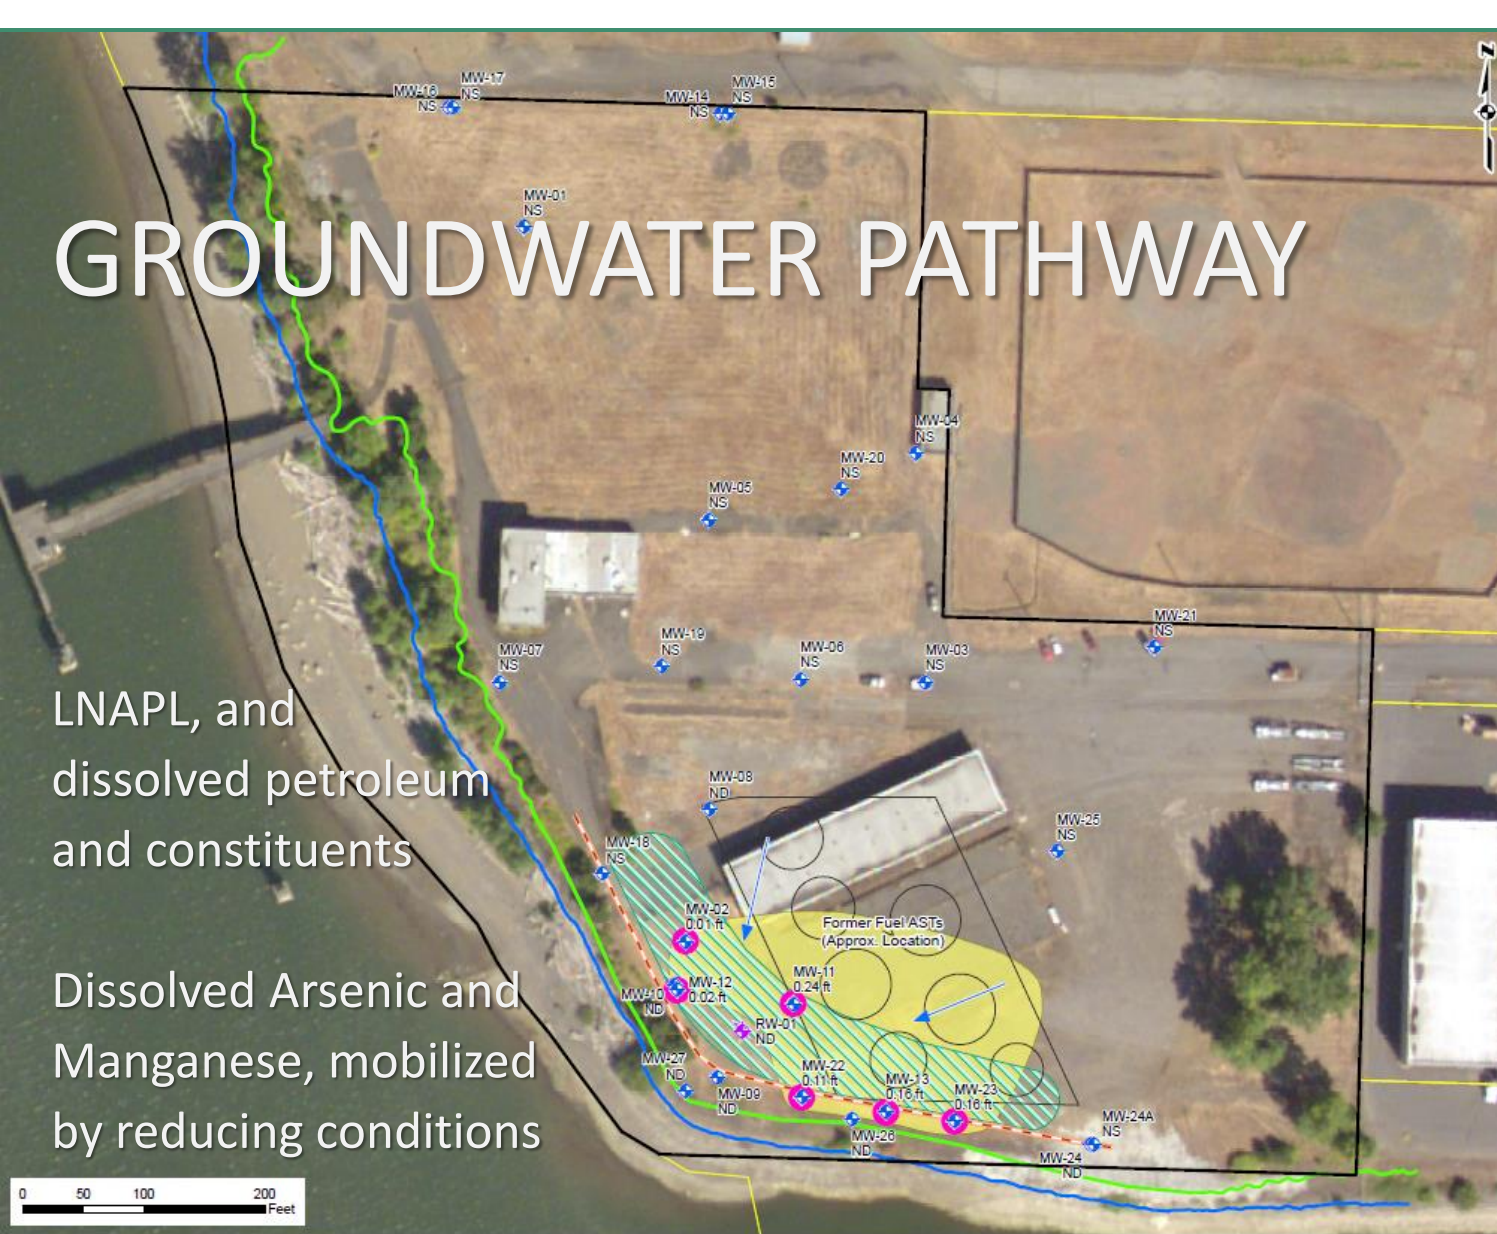
Figure 2
 GW SCM Layout
 Performance Monitoring Plan
 Southern PEO Site
 Portland, Oregon

GROUNDWATER PATHWAY

LNAPL, and dissolved petroleum and constituents

Dissolved Arsenic and Manganese, mobilized by reducing conditions

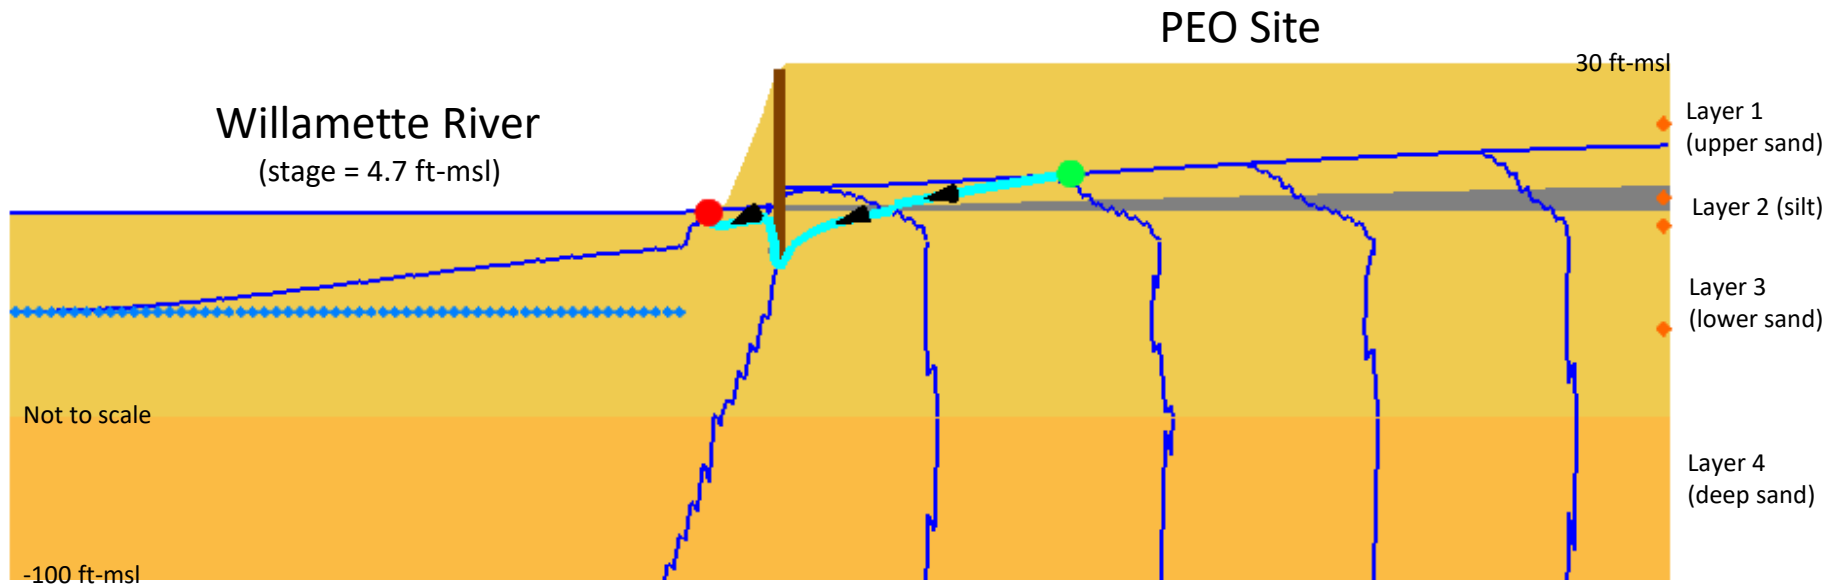
Increase Travel Distance

Increase Degradation (LNAPL)

Introduce Oxygen

Promote Degradation (LNAPL)

Shift Geochemistry (Metals to Less Mobile Form)

Particle Track

Start Finish

1 year travel time
tick mark

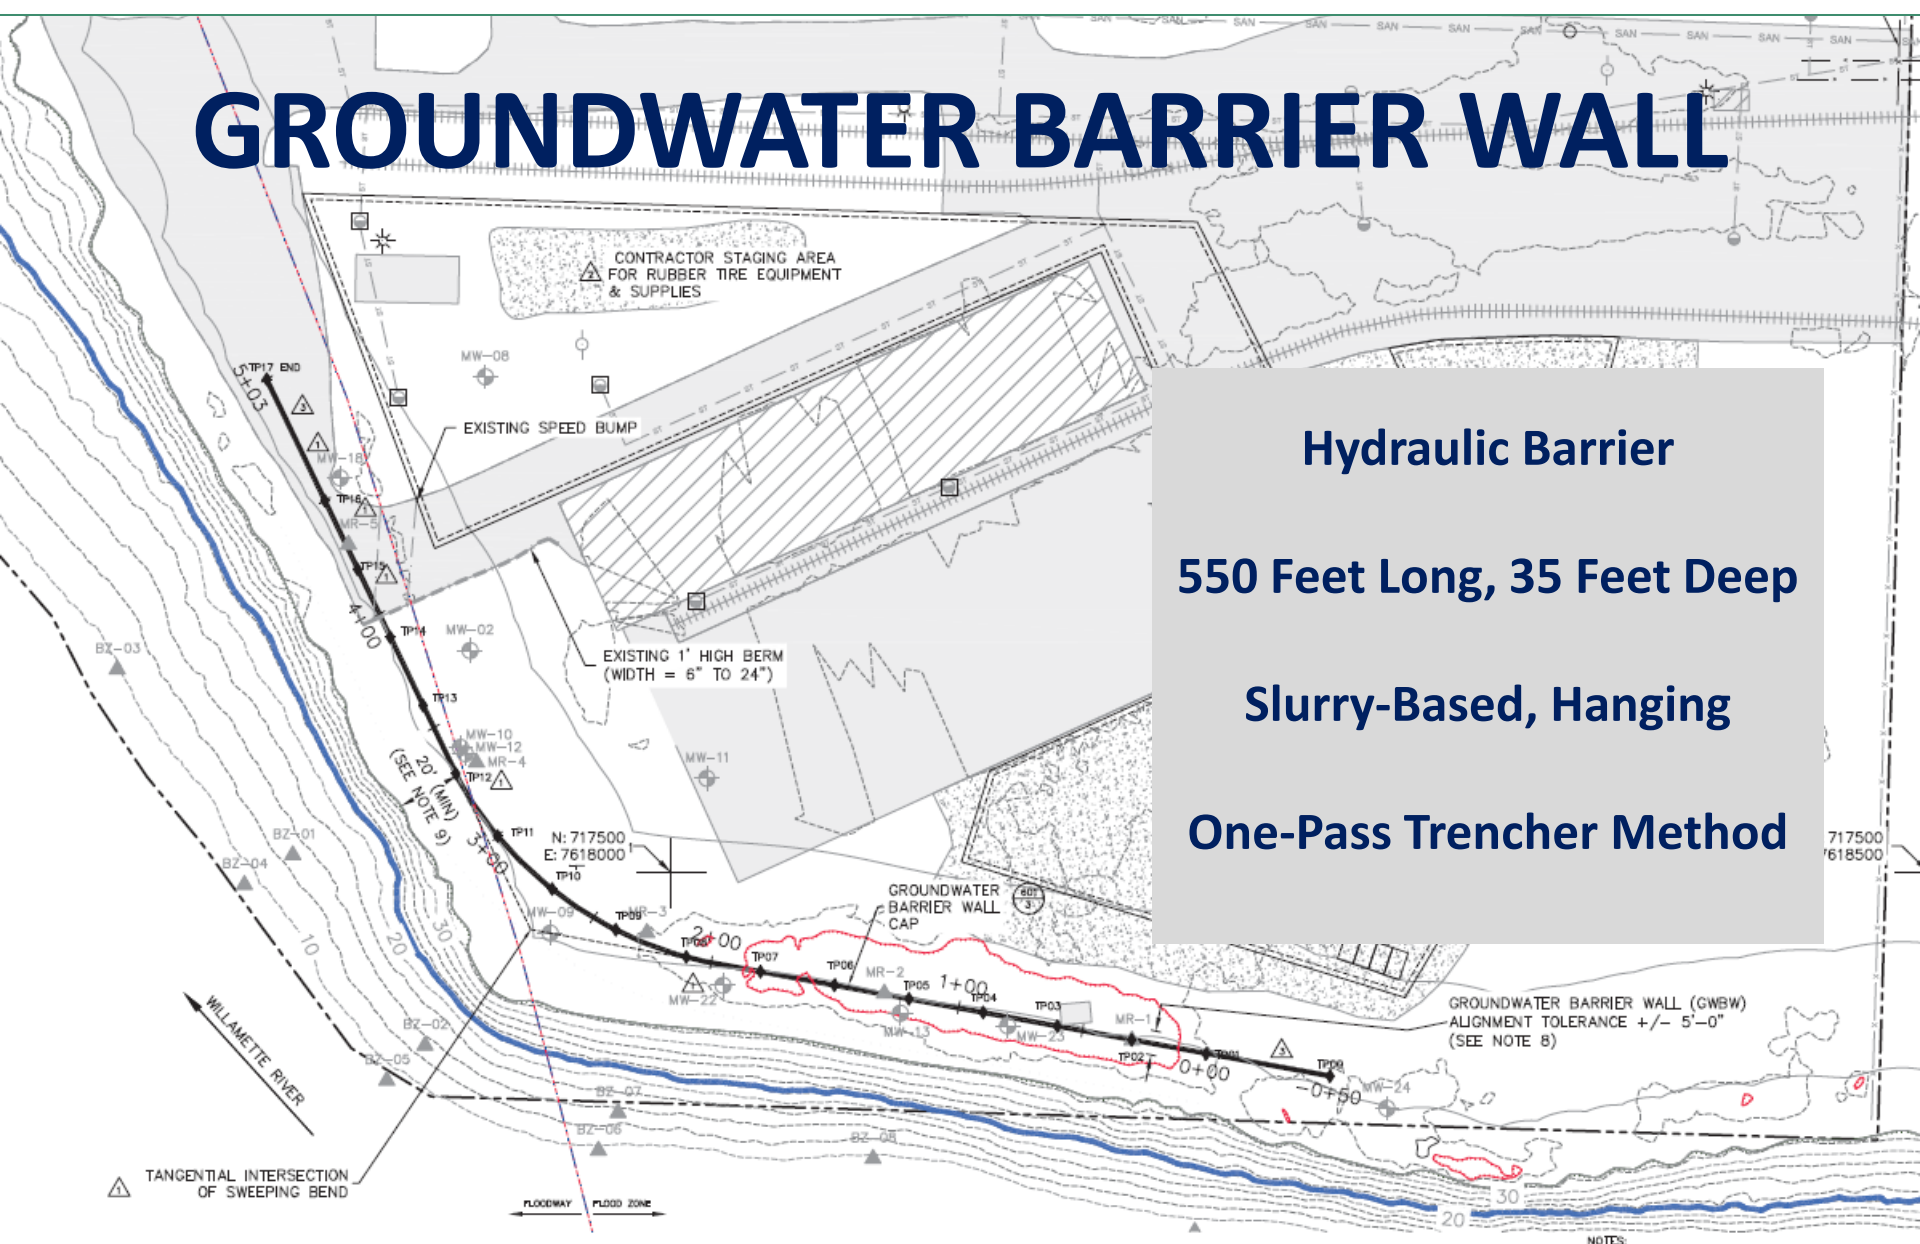
GROUNDWATER BARRIER WALL

Hydraulic Barrier

550 Feet Long, 35 Feet Deep

Slurry-Based, Hanging

One-Pass Trencher Method
