The Technology of Hip Replacement

by Michael B. Mayor and John Collier

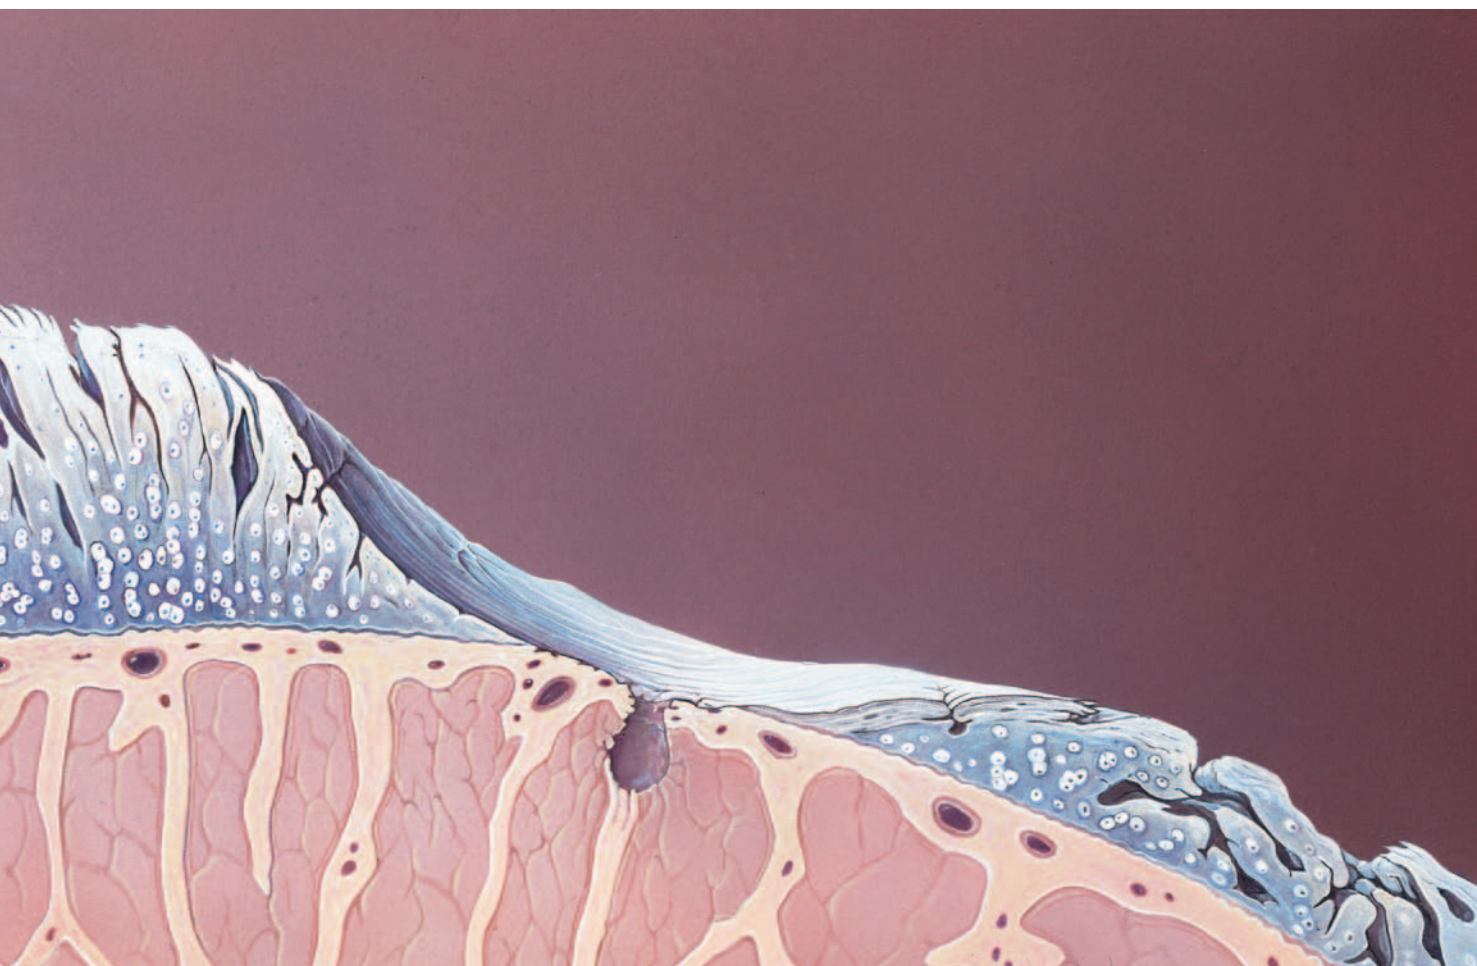
Deterioration and inflammation of articular cartilage causes progressive joint destruction. Normal cartilage appears at the left and inflamed cartilage at the right in this illustration.

Progressive damage to joints becomes increasingly prevalent as the population ages and can result from any of more than 50 different disorders. As the joint surface is degraded from whatever cause, the various forms of arthritis come to remarkably similar ends. Once the intimate architectural details that characterize normal articular cartilage

are destroyed, a rapid downhill course renders the joint's surface bald, polished, and painful. The result is that raw bone articulates against raw bone.

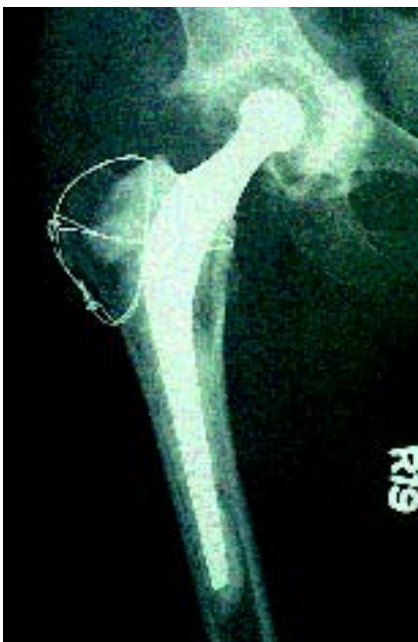
A traditional Charnley cemented arthroplasty with a 22-mm head and all-polyethylene cup.

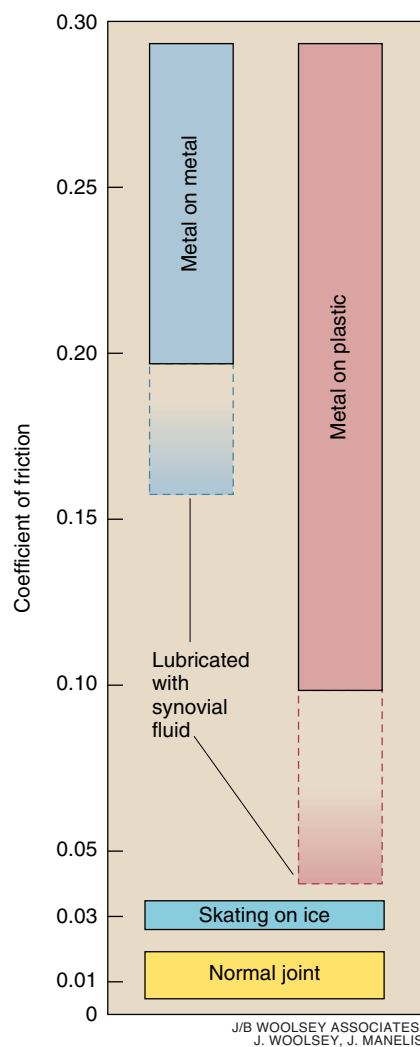
Coefficients of friction of normal joints compared with artificial joints and with an everyday low-friction experience. Neither engineering nor lubrication can approach the frictional coefficient of a healthy human joint.

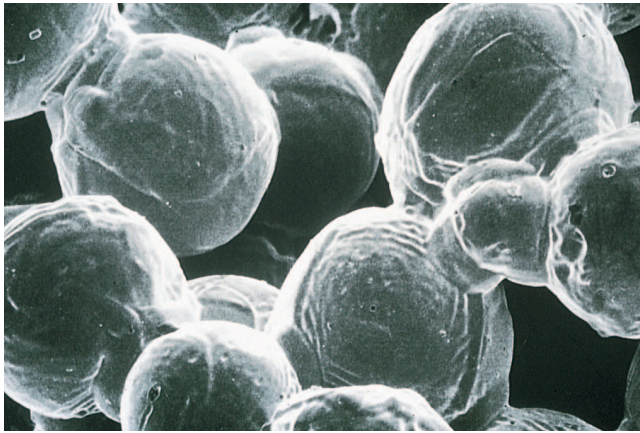
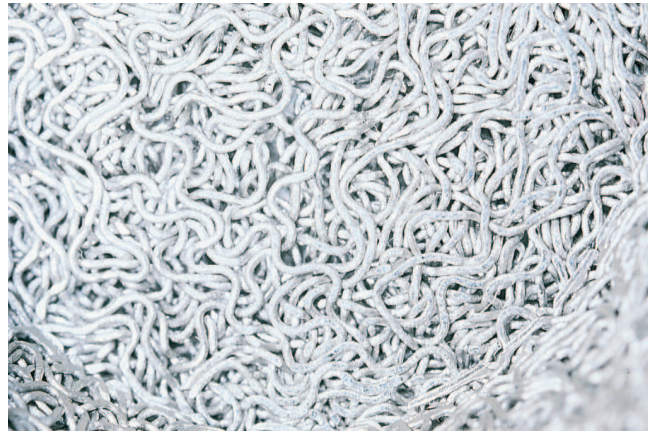
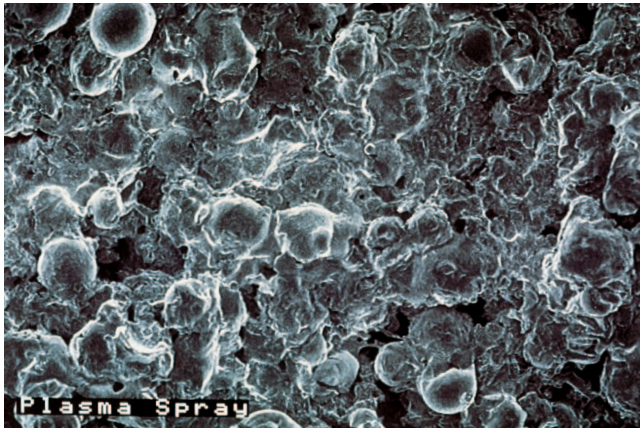
Porous-coated implant surfaces encourage fixation by providing three-dimensional interdigitation. *Above, left*, Sintered beads on cobalt-chrome (original magnification X 40). *Above, right*, Diffusion bonded titanium wire mesh (X 10). *Left*, Plasma spray titanium coating (X 50).

Manufacturers developed more effective porous-coated implants by sintering beads or particles of metal, by plasma spraying, and by attaching preformed wire or mesh.

Porous coating produces a greatly increased surface area to which fibrous tissue and growing bone can attach to transmit stresses to elastic bone instead of brittle cement. One disadvantage is that the manufacturing process reduces fatigue strength because relatively high temperatures are necessary to achieve metallurgical bonding. Another drawback is that porous-coated prostheses are difficult to remove if revision becomes necessary.

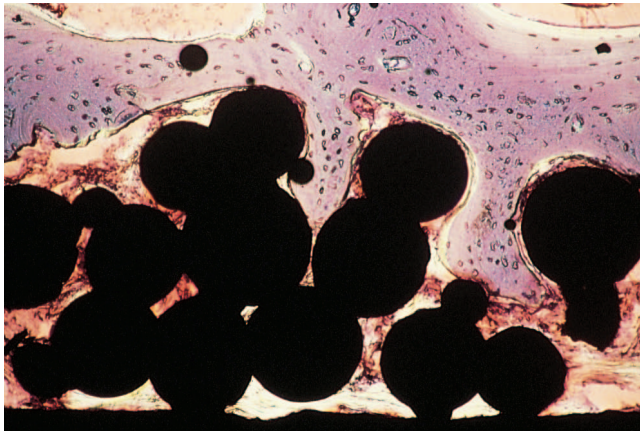
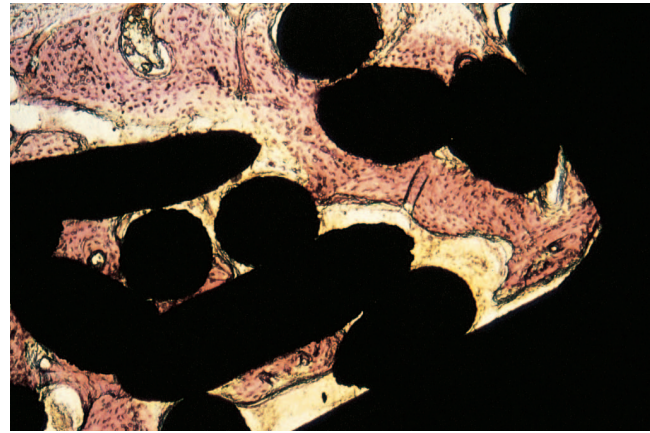
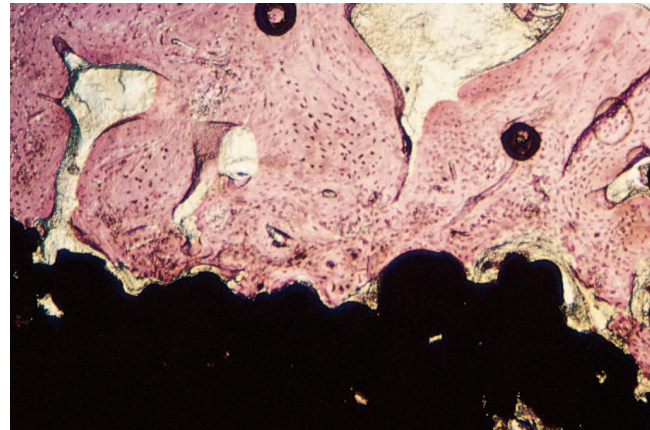
Ingrowth of bone viewed by microscopy of stained sections. *Above, left*, In sintered bead coating (original magnification X 100). *Above, right*, In wire mesh titanium coating (X 25). *Right*, On plasma sprayed titanium coating (X 25).

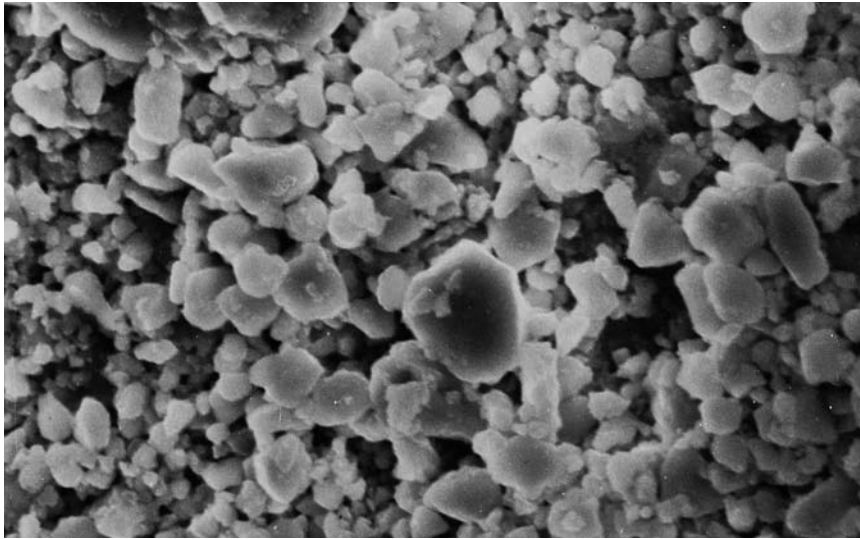
Hydroxyapatite applied by plasma spraying coats a metal prosthesis to a depth of 50 μm in this scanning electron micrograph (original magnification X 3000).

bone for some time but are too brittle for use alone in hip implants. Applied in thin layers to titanium implants by plasma spraying, hydroxyapatite may increase osseous attachment over the short term, although all these coatings will resorb over time.

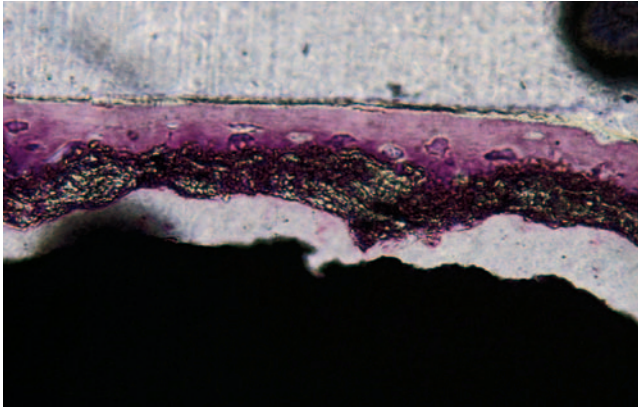
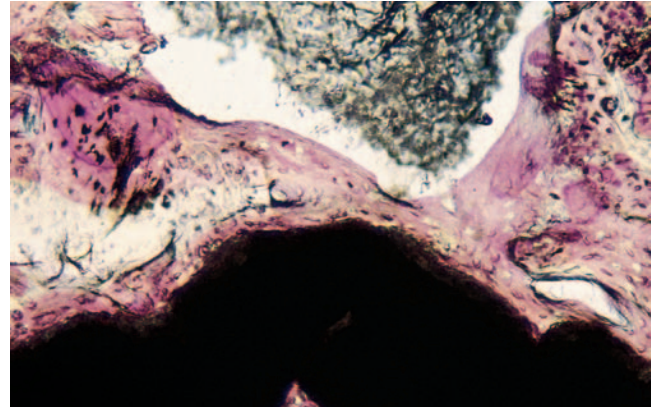
Bone grows tightly onto hydroxyapatite coating applied to a textured surface (*left*; original magnification X 100) and to a porous surface (*right*; X 75). The early use of thick coatings (*left*) could lead to coating separation. Thin coatings now used are more adherent.

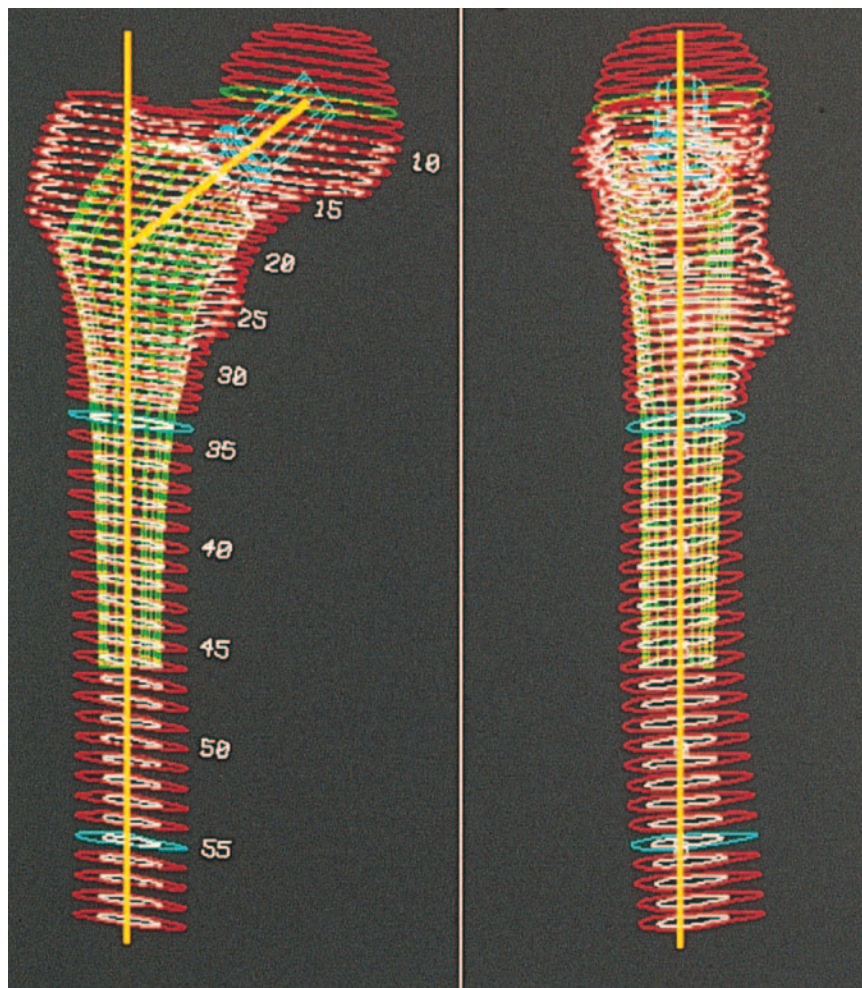
Computer-generated design of a femoral implant appears within the image of a femur built up from CT scans. Finite element stress analysis is incorporated into the design of the prosthesis.

Computer-assisted design and manufacturing techniques have been used by the makers of prostheses for more than a decade, and some suppliers will produce custom shapes and sizes for special cases. But CAD-CAM systems are too complex for routine use at reasonable cost. Jeffrey Reuben of the University of Texas Medical School in Houston developed an expert system based on high-resolution CT scans and finite element stress analysis to design a prosthesis that fills the medullary canal as completely as possible. A femoral prosthesis that fills the canal

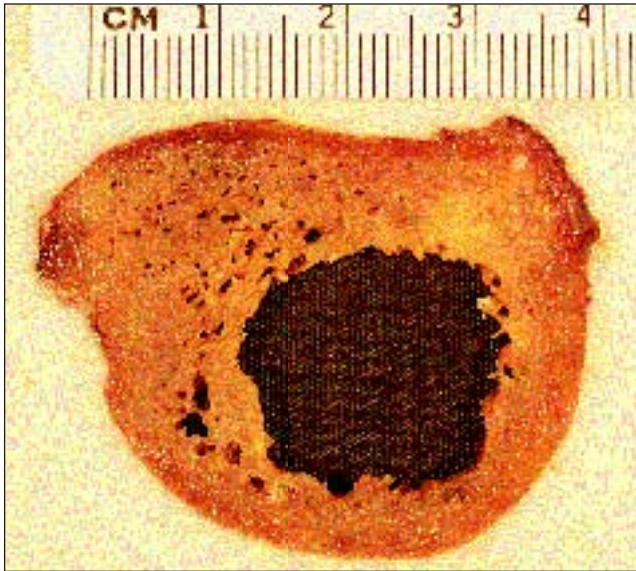
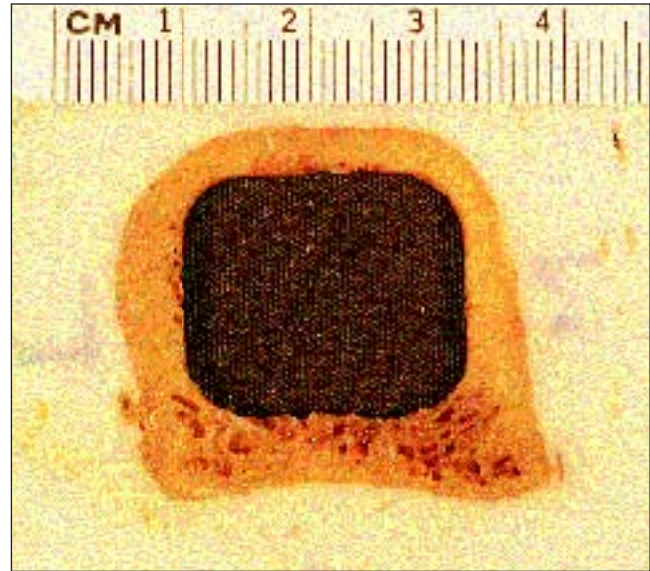
Robot preparation of the medullary cavity of a canine femur is an order of magnitude more precise than surgeons achieve with hand-held tools.

matches the dimensions of the intended prosthesis within 0.4 mm (which is ten times better than a surgeon can do) and that is correctly oriented to position the implant with respect to femoral rotation and version. Bench and animal experiments were successful; a human trial has yet to be reported.
