BMW Airhead Oil Filter Canister Displacement: Service Practice, Load Paths, and the \$2,000 O-Ring Myth

Custom Konrad

Abstract

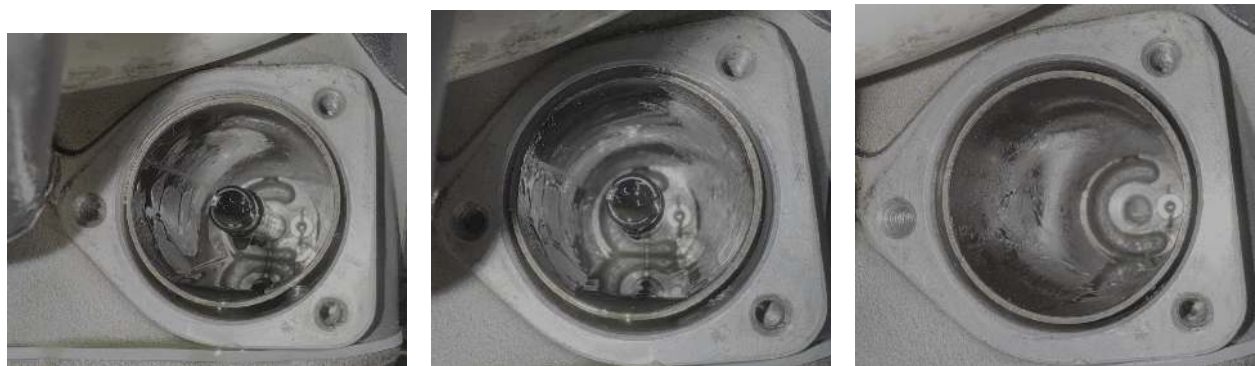
The mechanical response of the canister to this interference is documented in Fig. 2(a–c). After removal of the fastener, partial elastic spring-back was observed, but the canister did not fully re-center on its own. Deliberate mechanical re-centering at the mouth was required

(a) Localized deformation identified **(b)** Fastener removed as first corrective action **(c)** Canister mechanically re-centered by controlled levering

Figure 2: Canister displacement and recovery sequence, demonstrating dominant rigid-body motion about the distal press-fit region. (a) Localized deformation at the canister mouth caused by unintended radial jacking. Note the bolt protrusion visible in the lower-right quadrant (near the 5 o'clock position). (b) After fastener removal, partial elastic spring-back occurs, but full self-centering does not occur without an applied corrective moment. (c) Deliberate mechanical re-centering at the mouth restores nominal alignment of the canister relative to the crankcase bore. The central PIPE was removed at this stage to provide clearance for controlled levering without interference.

Distinguishing rigid-body motion from localized yielding is difficult *in situ*; however, both mechanisms are consistent with the observed seal extrusion shown in Fig. 1. The demonstrated ability to re-center the canister (Fig. 2) strongly supports a lightly retained, non-

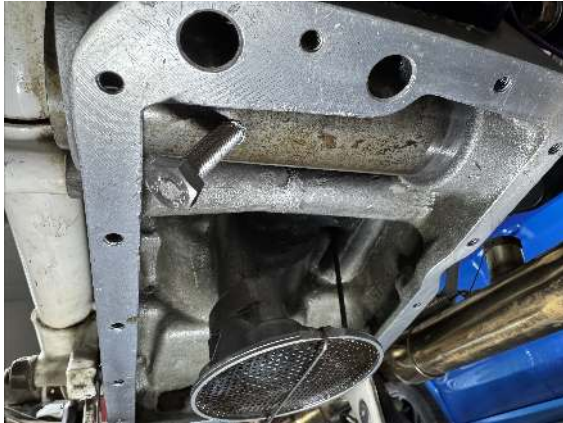
(a) Localized canister wall deformation during drive-out tapping. Repeated tapping blows applied at the bolt head produce unavoidable plastic deformation and bolt rotation in the thin wall.

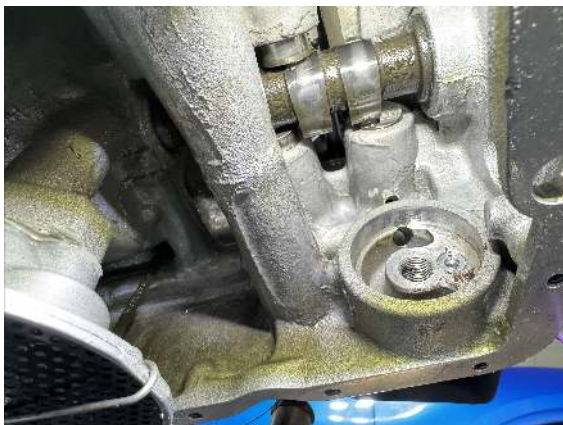
(c) Canister removed after controlled tapping sequence.

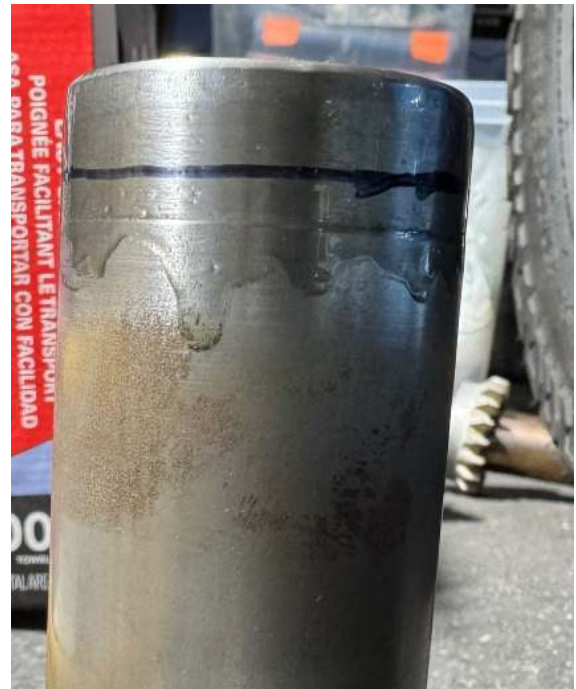
(d) Replacement canister distal end cleaned and lightly oiled prior to insertion. Note the traced insertion depth check line.

Prior to insertion, the distal end of the replacement canister was cleaned with gray Scotch-Brite to remove light surface oxidation and condition the surface for uniform contact during seating. The contact region was then lightly lubricated with engine oil to reduce insertion friction and mitigate the risk of galling.

- Final depth control was achieved through direct measurement by transferring the wear mark from the original canister onto the replacement canister (Fig. 3d), and tapping the replacement canister into the bore until this reference mark was reached (Fig. 3g). This approach leverages the confirmed axial equivalence of the original and replacement canisters, with any residual variation accommodated using external shims.

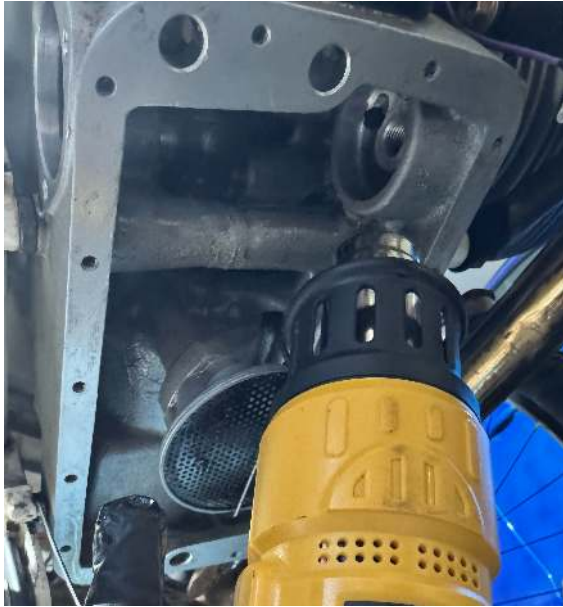
(e) Crankcase warmed with heat gun to reduce insertion force via differential expansion.

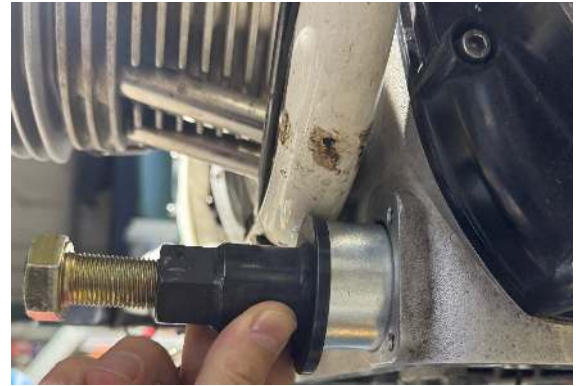
(f) Temporary axial driver assembled from available engine tools.

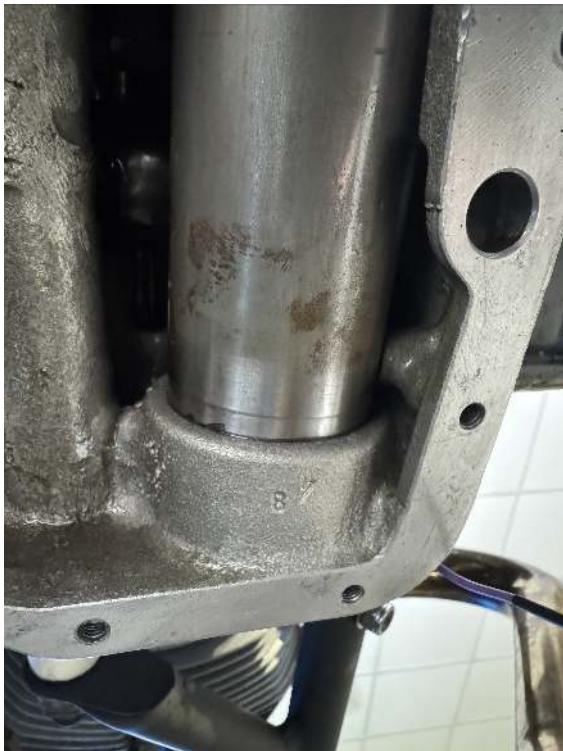
(g) Final installed position relative to the reference depth mark.

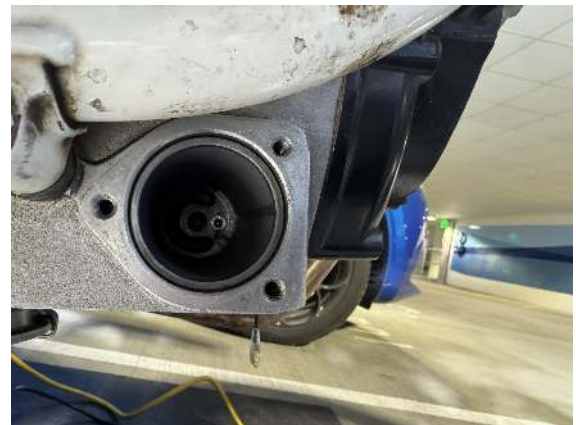
(h) View into installed canister showing improved concentricity and enhanced passive self-centering relative to the removed canister.

At no point during the installation was corrective re-centering required, and no evidence of asymmetric resistance or elastic spring-back was observed after seating. These observations are consistent with a clean, undistorted bore and with the later-style canister mouth geometry, which incorporates a larger, flared outer diameter that passively promotes self-centering through reduced annular clearance at the proximal crankcase-side mouth region.
