BMW Airhead Oil Filter Canister Displacement: Service Practice, Load Paths, and the \$2,000 O-Ring Myth

Custom Konrad

January 13, 2026

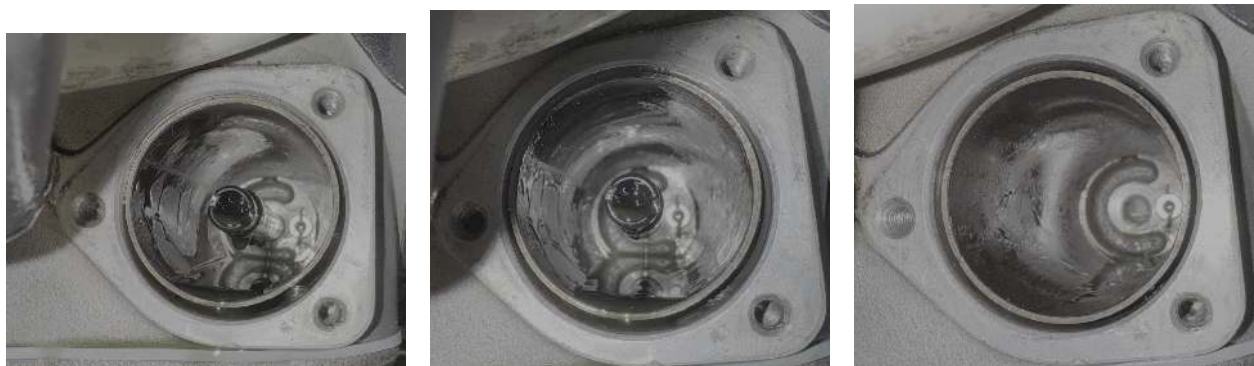
The mechanical response of the canister to this interference is documented in Fig. 2(a–c). After removal of the fastener, partial elastic spring-back was observed, but the canister did not fully re-center on its own. Deliberate mechanical re-centering at the mouth was required

(a) Localized deformation identified **(b)** Fastener removed as first corrective action **(c)** Canister mechanically re-centered by controlled levering

Figure 2: Canister displacement and recovery sequence, demonstrating dominant rigid-body motion about the distal press-fit region. (a) Localized deformation at the canister mouth caused by unintended radial jacking. Note the bolt protrusion visible in the lower-right quadrant (near the 5 o'clock position). (b) After fastener removal, partial elastic spring-back occurs, but full self-centering does not occur without an applied corrective moment. (c) Deliberate mechanical re-centering at the mouth restores nominal alignment of the canister relative to the crankcase bore. The central PIPE was removed at this stage to provide clearance for controlled levering without interference.

Distinguishing rigid-body motion from localized yielding is difficult *in situ*; however, both mechanisms are consistent with the observed seal extrusion shown in Fig. 1. The demonstrated ability to re-center the canister (Fig. 2) strongly supports a lightly retained, non-

Following removal of the unintended load, partial elastic recovery of the canister position was observed. However, full self-centering did not occur without deliberate mechanical intervention at the mouth.
