BMW Airhead Oil Filter Canister Displacement: Service Practice, Load Paths, and the \$2,000 O-Ring Myth

Custom Konrad

January 13, 2026

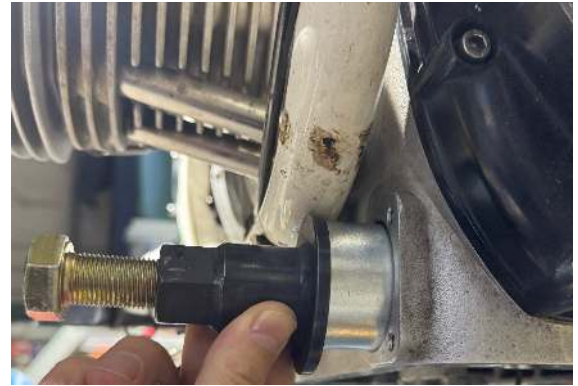
(f) Temporary axial driver assembled from available engine tools.

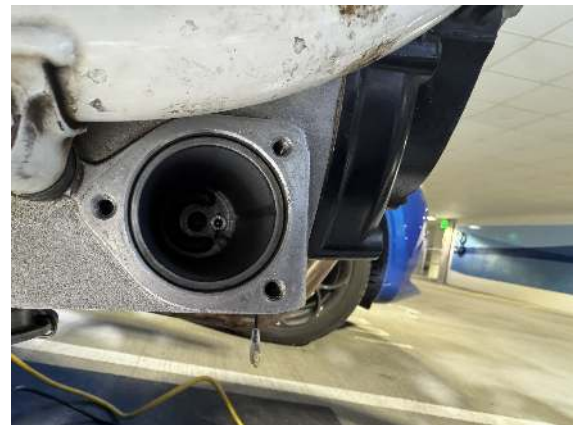
(h) View into installed canister showing improved concentricity and enhanced passive self-centering relative to the removed canister.

At no point during the installation was corrective re-centering required, and no evidence of asymmetric resistance or elastic spring-back was observed after seating. These observations are consistent with a clean, undistorted bore and with the later-style canister mouth geometry, which incorporates a larger, flared outer diameter that passively promotes self-centering through reduced annular clearance at the proximal crankcase-side mouth region.
