## A Geoenvironmental Study of Anjana – an endangered wetland in Krishnanagar I Block, West-Bengal

Dr. Indira Samajdar Gangopadhyay,  
Assistant Professor, P.G. Dept. of Geography, Barrackpore Rastraguru Surendranath College, Kolkata

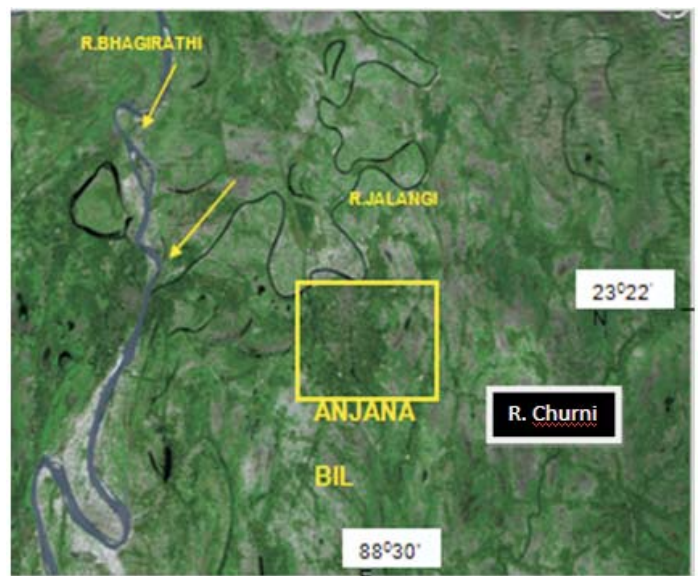
Fig. 2: Satellite Imagery of the Anjana Wetland and its Catchment Area

Anjana is an abandoned channel of River Jalangi, almost drying. The wetland is mainly rainfed and is connected with River Churni at present. The depth of water varies seasonally (Table - 1)

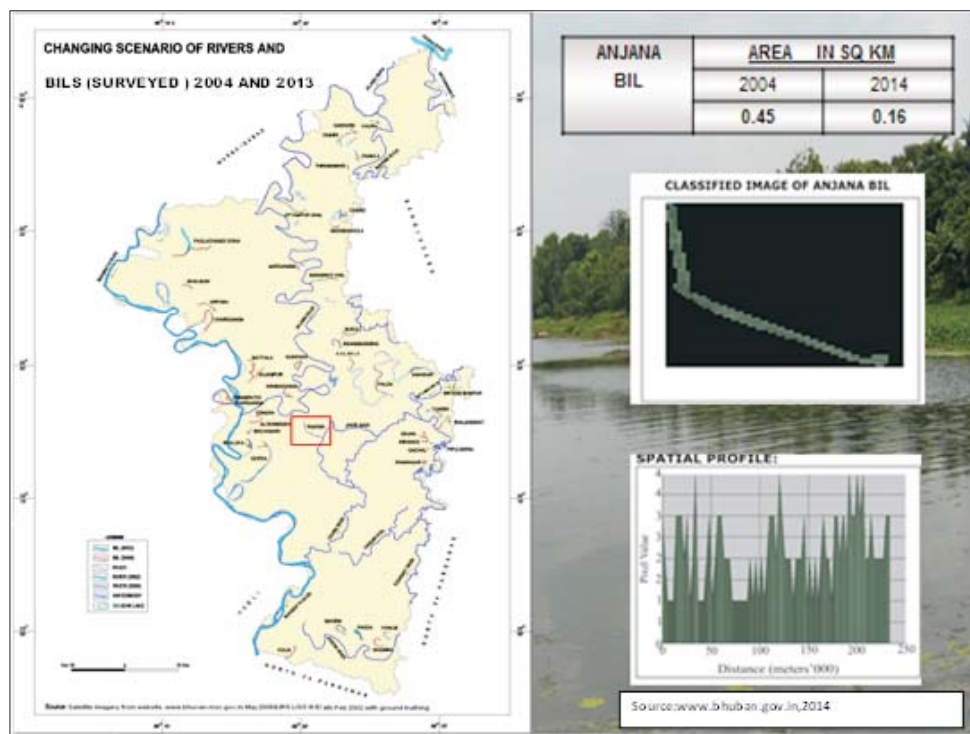
Fig. 3: Changing Scenario of the Rivers and Bils and Classified Image with Spatial Profile

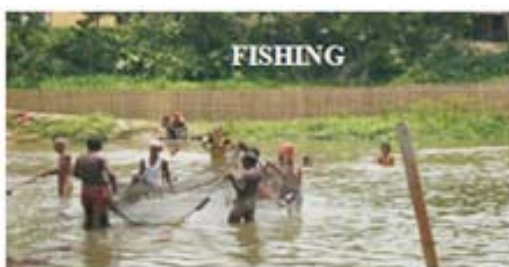
Fig. 4

The wetland is mainly utilized for fishing, domestic work, irrigation, immersion of deities and other activities. Anjana is owned by the fishery department of West Bengal Government and fishing right is given to the cooperative society. Around 160 Quintal of fishes are produced from this Wetland and the average annual income of the fishermen is around Rs.1.2 million (Fig. 4 and 52)

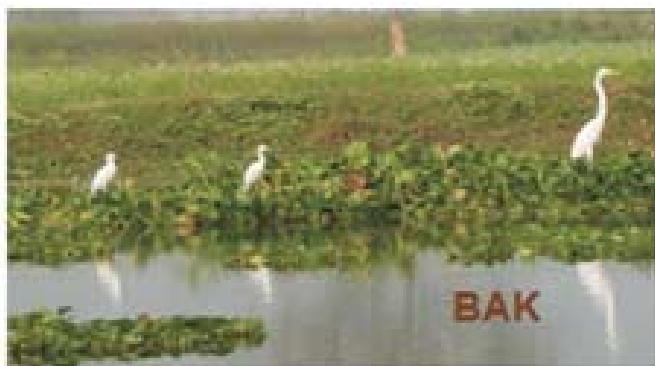
There is great diversity in floral and faunal species of the surveyed wetland in this block. The common flora of the wetland are Water Hyacinth, rooted submerged Hydrophytes like Hydrilla, Ottelia, Vallisneria etc. which grow at various depth. There are also plant species rooted in the mud but their leaves reach water surface and float. They are Nelumbo, Nymphaea, Trapa etc. There are free floating plants that are not fixed in the mud like Lemna, Wolfia, Pistia, Salvinia, Azolla etc (Table 2 and 3). Other fauna are Zooplanktons like Daphnia lumhaltazi, Moina micrura, D. carinata etc. Insects like May fly, Dragon fly, Water stridergerris, Water boatman, Whirling beetle, Leaf insect, Spiders, Crab are common. Annelids like Earth worm, Leach are common. Molluscs like Lymnaea, Pila globosa etc. are common (Fig. 6 and 7).

Fig. 6: Location of Tangri Watershed and its Geomorphological Features

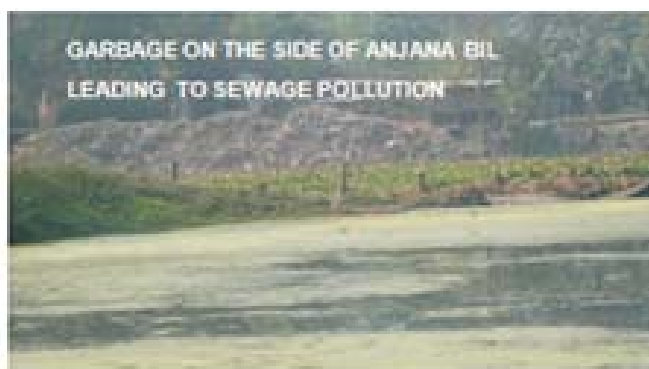
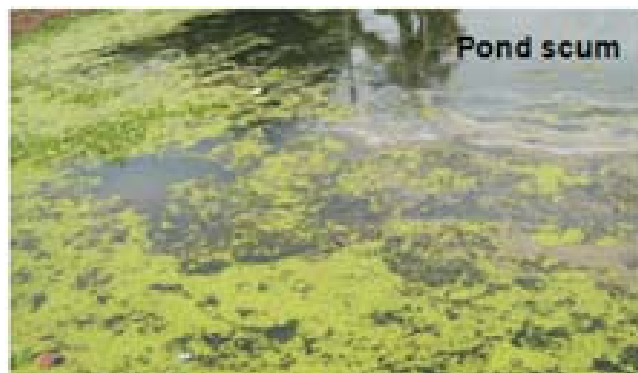
This has been studied and analysed with the help of remote sensing software. It is observed that deeper the shade of green lower the turbidity i.e. more clear water, less sedimentation and less vegetative cover. This indicates higher absorption of light and more transparent water. On the other hand, higher turbidity and areas of macrophyte algae bloom are indicated by light and lighter green shades. It shows greater reflection of light and high rate of siltation. After classification, the fourth class indicates higher turbidity values and first class shows lowest values. i.e the pixel values ranging between 1 and 2 indicates low turbidity, between 2 and 3 indicates medium turbidity and between 3 and 4 indicates highly turbid water quality. It is observed from the diagram that most parts of the wetland are highly turbid and are infested with macrophytes. The main cause is high rate of suspended clay, silts and organic load due to sewage pollution leading to algal boom and weed infestation ( Fig.8 and 9)

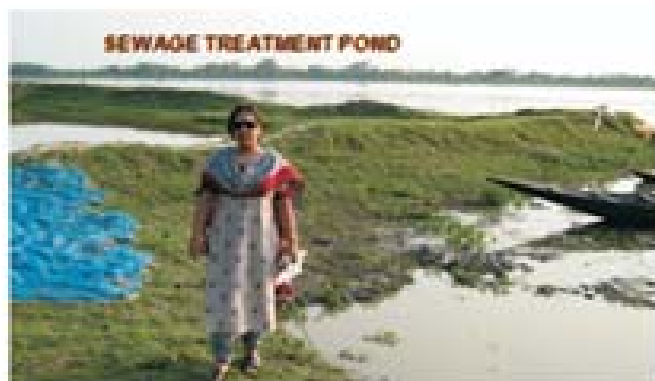
Fig. 10

Wetland resource management implies sustainable use of its resources for maximization and long term benefit of society and minimization of waste products. In this context proper conservation and management of the wetland and planned harnessing of its resources is needed. In view of the fact, firstly the problems should be identified and accordingly management programmes should be taken up. Here the micro level planning is needed (Fig. 10 and 11):
