The Study of Paglajhora Landslide in the Darjeeling Hills, West Bengal, India

Sudip Kr. Bhattacharya

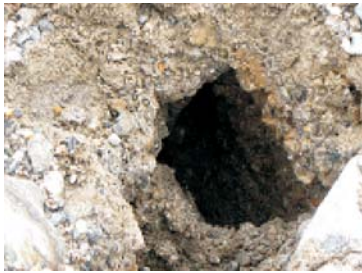
Fig. 10. Hollow formed by Hydraulic Pressure

Soil is coarse textured, and thin with maximum depth as 30 cm (Plate – 4). Sand fraction exceeds 80% which indicates that the compactness of soil over this area is very low for which micro pores have greater ability to be filled by water when soil is over-saturated. This rapidly increases the pore water pressure that enhances shearing stress and lessens soil coherence (Plate 5). It has a very steep angle of rest for which gravitational pulling of soil is quite natural. The liquidity index being very high along with very high degree of saturation and volume of expansion (not less than 71.26% and 8.51% respectively) during monsoon, detachment of soil from in situ position is easily possible.

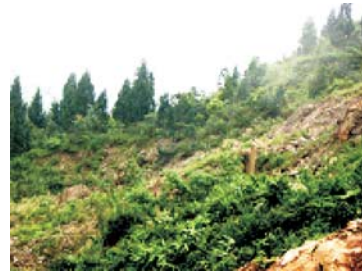
Fig. 11. Scattered Tree / Thin Cover

Since the pre-independence period, forest depletion through increasing human activities has been rampant in the entire Darjeeling Hills region; the level is far below the recommended amount (i.e. 33%) prescribed by National Forest Policy 1952 (Bhattacharya, 1998, 2009). The area around the slide is mostly covered by scattered trees interspersed with agricultural lands (Plate – 6). True forest is found only at the bottom of the slide scar

The site of the slide is devoid of true forest cover (except at the bottom which is inaccessible). It is mostly covered with scattered trees with poor undergrowth, and thin soil cover. On the northern side of the slide scar there are cultivated lands where poor agriculture is practised on slopes. Although there is a tea garden in the northern side, it has become sick with poor bush and poor maintenance.

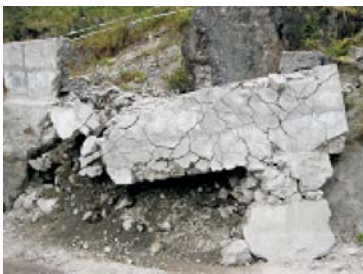
Fig. 12. Weight-induced Shattering
in Constructions

Landslide controls are attempted by the geotechnical engineers in most of the cases over this area by building huge concrete constructions without considering the weight of the materials. For construction of damaged roads or filling up the subsided roads the same procedure is applied. This

causes weight induced shattering on steep slopes (Plate – 7), subsequent slumping and sliding.

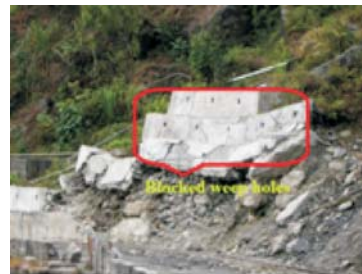
Fig. 13. Blockage of Weep Holes

Moreover, in the masonry constructions like retention wall or sausage wall, little care is taken in making weep holes so that during monsoon these become incapable of letting water pass at high pressures during heavy discharges and the construction gives in (Plate - 8) setting the stage ready for subsequent sliding and slumping. It also facilitates old scars to recur in the same spot year after year. Such incidences are common in the Paglajhora area, specially at 14 Mile spot.
