# Solar Energy

## A comprehensive review of visual inspection and detection techniques for identifying failure modes and potential defects in solar modules

# A comprehensive review of visual inspection and detection techniques for identifying failure modes and potential defects in solar modules

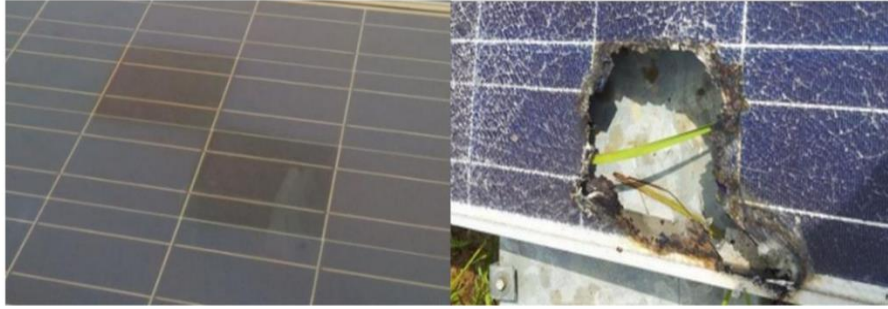
**Fig. 21.** Locations of hot spots of damaged cells in photovoltaic modules [86].

A "hot spot" is an area of cells where there is a thermal anomaly, meaning the temperature of some cells is significantly higher than that of others as shown in **Fig.21** [86]. This can be caused by damaged connections, partial shading, or the accumulation of dirt in a specific location. Furthermore, the I-V curve of the various cells places an additional burden on the remaining cells, as a reverse current flows through the series, resulting in heat dissipation at different points. There are other factors that contribute to the formation of hot spots, including partial aging of the cell, defective bypass diodes, mismatch of panels in the series, and insufficient ventilation. These issues result in reduced efficiency of photovoltaic panels and, in some cases, pose a fire hazard.

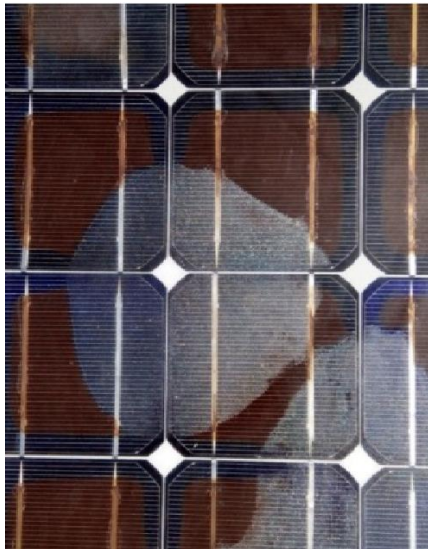
**Fig. 22.** A delamination of the solar panel [90].

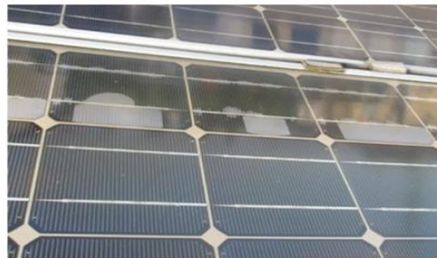
**Fig. 23.** The image shows the adhesion delamination between the front cover glass and the coated material, (a) shows the beginning of the separation process, (b) shows a significant delamination [90].

The environmental factors of hot and humid climates have been identified as a significant contributor to the degradation of solar modules, particularly in relation to the composition and structure of the modules themselves. Additionally, the quality of the adhesives utilized in the manufacturing process has been found to be a potential source of weakness in the overall durability of the modules. The combination of high temperatures and humidity, in addition to manufacturing defects, can result in a loss of adhesion between the layers of a solar panel. The coating may separate from the glass or the glass and the cell material or with the backing layer, resulting in water leakage, moisture entering between the layers, and contamination of the photovoltaic modules. This type of degradation leads to a continuous decrease in efficiency as evidenced by a power loss of up to 4% and a degradation of the safety class A rating at a single air/polymer interface [89], and may be a cause of greater risks. Detachment defects are detected by visual inspection or advanced imaging techniques. **Fig.22, fig.23** provides further illustration of the process of separating the components of the modules [90],[91].

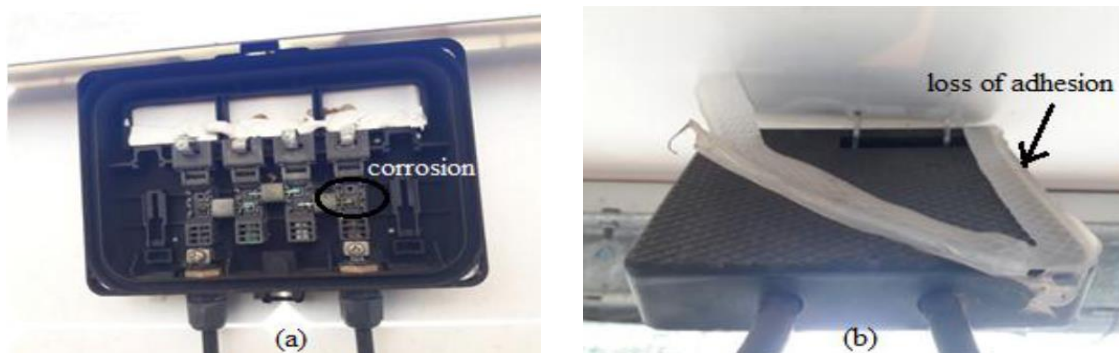
**Fig. 25.** The failure condition of the junction box is indicated by corrosion and loss of adhesion in the PV modules at the PNK (a) and Babuin (b) solar plants [95].

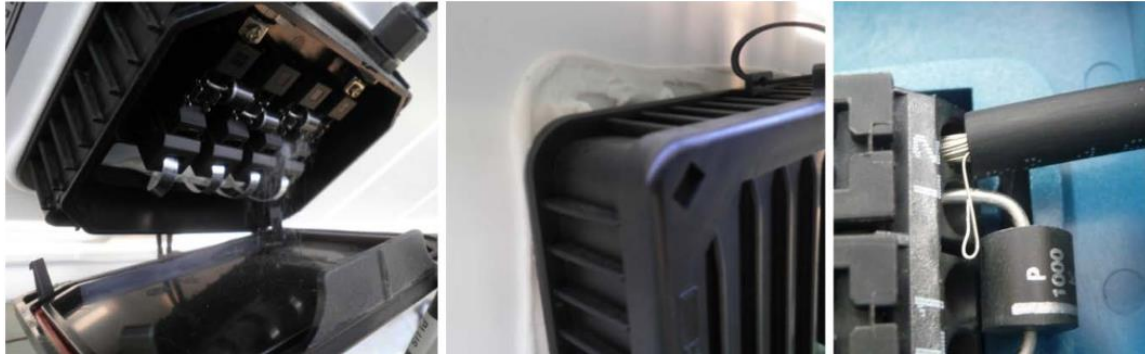
**Fig. 26.** Junction box degradation: The left image shows an open junction box, the middle image shows a poorly connected junction box, and the right image shows a junction box with poor wiring [89].

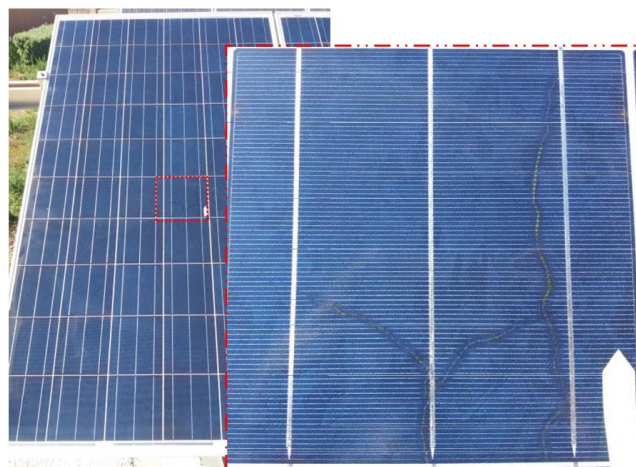
**Fig. 32.** Defective snail trails on a solar panel [108].

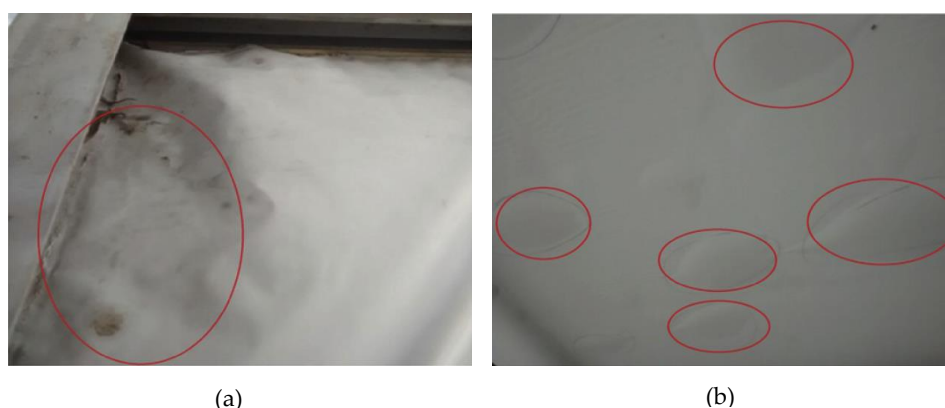
49 **Fig. 33.** (a) Delamination of the PV module's backsheet; (b) The presence of bubbles in the backsheet of  
50 the PV module [113].  
51  
52  
53  
54  
55  
56  
57  
58  
59  
60  
61  
62  
63  
64  
65
