A comprehensive review of visual inspection and detection techniques for identifying failure modes and potential defects in solar modules

Manuscript Number:	SEJ-D-24-03884
Article Type:	Review article
Section/Category:	Other solar energy topics
Keywords:	PV Systems Visual inspection Detection techniques Diagnosis of defects
Abstract:	<p>To guarantee uninterrupted and optimal power generation from photovoltaic solar energy systems, it is essential to ensure that these systems are free from any errors. Prompt detection and accurate diagnosis of solar panel faults allows for the avoidance of degradation of the PV system. Some faults can have a severe impact, potentially leading to significant human and material losses, even to the extent of causing fires in solar fields. There are various methods for detecting and characterizing faults and degradation cases in solar panels. At present, research is being conducted on one aspect through a review of the literature. Some reviews concentrate on classifying faults in solar panels, while others concentrate on detection techniques for these faults. Some reviews investigate artificial intelligence models that are applied to detect and diagnos

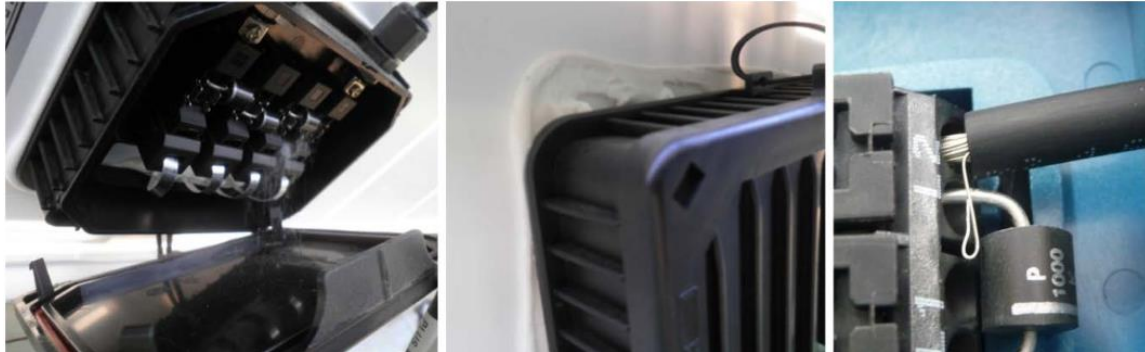
Fig. 26. Junction box degradation: The left image shows an open junction box, the middle image shows a poorly connected junction box, and the right image shows a junction box with poor wiring [89].
