Collins 30L-1 Linear Amplifier - Restoration & Repair

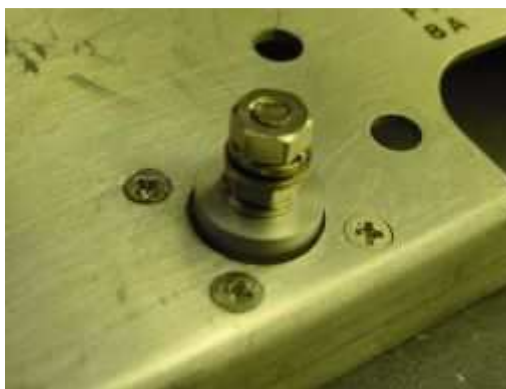
I wanted to return the original ground connection to the location of the replacement SO-239. So I made a small flange out of steel that was the same size as the flange on an SO-239. It is now mounted on the inside of the rear cover plate. A small hole was drilled for a grounding screw. To improve the look I added a thick aluminum washer (spacer) on the grounding post. This washer fills the hole from the old SO-239 connector. I countersunk the flange mounting holes and used flat head screws. I think it looks a little bit more professional.

Original Ground returned in place of the modified RF IN

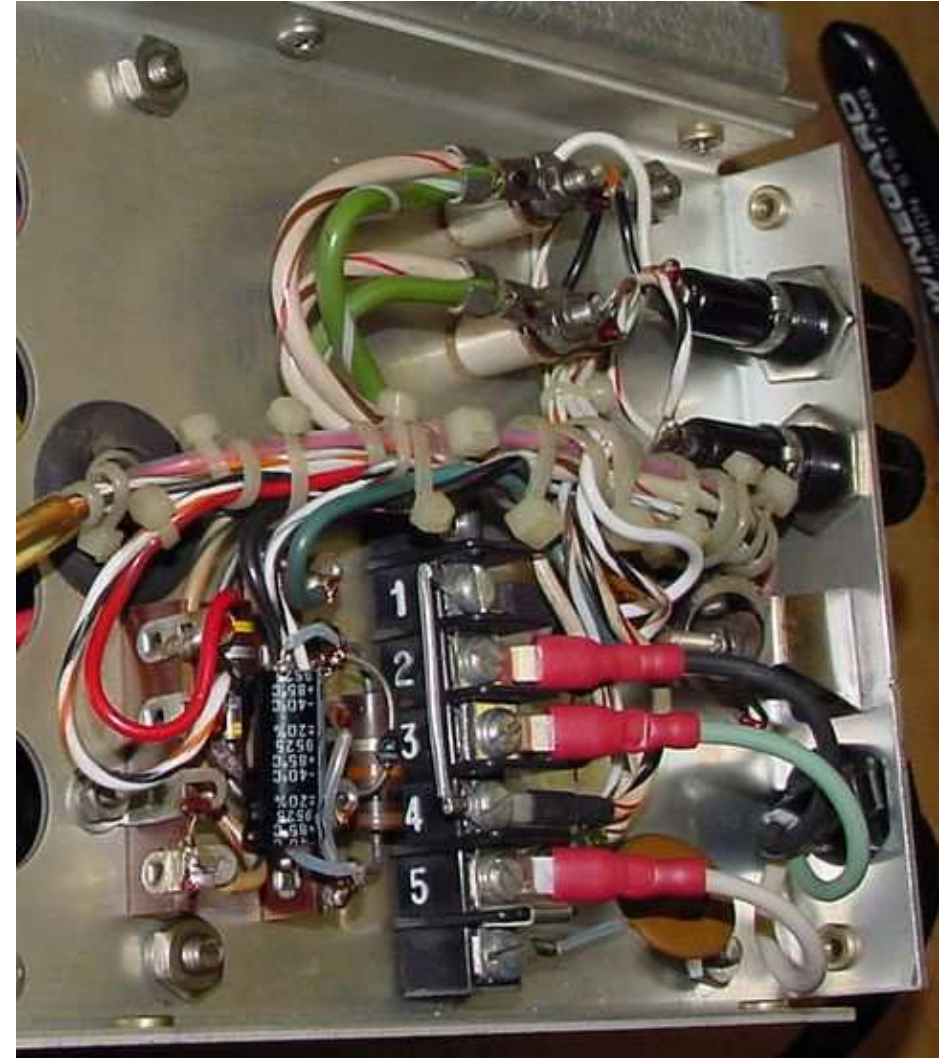
My Replacement AC Input Strip - The Way Collins should have done it! Just to the left of the new AC Input Strip above is the LV DC power supply circuit. There is a 10uF 250VDC electrolytic capacitor that should also get replaced here. Note this picture shows the new cap in place.

Also, notice the small wire (#30) that runs between the two lower terminals of that terminal strip at the far left. That is actually a fuse in the center tap to ground of the filament voltage secondary. If you have a 30L-1 that is experiencing hum in the output signal this little fuse wire may be blown. The tube filament will still glow when this wire is blown! Beware...

Interestingly it was actually engraved with the numbers 1 through 5 just like the Collins schematic. As you can see all the AC input wires from the line cord now connect via push-on terminals. Changing to 120VAC in the future will be a simple movement of the line cord terminals and the movement of one or two terminal-to-terminal jumpers. All original transformer primary winding connections, jumpers and bypass noise capacitors use simple eyelet terminals that now screw down for ease of removal and/or relocation.

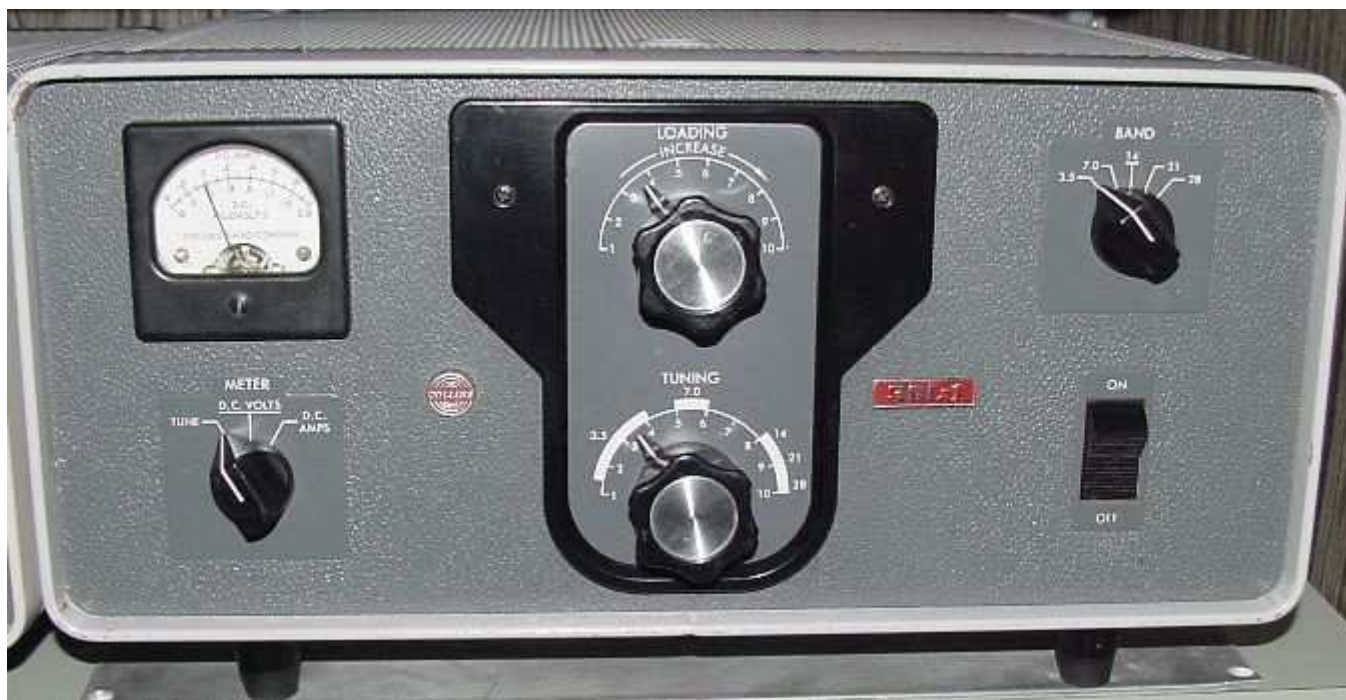
The completed 30L-1 RE. If you look closely you can see the scratches in the trim ring
