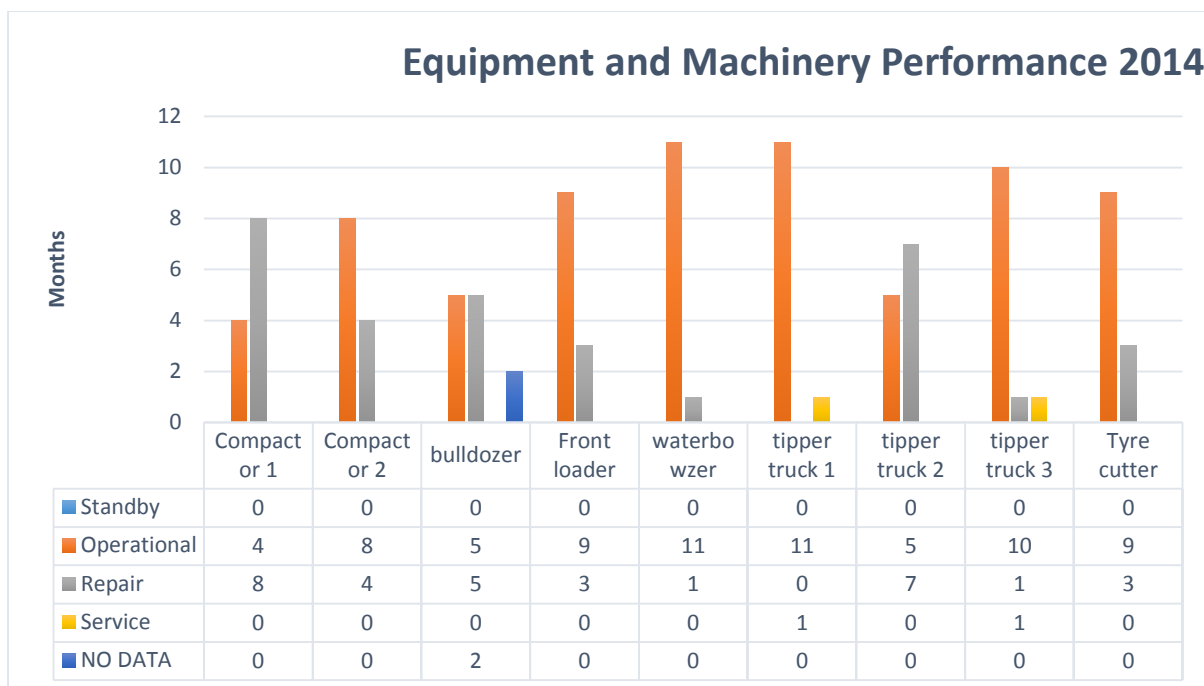
Figure 5: Landfill Equipment and Machinery Performance 2014

The chart shows that most of the landfill equipment were operational for eight months or more in the year 2014. However, this is with the exception of compactor 1 (four months), bulldozer (five months) and tipper truck 2 (five months). The chart also shows that compactor 1 and tipper truck 2 spent a considerable amount of time under repairs with compactor 1 having spent eight months and tipper truck 2 spending seven months. Other equipment which spent some time under repairs included ; compactor 2 (four months), bulldozer (5 months), front loader (three months), tyre cutter (three months) water bowser and tipper truck (one month) respectively.
