Engineered Materials Arresting Systems (EMAS)

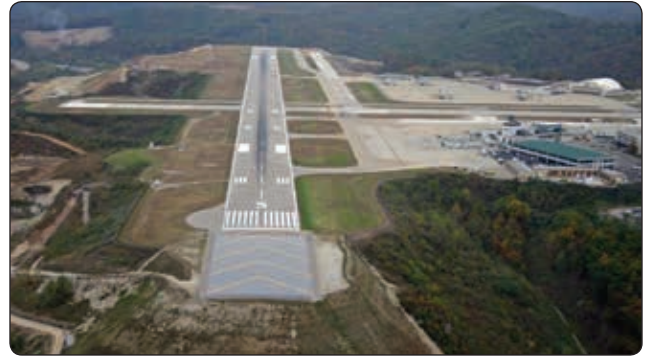
Figure 14-55. Engineered material arresting system (EMAS) located at Yeager Airport, Charleston, West Virginia.

The most dangerous of these incidents are overruns, but since many airports were built before the 1,000-foot RSA length was adopted some 20 years ago, the area beyond the end of the runway is where many airports cannot achieve the full standard RSA. This is due to obstacles, such as bodies of water, highways, railroads, populated areas, or severe drop-off of terrain. Under these specific circumstances, the installation of an Engineered Materials Arresting System (EMAS) is an acceptable alternative to a RSA beyond the runway end. It provides a level of safety that is generally equivalent to a full RSA. [Figure 14-55]
