# Project: Using lidar to assess impacts of dune restoration on coastal resilience in North Carolina

# Method (Coastal Laser Scanner System)

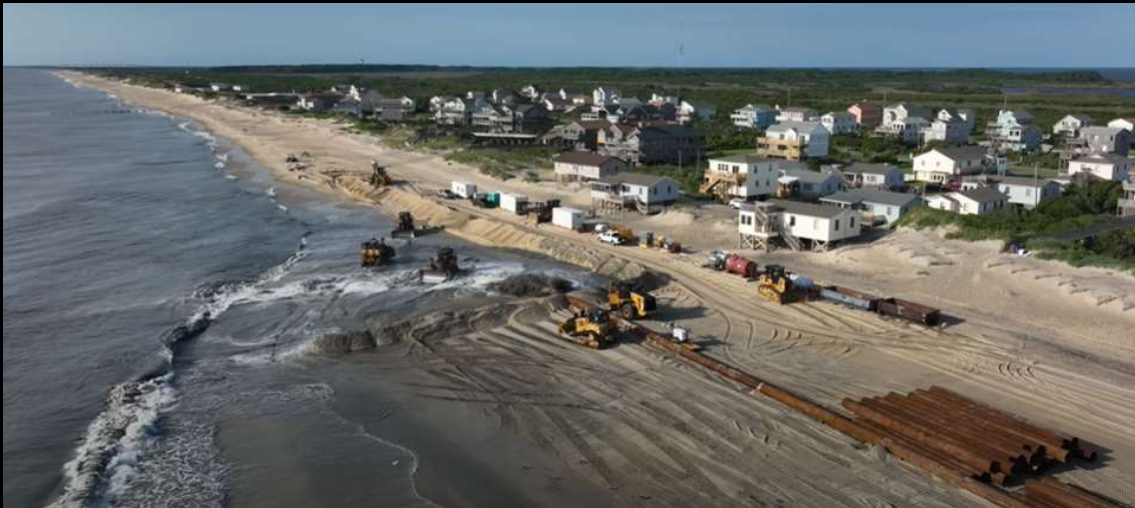
Nags Head Beach Restoration Project, July 2022

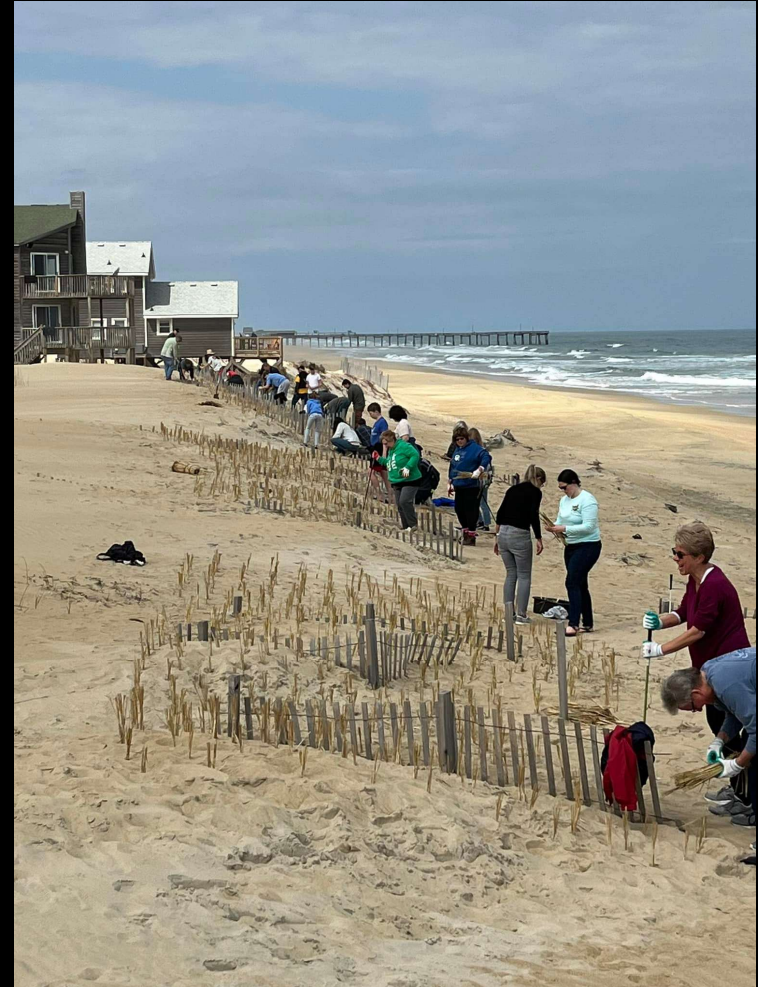
Grass planting by BBOBX, March 2022

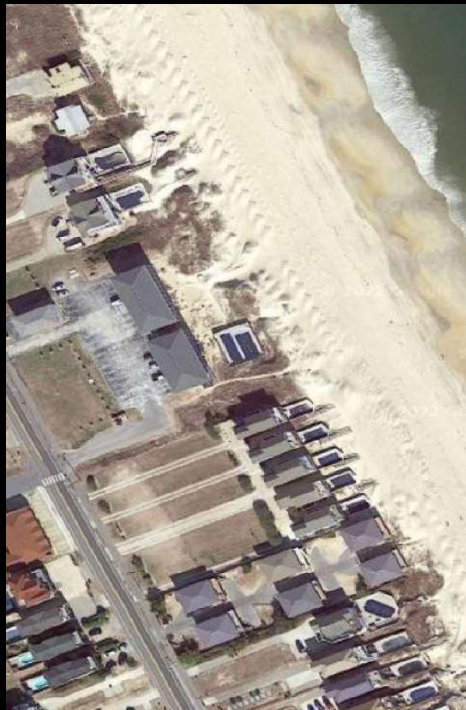
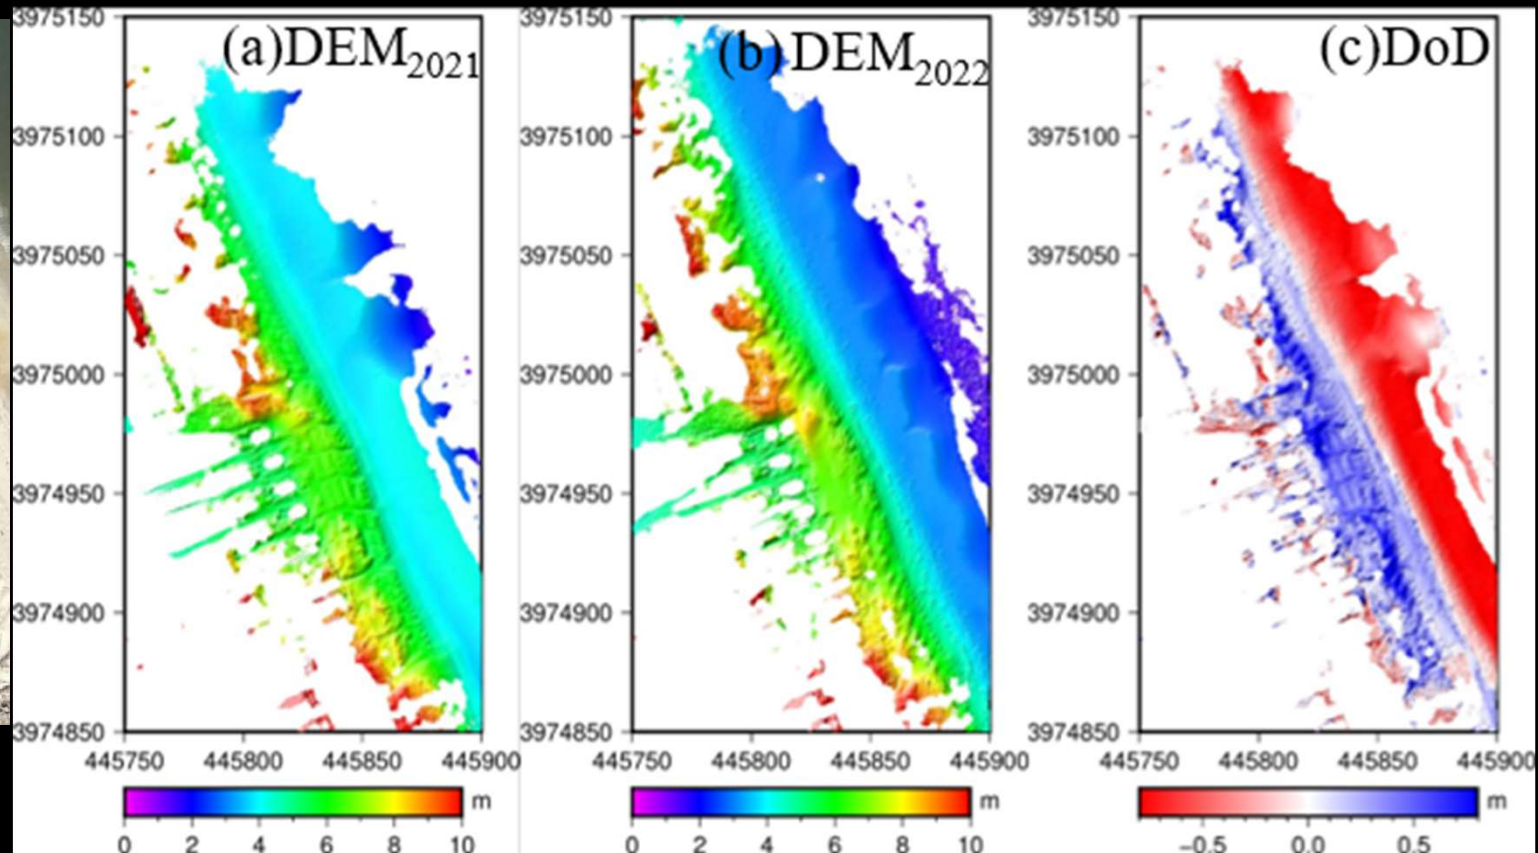
# DEMs and DoD of beach and dunes

- Location: Grouse Street, Nags Head, Time: August 2021 and March 2022

- 1) lidar point cloud data of coastal beach and dunes in LAS format,
- 2) data processing codes that will be openly shared in GitHub,
- 3) high-resolution (10 cm  $\times$  10 cm) and high-accuracy ( $\sim$ 2 cm) Digital Elevation Models (DEMs) and Difference of DEMs (DoDs) before and after restoration,
- 4) changes in dune toe, ridge, volume, shoreline and vegetation,
- 5) interactive webmaps using Google Earth Engine Apps to share results for stakeholders and the community,
- 6) recommendations for future dune restoration management

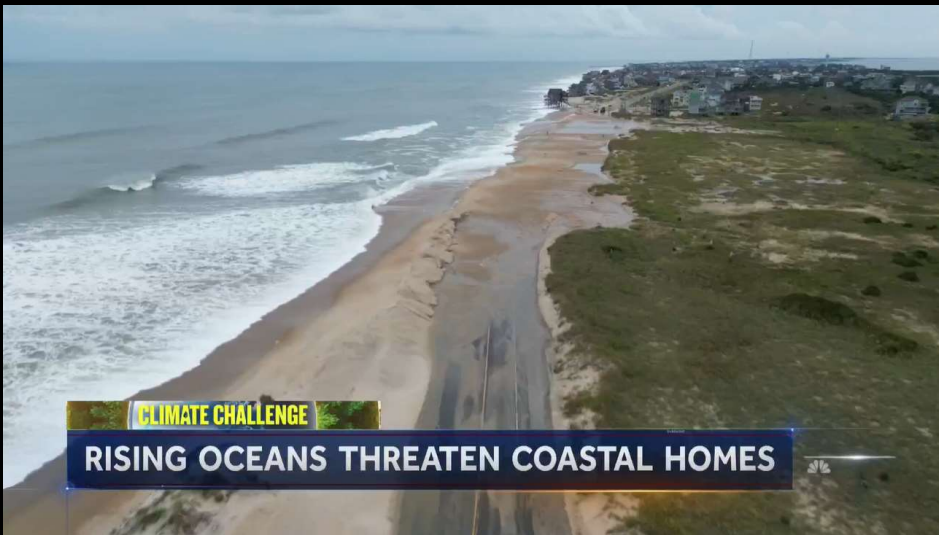
# Washover area in Mirlo Beach

Drone photo from NBC news  
([www.nbcnews.com](http://www.nbcnews.com), 10/07/2022)
