**Model:** Nexia R3 **Production date:** 07. Sep. 2018

**Part name:** Expansion tank cap

**Problem description:** Expansion tank cap defect

### WPAC Warranty Part Analysis Results :

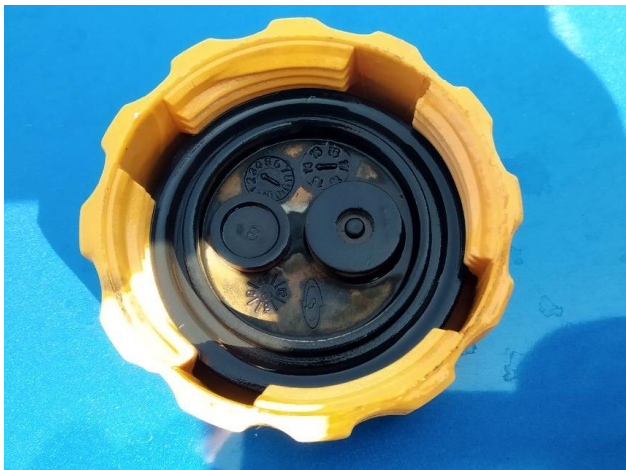
Appearance: The first step is carefully inspected the reservoir tank cap. The cracks, tears of sealing linings, severe abrasion or other mechanical damage were not found.

Functionality: After installing the cap of the expansion tank on the WPAC car, the engine was started, waited until the engine warmed up and began to slowly open the cap. There was a sound of air escaping (as when opening a bottle of carbonated drink), the cap restrains the pressure generated in the system. This indicates its failure. **Defect was confirmed.**
