ASH PARK HISTORIC DISTRICT WALKING TOUR

THE ASH PARK DISTRICT IS FROM 5TH TO 8TH AVENUE AND 6TH TO 8TH STREET.

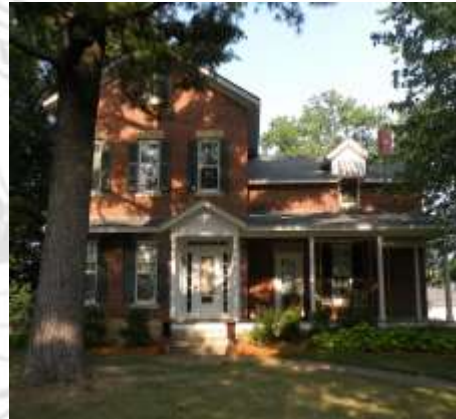
#1

WE BEGIN THE TOUR AT THE CORNER OF 7TH ST. SW AND 8TH AVE. NW, LOOKING TOWARD THE EAST AT THE HOMESTEAD OF RUEBEN ASH (702 8TH AVE. NW). HE WAS ONE OF THE EARLY SETTLERS OF THE AREA, REPORTED TO HAVE A CABIN ON THIS SITE AROUND 1838. THIS HOUSE OF RED BRICK WAS BUILT IN TWO PHASES. THE HOUSE TO THE LEFT, WITH THE ENTRANCE, WAS BUILT AROUND 1853. THE WING TO THE RIGHT WAS ADDED IN A FEW YEARS LATER, WITH NO CHANGE IN STYLE OR BRICK COLOR. THIS IS A TYPICAL RECTANGULAR-STYLE HOUSE MADE OUT OF BRICK, AND THIS SAME STYLE IS FOUND IN BOTH BRICK AND STONE ALL AROUND TOWN. THIS IS THE ONLY ONE OF THIS KIND OVER IN THIS AREA, BECAUSE IT WAS THE FARMSTEAD AND SURROUNDED BY HUNDREDS OF ACRES OWNED BY ASH. THERE ARE THREE-OVER-THREE WINDOWS, AND OVER THE DOOR IS A LOVELY TRANSOM THAT LET LIGHT INTO THE HOUSE. THERE IS A LARGE SITTING ROOM AREA OFF TO THE RIGHT IN THE ADDITION. THE PILLARS ARE PROBABLY NOT ORIGINAL, BUT THE PORCH LINE IS. IT IS A GREEK REVIVAL HOUSE, WITH DOUBLE-BRICK WALLS MADE OF LOCAL BRICK BAKED ON THE PROPERTY. THE BRICK IS THE SAME TONE OF COLOR AND TEXTURE AS THE BUILDINGS ON THE CORNELL CAMPUS AND OTHER BUILDINGS IN TOWN. EVERY SEVERAL ROWS OF BRICK YOU WILL SEE A ROW OF HEADERS THAT ARE TYING THE WALLS TOGETHER, MIXED WITH THE STRETCHERS.

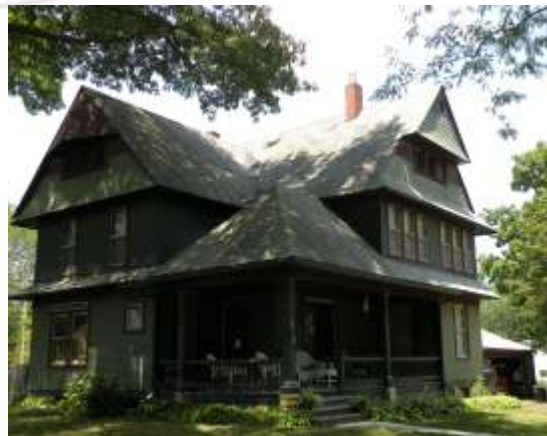
#3

WE ARE ON THE CORNER OF 7TH AND 7TH. 703 7TH AVE. NW, THE VERY LARGE HOUSE WITH THE PARTIAL WRAP-AROUND PORCH WAS BUILT BY CHARLES M. HARTUNG, A BANK OFFICER AND ONE OF THE DEVELOPERS OF THIS AREA. IT SITS ON A VERY LARGE CORNER LOT AND WAS BUILT IN 1902. THE HOUSES TO THE NORTH OF THIS HOUSE ARE NOT INCLUDED IN THE ASH PARK DISTRICT. THEY ARE MOSTLY IN-FILL. THIS HOUSE IS VERY CHARACTERISTIC OF ITS PERIOD. IT HAS A PORCH WITH ITS LOVELY BALUSTRADE AND COLUMNS, AND THE FIRST FLOOR HAS NARROW SIDING AND THE SECOND FLOOR AND GABLE ENDS ARE SHINGLED AS WELL. NOTICE THE COMPLEX ROOF CONSTRUCTION --

POPULAR IN THE VICTORIAN ERA. IF YOU LOOK TO THE EAST SIDE OF THE HOUSE YOU WILL SEE THE LARGE WINDOWS AND THE LOVELY HIGHLIGHTED FISH SCALING.

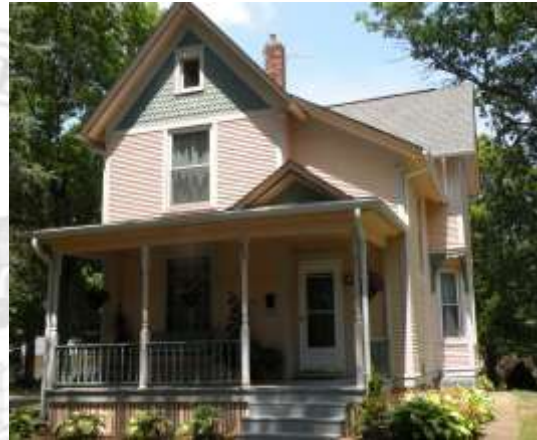
#4

617 7TH ST. WAS BUILT IN 1914. IT HAS CROSSED GABLES AND AN UNUSUAL GABLE EXTENSION TO THE FRONT-FACING GABLE, CHAMFERED CORNERS AND VERY NARROW SIDING, AND A FRONT PORCH WITH SPINDLE BALUSTERS. THERE IS A SIZEABLE ADDITION ON THE NORTHWEST CORNER, AND A SMALL SITTING PORCH ON THE NORTHEAST CORNER.

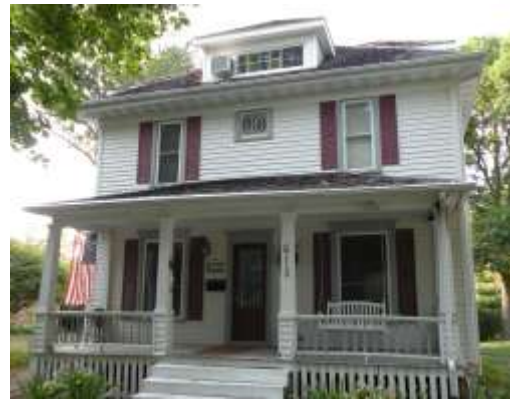
#5

NEXT DOOR TO THE EAST IS 615 7TH ST. NW. THIS IS A FOUR-SQUARE HOUSE, REPORTEDLY BUILT BY HENRY BAIR IN 1915. NOTE THE HIPPED ROOF AND ITS AMPLE DORMER WITH THREE SQUARE, MULTIPLE-PANE WINDOWS. THE HOUSE IS SYMMETRIC IN DESIGN. A SMALL GABLED REAR ADDITION WAS BUILT IN 1977.

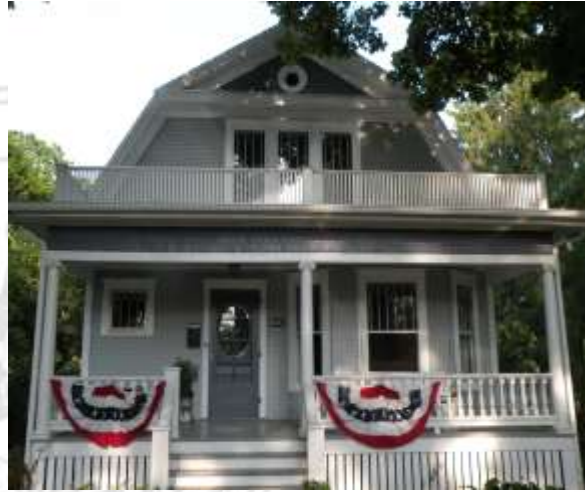
#6

616 7TH AVE. NW WAS BUILT IN 1900. IT IS A GOOD EXAMPLE OF WHAT WAS GOING ON IN DOMESTIC ARCHITECTURAL STYLES AT THE TIME. THIS IS A GAMBREL ROOF (THAT MEANS THAT THE GABLE HAS AN EXTRA HIP IN IT). THERE IS A LOVELY PORCH ENHANCING AND PROTECTING THE BAY WINDOW, THE BALUSTRADE LOOKS ORIGINAL, AND ON THE SOUTH SIDE THERE IS ANOTHER BAY WINDOW. THERE IS ANOTHER GAMBREL ON THAT SIDE, DELICATE WINDOW TREATMENTS, AND A BANDING OF FISH SCALE FORMING A FRIEZE JUST ABOVE THE COLUMN AND BELOW THE OVERHANG OF THE PORCH. THAT GOES ALL AROUND THE HOUSE. IT IS REALLY QUITE INTERESTING AND GIVES THE HOUSE A VERY DISTINCTIVE DESIGN FEATURE.

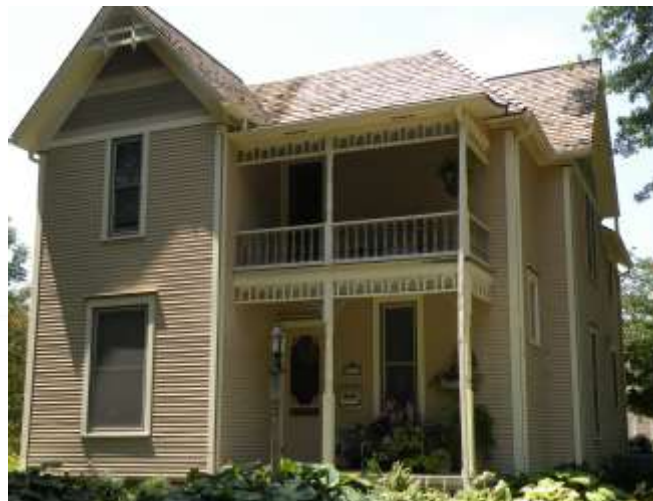
#7

ACROSS 7TH ST. (ON THE WEST SIDE OF THE STREET), YOU WILL SEE THE CHAFFEE HOUSE AT 617 7TH AVE. NW (STILL AT THE CORNER OF 7TH AND 7TH). IT WAS BUILT IN 1895. IT WAS ONE OF THE FIRST HOMES BUILT IN THE

DISTRICT. IT HAS A DELICATE PORCH ABOVE THE PORCH, FISH SCALING IN THE GABLE ENDS, AND IT HAS A BEAUTIFUL BARGEBOARD AT THE END OF EACH GABLE. THIS HOME IS VERY STRAIGHT FORWARD, AND A MODEST AND CHARMING HOUSE BUT NOT IMPOSING. THERE HAVE BEEN VERY FEW ALTERATIONS, AND WE ARE VERY PLEASED THAT IT HAS BEEN WELL CARED FOR OVER THE YEARS.

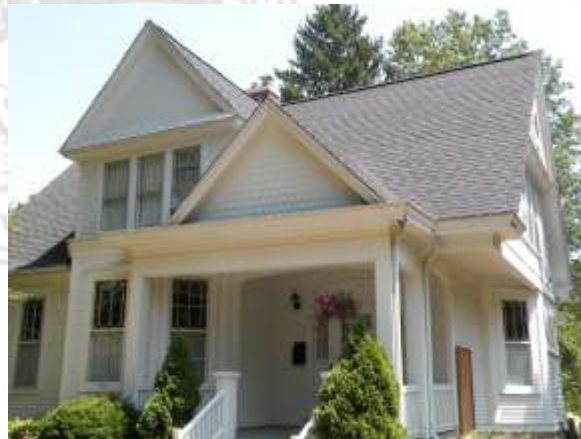
#8

608 7TH AVE. NW, ALSO BUILT AROUND 1900, HAS A COMPLEX ROOF LINE AND A LARGE AMOUNT OF FISH SCALE IN TWO DIFFERENT PATTERNS. THESE LAST FOUR HOUSES THAT WE HAVE SEEN USE A LARGE AMOUNT OF FISH SCALES. THIS HAS A LOVELY ONE-STORY BAY, THE PORCH

IS VERY STRAIGHTFORWARD, AND THE GABLE ENDS ARE INTERESTING. NOTICE THE OVAL WINDOW IN THE ATTIC ON THE NORTH SIDE, CALLED AN OCULUS. THERE ARE WINDOW PANES OR MUNTINS IN THESE HOUSES, ESPECIALLY IN THE UPPER WINDOWS, THAT ARE NOT UNUSUAL IN THE EARLY 1900'S. IF YOU ARE LOOKING AT THE SOUTH SIDE OF 616 THE BEAUTIFUL PANES MOVE NATURAL LIGHT INTO THE SITTING ROOM, AND THERE IS AN ENCLOSED PORCH ON THE BACK. THE HOUSE AT 608 GIVES A SENSE OF WARMTH IN PART FROM THE DELICATE TRANSOM WINDOWS ON EITHER SIDE OF THE DOOR. THESE, WITH THE MOLDED PANE OVER THE DOOR, FRAME THE DOOR WITH A SUBTLE ARCH SHAPE. THIS ARCH GIVES THE ENTRANCE A SENSE OF GRANDEUR WHEN LIT AT NIGHT. IT IS A CENTRAL FEATURE OF THE HOUSE.

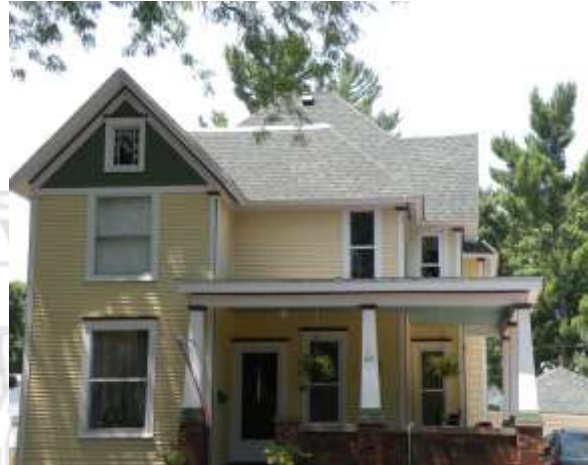
#9

605 7TH AVE. NW WAS BUILT IN 1900. IT HAS A COMPLEX OUTLINE DUE TO THE HIPPED ROOF, THE ADDITIONAL GABLES, AND THE PORCH ROOF. THERE IS CLAPBOARD WITH WOOD SHINGLE, MOLDED LINTELS, A CHAMFERED SIDE BAY, AND FISH SCALES ON THE GABLES. ALTERATIONS INCLUDE THE ENCLOSURE OF A TWO-STORY SLEEPING PORCH ON THE BACK. THE FRONT PORCH, WITH ITS INTERESTINGLY-PATTERNED BRICK SKIRT AND ITS BUNGALOW-STYLE PILLARS, MAY BE A LATER ALTERATION.

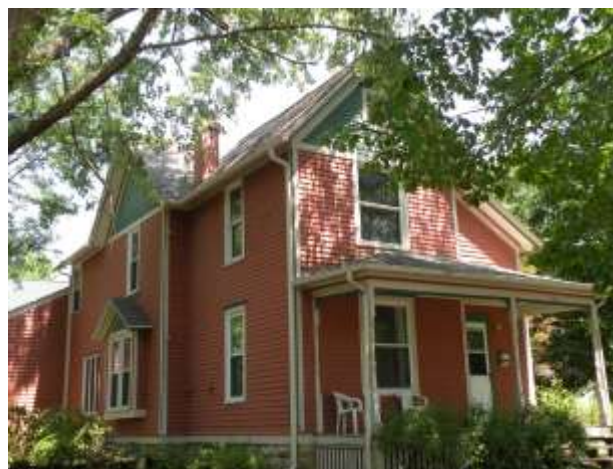
#10

THE HOUSE ON THE CORNER IS 625 6TH ST. NW. DESPITE A NUMBER OF ADDITIONS AND ALTERATIONS, THIS HOUSE IS CLEARLY FROM THE TURN OF THE CENTURY (BUILT ABOUT 1900). IT HAS A LITTLE FISH SCALING IN THE GABLE END, A HINT OF A BAY WINDOW ON THE WEST SIDE, A SMALL PORCH AND ON THE EAST SIDE A CHAMFERED CORNER PART OF THE VICTORIAN STYLE. IT IS A RELATIVELY COMMON STYLE OF HOUSE IN MT. VERNON AND POPULAR IN IOWA AT THE TURN OF THE

CENTURY. THE ADDITION ON THE SIDE IS PROBABLY NOT ORIGINAL.

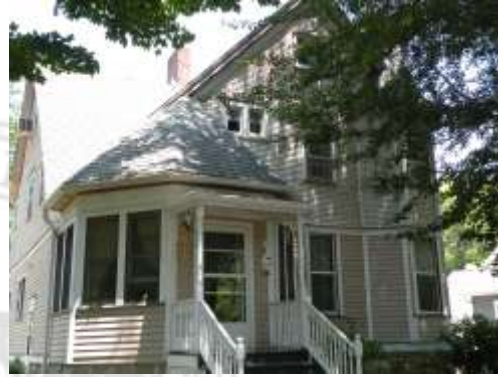
#11

THE NEXT HOUSE IS 615 6TH ST. NW. IT IS A REAL QUEEN ANNE-STYLE, BUT A RATHER RESTRAINED EXAMPLE. NOTICE THE TURRET ON THE ENTRANCE AND ANOTHER ONE IMMEDIATELY TO YOUR RIGHT. THERE ARE TWO DIFFERENT STYLES OF SIDING, A LARGE SIDING ON THE LOWER FLOOR AND A NARROWER ONE ON THE SECOND FLOOR. THERE ARE LOTS OF WINDOWS AND IRREGULAR ROOF LINES, PART OF THE QUEEN ANNE STYLE. UNDOUBTEDLY THERE WERE PORCHES ON THE BACK THAT WERE CLOSED IN. NOTE THE SECOND FLOOR PORCH IN THE BACK WHERE THE LARGER SIDING IS USED IN THE UPPER PART OF THE HOUSE WHILE THE ORIGINAL HOUSE HAS IT ON THE LOWER PART OF THE HOUSE. THAT IS PRETTY TELL-TALE EVIDENCE THAT AN ADDITION HAS BEEN MADE OR THAT IT HAS BEEN ENCLOSED. THE ROOFLINE IS ORIGINAL. THE EAST SIDE OF THE HOUSE HAS THE MAIN TURRET WITH ITS 2-FLOOR BAY WINDOWS. THERE IS YET ANOTHER BAY WINDOW, ON THE EAST SIDE.

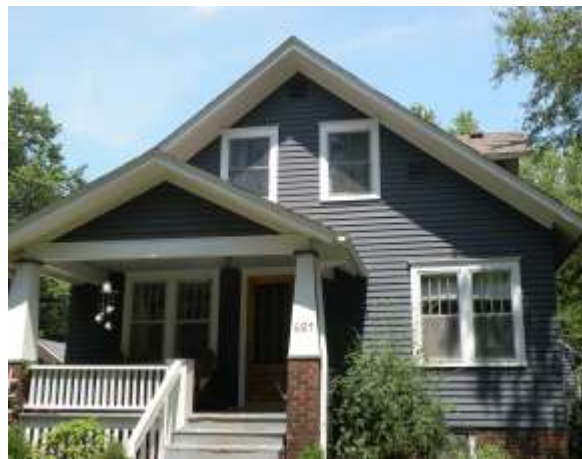
#12

THE BUNGALOW STYLE HAS MANY EXAMPLES IN TOWN. THE ONE AT 609 6TH ST.

NW, AN EXCELLENT EXAMPLE OF A CRAFTSMAN-STYLE BUNGALOW, FITS WELL IN THE ASH PARK DISTRICT. THIS IS VERY TYPICAL OF THE WHOLE BUNGALOW MOVEMENT, AND THIS HOME WAS ONE OF THE LAST HOUSES BUILT HERE UNTIL AFTER WWII. IT WAS BUILT IN 1921. MOST OF THE BUNGALOWS IN TOWN WERE BUILT BETWEEN 1910 AND 1925. THE GABLES OFF THE WEST AND EAST ARE MOST LIKELY AN ADDITION, AND THE GARAGE ON THE NORTH END IS A RECENT ADDITION. THERE IS A NICE SENSE OF ENTRY AS ONE CROSSES THE LARGE PORCH. A BUNGALOW IS USUALLY CONSIDERED A STORY AND A HALF. IN THIS KIND OF STRUCTURE, THE INTERIOR OF THE TOP FLOOR HAS A CRAZY SHAPE DUE TO THE CRAZY ROOF LINE, AND THERE ARE DIFFERENT POSSIBLE WAYS TO HAVE IT FINISHED OFF. THE OWNERS CAN HAVE ONE BIG ROOM IF THEY WISH.

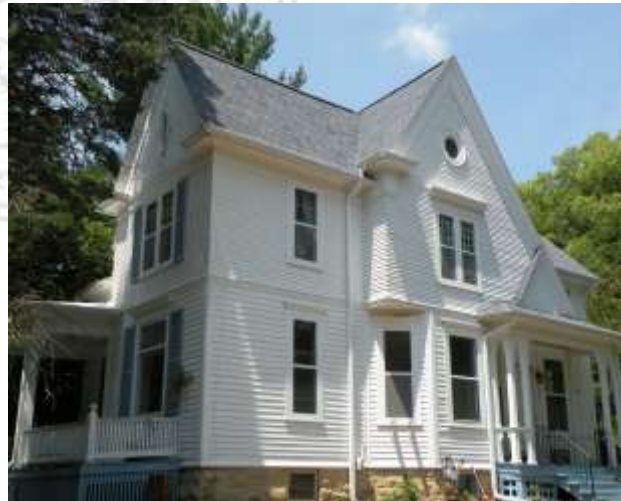
#13

ON THE CORNER IS 603 6TH ST. NW. THE HOME IS KNOWN AS THE (HISTORICAL) FREER HOUSE AND IT DATES FROM 1901. FREER WAS A LONG-TIME DEAN OF THE COLLEGE. THIS IS A VERY LOVELY HOUSE BUT THE TREES HERE HAVE MADE IT VERY HARD TO SEE THE HOUSE. THERE IS WIDE SIDING ON THE

FIRST FLOOR, NARROW SIDING ON THE SECOND FLOOR, AND FISH SCALES IN THE GABLE END ALONG WITH THE OVAL (ORIEL) ATTIC LIGHT. THERE IS A BAY WINDOW ON THE WEST SIDE. THERE IS FISH SCALING AS WELL. THIS IS ONE OF THOSE HOUSES WHERE YOU HAVE TO WALK ALL THE WAY AROUND IT TO GRASP ALL THE DETAILS. HEAVY USE OF DECORATIVE ELEMENTS ON THE EXTERIOR OF THE HOUSE IS A CHARACTERISTIC OF THE VICTORIAN STYLE.

ONE OF THE STYLISTIC MYSTERIES OF THIS HOUSE IS THAT THERE IS NO ROOF OVER THE EXTENSION OF THE FRONT PORCH AND THERE NEVER HAS BEEN. YOU CAN TELL BY THE WAY THE SHINGLES

AND WOOD ARE RIGHT ABOVE THE WINDOW. IT IS VERY UNUSUAL TO SEE ANY VICTORIAN HOUSES WITHOUT A ROOF ON THE FRONT PORCH. THERE ARE TRANSOMS ON EITHER SIDE OF THE DOOR AND ONE ABOVE. THE DECORATIVE WORK INSIDE THE WINDOWS WAS ADDED. THERE ARE VERY STEEP ROOF LINES ON THE STRUCTURE. THE SCREENED PORCH ON THE WEST SIDE IS AN ADDITION.

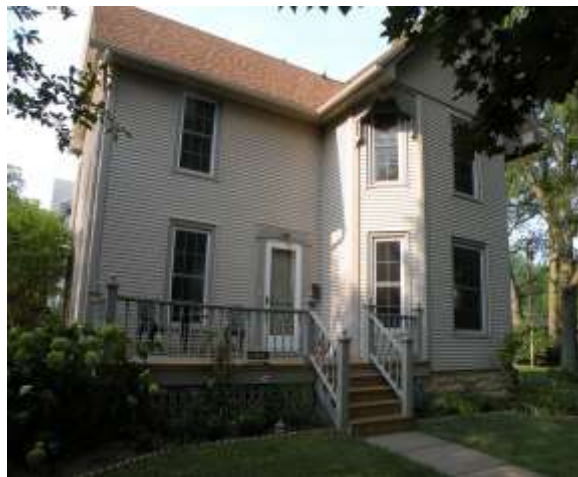
#14

ON THE NORTH-EAST CORNER OF 6TH AND 6TH IS 525 6TH ST., A LOVELY SAND BROWN HOUSE WITH CHAMFERED CORNERS. THIS HOUSE IS FROM 1897 AND IS ONE OF THE EARLY HOMES IN THE DISTRICT. IT IS CLOSE TO THE TOWN AND JUST ABOUT THREE BLOCKS FROM THE COLLEGE. THE HOUSE IS CONSIDERED NON-

CONFORMING BECAUSE IT HAS BEEN COVERED WITH ALUMINUM SIDING AND HAS LOST SOME OF ITS SHARPNESS OF THE ANGLES, BUT SOME OF IT HAS BEEN RETAINED. IT WOULD ORIGINALLY HAVE HAD A VERY DIFFERENT PORCH LINE AS WELL.

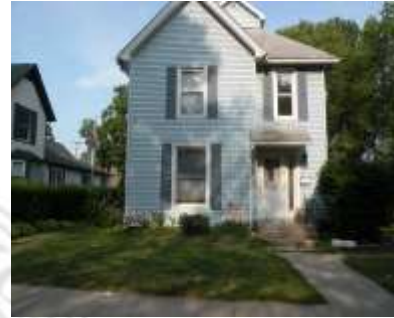
#15

606 6TH AVE. NW IS A NON-CONTRIBUTING STRUCTURE (LARGELY BECAUSE OF ALTERATIONS) FROM 1895. IT HAS A BAY WINDOW AND AGAIN, A COMPLEX ROOF LINE. THE BAY IS ON THE SOUTH SIDE, AND THE ALUMINUM SIDING HAS DEPRIVED US OF SOME SUBTLETIES OF THE HOUSE. THE DOORWAY IS NOT ORIGINAL. A LARGE FRONT PORCH HAS PROBABLY COME OFF. THE GABLE ON THE VERY TOP IS SOME SORT OF ADDITION.

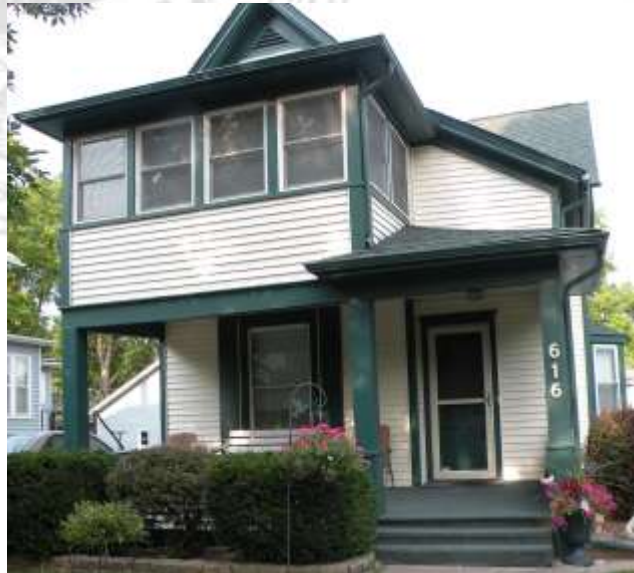
#16

FIND 616 6TH AVE., NEXT DOOR. THIS IS A VERY SMALL AND MODEST HOUSE, AND LIKE 606 IS CONSIDERED A NON-CONTRIBUTING STRUCTURE IN THE DISTRICT BECAUSE OF THE ALTERATIONS. THIS PORCH IS VERY CONFUSING. ITS DIMENSIONS LOOK ORIGINAL, AND 606 SHOULD ORIGINALLY HAVE HAD A VERY SIMILAR PORCH. THE SECOND FLOOR PORCH HAS OBVIOUSLY BEEN ADDED. THE PORCH MIGHT HAVE COME CLEAR ACROSS AT ONE TIME. YOU HAVE TO USE A LITTLE IMAGINATION TO SEE THE ORIGINAL SHELL OF THE HOUSE UNDER THE ALTERATIONS. THIS HOUSE MAY HAVE BEEN IDENTICAL TO THE HOUSE ON THE RIGHT. THERE IS SHINGLING IN THE GABLE ENDS. IT IS ASYMMETRICAL AND THE ROOF SLOPES TO THE SOUTH. THE LITTLE GABLE ABOVE THE PORCH THAT ANCHORS THE DOORWAY IS AT ABOUT THE SAME ANGLE AT THE ROOF. THERE IS A LITTLE BIT OF

BALANCE IN ANGLES BUT NOT IN MATERIALS. THE SOUTH SIDE OF THE HOUSE HAS BAY WINDOWS, WITH CHAMFERED CORNERS AND WIDE SIDING ALL THE WAY UP. LOOK CAREFULLY AT THE GABLE ENDS ON THE NORTH SIDE. THERE IS A DIFFERENT TYPE OF FISH SCALING HERE THAN ON THE FRONT. WE HAVE A HINT OF A BAY WINDOW, WHICH PROTRUDES ENOUGH TO BREAK UP THE LONG WALL.

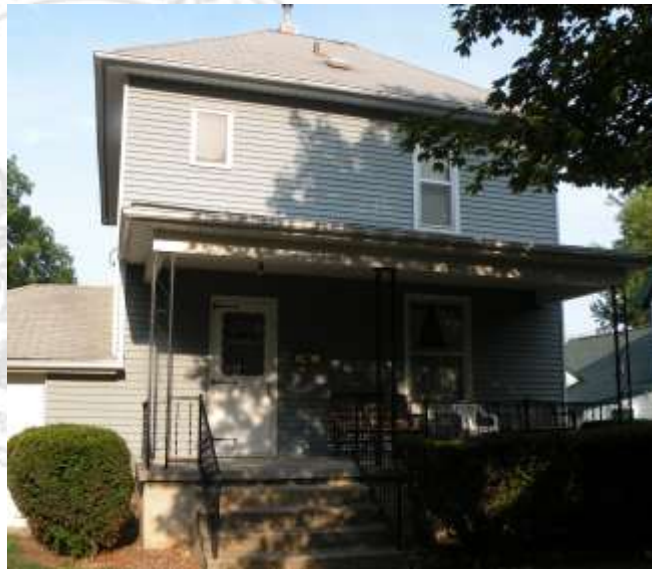
#17

THE HOME AT 620 6TH AVENUE (NO HOUSE NUMBER!) IS A NON-CONTRIBUTING STRUCTURE DATING FROM 1910. THE PORCH LINE MAY BE ORIGINAL. THERE ARE NO BAY WINDOWS. THIS IS AN AMERICAN FOUR-SQUARE STYLE HOUSE. IT IS VERY STRAIGHTFORWARD. IT IS A SIMPLE, INEXPENSIVE MODEL OF HOUSE. THE STRIPPED-DOWN BASIC DESIGN OF THE FOUR-SQUARE IS A CONVENIENT PLATFORM FOR ADDITIONS.

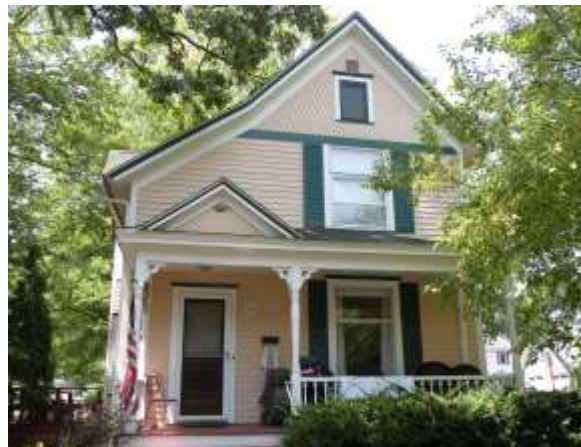
#18

THE HOUSE AT 615 6TH AVE. WAS BUILT IN 1900. IT HAS A CHAMFERED BAY ON THE SIDE AND A SLIGHTLY ANGLED GABLE, EXTENDED ON ONE SIDE TO PROVIDE ADDITIONAL INTERIOR SPACE. THE DIAMOND-PATTERNED DECORATIVE

TREATMENT ON THE FRONT GABLE, STILL IN THE ORIGINAL WOOD SHINGLE, IS UNIQUE IN MT. VERNON.

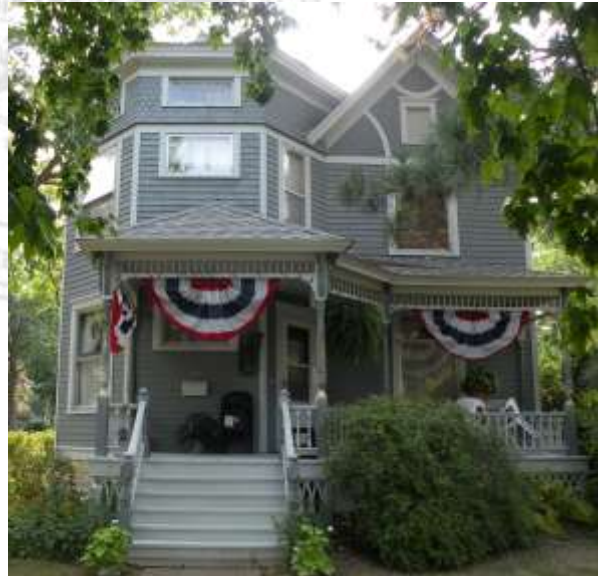
#19

THE BLOCK ON 6TH AVENUE N. BETWEEN 7TH STREET AND 8TH STREET HAS SOME OF THE MOST ELEGANT HOUSES IN THE DISTRICT. THERE ARE THREE HOUSES ON THIS BLOCK DEFINED AS “KEY CONTRIBUTING STRUCTURES” TO THE HISTORIC DISTRICT. THE HISTORIC VANVALKENBURG HOME (703 6TH AVE. NW), ON THE NORTH-WEST CORNER OF THE INTERSECTION, IS ONE OF THEM. IT IS A LOVELY HOUSE, BUILT IN 1896, AND WAS THE LONGTIME RESIDENCE OF CORNELL PROFESSOR VANVALKENBURG.

THIS IS AN EXCELLENT EXAMPLE OF THE QUEEN ANNE STYLE, CHARACTERIZED BY ONE OR MORE LARGE TOWERS. ANOTHER HALLMARK OF THIS STYLE IS THE USE OF DIFFERENT BUILDING MATERIALS AND TEXTURES. OBSERVE THE FRIEZE OF FISH SCALES AND THE DECORATIVE BORDER RESEMBLING DOWNWARD-POINTING ARROWS ALONG THE BOTTOM EDGE OF THE SHINGLED SURFACE. THERE ARE VERY FEW OF THIS DESIGN IN TOWN. THE GABLE END TO THE RIGHT HAS FISH SCALES AND SUNBURST DESIGNS. THERE IS A DELICATE PORCH WITH BALUSTERS ON THE BOTTOM AS WELL AS UNDER THE OVER HANG. THE PORCH SKIRT (THE AREA BETWEEN THE PORCH AND THE GROUND) IS QUITE INTERESTING. THE GARAGE IN THE REAR, COMPLETED IN 2009, IS A TASTEFUL RECREATION OF A

LARGE CARRIAGE HOUSE FROM THE PERIOD OF THE HOUSE'S CONSTRUCTION (REPLACING A VERY SMALL AND BADLY DETERIORATED ONE-CAR GARAGE ON THE SAME SITE).

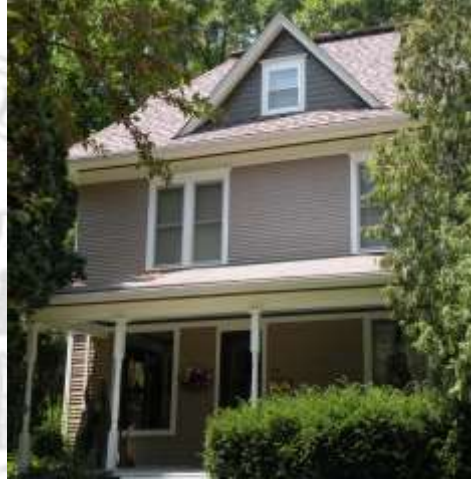
#20

WE ARE NOW AT 711 6TH AVE. THIS IS AN INTERESTING FOUR-SQUARE, BUILT ABOUT 1902, WITH INTERESTING LITTLE DETAILS ON IT. THERE ARE TWO DIFFERENT WIDTHS OF SIDING THAT BREAK UP THE LARGE EXTERIOR WALLS VISUALLY AND MAKE THE SURFACE MORE INTERESTING. THE PATTERN ON THE FIRST FLOOR IS MORE STANDARD THAN THE ONE ON THE SECOND FLOOR WITH NARROWER, LONGER BOARDS. THE GABLE IS COMPLETE WITH FISH SCALING AND A FLAT ROOF. THERE IS A LARGE WINDOW TO THE LEFT OF THE FRONT DOOR WITH CUT GLASS IN THE UPPER PART THAT IS ORIGINAL. IT IS ASYMMETRICAL, AFTER THE VICTORIAN ARRANGEMENTS. THE FRONT PORCH (LACKING THE USUAL RAILING) HAS BEEN REBUILT AND THE DECK ON THE BACK IS A RECENT ALTERATION, AS IS THE GABLE ON THE SOUTH SIDE WITH ITS FLOOR-TO-CEILING WINDOW. THE LARGE GARAGE IN THE BACK IS RECENT, BUT SIMILAR IN APPEARANCE TO THE HOUSE PARTLY BECAUSE THE OWNER CHOSE SIDING SIMILAR IN WIDTH TO THAT ON THE HOUSE. IT INCLUDES A LARGE STUDIO OR WORKSHOP SPACE ON THE SOUTH SIDE AND THE SECOND FLOOR.

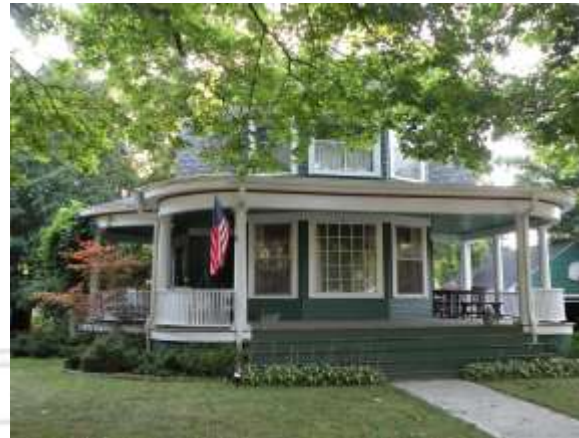
#22

717 6TH AVE. IS A KEY CONTRIBUTING STRUCTURE, ANCHORING THIS BLOCK WITH THE TWO OTHER KEY STRUCTURES. THIS WAS BUILT IN 1905. THERE IS A LARGE WRAP-AROUND PORCH THAT COVERS A HUGE BAY WINDOW. IF YOU LOOK ABOVE THE

PORCH YOU CAN SEE THAT THE BAY IS A TWO-STORY BAY THAT MOVES TOWARD A CONICAL ROOF LINE. IT HAS THE FEATURES OF A TURRET, SET AGAINST A SWEEPING ROOF LINE THAT REACHES MUCH HIGHER THAN THE TOP OF THE TOWER. THE BROAD FRONT STEPS MAY BE ORIGINAL AND AT LEAST WORK WELL IN THE OVERALL DESIGN. THERE ARE VERY PLAIN BALUSTERS AND COLUMNS. THIS IS CLEARLY A PORCH FOR SITTING AND ENTERTAINING.

FROM THIS SIDE YOU CAN SEE THE ANGLES OF THE ROOF LINES. THERE IS A LARGE AMOUNT OF FISH SCALING ON THE SECOND FLOOR AND A VERY LONG STRETCH OF UNBROKEN NARROW SIDING. THERE IS ANOTHER BAY WINDOW ON THIS SIDE, IN THE DINING ROOM. WHEN THEY BUILT THE GARAGE THEY MAINTAINED THE SAME NARROW SIDING CONCEPT. THIS AGAIN HELPS CONSIDERABLY; THE GARAGE ALMOST SEEMS TO FADE INTO THE LANDSCAPE FRAMING THE HOUSE. YET ANOTHER OF THE NICE THINGS ABOUT THIS HOUSE IS THAT IT SITS ON A GORGEOUS LOT.

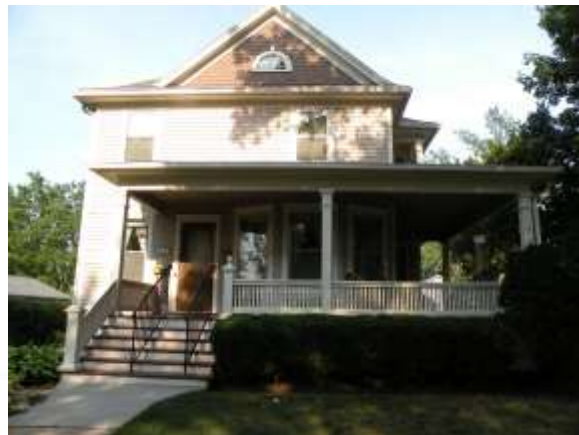
#24

716 6TH AVE., ALSO A KEY STRUCTURE, WAS BUILT IN 1901. IT HAS A COMPLETE WRAPAROUND PORCH AND AGAIN A DOOR ON THE SIDE (USUALLY THIS PLACEMENT INDICATES ITS INTENDED FUNCTION AS A FAMILY DOOR). THE FRONT DOOR WITH THE OVAL GLASS IS THE COMPANY DOOR. THERE IS A

LOVELY COVERED BAY WINDOW THAT ALLOWS LIGHT INTO THE LIVING ROOM, WHERE ONE ENTERS THE HOUSE. THERE IS A STAIRWAY HUNG ON THE NORTH SIDE OF THE HOUSE. THE WOOD CLADDING ON BOTH FLOORS IS THE SAME. ON THE GABLE END WE HAVE A SEMI-CIRCULAR ATTIC WINDOW AGAINST FISH SCALING.

THERE IS A PORCH ABOVE THE PORCH, WHOSE FUNCTION BEGINS TO BE AN INTERESTING TOPIC. SOME WOULD SAY THAT IT IS JUST A SITTING PORCH OFF THE BEDROOM, WHERE SOMEONE COULD SIT IN SOME PRIVACY ON A HOT IOWA NIGHT. MANY OF THESE PORCHES ARE THAT TYPE. THOSE PORCHES ALSO SERVED AS A PLACE WHERE SOMEONE COULD SHAKE OUT A DUST MOP. DOING HOUSE CLEANING ON THE SECOND FLOOR, ONE COULD SHAKE IT OFF THE PORCH INSTEAD OF OPENING A WINDOW. PORCHES WERE OFTEN USED TO AIR THE CLOTHS OR THE RUGS. THEY WERE ALSO GREAT FOR LETTING AIR INTO THE HOUSE FOR CROSS VENTILATION. THIS IS A DESIGN FEATURE WITH SOME PRAGMATIC VALUE.

THE FLUTED COLUMNS ON BOTH FLOORS ARE QUITE LOVELY AND WORK WELL ON THIS HOUSE. THEY ALSO VISUALLY KEEP THE HOUSE FROM BEING SO TALL. IT IS A VERY LARGE STRUCTURE AND THE PORCH BALUSTERS ARE HEAVY. THERE IS A HINT OF A BAY WINDOW THAT IS PROBABLY THE DINING ROOM. PEOPLE COULD GO DIRECTLY INTO THE DINING ROOM AND THEN ONTO THE PORCH FOR DESSERT.

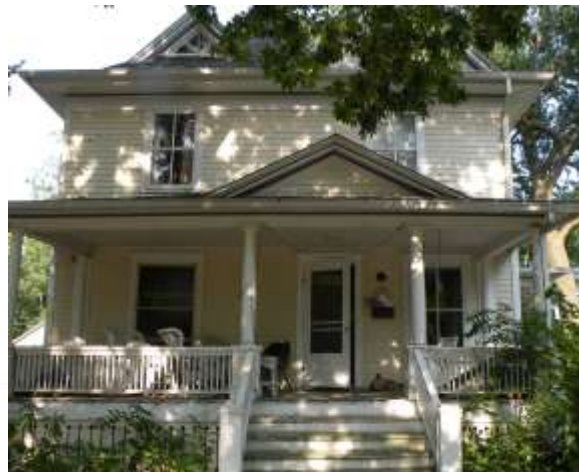
#25

712 6TH AVE. WAS BUILT IN 1907. IT IS A BASIC AMERICAN FOUR-SQUARE HOUSE WITH SUBTLE COMPLICATIONS LIKE THE ROOF LINE ON THE PORCH. THERE ARE TWO VERY INTERESTING GABLE ENDS ON THE STRUCTURE. THERE ARE NARROW-PANED

WINDOWS – ONE WITH FISH SCALING AND THE OTHER WITH ELABORATE LITTLE TRIANGLES. THEY ARE TO LET LIGHT INTO THE ATTIC AND PERHAPS TO HELP VENTILATE THAT HOT SPACE – A FUNCTIONAL AND AESTHETIC DESIGN ELEMENT. A CLOSE LOOK AT THIS HOUSE FROM ACROSS THE STREET HIGHLIGHTS THREE GABLES. IF YOU LOOK UP INTO THE GABLE THAT FACES THE SOUTH YOU WILL NOTICE THOSE 12-PANED WINDOWS. THEY ARE ON BOTH OF THESE GABLES – ONE FACING WEST AND THE OTHER FACING SOUTH. THEY BECOME A DECORATIVE ELEMENT IN THAT SPACE AGAINST FISH SCALES.

THE HOUSE HAS SOME VERY INTERESTING BREAKS FROM SYMMETRY. THE NORTH SIDE OF THE HOUSE IS VERY PLAIN, BUT ON THE SOUTH SIDE THERE IS ANOTHER ENTRY. THIS, LIKE WE SAW ON THE LAST TWO HOUSES, IS A SECOND FRONT DOOR. THE PORCH IS SCALED DOWN AND DELICATE. THE BACK STOOP, WITH A STYLISTICALLY APPROPRIATE ROOF AND RAILING, IS A TASTEFUL RECENT ALTERATION. THAT CORNER OF THE HOUSE WAS ORIGINALLY A SIMILAR PORCH THAT WAS ENCLOSED AT SOME POINT.

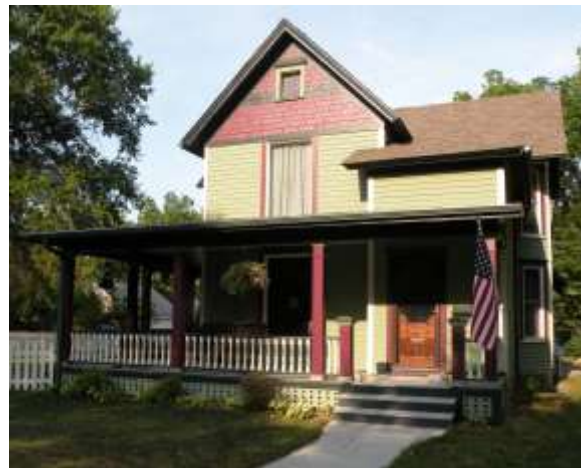
#26

702 6TH AVE. HAS BEEN ALTERED CONSIDERABLY, BUT THE ORIGINAL PART OF THE HOUSE, BUILT IN 1900, IS ESSENTIALLY A FOUR-SQUARE DESIGN WITH BAY WINDOWS ON BOTH FLOORS. NOTICE THE GABLE END WITH THE BAY WINDOW AND THE QUEEN ANNE-STYLE

PANES IN THE WINDOWS ON THE FIRST FLOOR. SMALL WINDOWS WITH SMALL PANES ASCENDING A LARGE WALL, LIKE WE SEE ON THE SOUTH SIDE, USUALLY INDICATE THAT A STAIRCASE IS HUNG ON THE INTERIOR OF THAT WALL. THE WRAPAROUND COVERED PORCH IS A RECENT ADDITION. NOTE THE GENTLY SLOPED ROOF, THE SQUARE PILLARS, THE TURNED BALUSTERS ON THE RAILING, AND THE

LATTICEWORK PORCH SKIRT. THE ENCLOSURE OVER THE FRONT DOOR OBSCURES WHATEVER MIGHT HAVE BEEN ORIGINALLY IN ITS PLACE. THE ATTACHED GARAGE IS AN EARLIER ADDITION, RECENTLY ALTERED BY THE ADDITION OF A SECOND FLOOR AND A HIGHER-PITCHED ROOF WITH CROSS GABLES. BOTH THE ORIGINAL GABLE ENDS AND THE NEWER ONES ARE DECORATED WITH FISH SCALES. THESE, THE WINDOWS, AND THE PORCH PILLARS ARE ALL BROUGHT OUT NICELY BY THE USE OF HISTORICALLY APPROPRIATE TWO-TONE TRIM IN THE VICTORIAN STYLE, CHOSEN WHEN THE CURRENT OWNERS REPAINTED THE HOUSE AS PART OF THE RECENT REMODELING.

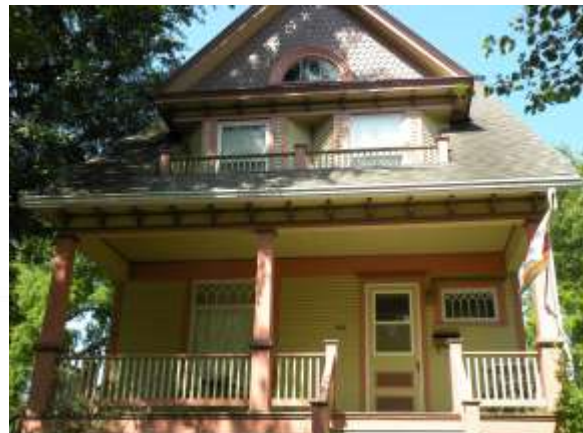
#28

615 5TH AVE. IS A REMARKABLE HOUSE BUILT IN 1901. YOU HAVE TO LOOK AT IT FOR A LONG TIME IN ORDER TO GRASP THE PLAN AND DETAILS. THERE IS A BAY WINDOW ON THE NORTH SIDE, A HUGE ROOF LINE WITH VERY INTERESTING

TREATMENT OVER THE ATTIC WINDOW (WITH DENTILS), AND A BARGEBOARD COMPLETE WITH BRACKETS. THE UPPER PART OF THIS HOUSE HAS A TREMENDOUS AMOUNT OF DETAIL. THERE ARE BRACKETS, SEMI-CIRCULAR WINDOWS, AND IT IS CUT DEEPLY INTO THE ROOF. THERE WAS PROBABLY A BALUSTRADE AT THE FRONT OF THAT AREA. IT IS VERY DEEP AND COULD HAVE BEEN A SITTING PORCH. IT BEARS MUCH OF THE WEIGHT OF THE ROOF. THE PORCH YOU SEE TODAY IS THE LOVING WORK OF A COUPLE WHO RESTORED MUCH OF ITS ORIGINAL CHARM AND DIGNITY. THEY HAD NO PICTURES OF THE ORIGINAL TO GUIDE THEM, SO THEY FABRICATED A HANDSOME PORCH IN THE STYLE OF THE PERIOD. I THINK THEY DID A REMARKABLE JOB. THERE ARE NICE PANES IN THE WINDOW ON THIS SIDE, AND IN THE BACK OF THE HOUSE YOU CAN SEE THE HUGE SLEEPING PORCH. ON THE SOUTH SIDE OF THE HOUSE IS A BAY WINDOW AND LOVELY PORCHES. THERE IS ANOTHER HUGE PORCH ON THE BACK. THESE PORCHES ARE CLEARLY A PART OF THE PRIVATE AREA OF THE HOUSE. THE GARAGE IS A RECENTLY BUILT REPLICA OF A CARRIAGE HOUSE FROM THE TURN OF THE CENTURY, COMPLETE WITH SHINGLING AND FISH SCALES IN THE GABLES. PLEASE NOTICE THE GINGKO TREE (THE ONE WITH THE SWINGS). THERE IS A GINGKO AT THE CORNELL COLLEGE PRESIDENT'S HOUSE THAT IS THE LARGEST IN IOWA, AND THIS ONE IS VERY CLOSE TO THAT ONE IN SIZE AND AGE.

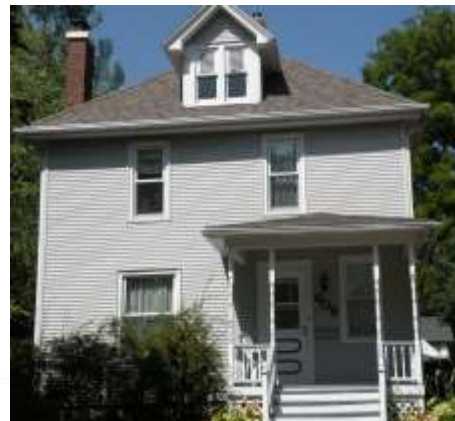
#29

THIS 1910 HOME, 609 5TH AVE., IS YET ANOTHER AMERICAN FOUR-SQUARE HOUSE FEATURING A NICE LITTLE PORCH. IT ATTRACTS LITTLE ATTENTION. IT IS ESSENTIALLY A SQUARE HOUSE WITH A SMALL GABLE. THERE ARE ALMOST NO DECORATIVE ELEMENTS. ON THE SOUTH SIDE IS A PORCH ARRANGEMENT ON THE BACK THAT COULD VERY

WELL HAVE BEEN A SLEEPING PORCH. NOTE THE ADDITION OF VINYL SIDING.

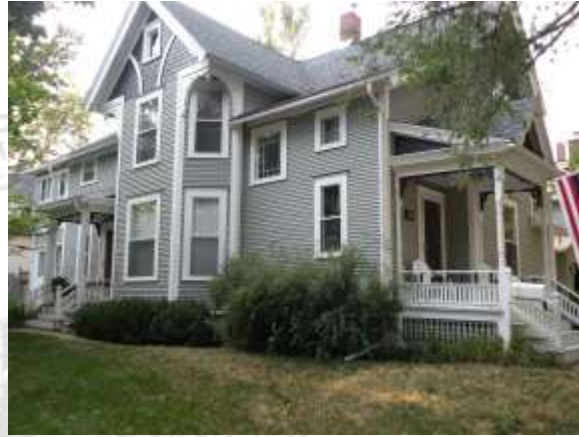
#30

603 5TH AVE. IS ONE OF THE EARLIEST HOUSES IN THIS DISTRICT, BUILT IN 1897, AND IS ESSENTIALLY UNTOUCHED ON THE EXTERIOR. IT IS NICELY PAINTED AND HAS A NICE SENSE OF ENTRY. THERE IS A SLEEPING PORCH IN THE BACK. THE BAY ON THE SOUTH SIDE HAS CHAMFERED CORNERS WITH DECORATIVE ELEMENTS. THIS HOUSE WAS BUILT BY A MR. CARLETON AND HAS HAD ONLY ABOUT FOUR OWNERS. THERE IS ANOTHER PORCH ON THE SOUTH SIDE. IF YOU WERE "COMPANY" YOU ENTERED THROUGH THE 5TH AVE. SIDE, BUT IF YOU WERE FAMILY YOU WOULD ENTER THROUGH THE 6TH ST. SIDE.

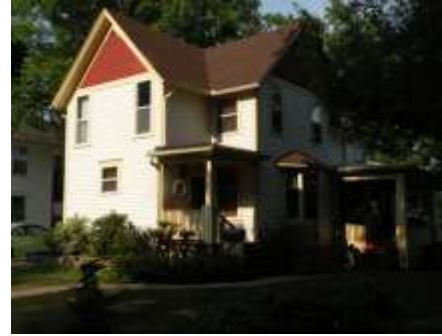
#31

ON THE CORNER IS A RATHER INTERESTING HOUSE, 608 5TH AVE., BUILT IN 1912. IT IS A VERY STRAIGHTFORWARD HOUSE AND THE ONLY DECORATIVE ELEMENTS ARE THE FISH SCALING IN THE GABLE ENDS. THERE IS A SMALL BAY ON THE SOUTH. THE PORCH ON THAT SIDE MAY BE A

REPLACEMENT FOR A SMALLER PORCH THAT WAS THERE AT ONE TIME. THERE ARE TWO DOORS ON THE STREET WITH BUNGALOW-STYLE PORCHES. THE BIG ADDITION ON THE NORTH SERVES AS AN OFFICE FOR THE OWNERS OF OVER THIRTY YEARS AND INCORPORATES ANOTHER DOOR. THE GARAGE IS RECENT BUT STYLISTICALLY APPROPRIATE.

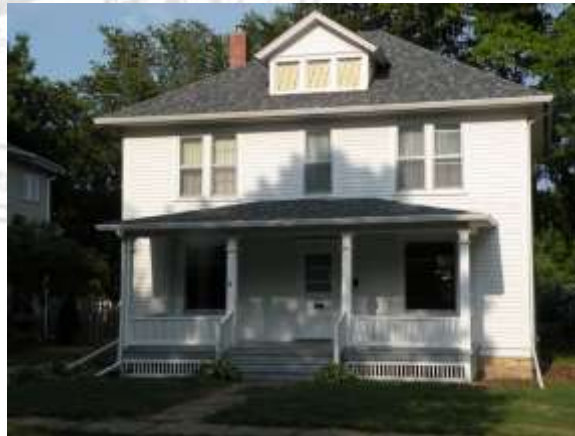
#32

THE THREE HOUSES ON THIS BLOCK ARE ALL FROM THE TURN OF THE CENTURY. THE HOUSE AT 610 5TH AVE. WAS CONSTRUCTED IN 1901 AND IS ANOTHER “KEY STRUCTURE” IN THE DISTRICT. IT IS IN THE AMERICAN FOUR-SQUARE STYLE, AND

HAS A SENSE OF SIMPLICITY EXCEPT FOR A FEW INTERESTING DECORATIVE ELEMENTS. NOTICE THE DENTILS UNDER THE OVERHANG ON THE FRIEZE. THERE ARE NICE MUNTINS IN THE WINDOW ON THE GABLE END. THIS HOUSE IS SYMMETRICAL – THERE IS A DOOR IN THE MIDDLE AND TWO BIG WINDOWS ON EITHER SIDE OF THE DOOR; THE WINDOWS ABOVE THEM LINE UP WITH THE LOWER WINDOWS. THE PORCH IS WELL PROPORTIONED. THIS WAS THE HOME OF HARRY KELLY, WHO WAS THE FIRST MANAGER OF THE LOCAL TELEPHONE COMPANY. HE WAS PART OF THE BUSINESS MEN’S COMMERCIAL CLUB AND A SUNDAY SCHOOL TEACHER. ACCORDING TO THE NEWSPAPER, THIS HOUSE WAS BUILT BY D.C. HARTUNG, ONE OF THE MAIN BUILDING

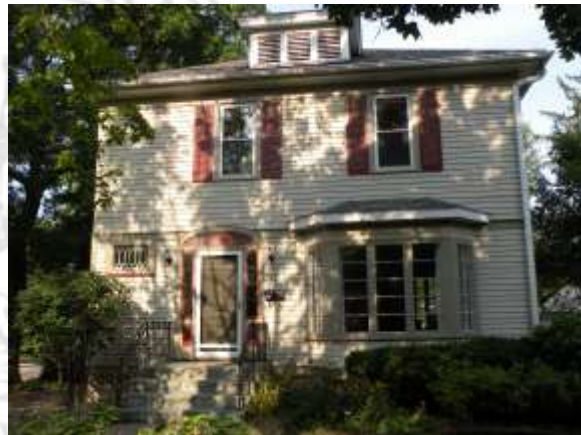
#33

616 5TH AVE., ON THE CORNER TO THE NORTH, WAS BUILT IN 1901. THE HOUSE LOOKS VERY PLAIN, AND THE SHUTTERS HAVE BEEN ADDED. THERE ARE NO BRACKETS OR FISH SCALING. IT DOES HAVE SOME ELEMENTS OF VICTORIAN STYLISTIC INFLUENCES. THE ENTRY HAS HINTS OF ELEGANCE AND MAY HAVE BEEN COVERED BY A NICE PORCH AT ONE TIME. THERE IS A SUNBURST DESIGN ON THE PANEL ABOVE THE DOOR, AND THE WINDOW IN THE STAIRWELL HAS DECORATIVE PRISM PANES. THE LARGE FRONT LIVING ROOM HAS A LOVELY BAY WINDOW WITH FIVE PANES INSTEAD OF THE ORIGINAL THREE. ON THE NORTH SIDE THERE IS ANOTHER LITTLE BAY AND A PROTRUDING AREA AT THE ROOF LINE. THE GARAGE DOES NOT HELP THE CHARM ON THAT SIDE OF THE HOUSE.

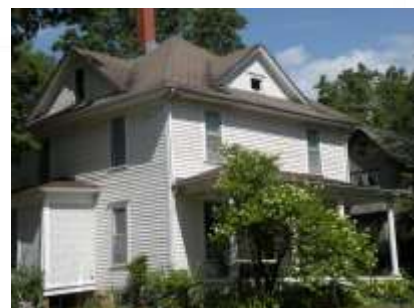
#34

THE HOUSE ON THE NORTH-WEST CORNER OF THE INTERSECTION, 703 5TH AVE., WAS BUILT ABOUT 1910. IT IS AN

AMERICAN FOUR-SQUARE WITH SYMMETRICAL WINDOWS, FISH SCALING IN THE GABLES, AND A FULL FRONT PORCH.

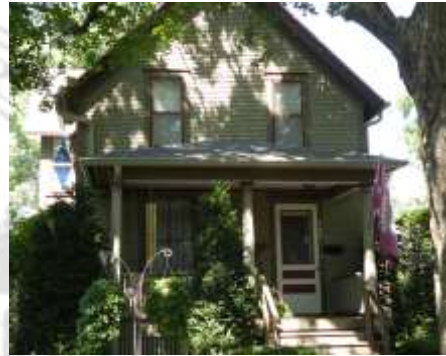
#35

707 5TH AVE. WAS BUILT IN 1910. IF YOU LOOK AT IT YOU CAN SEE THAT THERE IS A SECOND DOOR ON THE SOUTH SIDE; THE PORCH OR STOOP HAS BEEN REMOVED AND IT IS JUST UP IN THE AIR NOW. THE HOUSE HAS A SMALL BAY ON IT SUPPORTED BY SPLENDID BRACKETS. ON THE NORTH SIDE OF THE HOUSE, YOU WILL SEE THAT THERE IS A HINT OF A TURRET THAT IS ANOTHER ELEMENT OF THE QUEEN ANNE STYLE. THAT TURRET IS A CONTEMPORARY ADDITION TO THE HOUSE. YOU WOULD NOT FIND A VICTORIAN TURRET WITH DOUBLE WINDOWS. IT IS TIED NICELY TO THE HOUSE WITH THE SIDING AND THE ROOF LINES.

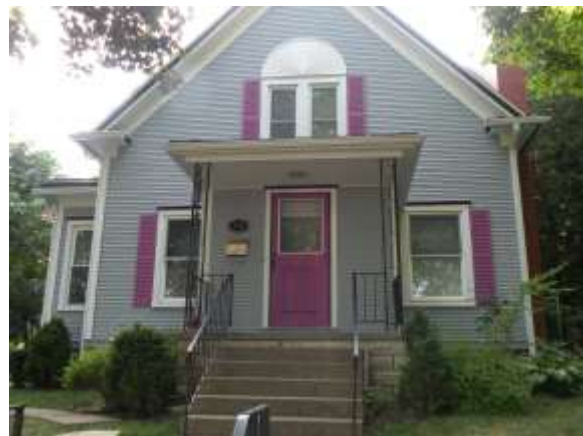
#36

715 5TH AVE. WAS BUILT IN 1905 AND IS ANOTHER LARGE FOUR-SQUARE HOUSE. THERE ARE NICE FISH SCALES, A SUNBURST DECORATION, AND A BROKEN PEDIMENT IN THE UPPER GABLE. THE SHUTTERS HAVE BEEN ADDED. THE PORCH HAS BEEN ALTERED, AND PROBABLY IT HAD A SMALL ENTRY PORCH. THE DIMENSIONS OF THIS PORCH ARE PROBABLY THE SAME, BUT IT IS JUST CLOSED IN. IT IS A RATHER COMPLEX HOUSE. THE BAY ON THE SOUTH IS ORIGINAL AND TYPICAL OF SOME FOUR-

SQUARES. THERE HAS BEEN A LITTLE BAY WINDOW ADDED ON THE NORTH SIDE, AND THERE IS A SMALL ADDITION ON THAT SIDE TOWARDS THE BACK.

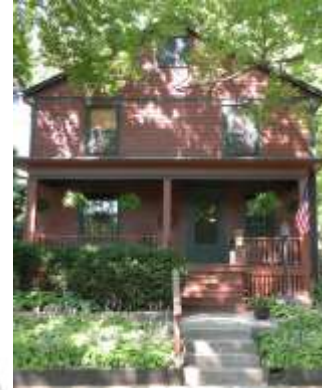
#37

719 5TH AVE. WAS BUILT IN 1912. IT IS A SYMMETRICAL FOUR-SQUARE HOUSE AND HAS BEEN COMPLETELY RE-SIDED. NOTE THE DENTILS ON THE FRONT PORCH OVERHANG. THIS AREA DEVELOPED QUITE QUICKLY; THE HOUSES ON THIS SIDE OF THE STREET WERE BUILT WITHIN A FEW YEARS. THEY ARE SIMILAR IN STYLE AND RELATIVELY SIMPLE.

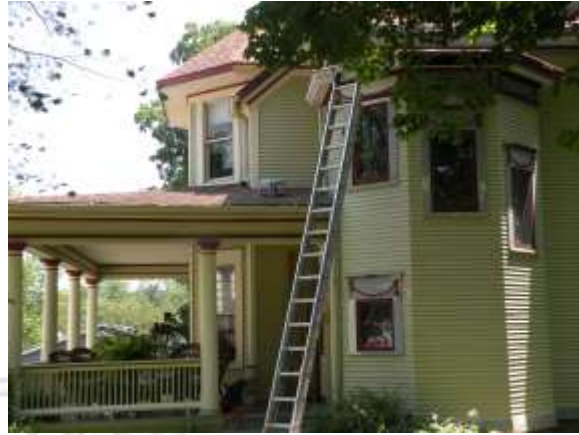
#40

724 5TH AVE. HAS A VERY INTERESTING HISTORY. THIS HOUSE WAS BUILT IN 1910 (VERY VICTORIAN IN STYLE) AND MOVED TO THIS SITE. IT WAS ON MAIN STREET AT THE PRESENT LOCATION OF THE MERNER DORMITORY ACROSS THE STREET FROM THE FIELD HOUSE.

WHEN THEY BUILT THAT DORMITORY (@1938) THEY MOVED A COUPLE OF HOUSES. THE COLLEGE APPARENTLY OWNED THIS LOT. IT WAS A COLLEGE RENTAL PROPERTY FOR MANY YEARS, BUT IN RECENT YEARS WAS SOLD TO A FACULTY MEMBER. THIS HOUSE MAY HAVE SET DIFFERENTLY ON ITS ORIGINAL LOCATION. THE HOUSE SHOULD PROBABLY BE TURNED TO THE RIGHT A QUARTER OF A TURN. THIS IS ONE OF THE KEY HOUSES IN THE DISTRICT.

THE TURRET WITH LITTLE SWAGS AND LEADED GLASS, IS A SPIRAL OAK STAIRCASE ON THE INSIDE. THERE IS LEADED GLASS TO THE RIGHT IN THE SITTING ROOM. THE PORCH WRAPS AROUND A SMALL PART OF THE HOUSE AND PROVIDES FOR THE DOORWAY. THE MAIN DOOR IS RATHER HIDDEN SO YOU HAVE TO LOOK FOR IT. YOU WILL NOTICE THAT THE WHOLE NORTH SIDE OF THE HOUSE IS A HUGE BAY AREA. THE ATTIC GABLE IS MOST UNUSUAL. THERE ARE SWAGS ALONG WITH FISH SCALES. THE WINDOWS HAVE VERY INTERESTING MUNTINS. NOTICE THE LETTER DROP IN THIS WINDOW ON THE TURRET. LETTERS FALL ONTO THE FLOOR AT THE FOOT OF THE STAIRCASE. IT HAS LOVELY OAK WOODWORK THROUGHOUT THE HOUSE.

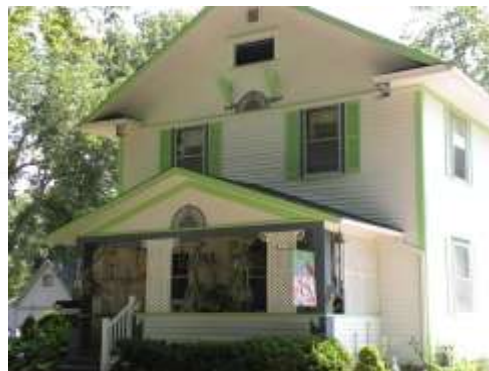
#41

THE NEXT HOUSE, 710 5TH AVE., WAS BUILT IN 1918 AND SHOWS MARKS OF TRANSITIONAL BUILDING STYLES BETWEEN THE OLDER ELEMENTS OF THE VICTORIAN STYLE AND THE NEWER

BUNGALOW STYLE. THERE ARE TWO BRACKETS UNDER THE WINDOW ON THE UPPER FLOOR. THERE COULD HAVE BEEN A WINDOW BOX ON THEM, BUT NO ONE IS REALLY SURE WHAT THEY WERE ORIGINALLY MEANT TO BE. THIS HOUSE HAS THE BROKEN PEDIMENT IN WHICH THE ROOF LINE STARTS BACK JUST A LITTLE BIT AS IF TO CREATE A TRIANGLE IN THE UPPER PART OF THE HOUSE. THERE IS A FLAT BAY (3 WINDOWS) AND A SHORT PORCH. THE LARGE GARAGE IS ANOTHER RECENTLY-BUILT REPLICA OF A CARRIAGE HOUSE.

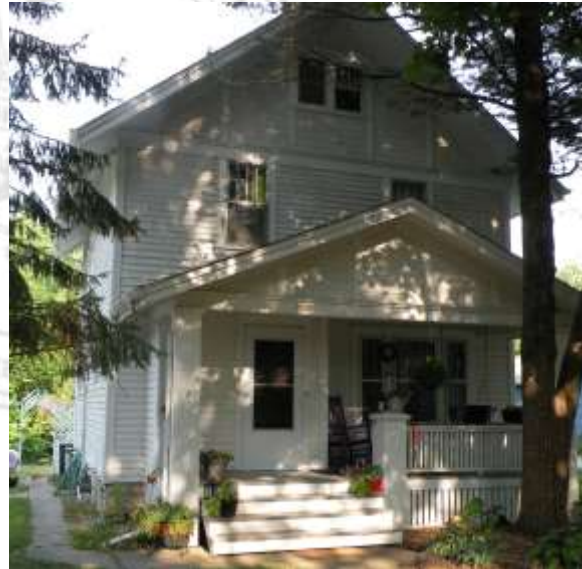
#42

BUILT IN 1915, 708 5TH AVE. IS CLEARLY FROM THE SAME PERIOD AS 710 WITH JUST LITTLE DIFFERENCES. IT HAS ELEMENTS OF THE BUNGALOW IN THE PORCH WITH ITS LARGE COLUMNS. THEY ARE PROBABLY ORIGINAL, GIVEN THE SHAPE OF THE PORCH ROOF.

THERE ARE THREE WINDOWS WHICH SEEM TO BE A SUBSTITUTE FOR THE USUAL, MORE ELABORATE BAY WINDOW. THERE IS A NICE SENSE OF ENTRY AND IT IS MOSTLY SYMMETRICAL. THE UPPER ROOF IS SYMMETRICAL. WE SEE NO BRACKETS OF ANY KIND. NOTE THE DECORATIVE WINDOWPANE PATTERNS AND THE SHINGLE ARRANGEMENT.
