Empire Pass Master Owner's Association

Level 2 Reserve Study

Type of Study	Update w/Site Visit
Date of Property Inspection	6/11/2020
Prepared By	Dale Gifford
Analysis Method	Cash Flow
Funding Goal	Full Funding

Report prepared on – Thursday, July 16, 2020

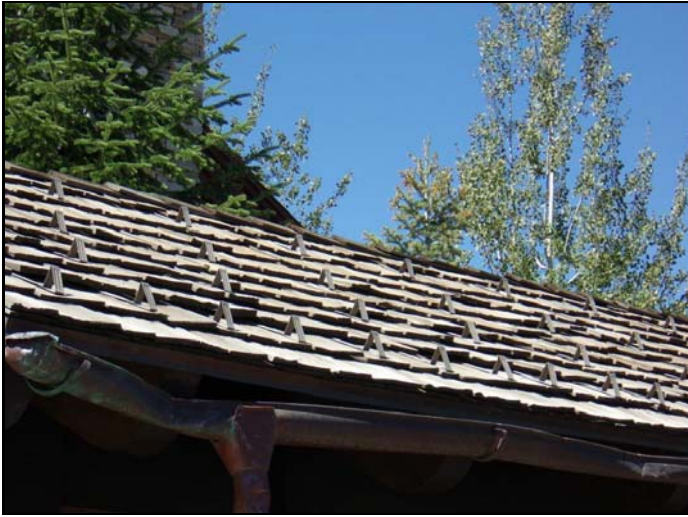
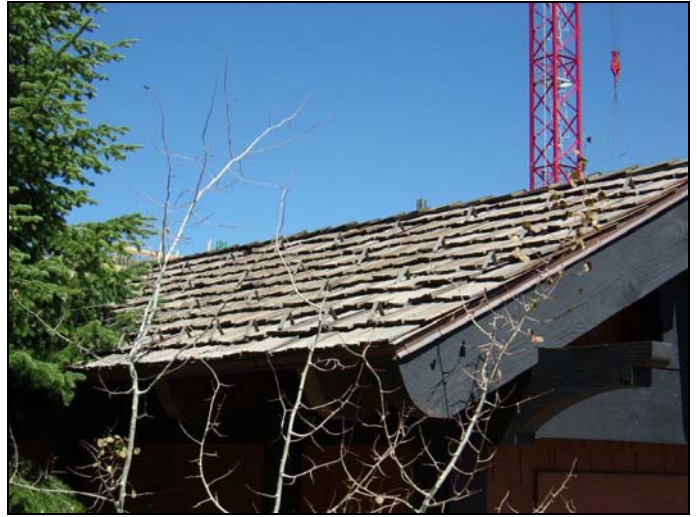
Comp #: 107 Transit Center Roof - Replace

The roof is in good condition. We recommend funding to replace this component approximately every 25 - 35 years. Remaining life based on current age.

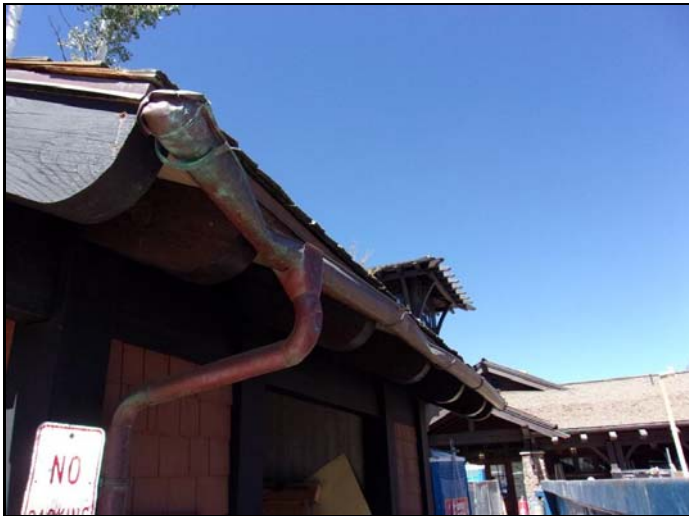
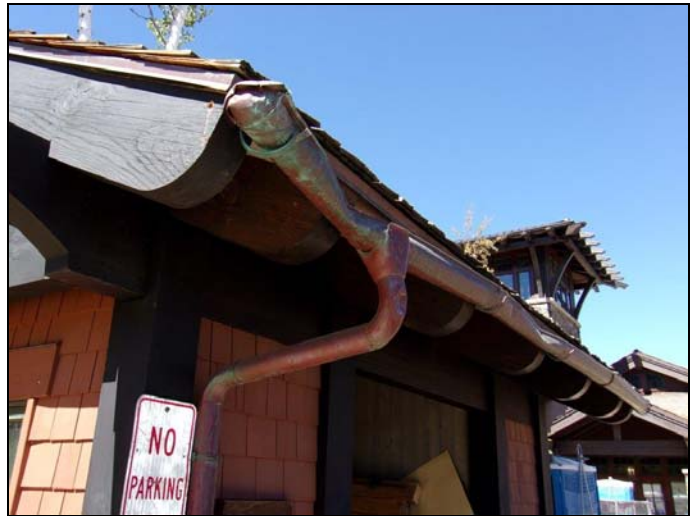
Comp #: 120 Transit Center Guttering - Repair/Replace

Due to the minimal amount of, and cost of replacing this component, reserve funding is not appropriate. Repair and replace as necessary as an operating expense.

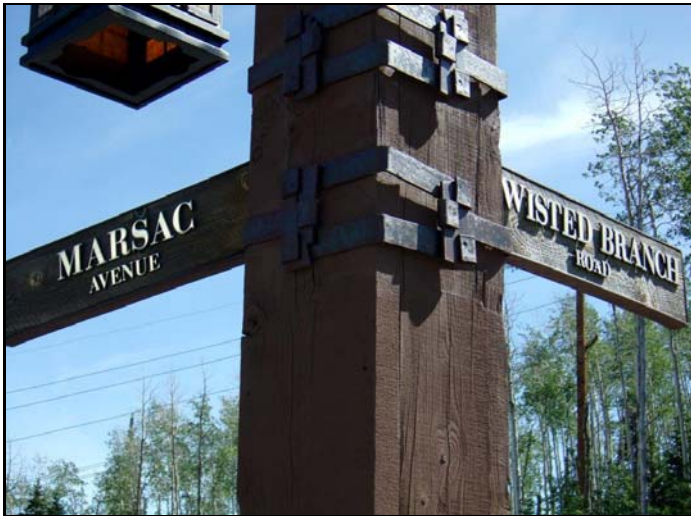
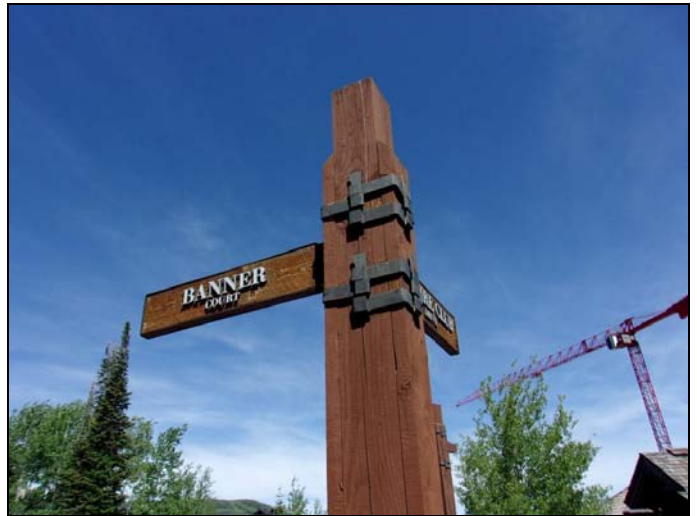
Comp #: 213 Sign Posts - Repaint

- (18) - Pole Light Posts
- (24) - Road Sign Posts
- (10) - Street Sign Posts

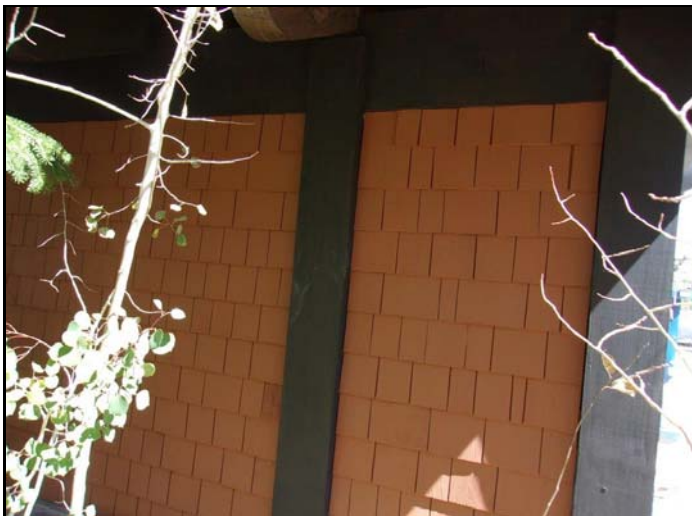
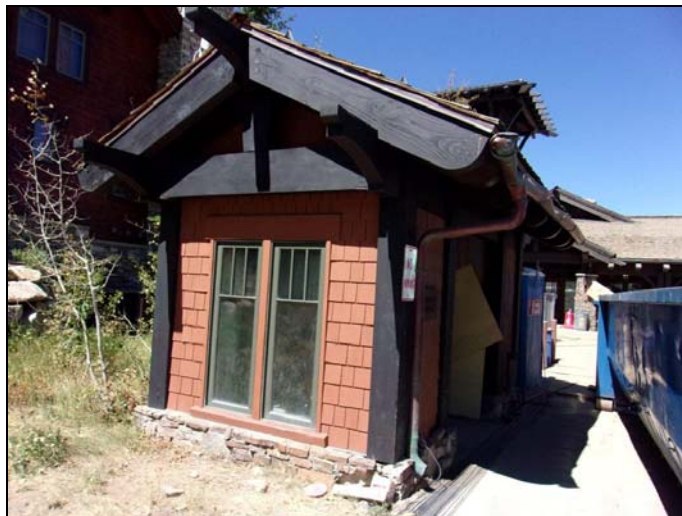
Comp #: 217 Transit Center - Repair/Repaint

The painted wood siding surfaces are in fair condition. We recommend funding to repair/repaint this component approximately every 4 - 6 years. Remaining life based on current age and condition.

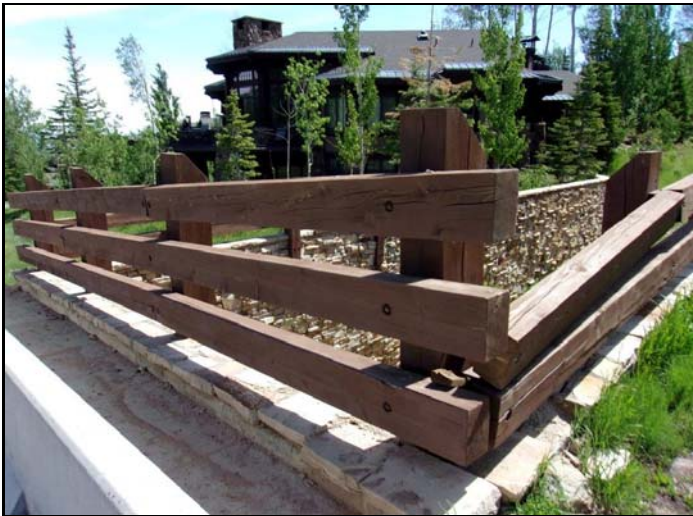
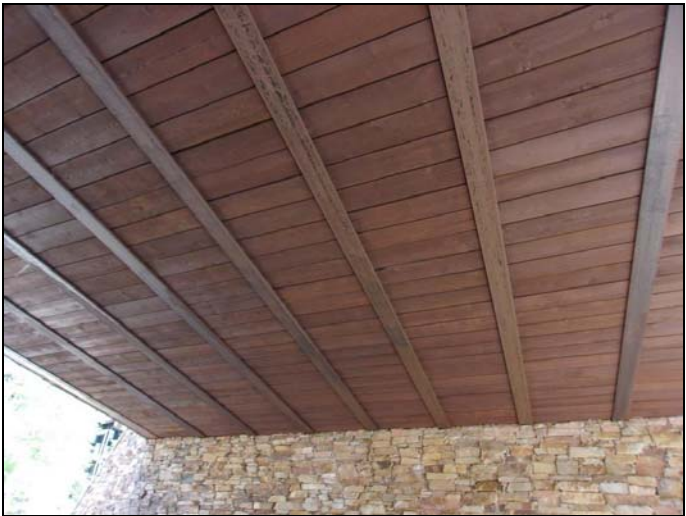
Comp #: 219 Wood Surfaces - Stain

Research with the client reveals this component is stained every four years. Remaining life based on current age.

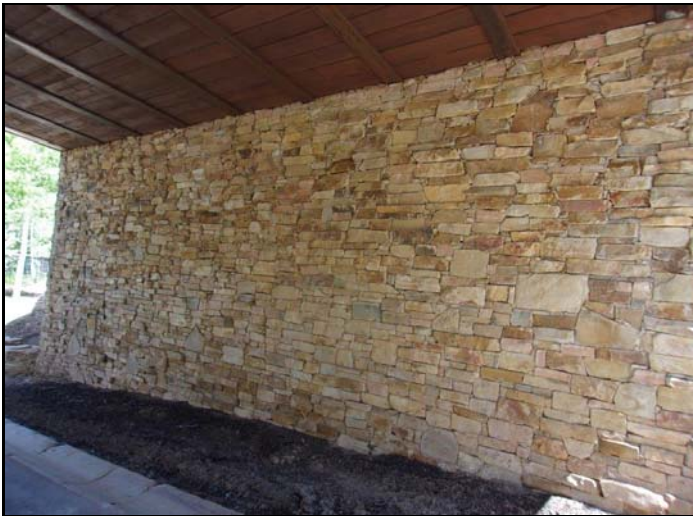
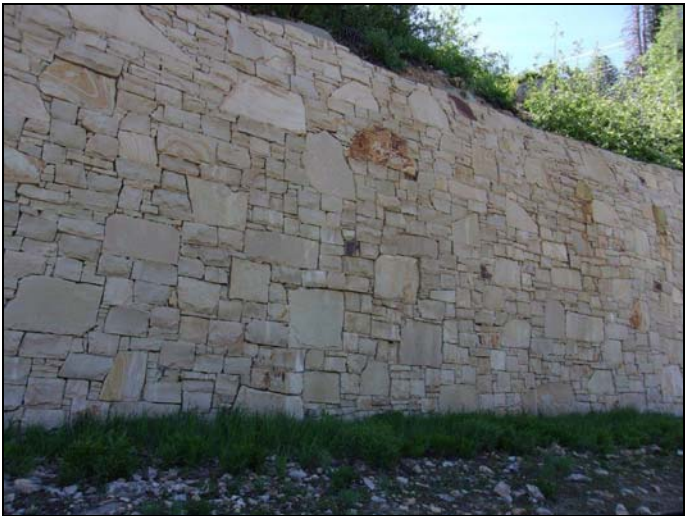
Comp #: 390 Stone Veneer - Repairs

Research with the client reveals this component is partially repaired every year.

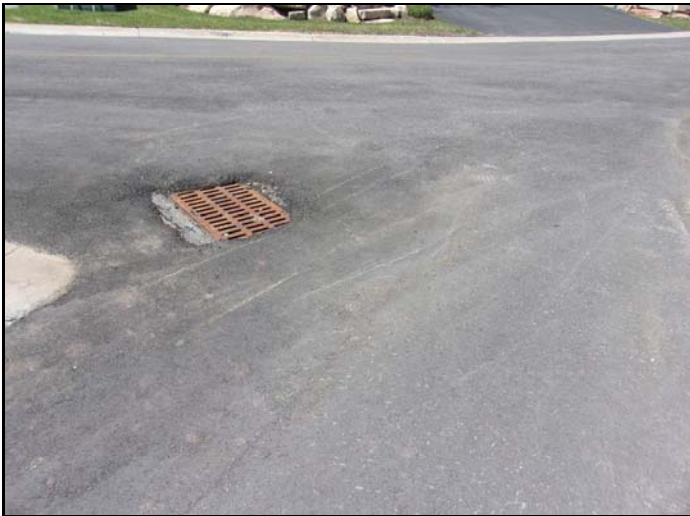
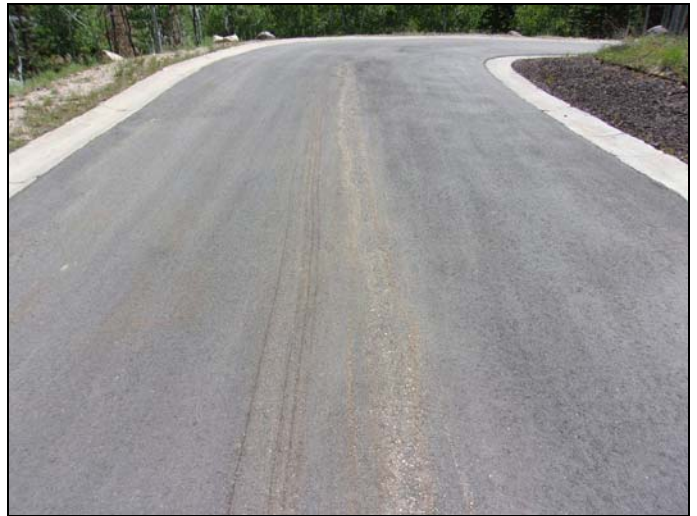
Comp #: 401 Asphalt - Banner Court - Major Rehab

The asphalt surfaces are in good to fair condition. We recommend funding for a major rehab of this component approximately every 16 - 20 years. Remaining life based on current age.

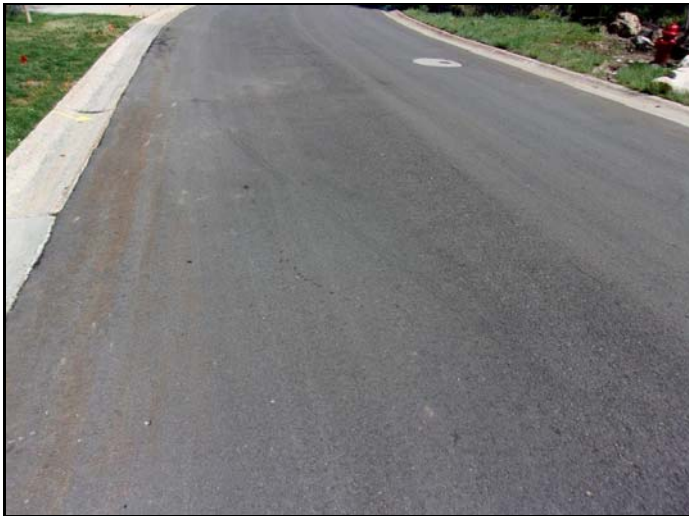
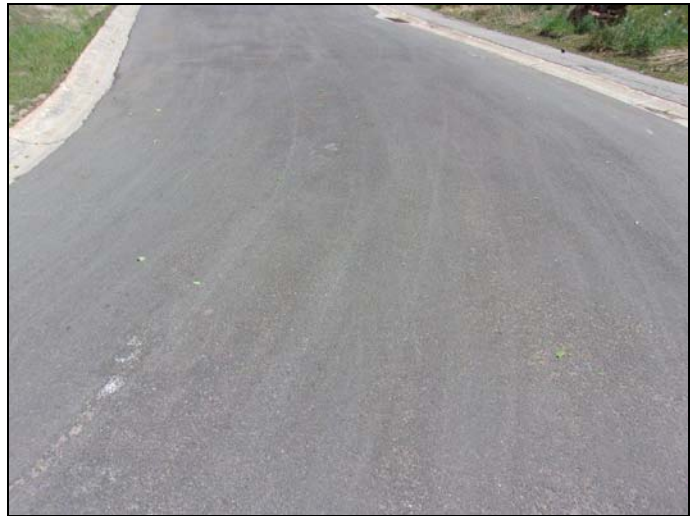
Comp #: 401 Asphalt - Empire Club Drive - Major Rehab

The asphalt surfaces are in good condition. We recommend funding for a major rehab of this component approximately every 25 - 30 years. Remaining life based on current age.

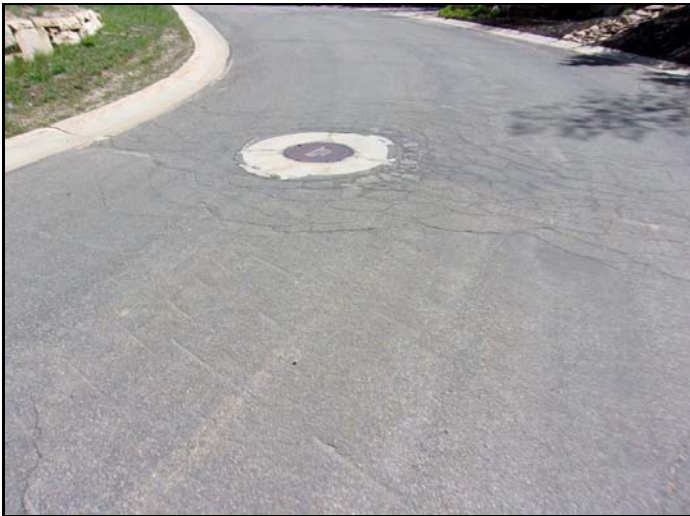
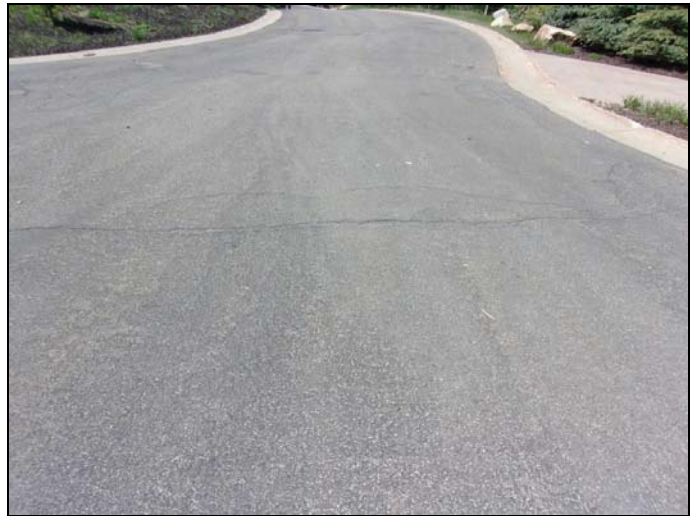
Comp #: 401 Asphalt - Hawkeye Place - Major Rehab

The asphalt surfaces are in good to fair condition. We recommend funding for a major rehab of this component approximately every 16 - 20 years. Remaining life based on current age.

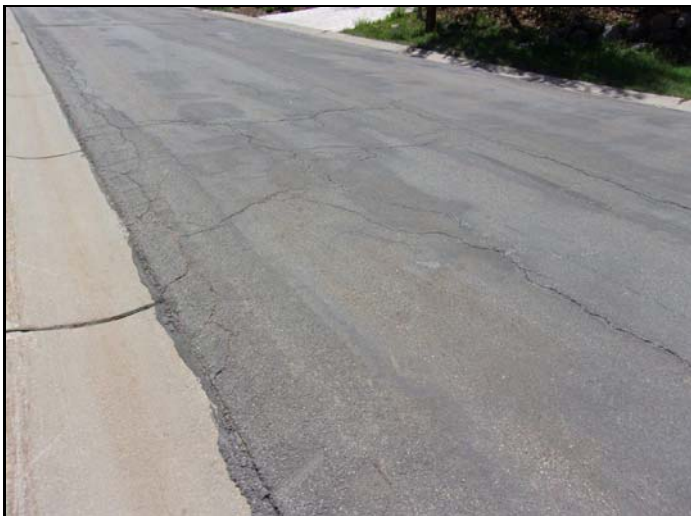
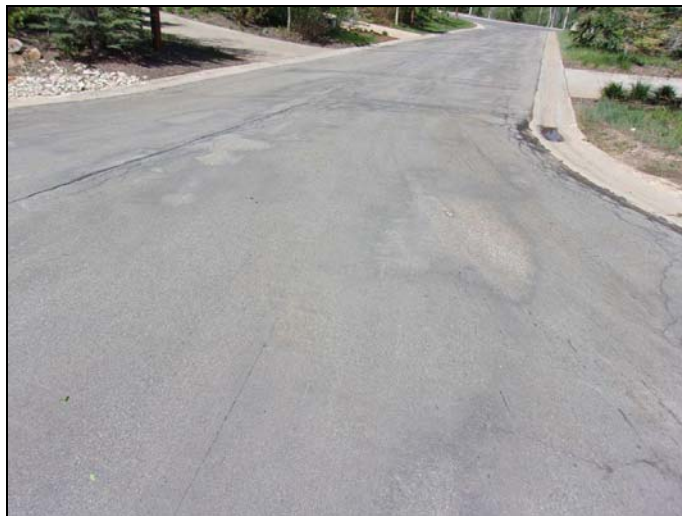
Comp #: 401 Asphalt - Northside Court - Major Rehab

The asphalt surfaces are in good to fair condition. We recommend funding for a major rehab of this component approximately every 16 - 20 years. Remaining life based on current age.

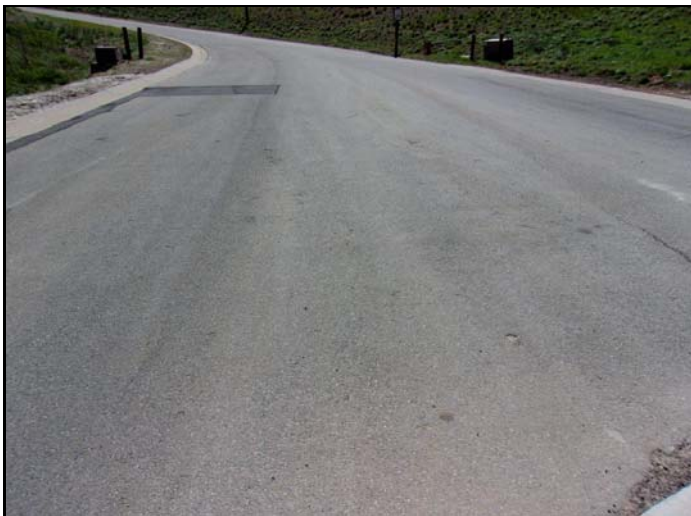
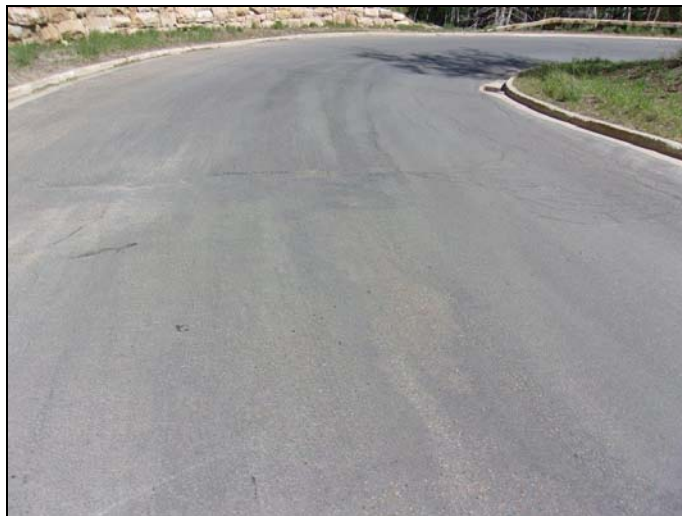
Comp #: 401 Asphalt - Red Cloud Trail - Major Rehab

The asphalt surfaces are in good to fair condition. We recommend funding for a major rehab of this component approximately every 16 - 20 years. Remaining life based on current age.

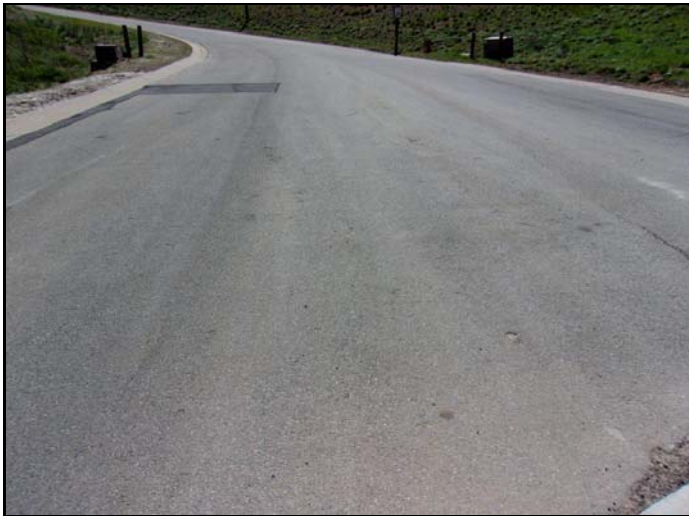
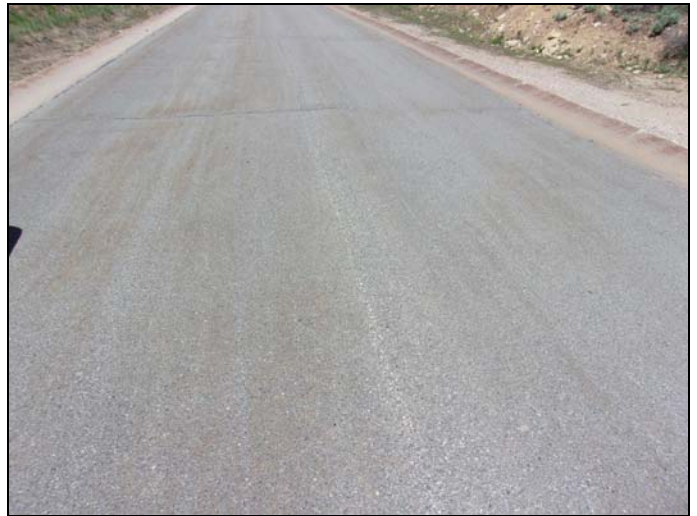
Comp #: 401 Asphalt - Red Cloud Trail 2016 - Major Rehab

The asphalt surfaces are in good condition. We recommend funding for a major rehab of this component approximately every 16 - 20 years. Remaining life based on current age.

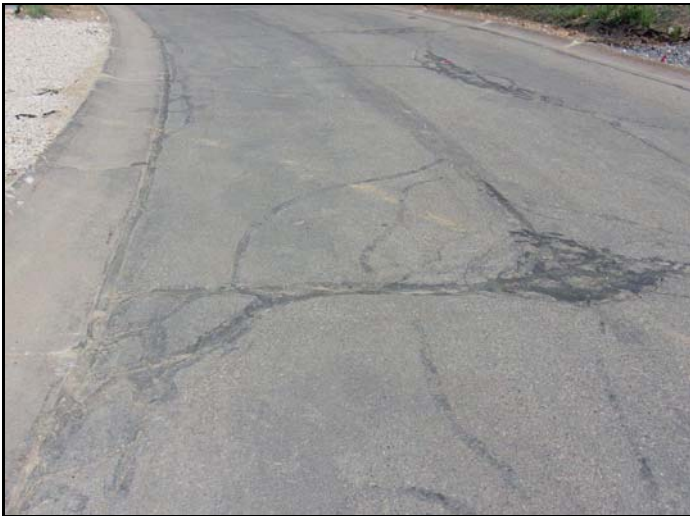
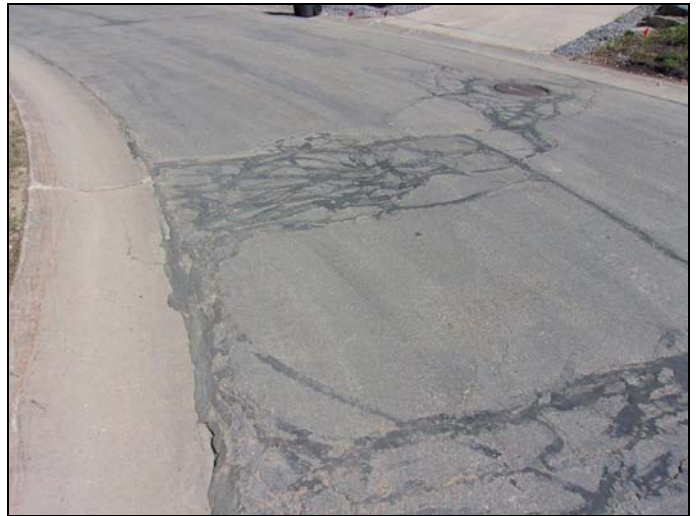
Comp #: 401 Asphalt - Ruby Hollow - Major Rehab

Research with the client reveals this component is scheduled to be replaced in 2021. We recommend funding for a major rehab of this component approximately every 16 - 20 years. Remaining life based on current age.

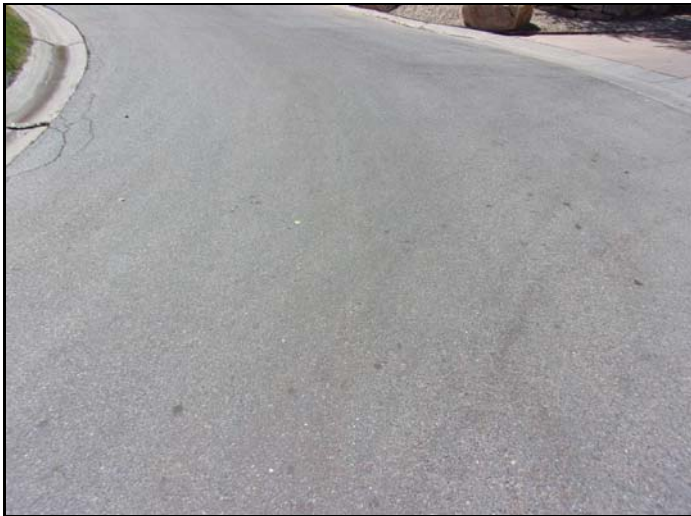
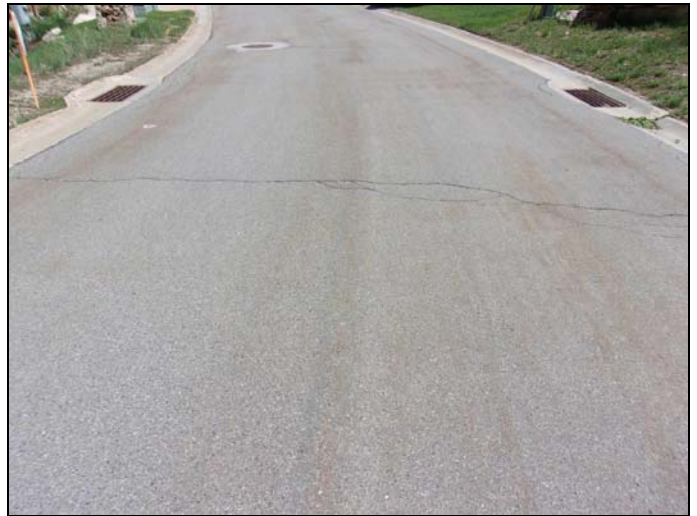
Comp #: 401 Asphalt - Silver Strike Trail - Major Rehab

The asphalt surfaces are in good condition. We recommend funding for a major rehab of this component approximately every 16 - 20 years. Remaining life based on current age.

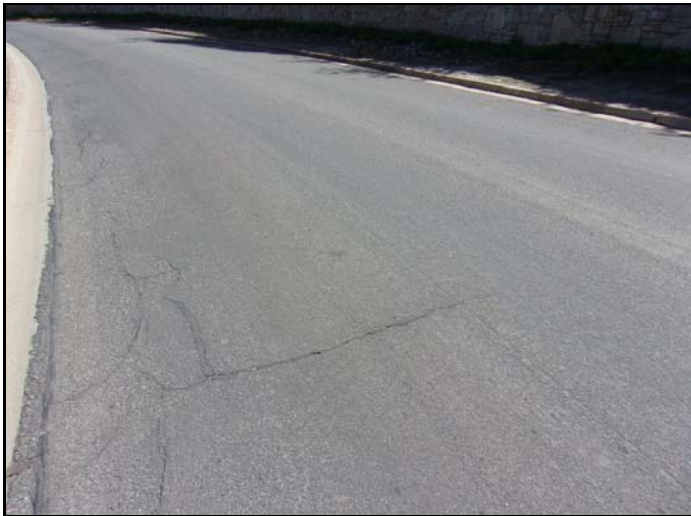
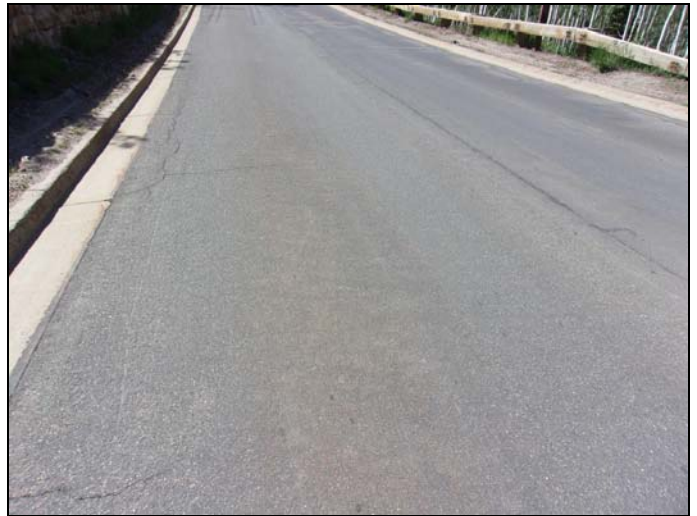
Comp #: 401 Asphalt - Twisted Branch - Major Rehab

The asphalt surfaces are in good to fair condition. We recommend funding for a major rehab of this component approximately every 16 - 20 years. Remaining life based on current age.

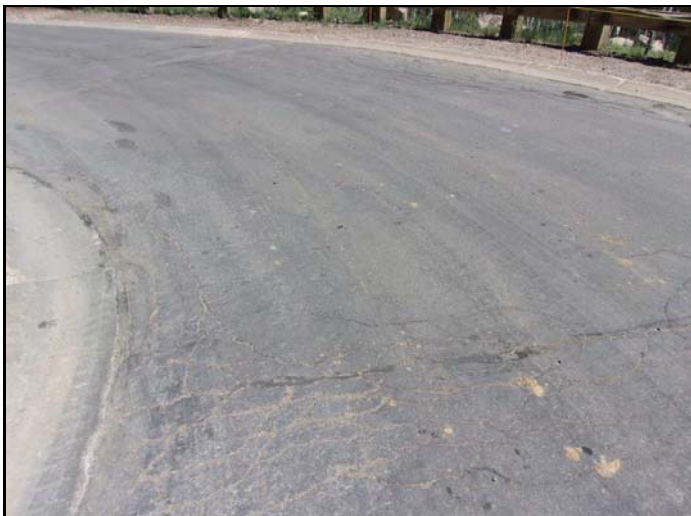
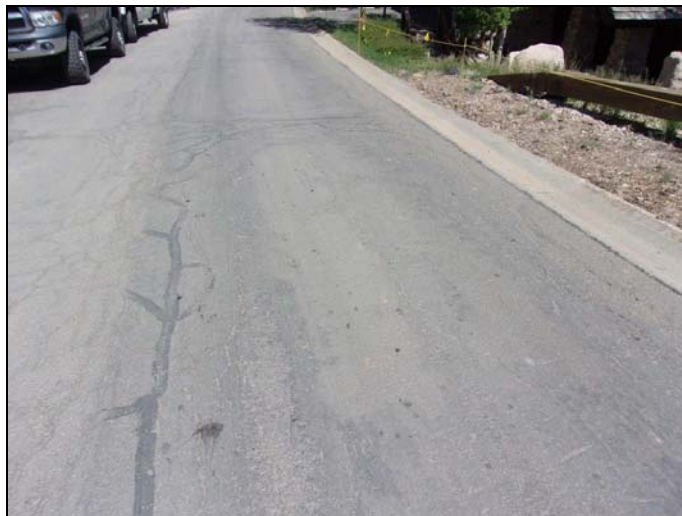
Comp #: 401 Asphalt - Village Way - Major Rehab

The asphalt surfaces are in good to fair condition. We recommend funding for a major rehab of this component approximately every 16 - 20 years. Remaining life based on current age.

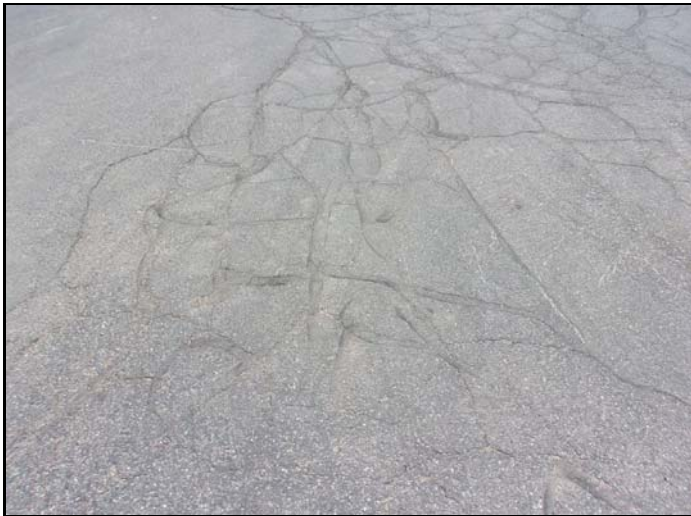
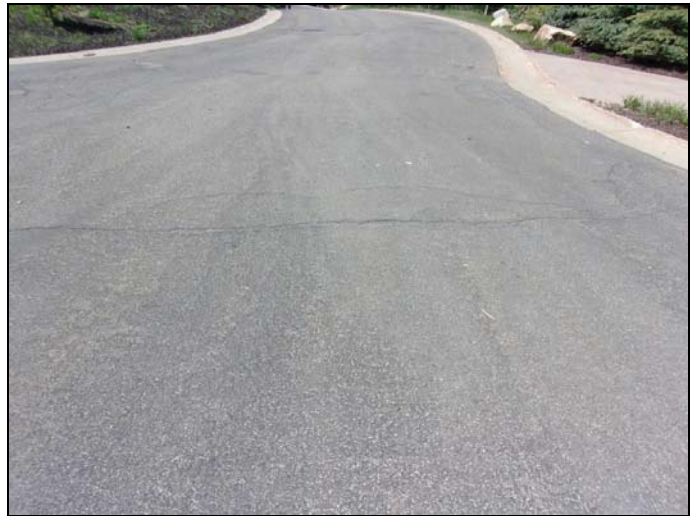
Comp #: 402 Asphalt - 2018 - Slurry Seal

The asphalt seal coat is in poor condition. We recommend funding to seal this component approximately every 3 - 5 years. Remaining life based on current condition.

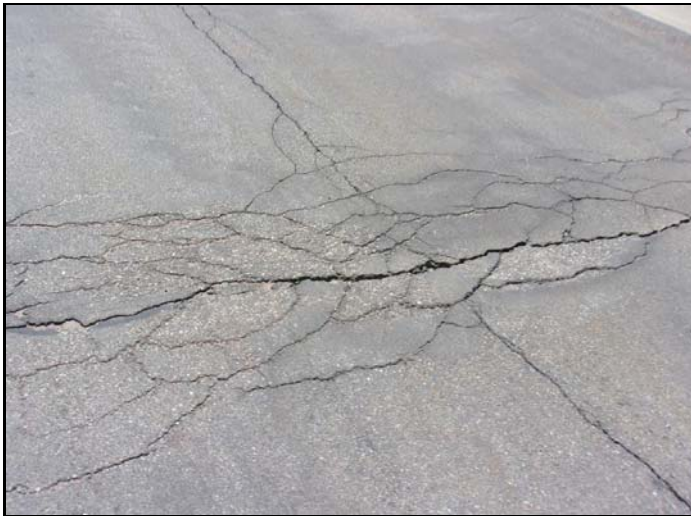
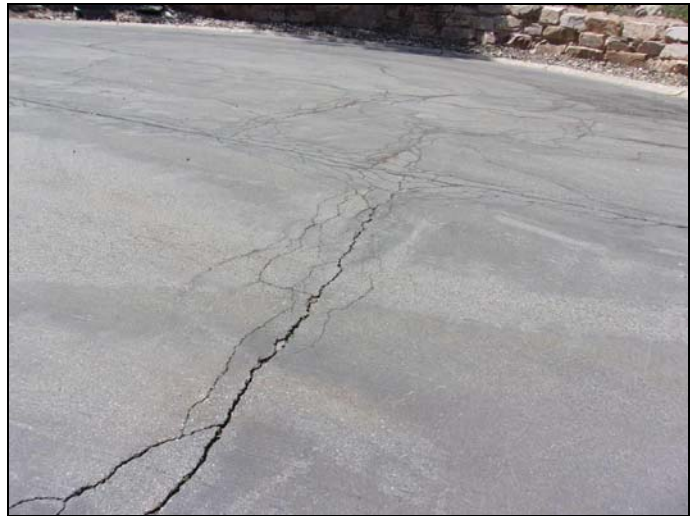
Comp #: 402 Asphalt - 2021 - Slurry Seal

The asphalt seal coat is in poor condition. We recommend funding to seal this component approximately every 3 - 5 years. Remaining life based on current condition.

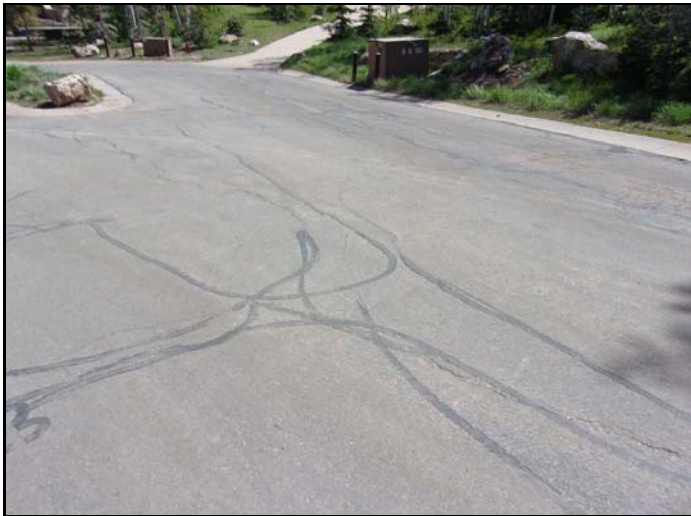
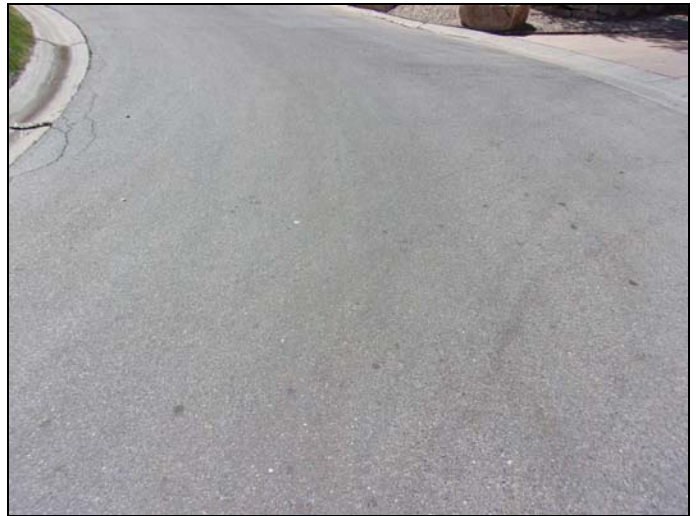
Comp #: 402 Asphalt - Slurry Seal

The asphalt seal coat is in poor condition. We recommend funding to seal this component approximately every 3 - 5 years. Remaining life based on current condition.

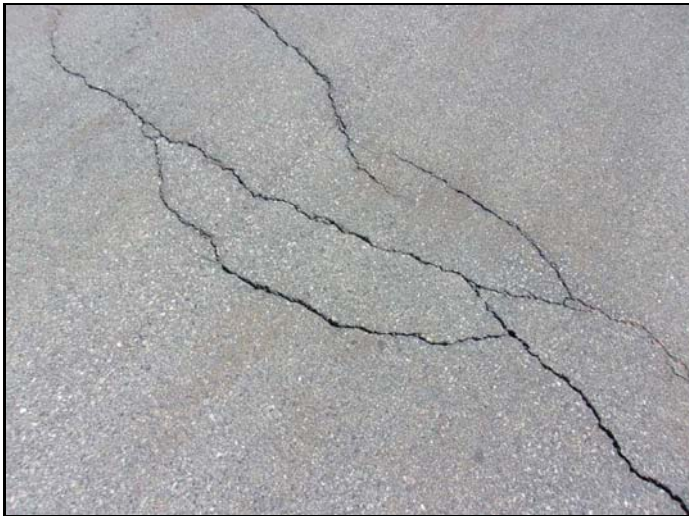
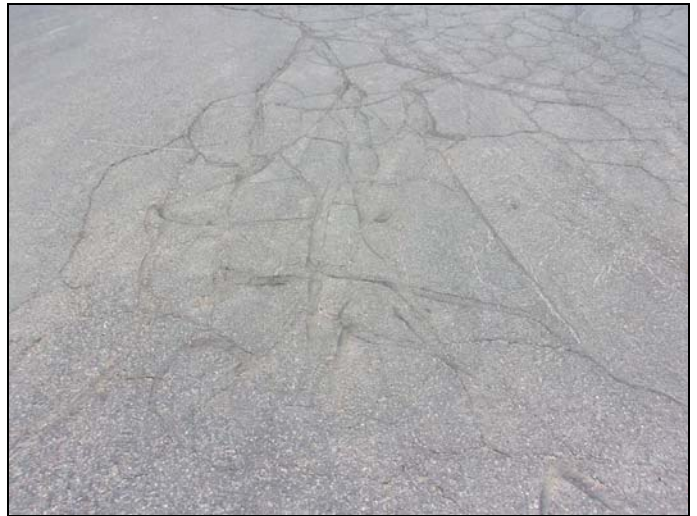
Comp #: 403 Asphalt - Crack Seal

Allowance for Crack Seal

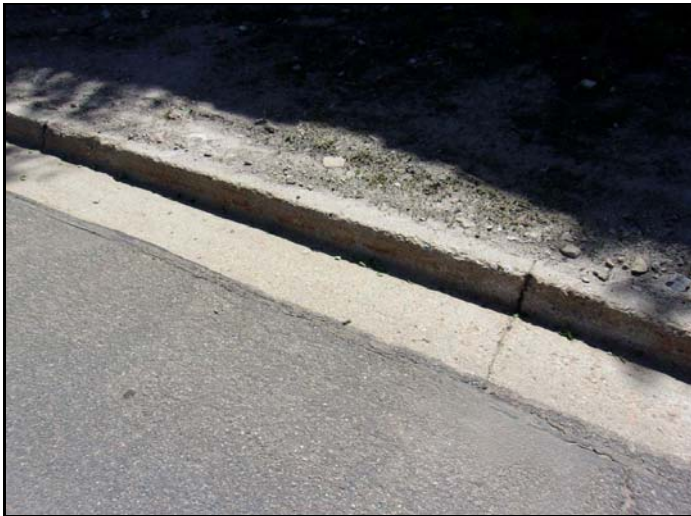
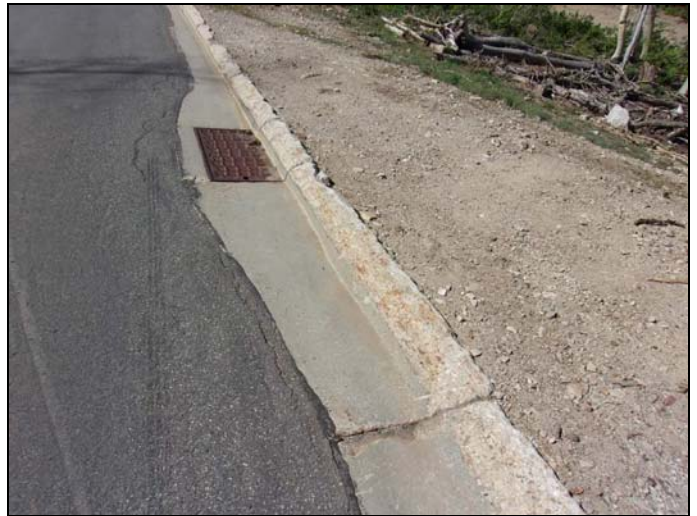
Comp #: 406 Curbing - Partial Replace

Research with the client reveals plans to partially replace this component. We recommend funding to partially replace this component every 10 years. Remaining life based on current age.

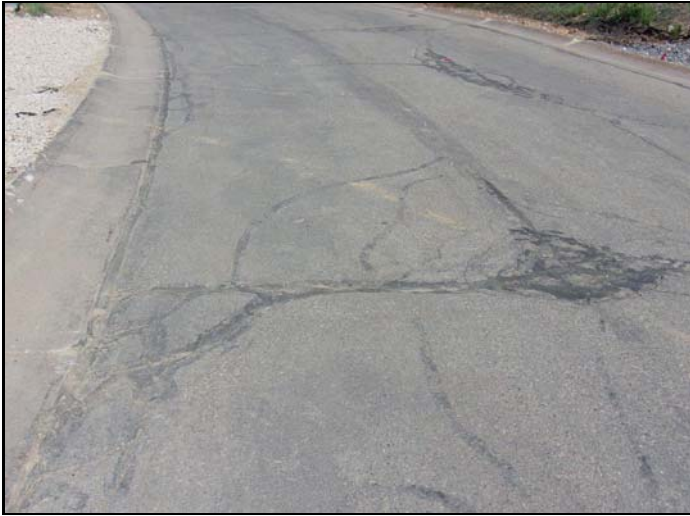
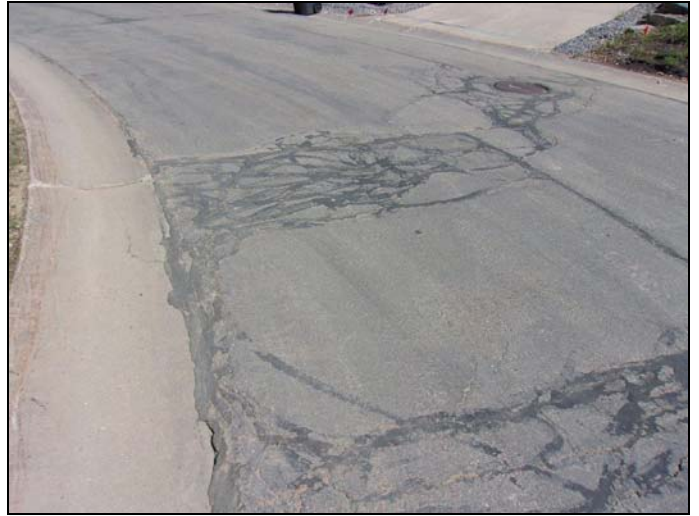
Comp #: 490 Asphalt - Ruby Hollow - Replace

Research with the client reveals this component is scheduled to be replaced in 2021. This is a one-time project

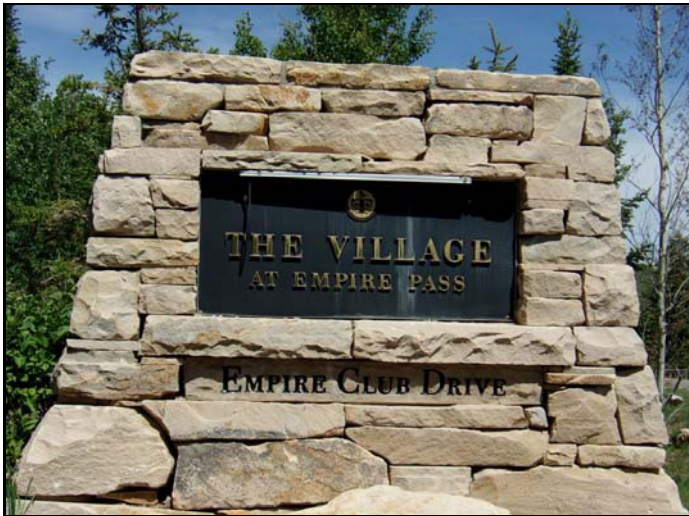
Comp #: 801 Monument Signs - Refurbish

The monument signs are in good to fair condition. We recommend refurbishing this component approximately every 15 - 20 years. Remaining life is based on current age and condition.

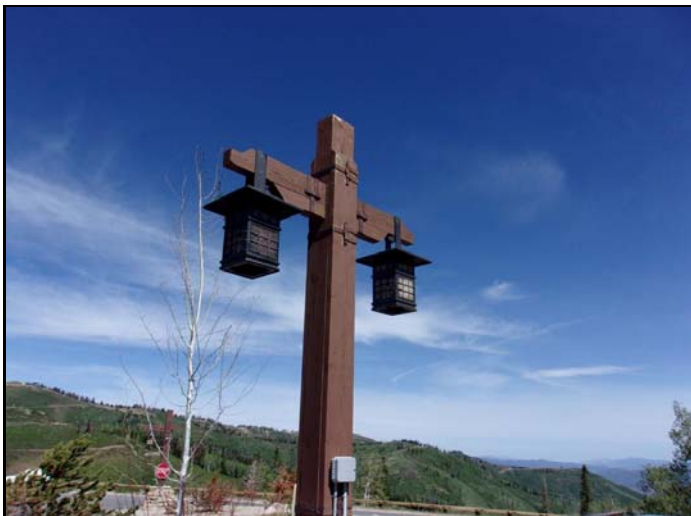
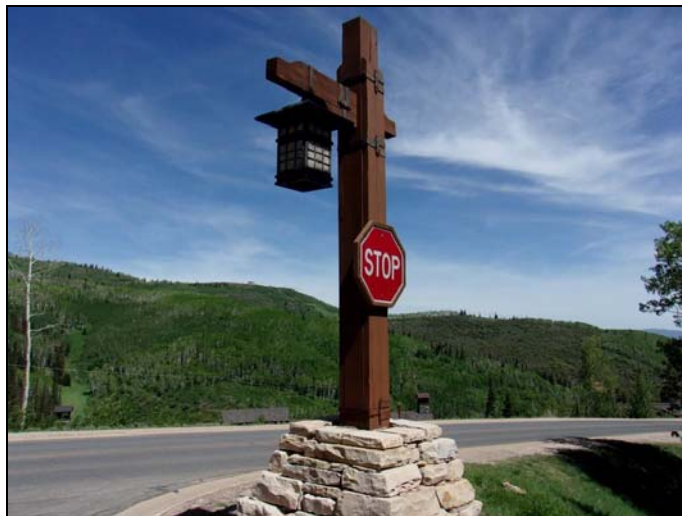
Comp #: 808 Sign Posts - Install/Replace

**(18) - Pole Light Posts
(24) - Road Sign Posts
(10) - Street Sign Posts**

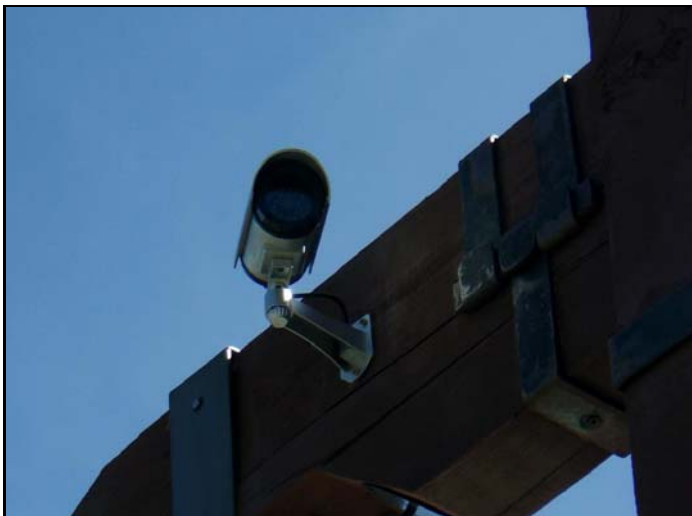
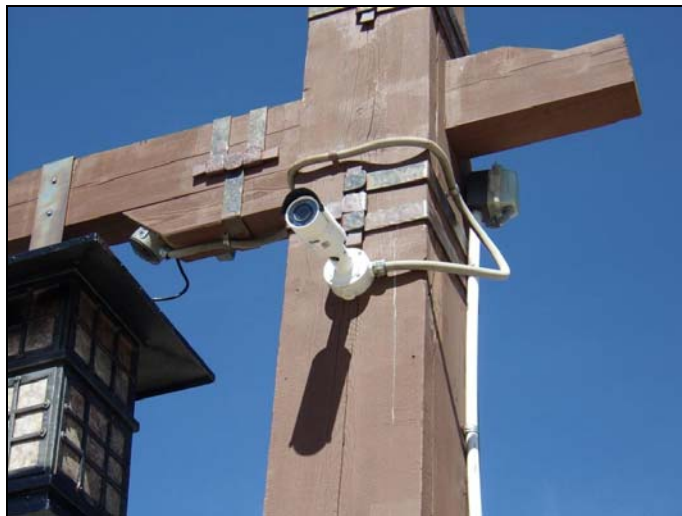
Comp #: 903 Camera System - Replace

The security camera system is in working condition. We recommend funding to replace this component approximately every 8 - 10 years. Remaining life based on current age.

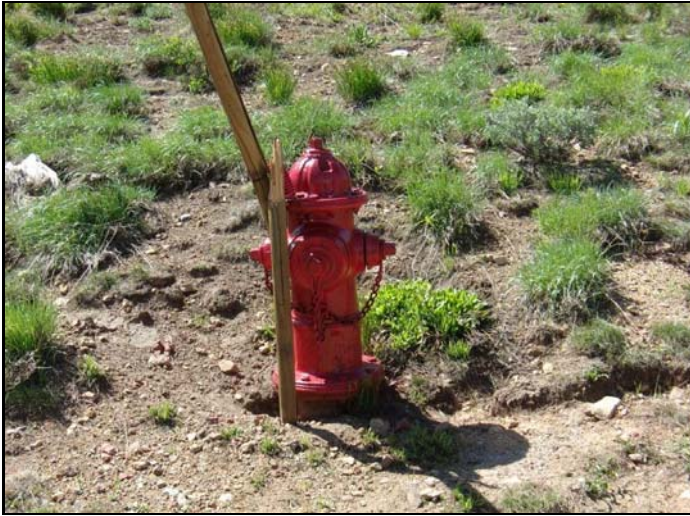
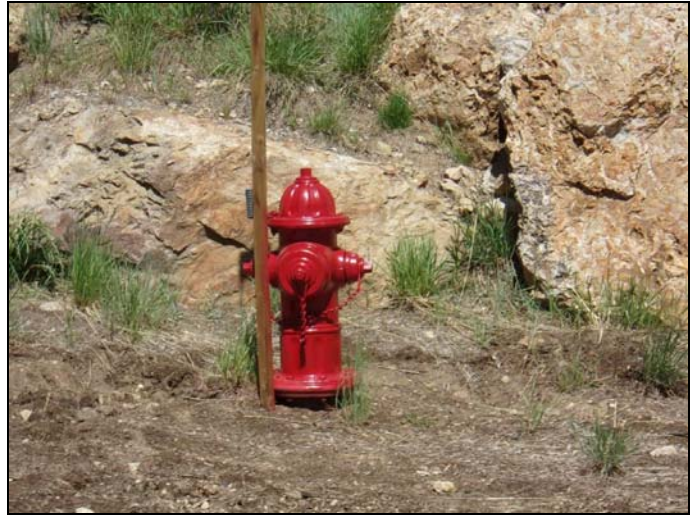
Comp #: 990 Fire Hydrants - Repair/Replace

The fire hydrant system is in working condition. We recommend funding to make repairs/replacements to this component approximately every 3 - 5 years. Remaining life based on current age.

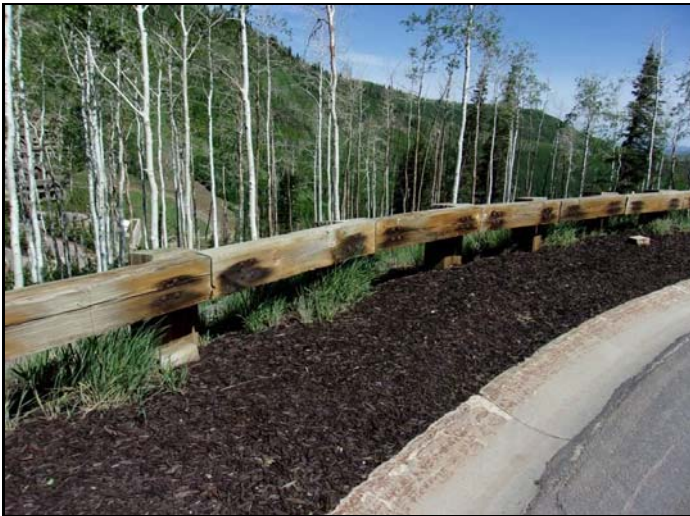
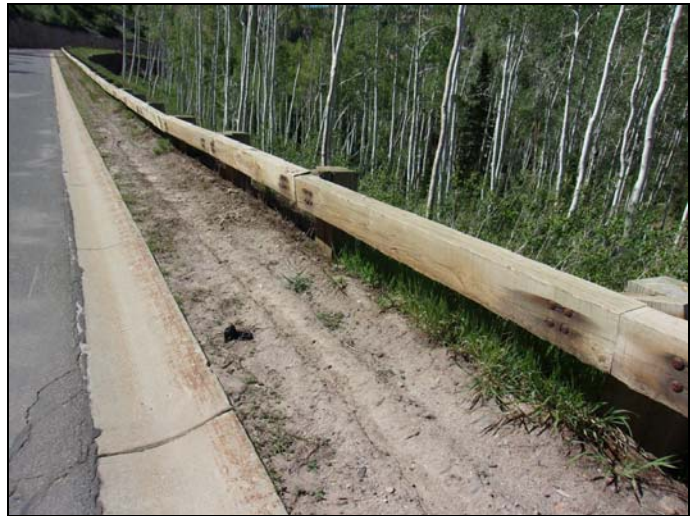
Comp #: 1007 Guard Rails - Repair

Research with the client reveals this component is inspected and repaired yearly.

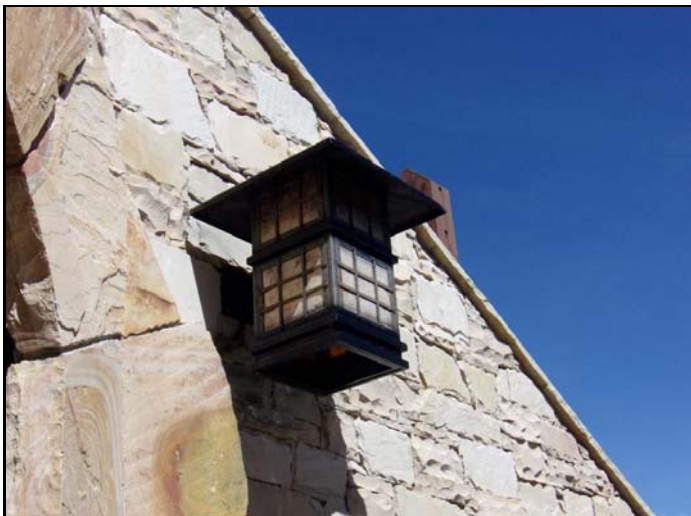
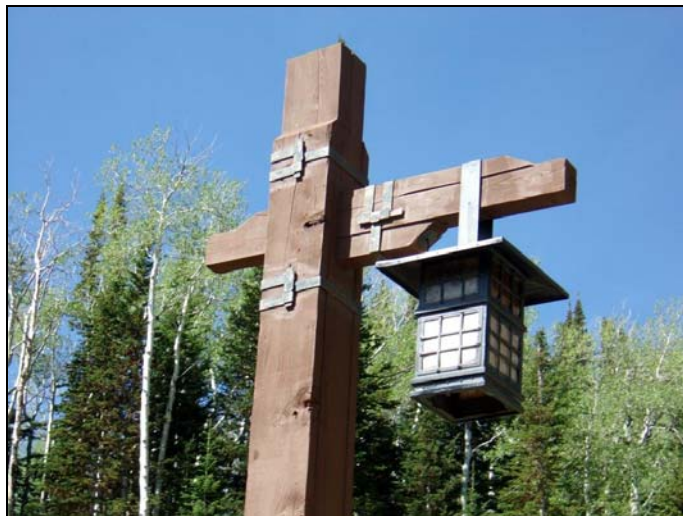
Comp #: 1604 Bridge & Pole Lights - Replace

(23) - Total Lights

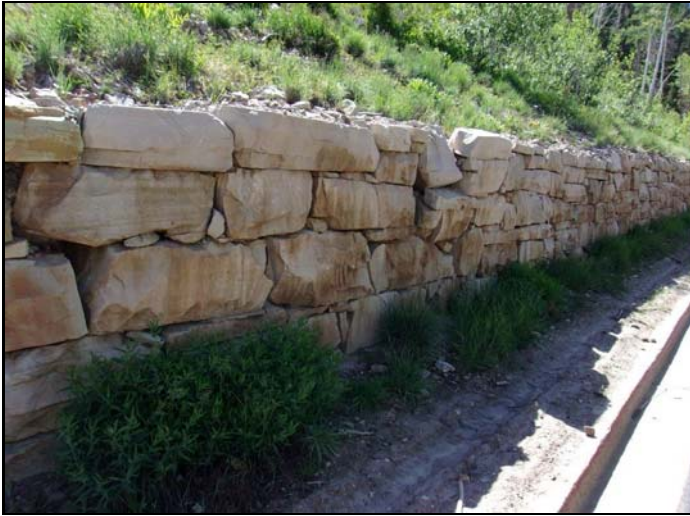
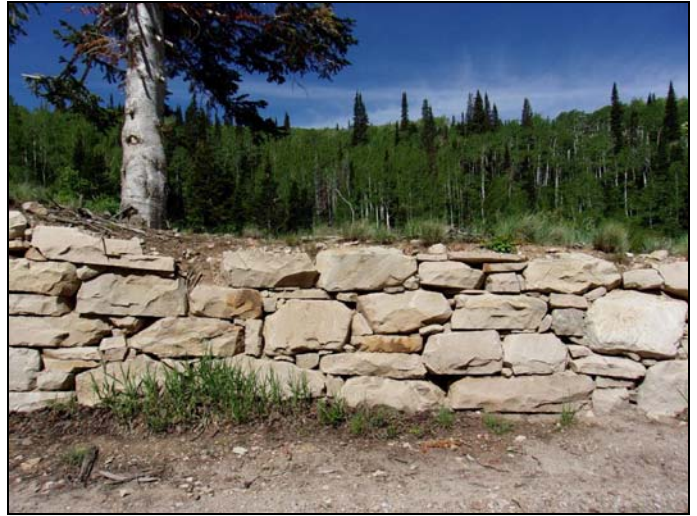
Comp #: 1890 Retaining Walls - Repair

Allowance to repair

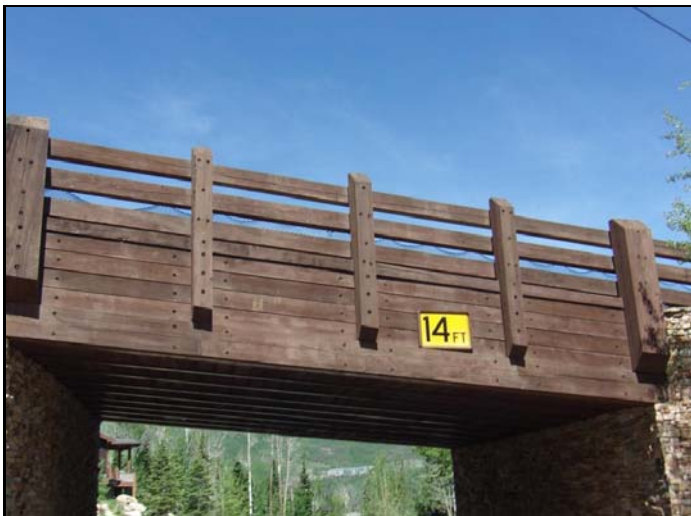
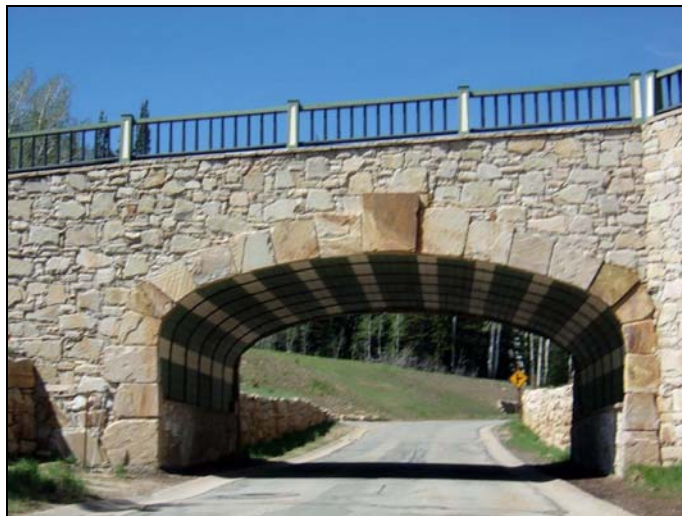
Comp #: 2302 Bridges Surfaces - Refurbish

(1) - Tunnel
