Empire Pass Master Owner's Association

Level 2 Reserve Study

Type of Study	Update w/Site Visit
Date of Property Inspection	6/11/2020
Prepared By	Dale Gifford
Analysis Method	Cash Flow
Funding Goal	Full Funding

Report prepared on – Thursday, July 16, 2020

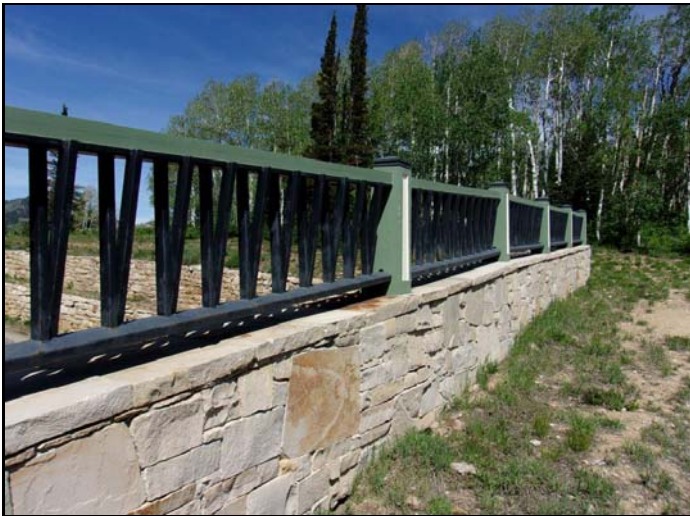
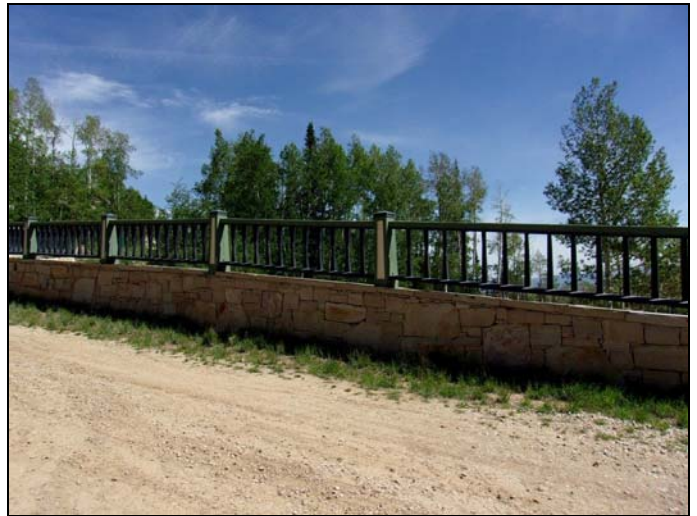
Comp #: 2302 Metal Bridge - Maintenance

Quantity: **(1) Bridge**
