Lab 3 – Riveted Joints

Section 5, Group 5

09/22/2023

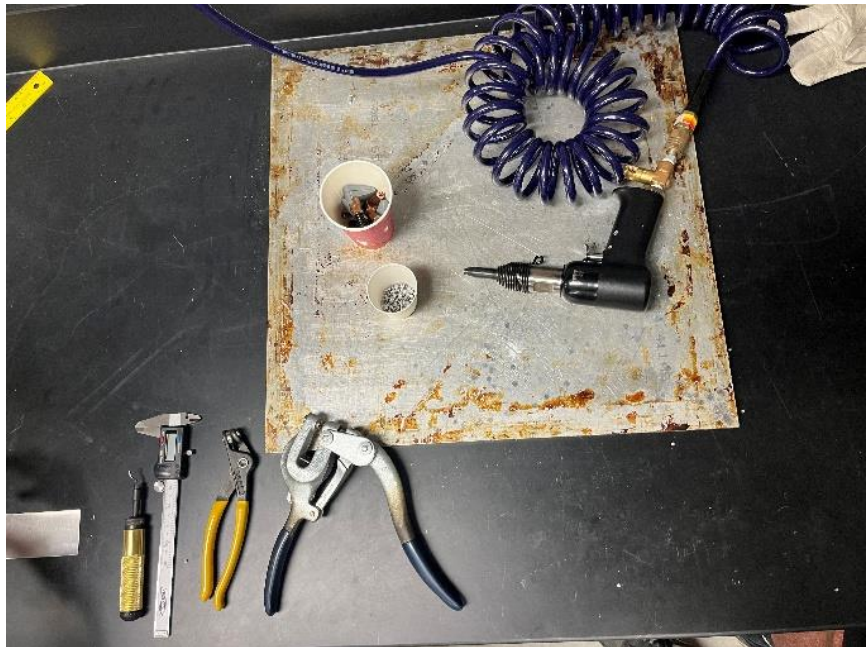
Figure 1. Riveting tools

Once the rivet design was chosen by the group, a little bit of practice riveting needed to be done before the final product was made. To the right in Figure 1, you can see that the lab provided all the necessary equipment to make our rivets.

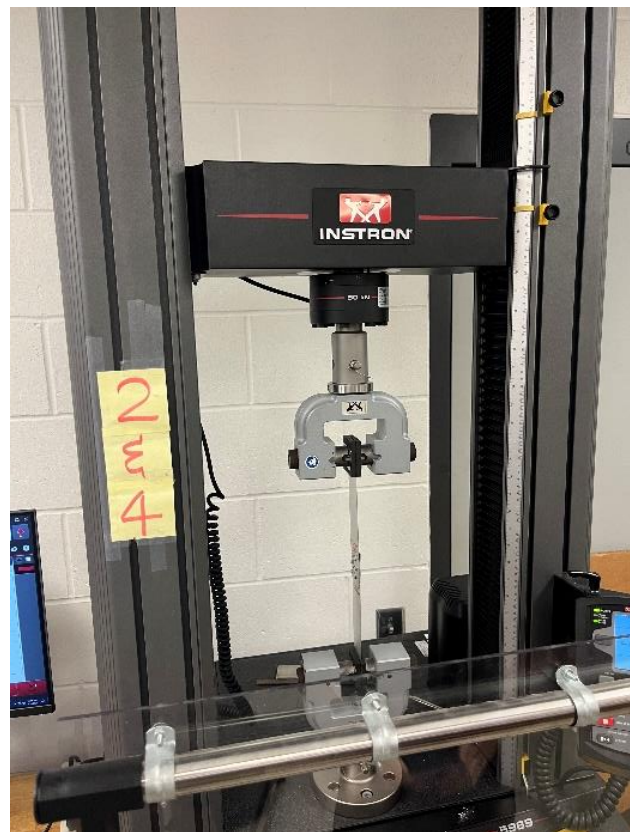
Figure 3. Instron dual-column materials testing system

The two aluminum sheets riveted together were then tested to failure with a tensile test using the Instron dual-column materials test system (Figure 3). The test system was connected to a computer, which was used to collect data. Once the data was collected, the lab was finished.

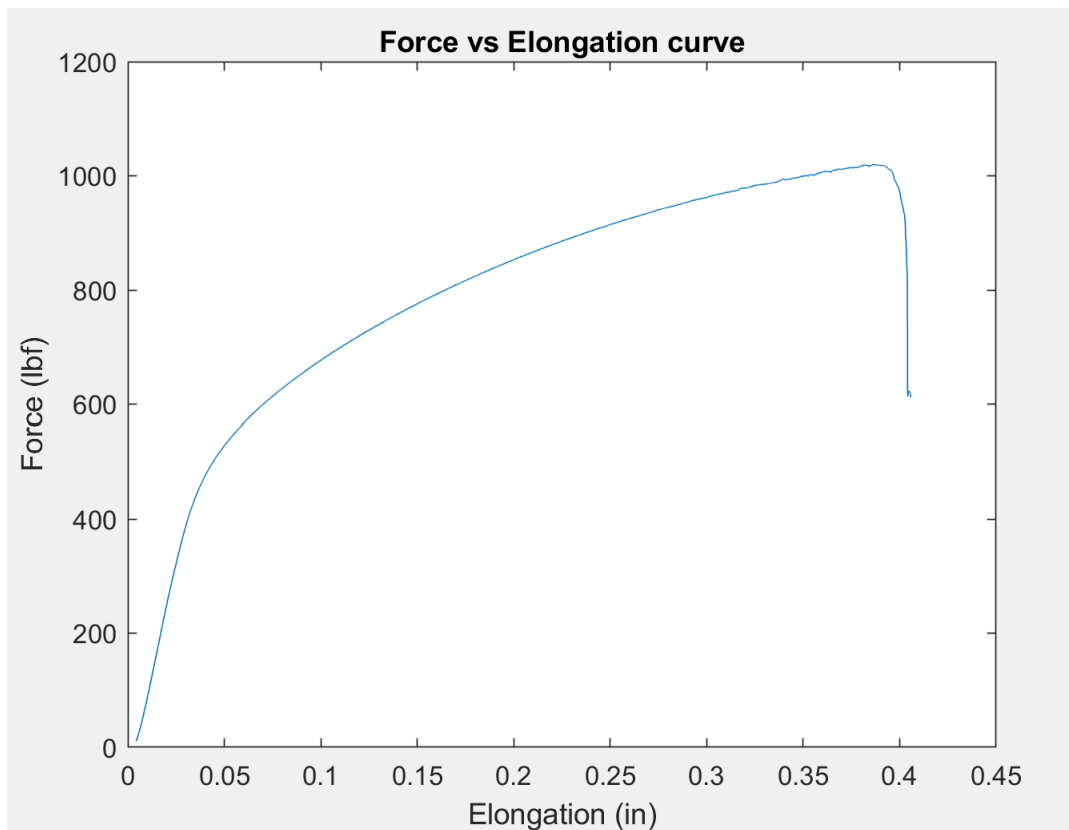
Figure 4. Force vs. elongation curve

We can observe on the Force vs Elongation graph the elastic and plastic deformations. The elastic deformation is represented by the linear section of the curve, on bottom left. The plastic deformation is represented by the curvilinear section of the curve. At around $F = 1019\text{lb}$ and deformation = 0.39in , the rivet panel failed by tension in the first row, as observed in Fig. 5.
